Talbot Mackenzie & Associates
Consulting Arborists

2220 Cook St, Victoria

Construction Impact Assessment & Tree Preservation Plan

Date of Issuance: March 26, 2019

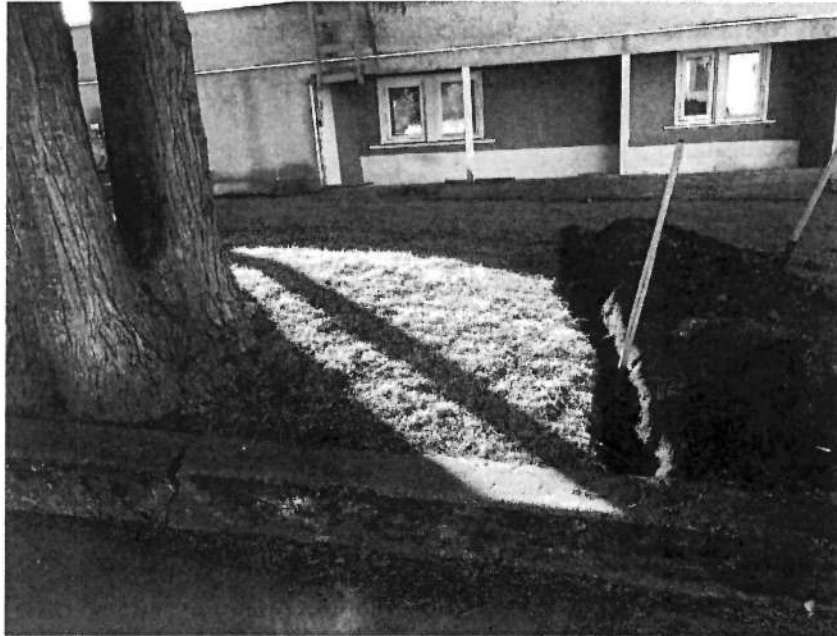
Photo 1

Exploratory excavations were completed by hand-digging a narrow trench, 1.6m west of the trunk of the tree, beginning from the existing retaining wall and ending 2-3m from the retaining wall at the house. The depth explored was 45 to 50cm below existing grade (at or below the grade of the existing sidewalk). Only three roots were observed within the trench (all were retained): one 7cm in diameter, one 2.5cm, and one 1cm. In our opinion, the loss of these roots alone is unlikely to significantly impact the health or stability of the tree. It should be noted that the root disease *Phytophthora* is responsible for the decline of Lawson Cypress trees locally and could rapidly infect and lead to the decline of the tree at any time.

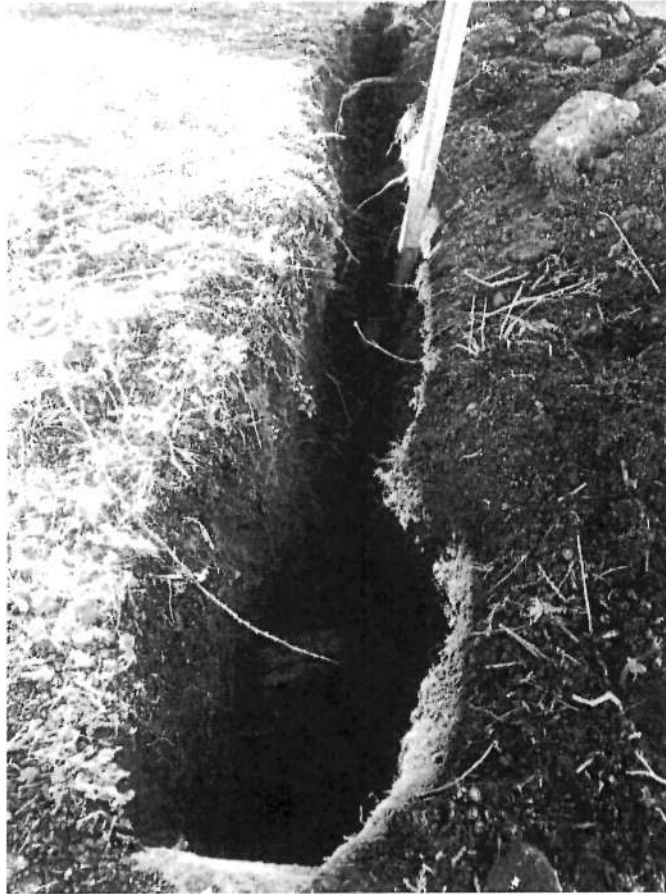
Photo 2: 7cm diameter retained root in foreground near existing retaining wall.

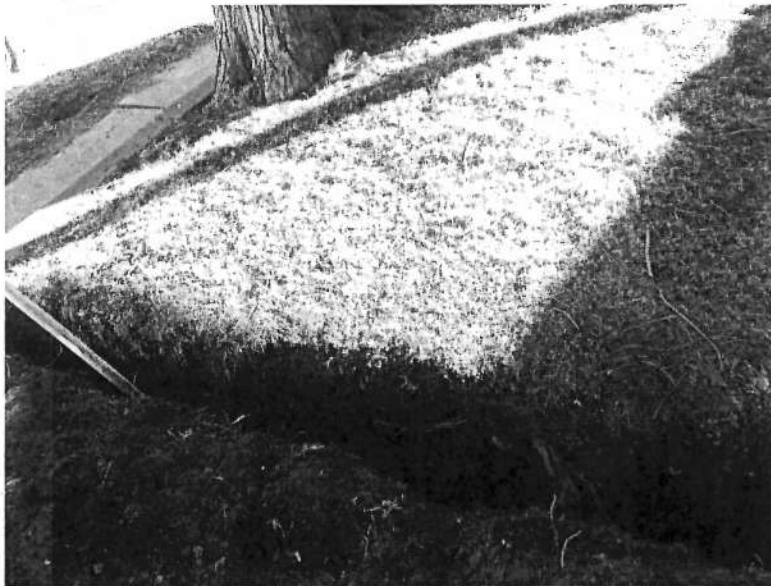
Photo 4: 2.5cm retained root on the right side within the trench.
