PARKWAY APARTMENTS

1050 PANDORA AVENUE, VICTORIA, BC

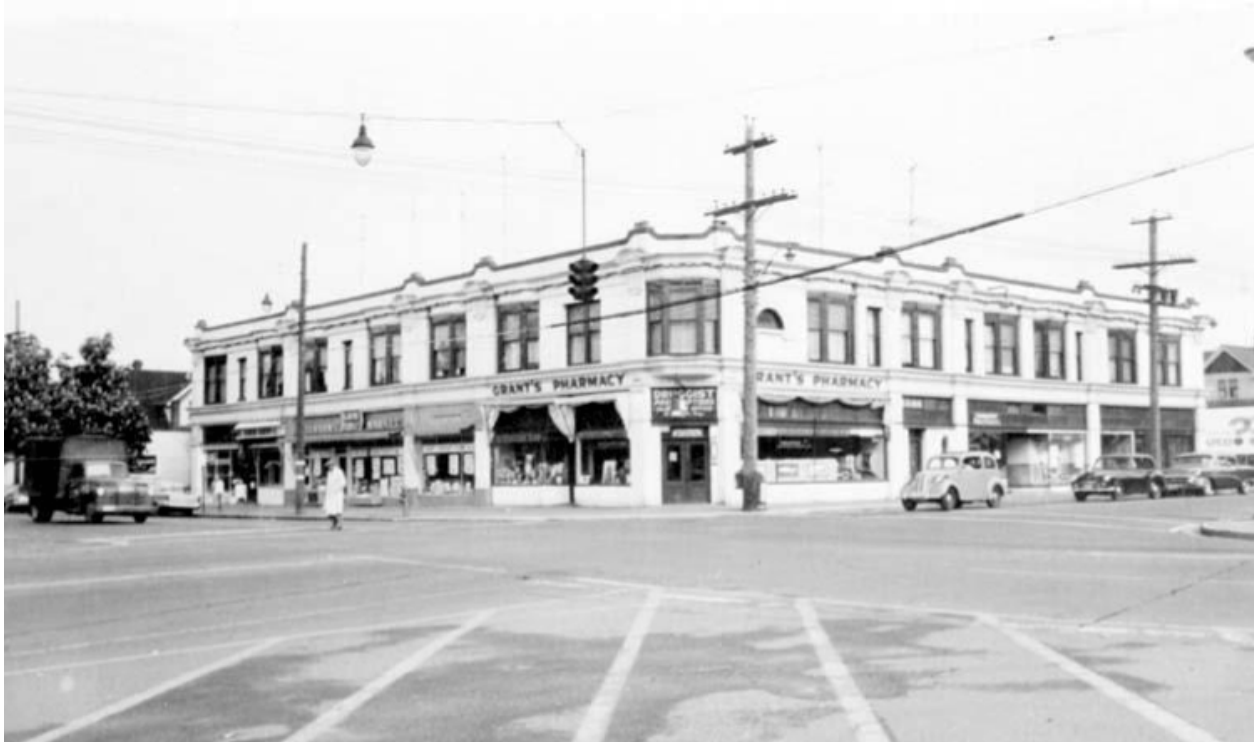
Above: Wellburn's Market before it had taken over nearly the entire ground floor, 1960, CVA M01462

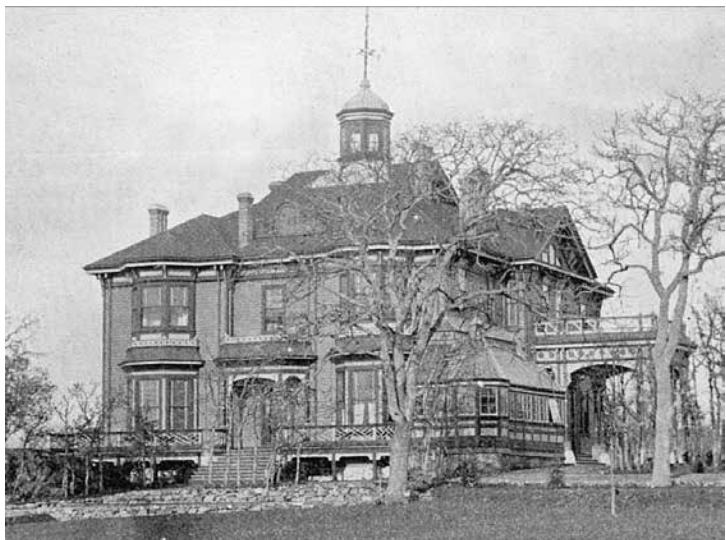
2.0 HISTORIC CONTEXT

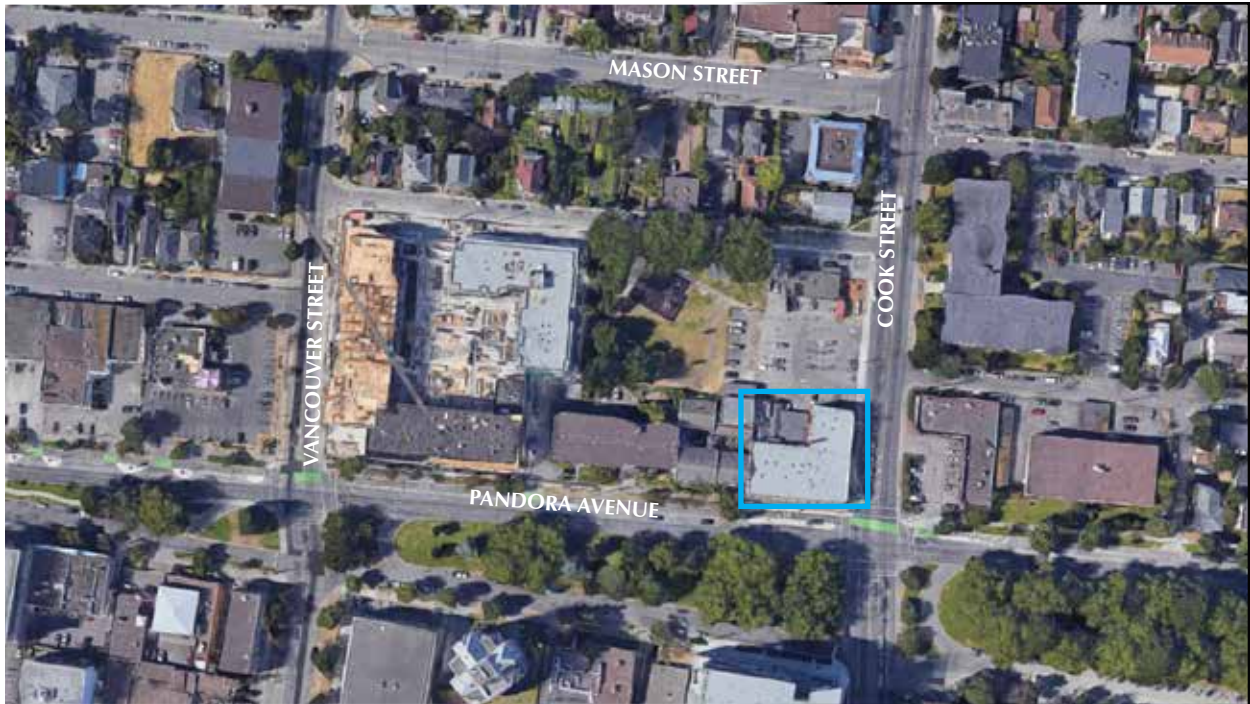
Above: Parkway Apartments (within blue box) and adjacent streets in Victoria.

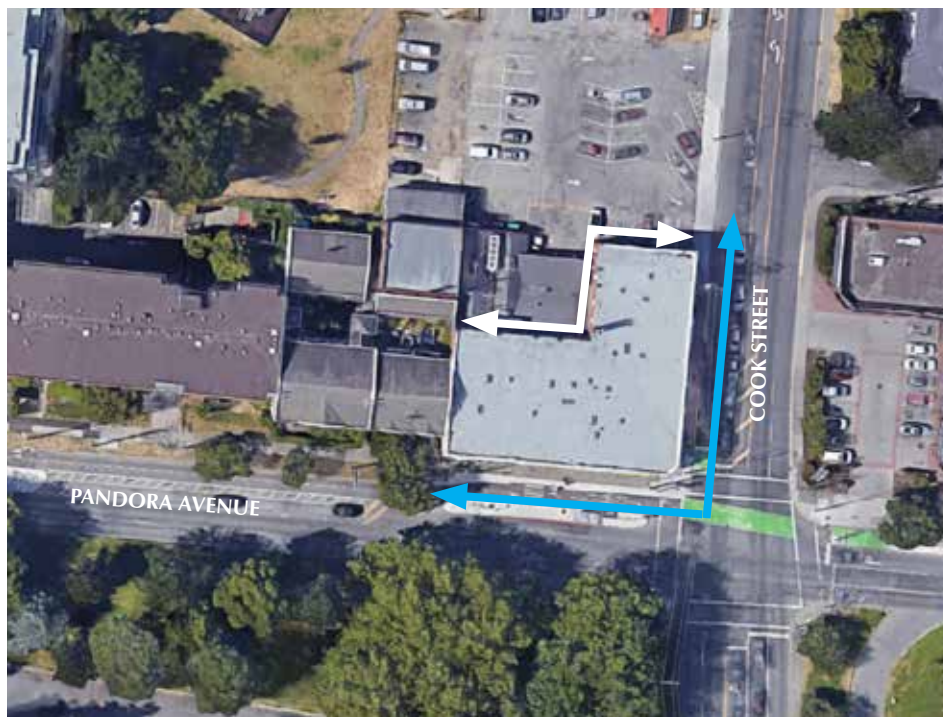
Above: For reference clarification “street” façades are those noted in blue arrows and “non-street” façades are those in white arrow.

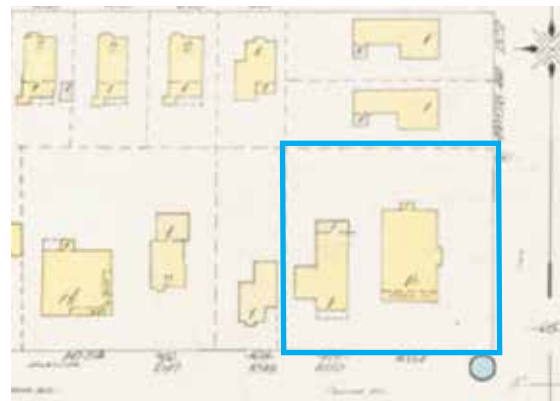
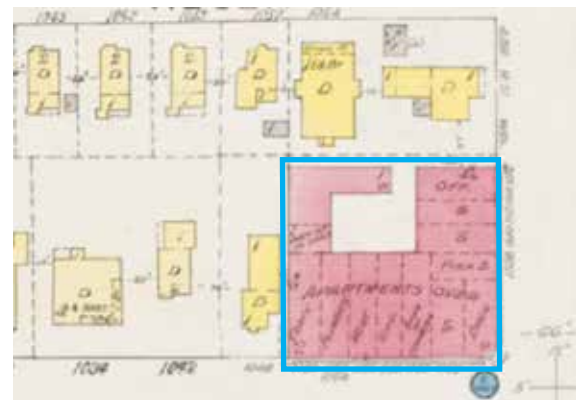
Top: Insurance Plan of Victoria, British Columbia 1903, revised 1909, showing northwest corner of Pandora Avenue and Cook Street.

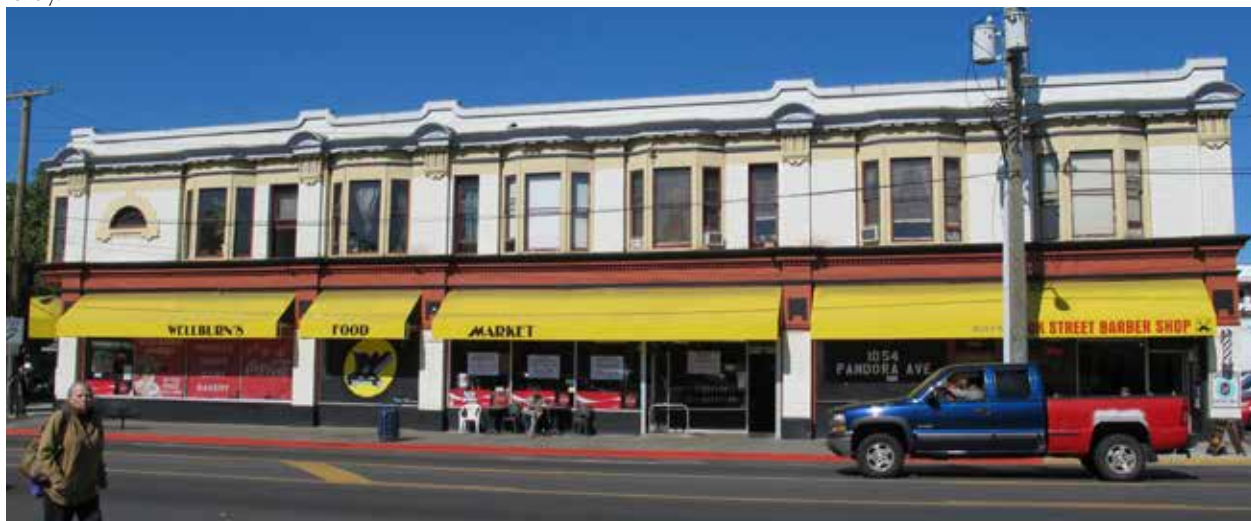
5.0 CONSERVATION RECOMMENDATIONS

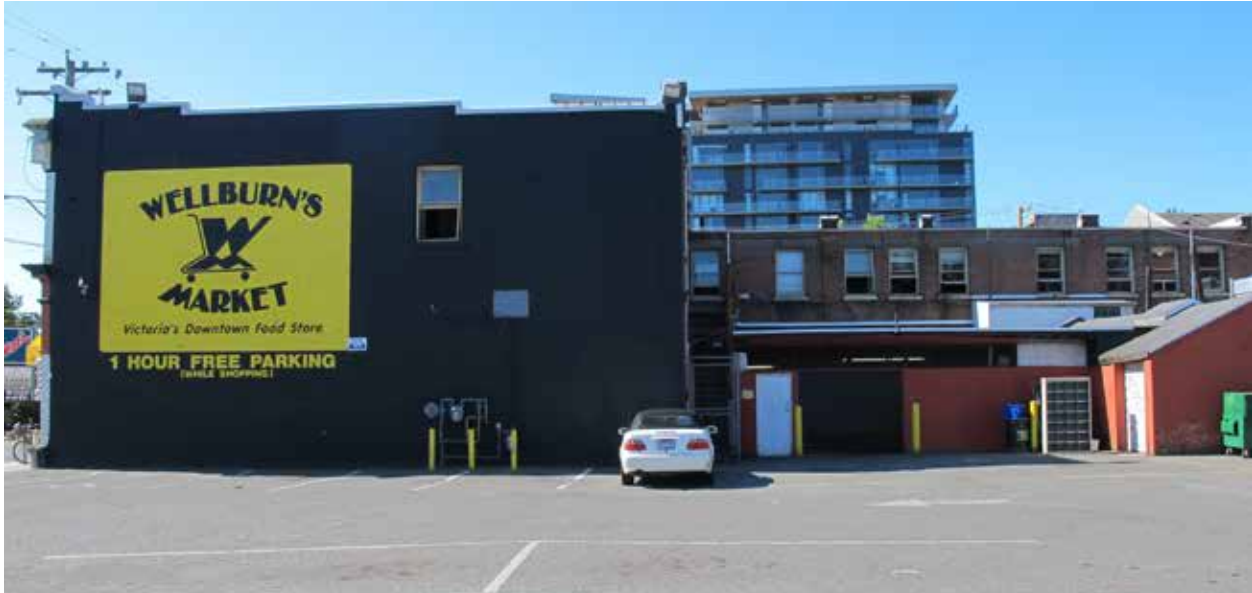
Above: “Non-street” (north) façade of Parkway Apartments showing later added additions to the rear of the building and parking lot located adjacent and to the north of the building.

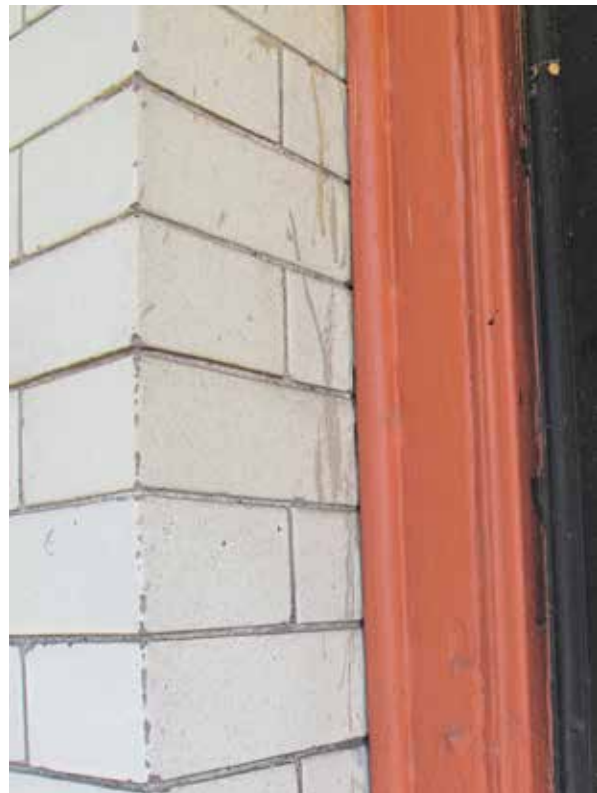
Above: Typical brick damage of chips and paint on brick face from painting adjacent wood elements, present on both "street" façades.

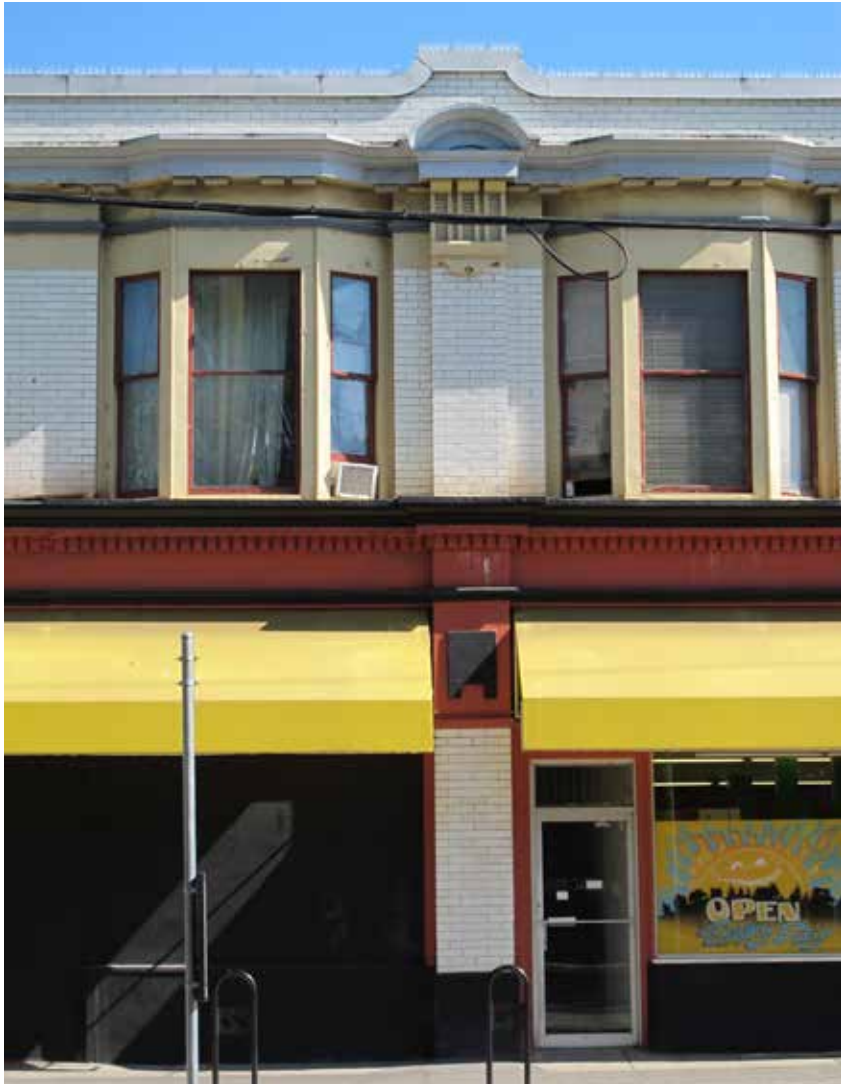
Left: Exterior of “street” façades with brick laid in running bond with white mortar. Brick present on pilasters separating storefront bays, second floor walls, and parapet. Overall in good condition with local areas of deterioration.

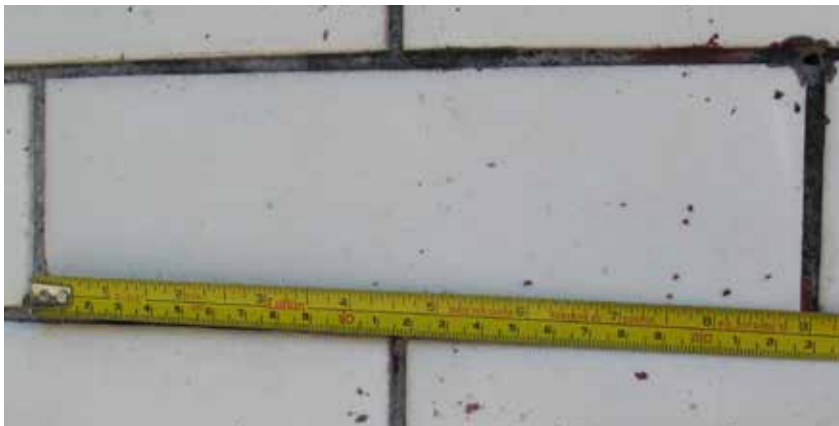
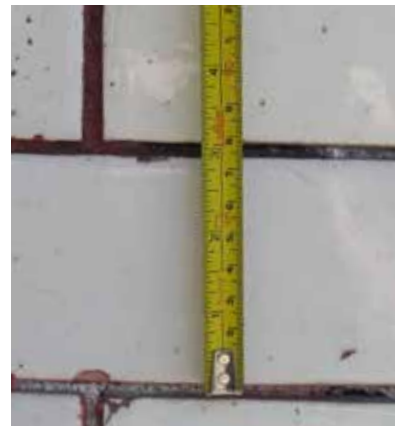
5.0 CONSERVATION RECOMMENDATIONS

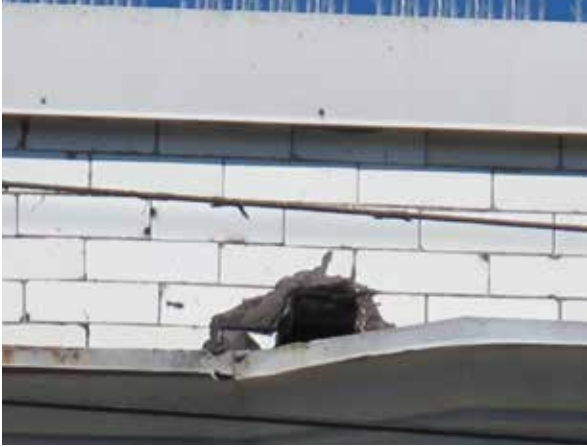
Above: Later installed scupper above roof cornice on Cook Street façade. Weather proofing material applied onto the face of the parapet.

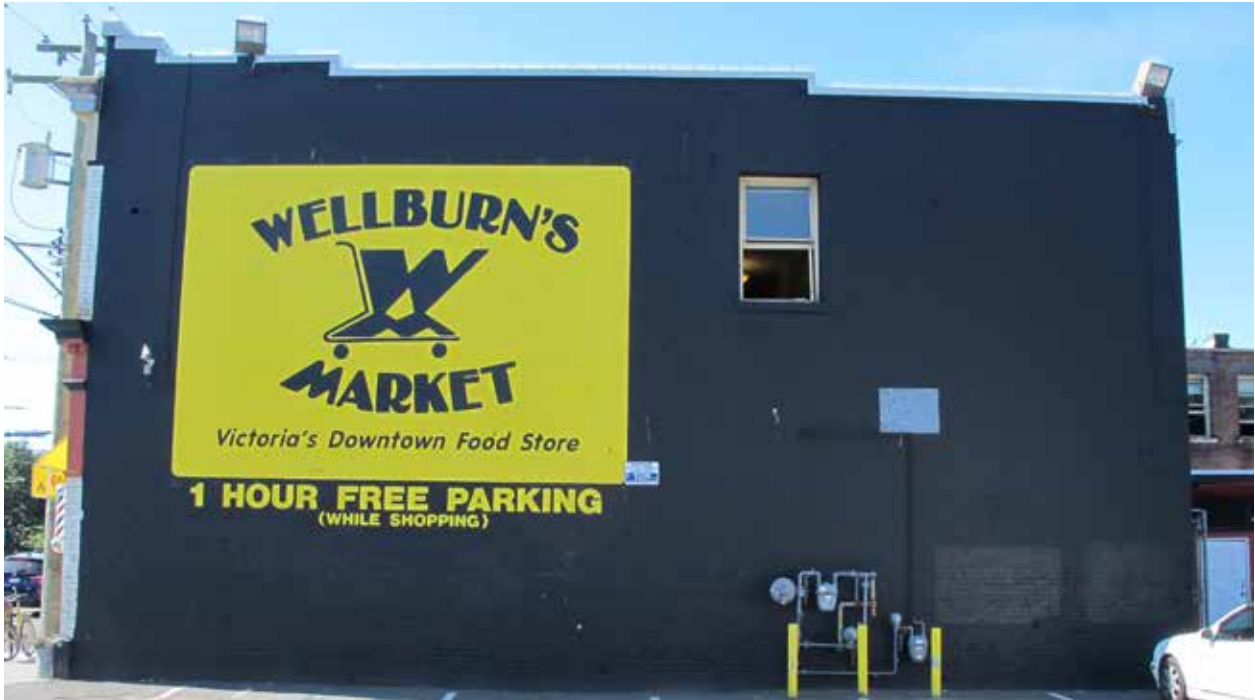
Above: Painted brick of the north façade. Paint is a later intervention and limits assessment of underlying brick. Surface damage to some brick and mortar loss present in areas at base of wall at approximate height of car mufflers and bumpers.

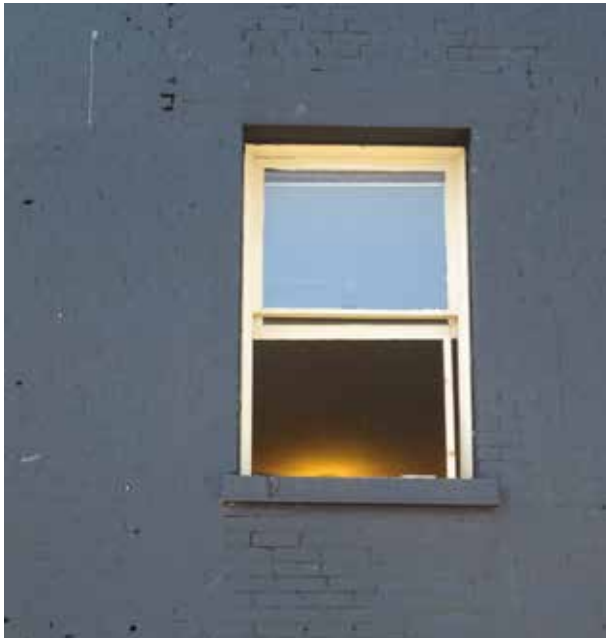
Above: Typical example of mortar loss and unpatched past penetrations in brick wall on “non-street” façade.

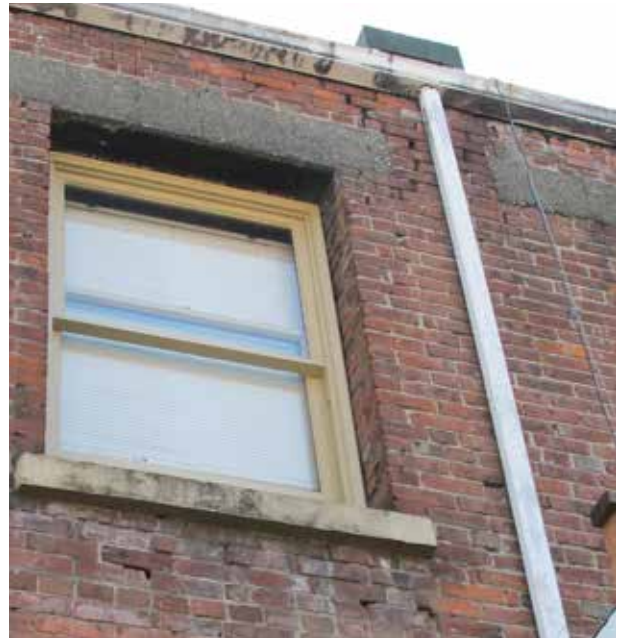
Above: Mortar loss, distortion of brick, and staining on rear of building likely caused by overflowing gutters and undersized downspout.

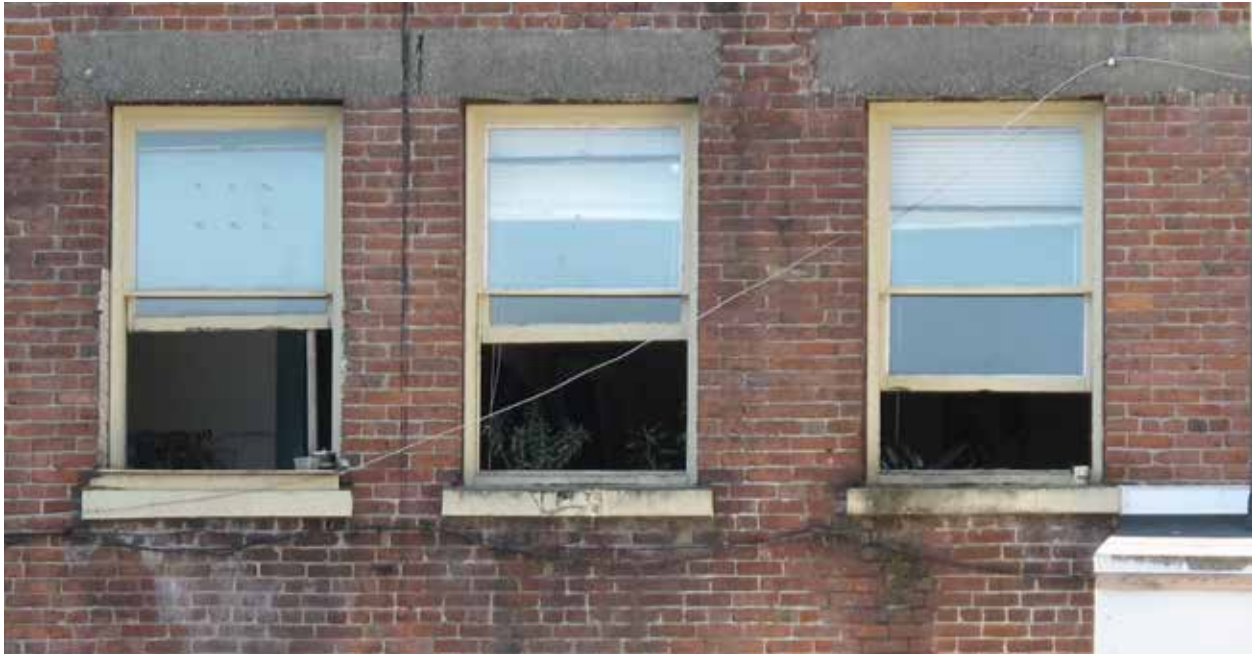
Above: Typical deterioration of masonry on rear of building including staining, cracked bricks, mortar loss, efflorescence and past unsympathetic repairs.

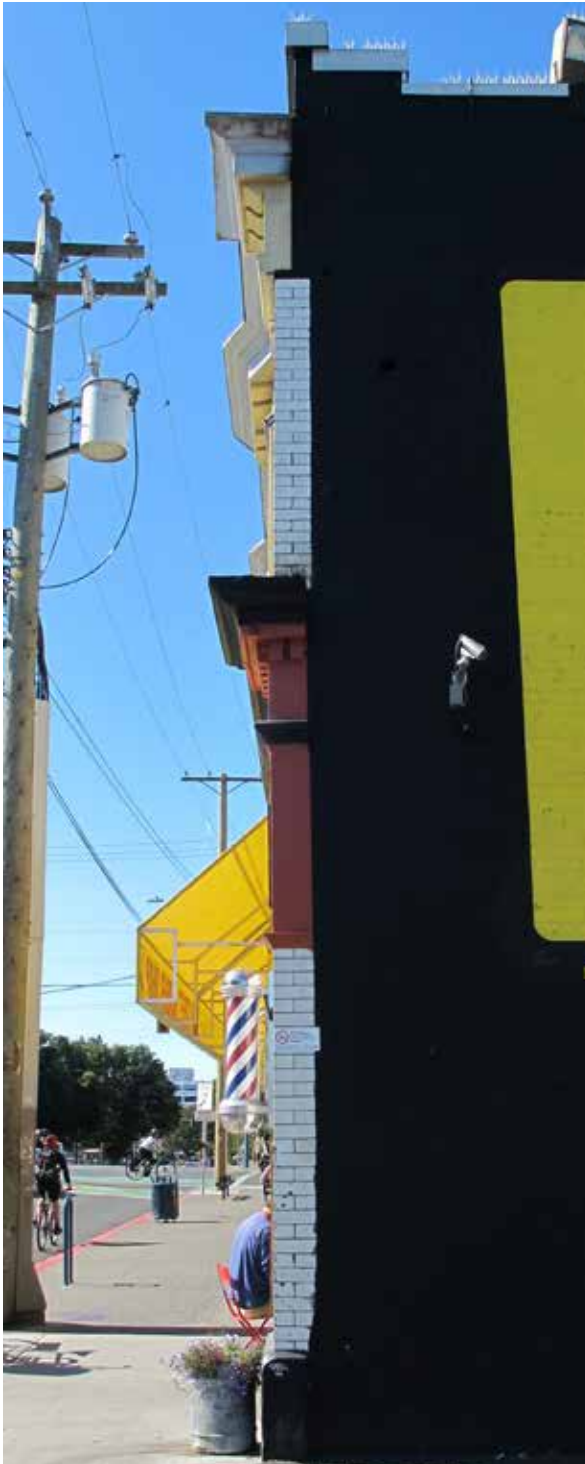
Above: Profile of storefront and roof level cornices that are present on Pandora Avenue and Cook Street façades.

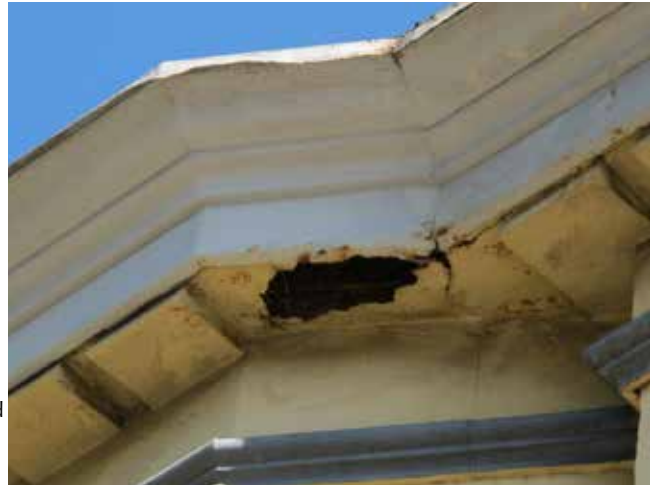
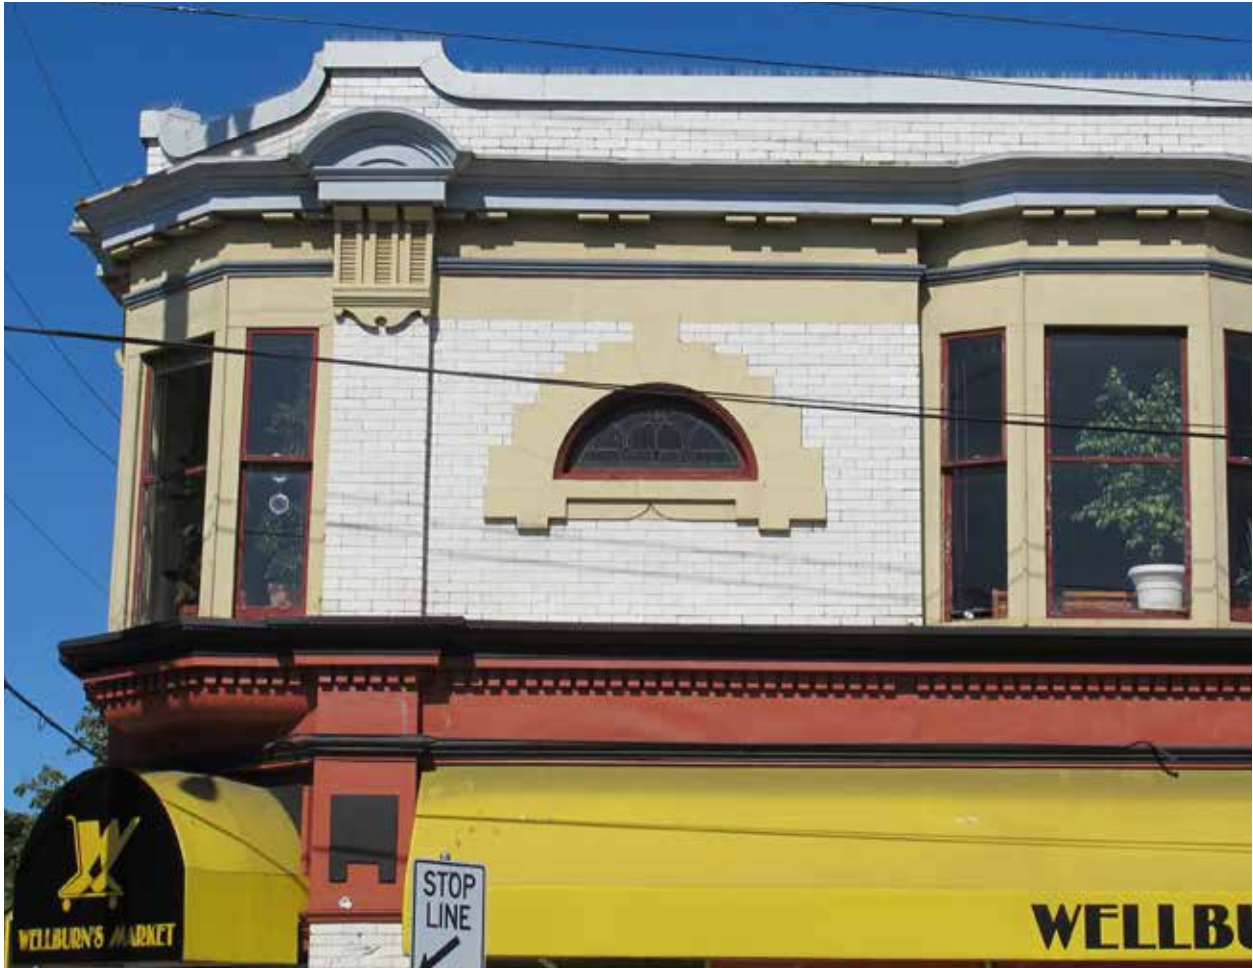
Above: Architectural metalwork of the storefront cornice, brick piers, oriole windows, roof level cornice and parapet cap.

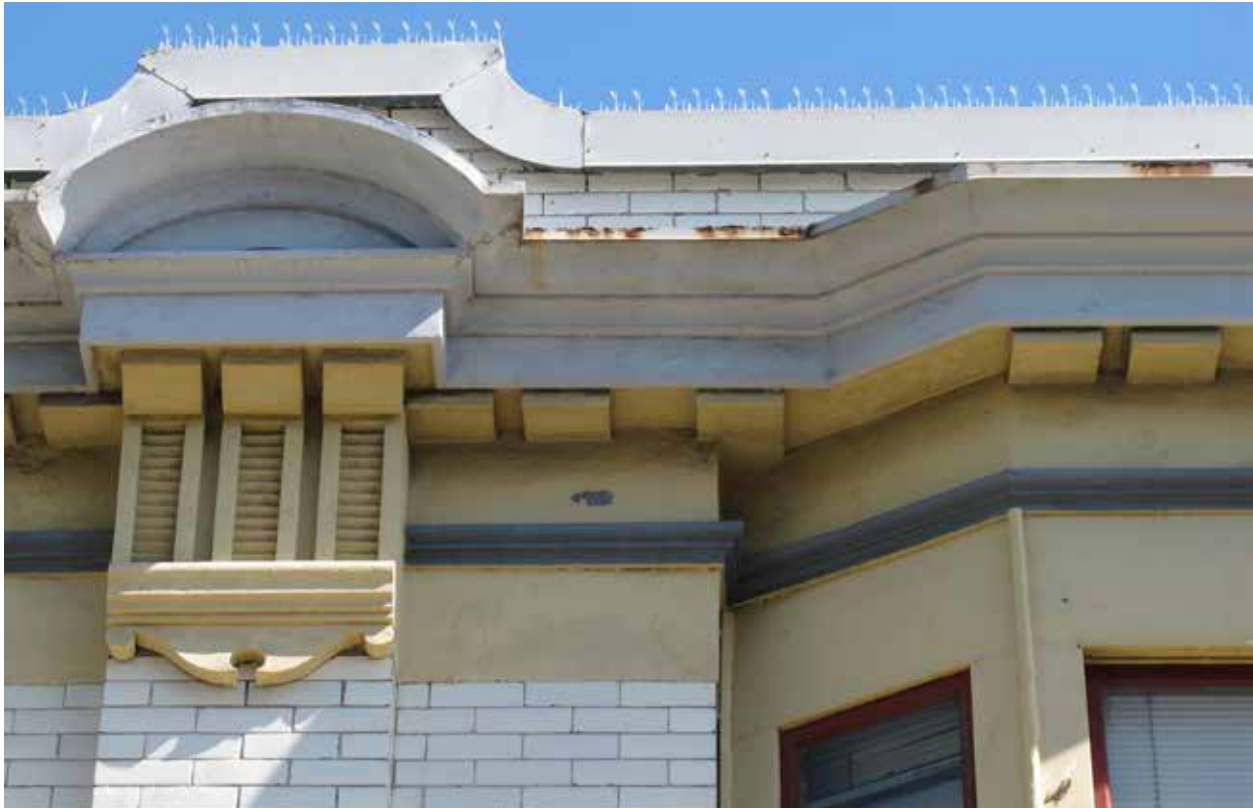
Above: Metal work of oriole windows, roof level cornice, top of brick pilasters, and parapet cap flashing. Paint failure evident and corrosion of drip edge on cap of cornice evident. Gap between parapet cap flashing and wall face noted. Bird spikes on parapet later addition.

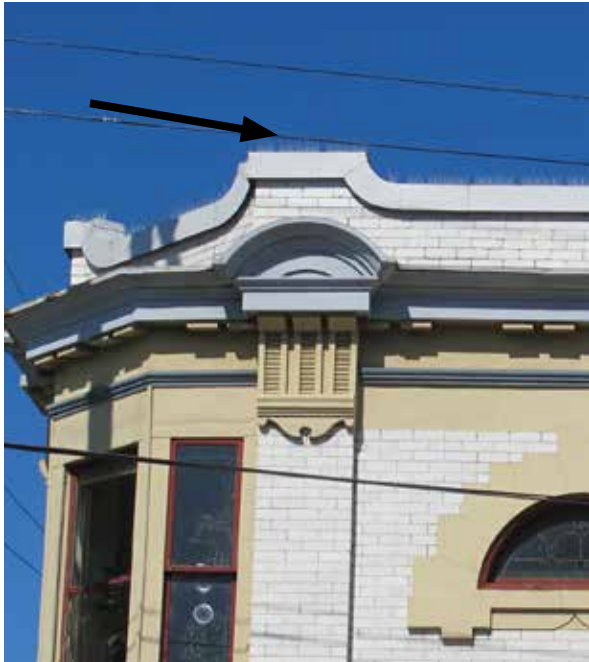
Above and Below: Pairs of cylindrical ‘chimney’ elements that were once present on top of each raised section of the parapet along the Pandora Avenue and Cook Street façades. These were removed post-1960, perhaps at the time the cap flashing was replaced and/or bird spikes installed.

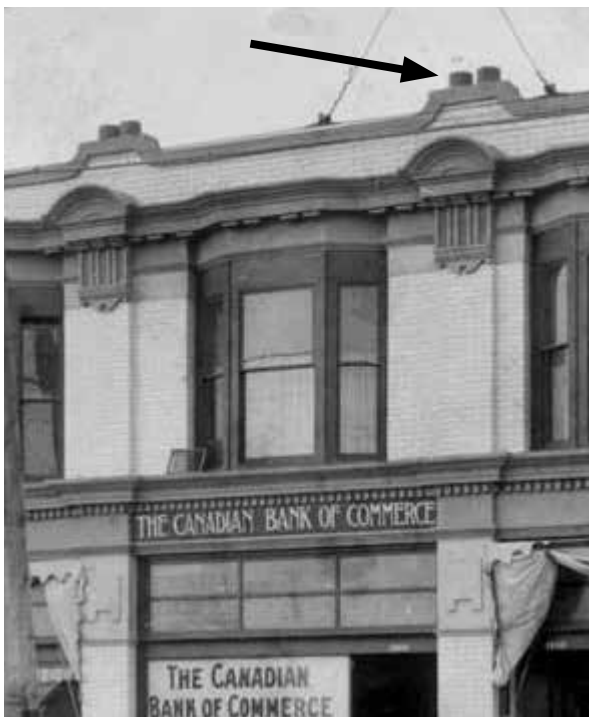
protection, maintenance and limited repair or replacement in kind is required.

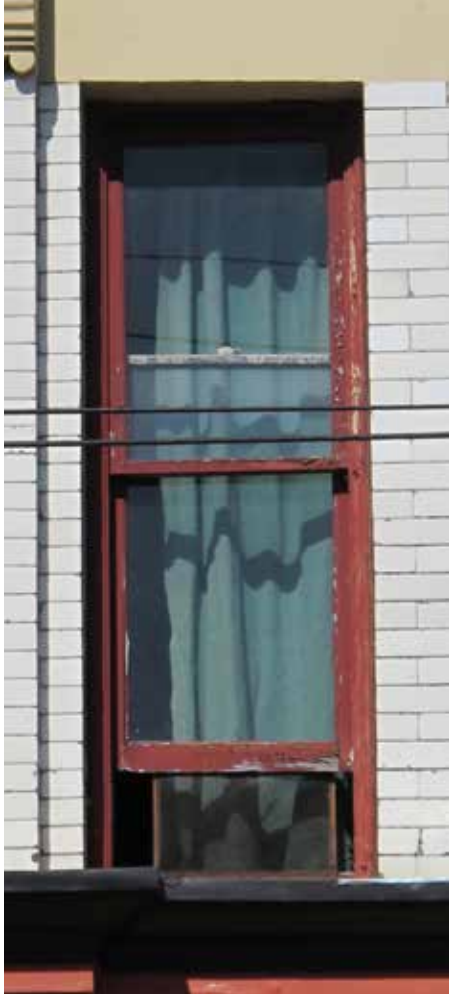
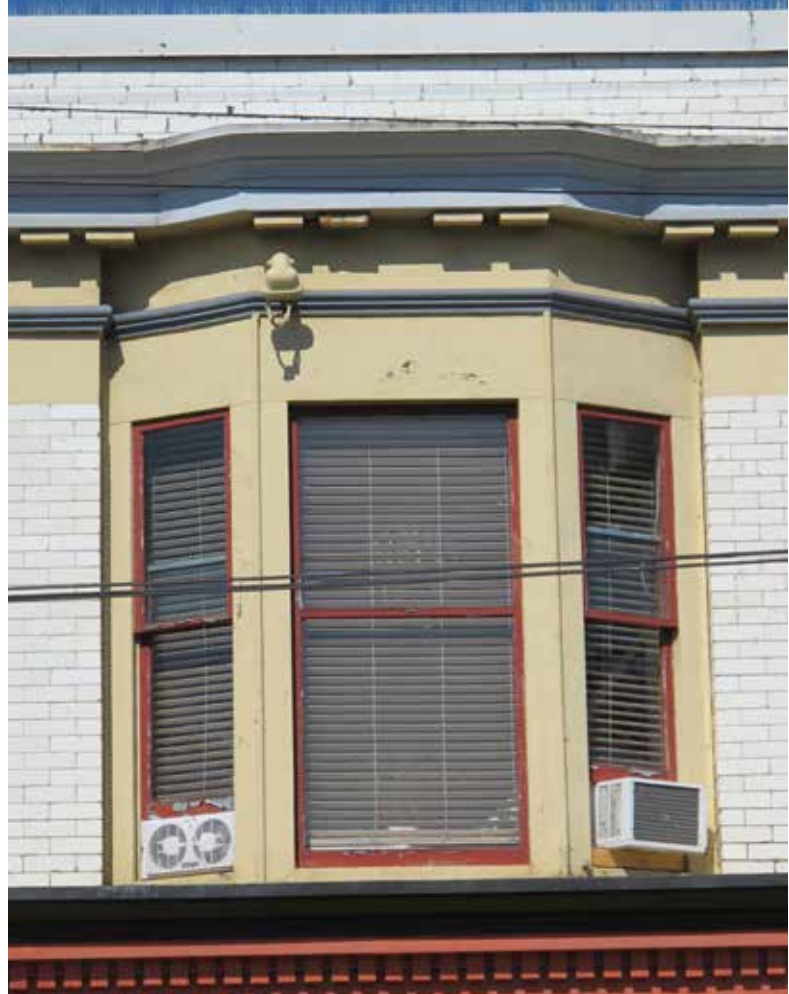
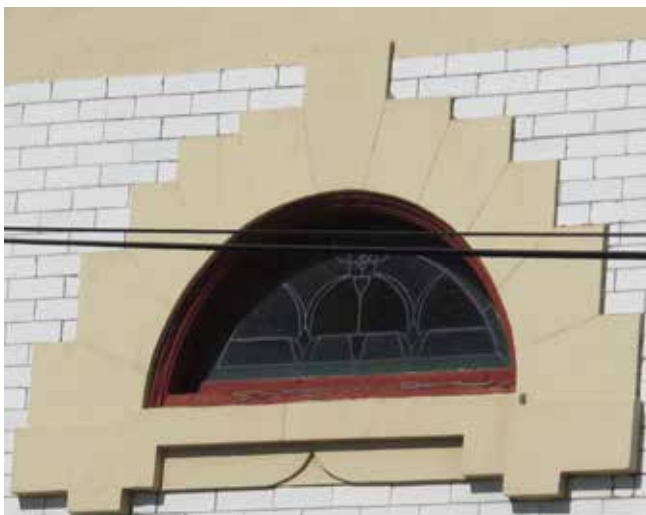
Above Left: Typical second floor wood sash and frame hung window. Typical example of condition of wooden elements and finish of windows on upper floor.

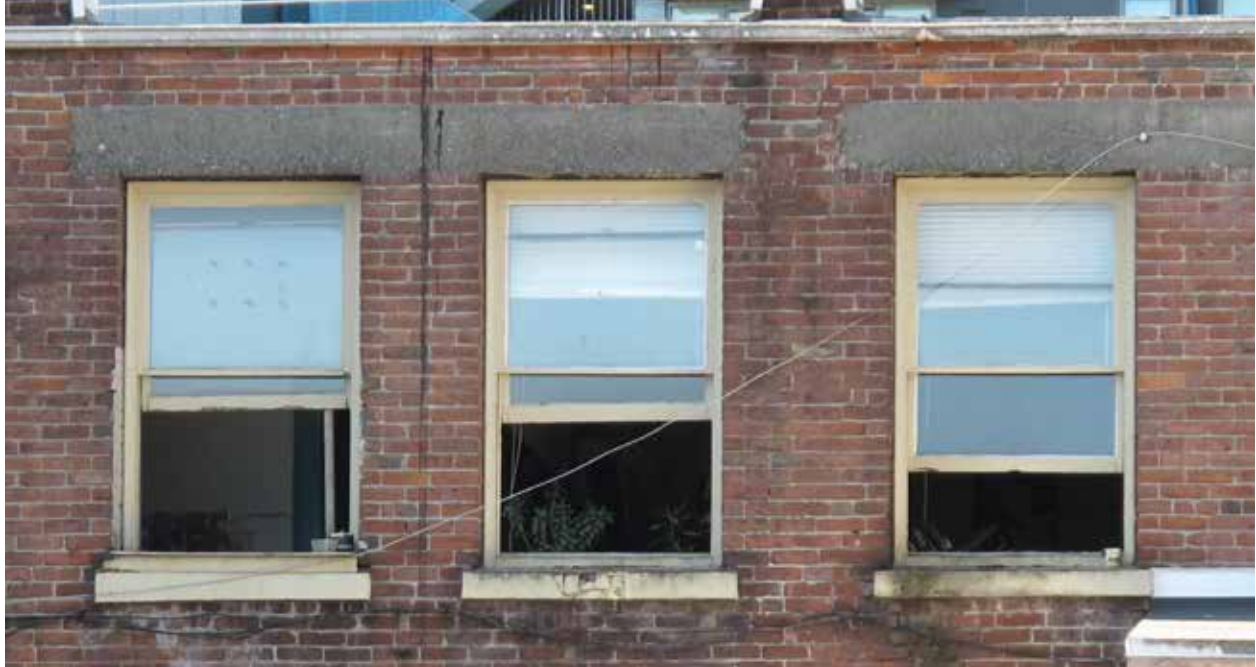
Above: 1-over-1 hung wood sash and frame windows on rear of building. Most windows appear to still have an operable lower-sash, unknown if upper-sash can be lowered. Concrete lintels span one to two window openings. Deterioration evident on sills lower jambs, bottom rail. Localized areas of paint failure present. Staining on and around brick sills.

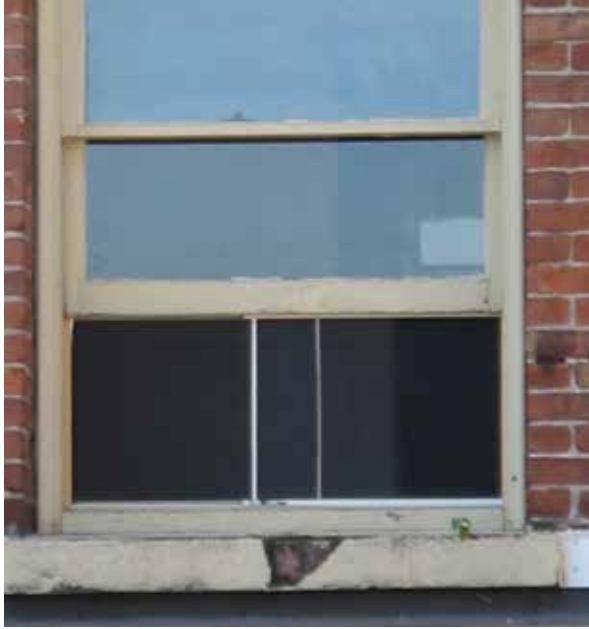
Above: Parge brick sill of rear façade window showing deteriorated parging.

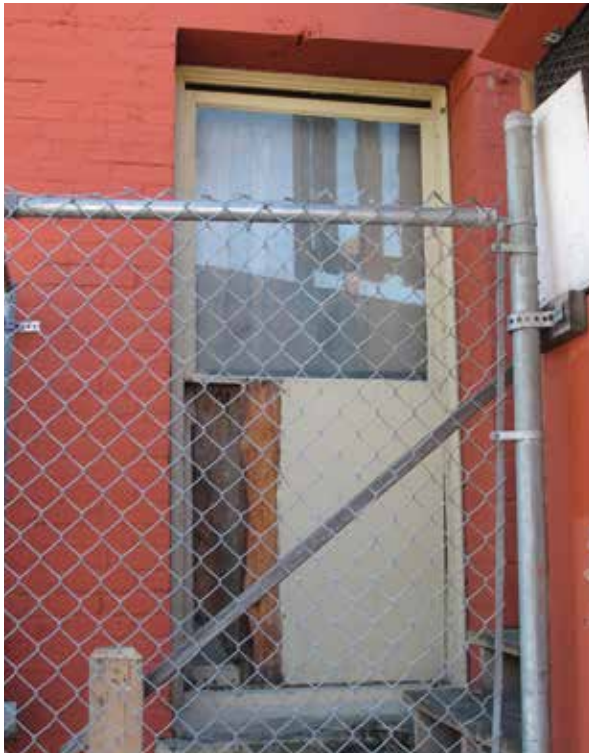
sashes, and sills show signs of deterioration. This deterioration is most evident on the second floor windows. Some glazing has been replaced. Those first floor windows that are visible possess either broken or missing glass with wood installed in its absence. The painted finish of all windows has deteriorated.

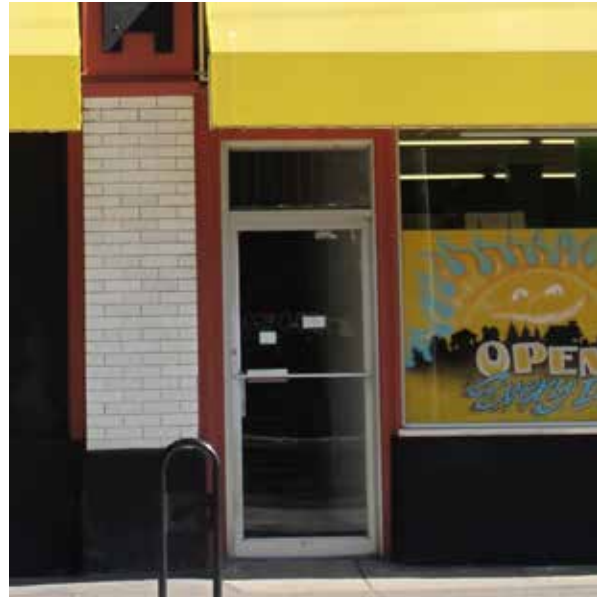
Above: Original door opening on Pandora Avenue façade providing access to second floor. Floor in entry retains penny-tiles mosaic. Door assembly has been replaced with modern materials.

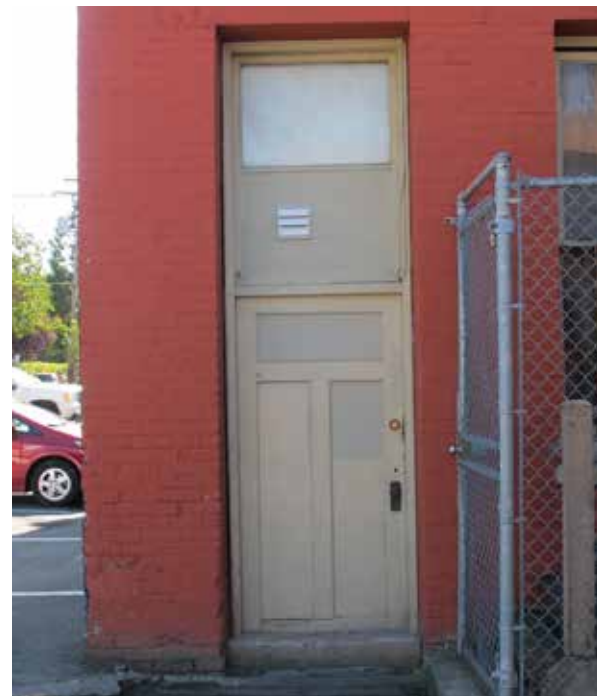
5.0 CONSERVATION RECOMMENDATIONS

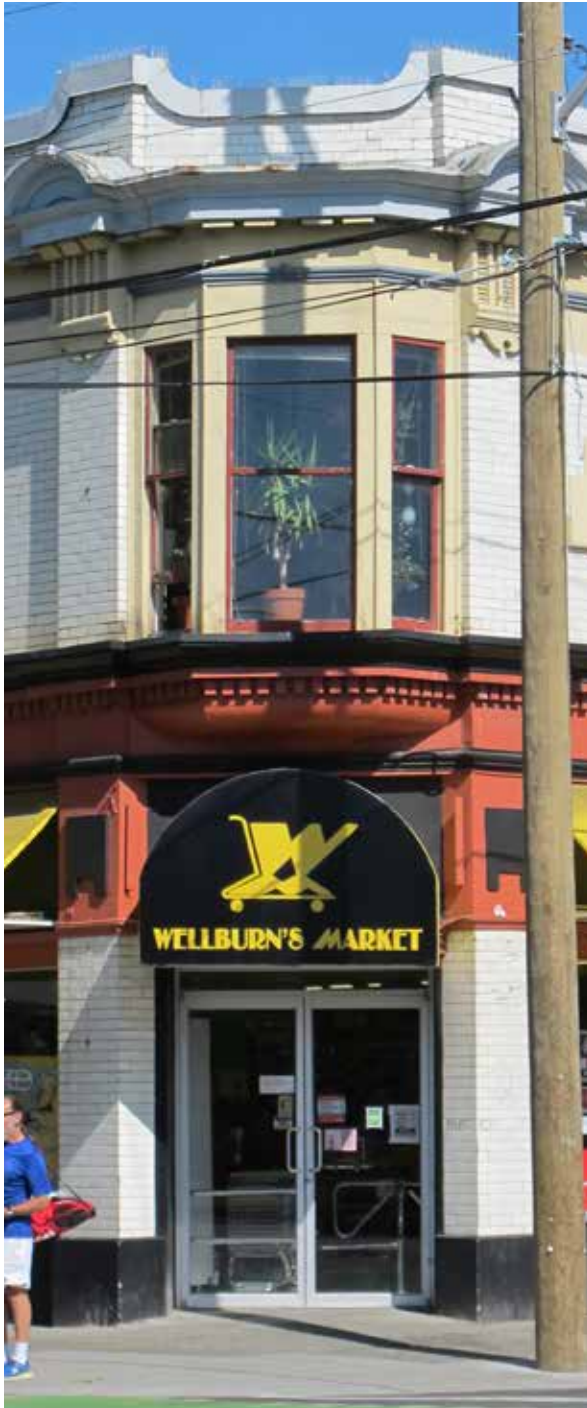
Above: Chamfered entry on ground floor with double doors and transom (hidden by awning). Historic assembly has been replaced with aluminum assembly, including transom.

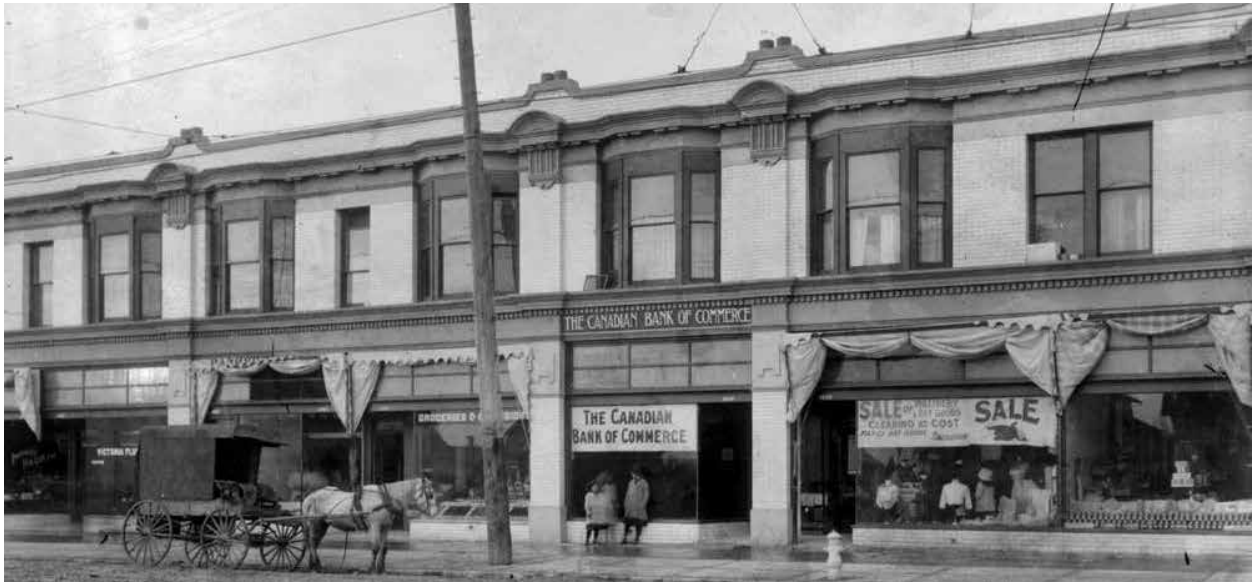
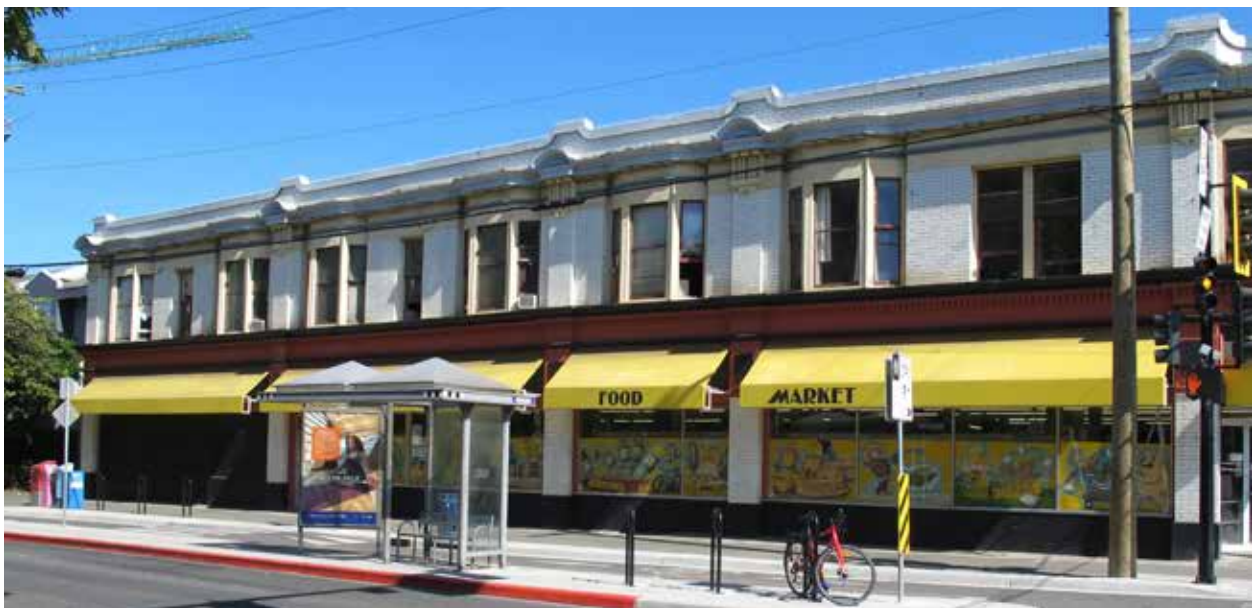
5.0 CONSERVATION RECOMMENDATIONS

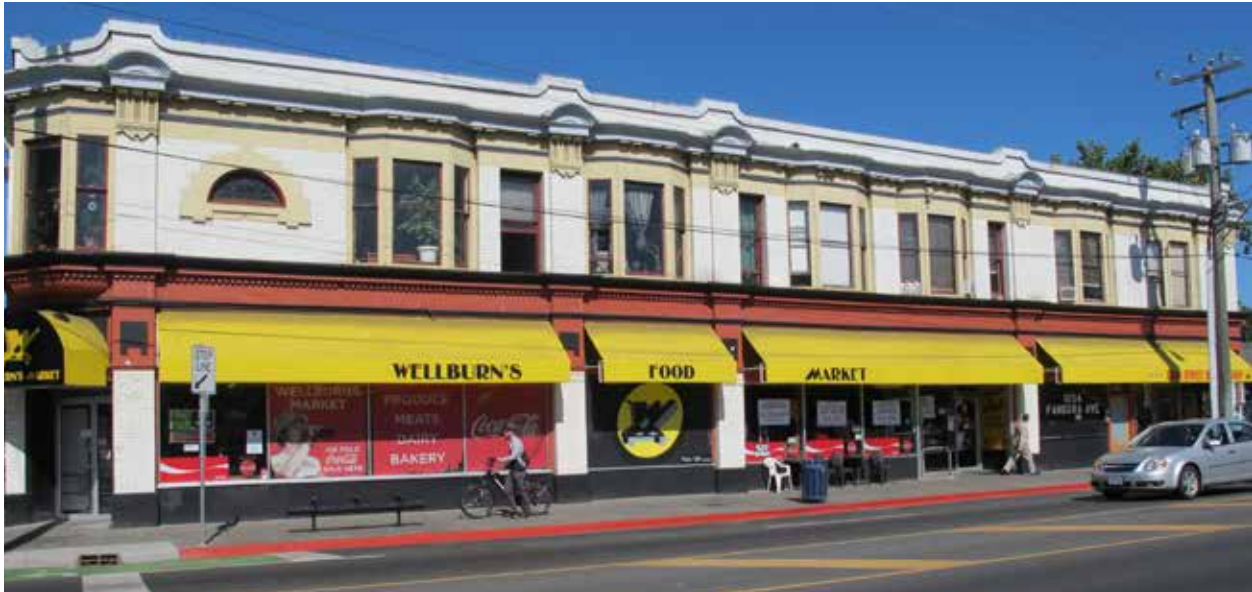
Above: Ground floor storefronts of Cook Street with original storefront design and assemblies altered and/or removed.

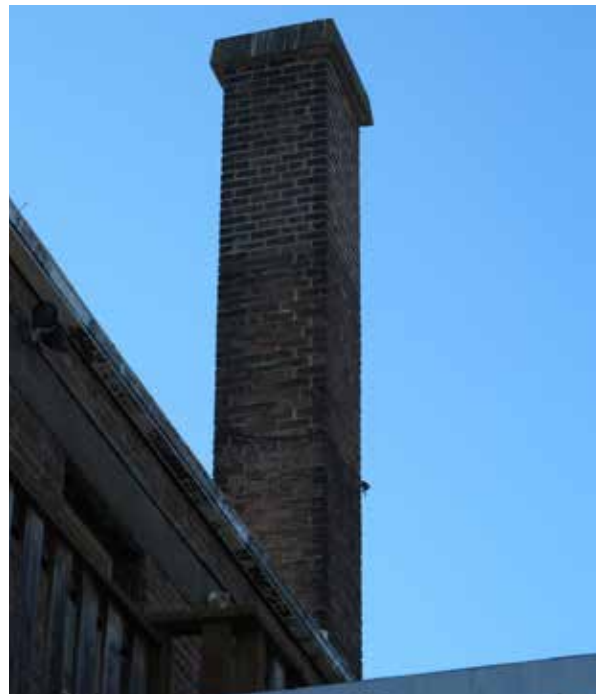
Above: Brick chimney with concrete cap. With proposed demolition of building, chimney brick could be salvaged for reuse.
