PARKWAY APARTMENTS

1050 PANDORA AVENUE, VICTORIA, BC

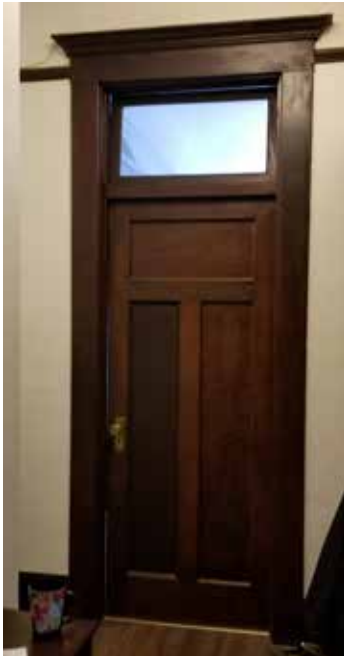
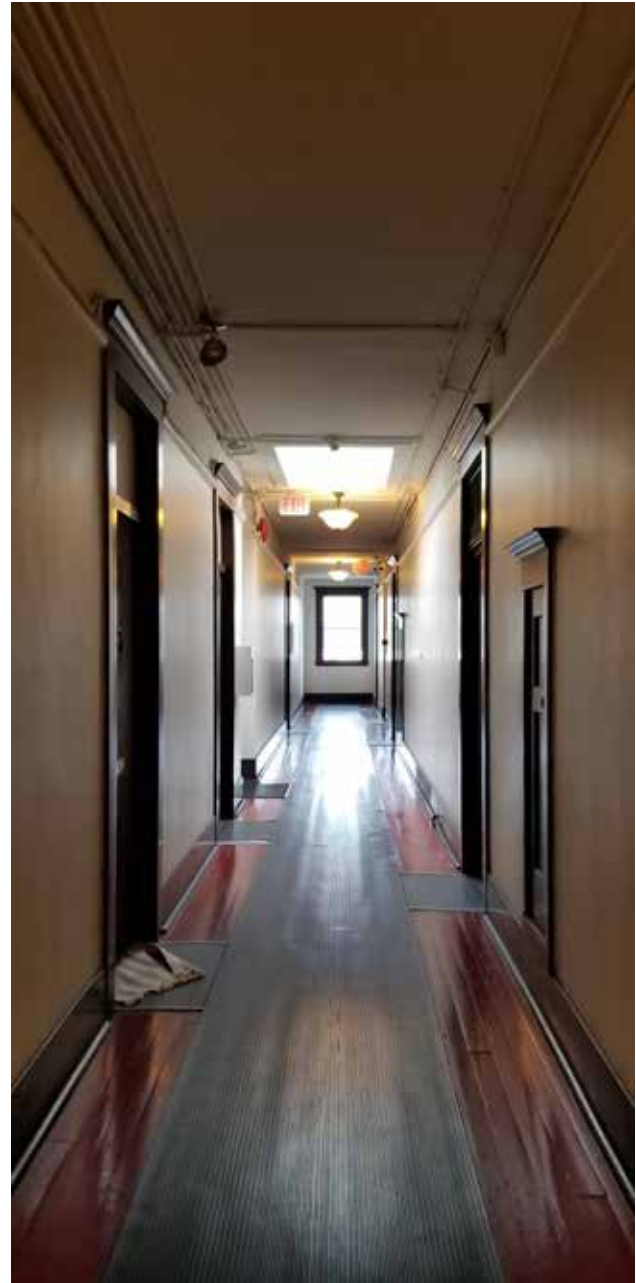
Above: Second floor hallway with intact wood floors, wood doors with transoms, wood trim including casings, baseboards, and picture rail. Rubber runner has been installed.

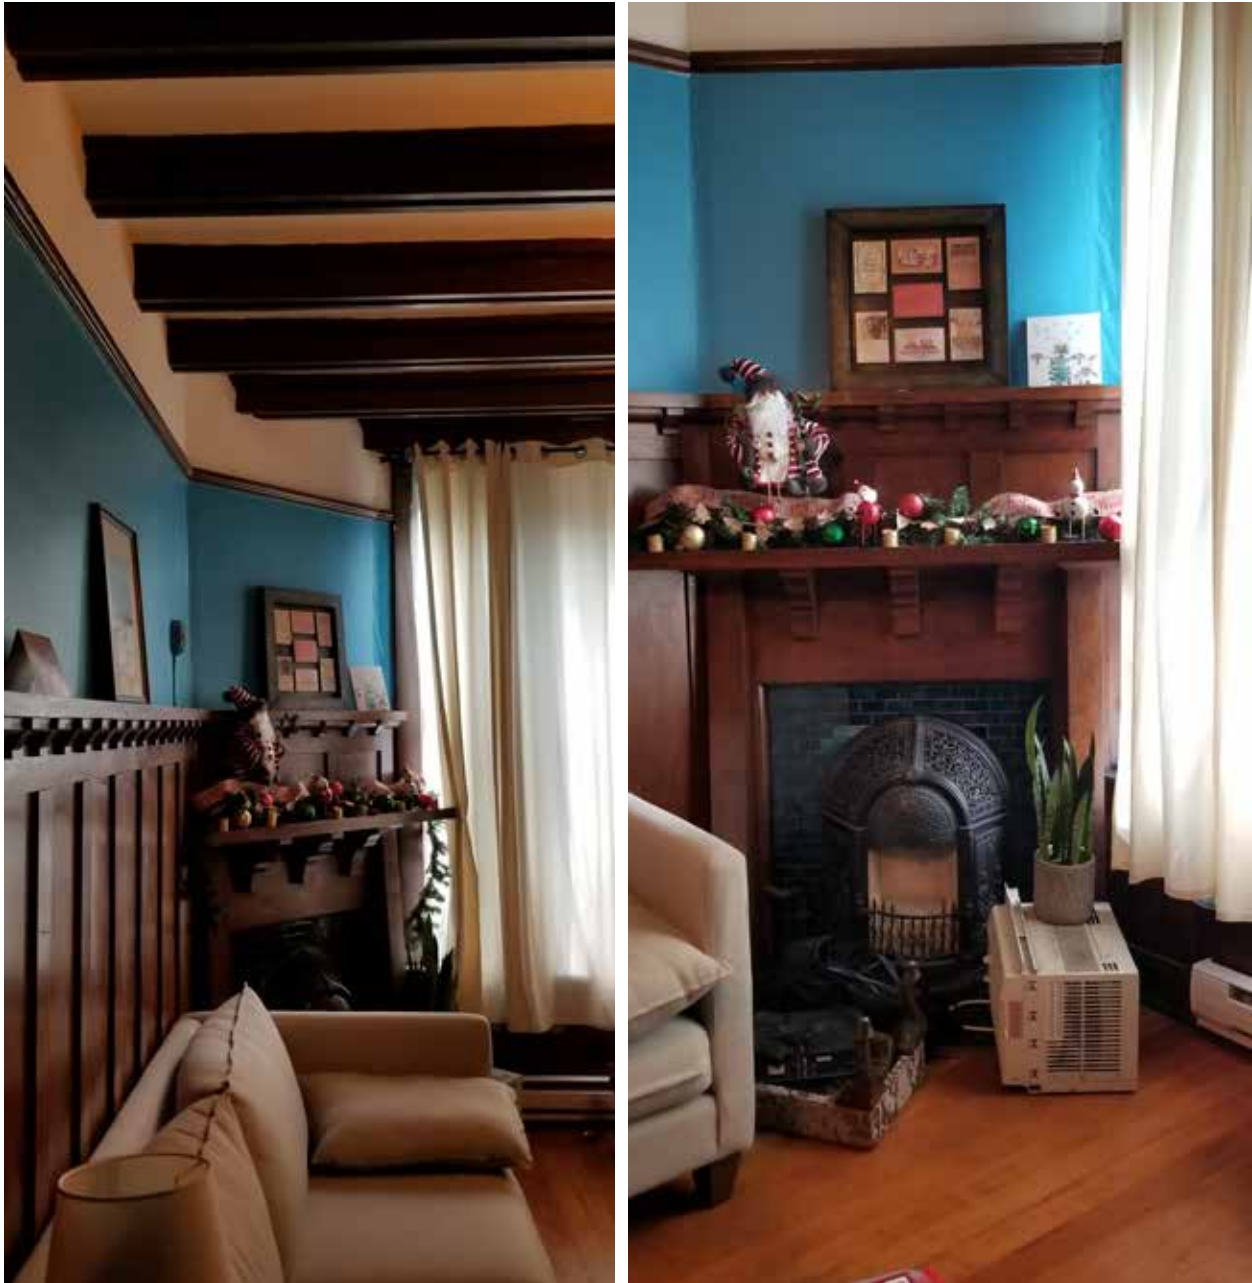
Above Left: Suite interior showing intact wood finishes including floor, trim work, wainscoting, and exposed beams.
