December 8, 2023  
223384

**Re: 1050-1058 PANDORA AVENUE HERITAGE BUILDING  
TAX INCENTIVE PROGRAM THIRD-PARTY STRUCTURAL ASSESSMENT**

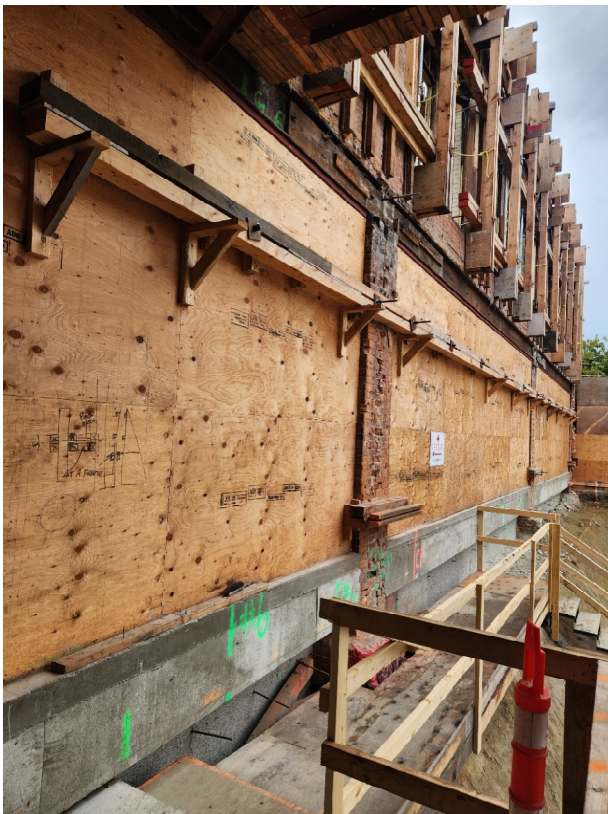
Figure 3 – Back of Façade along Pandora

The existing heritage structure located at 1050-1058 Pandora Avenue consists of two storeys, with the at-grade bottom storey serving as a commercial retail until historically used as a grocery store, and residential apartments in the second storey. The perimeter walls were constructed primarily with unreinforced mass clay brick walls, with the ground level frontages along Cook Street and Pandora Avenue being supported by brick pilasters and steel beams framing between storefront glazing and supporting the brick walls above. The building façade elevations along both Cook Street and Pandora utilize a mix of finishing bricks and tiles (as well as wood-silled windows and bent metal cornice), while the remaining walls use more utilitarian clay bricks. Reinforced concrete header beams are used at the second storey to span the clay brick walls above the punched window openings.

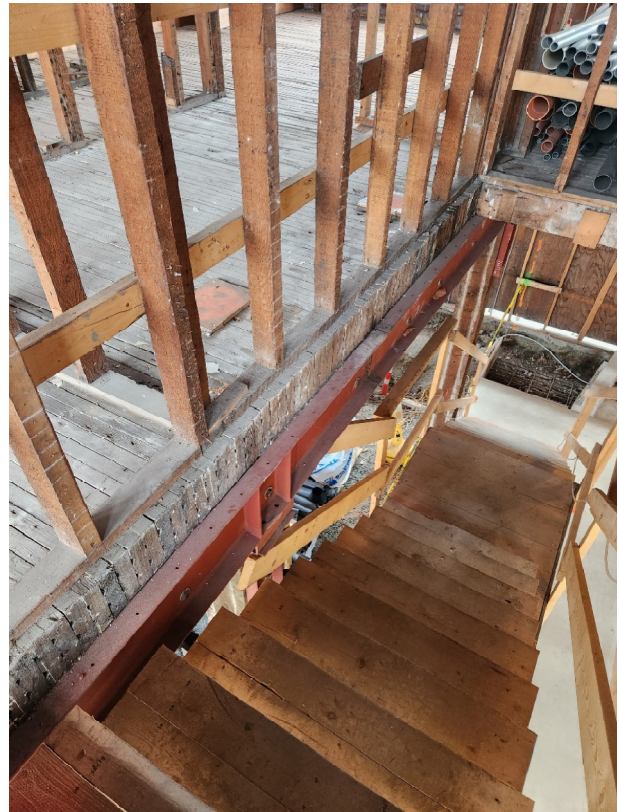
Figure 6 – Stair Opening Cut through 2x8 Floor

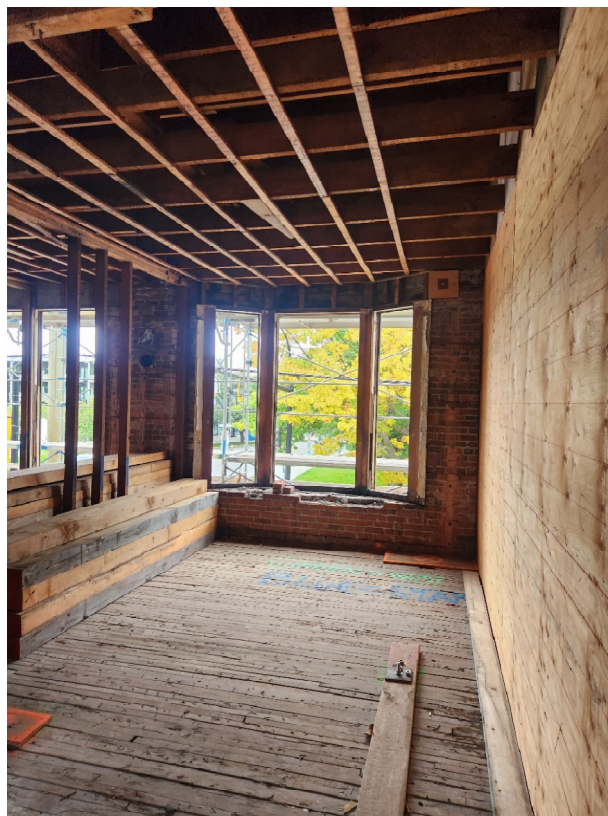
The second storey floor framing consists of a solid 2x8 wood floor stacked vertically, which in turn are supported by heavy timber beams and posts below. The roof framing consists of 1" tongue-and-groove planking supported by a double 2x joist system, with the upper set of joists sloped to suit and supported by regular pony stud walls which in turn are supported by the second set of joists which also serve to support the interior ceiling. The roof joist system is supported by 2x stud walls, which land on the solid 2x8 floor system below.

**Figure 7 – Typical Second Storey and Roof Framing**

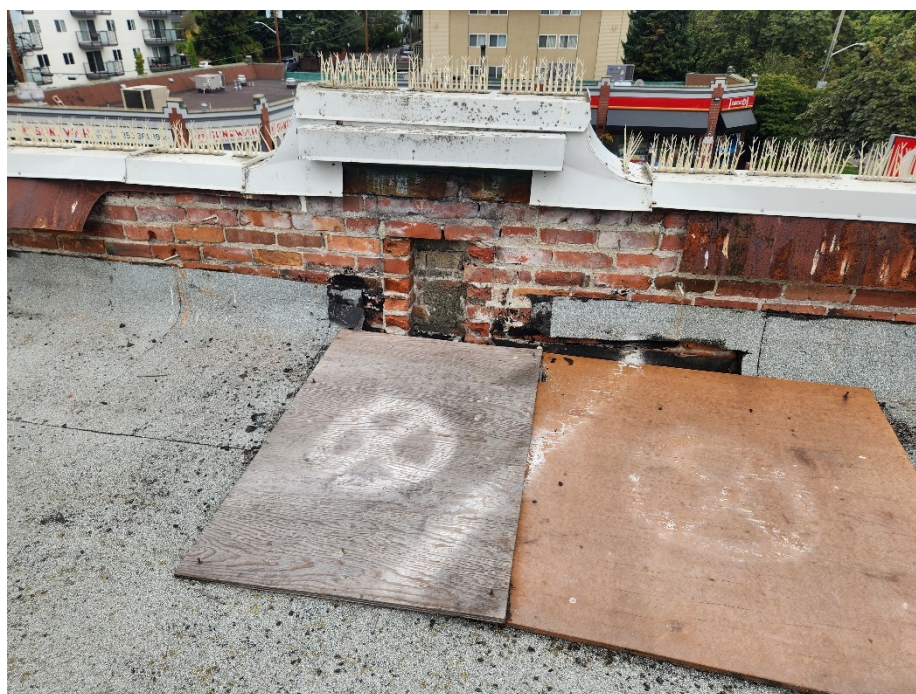
**Figure 8 – Deteriorated Roof and Parapet Condition**

Construction and rehabilitation of portions of the structure have already commenced; the construction scope and schedule as well as overall development is beyond the scope of this report. A field review of the existing site conditions was conducted on September 25, 2023 with representatives from the developer (Greg Mitchell), general contractor, City of Victoria Heritage Planner (Kristal Stevenot) and Glotman Simpson Consulting Engineers (James Macauley). The preceding condition photos were taken as part of this review. In general, the second floor interior 2x8 floor and supporting heavy timber framing appeared to be in fair condition. The condition of the exterior façade framing varied from fair to poor, with the second storey exterior bent metal cornice and brick roof parapet in very poor condition due to long-term weather exposure. The roof decking and membrane also varied in condition, with the portions around drains and abutting the perimeter brick walls in particularly poor condition.

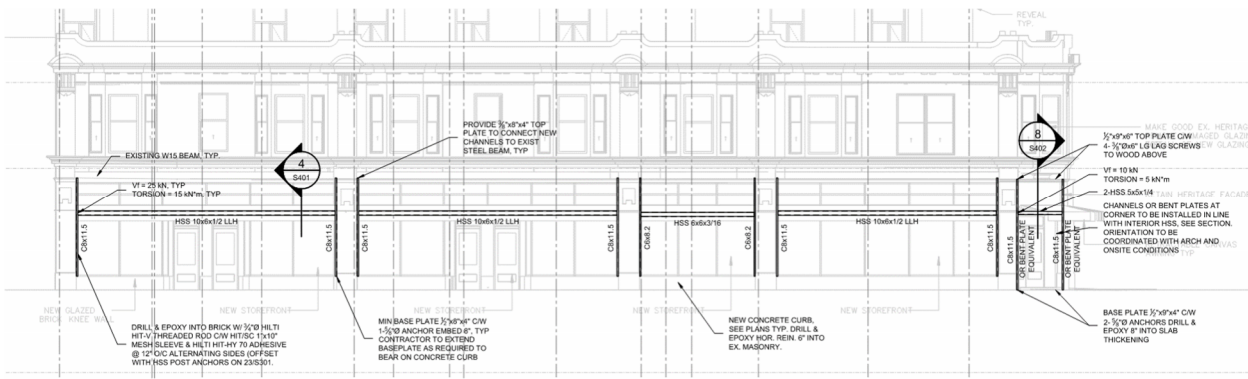
The brick façade does not have sufficient out-of-plane capacity to resist horizontal lateral movement in a seismic event (i.e. pulling away from the main building) and will require back-up framing. The façades are proposed to be retrofitted with tie-backs to the second storey and roof framing with supplemental steel posts and beams as well as connections. Additional framing is also required to support the parapet at the roof level. Additionally, there is very little in-plane stiffness or strength for the brick to act as a shearwall along the lengths of the wall; tie-in to the slab diaphragms is essential for bracing against out-of-plane and in-plane loading.

Figure 13 – Ground Level Façade Back-Up Framing along Pandora

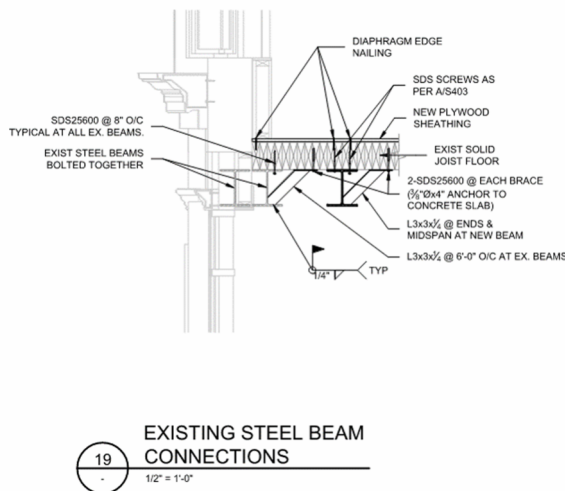
Figure 14 – Typical Façade Tie-Back at Second Storey
