**1042/1044 RICHARDSON STREET—
VICTORIA, BC**

**CONSTRUCTION IMPACT ASSESSMENT &
TREE MANAGEMENT PLAN**

DATE OF ISSUANCE: January 17, 2024

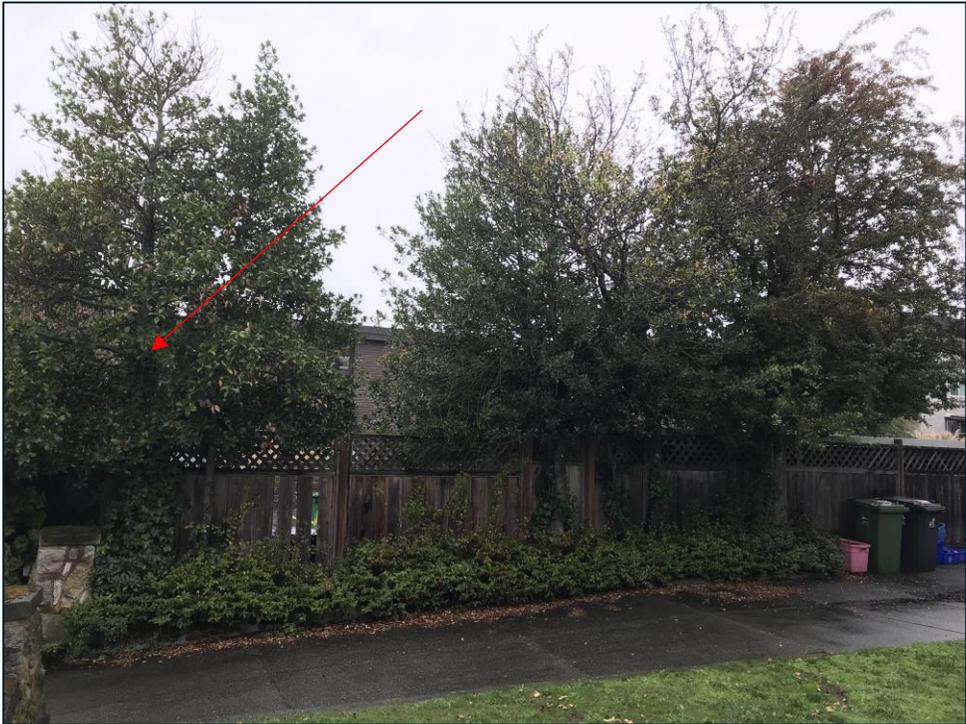
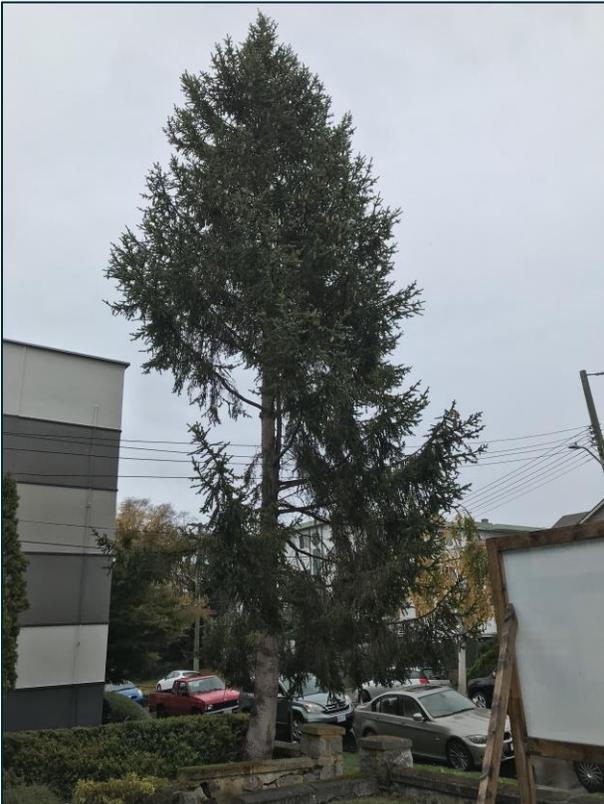
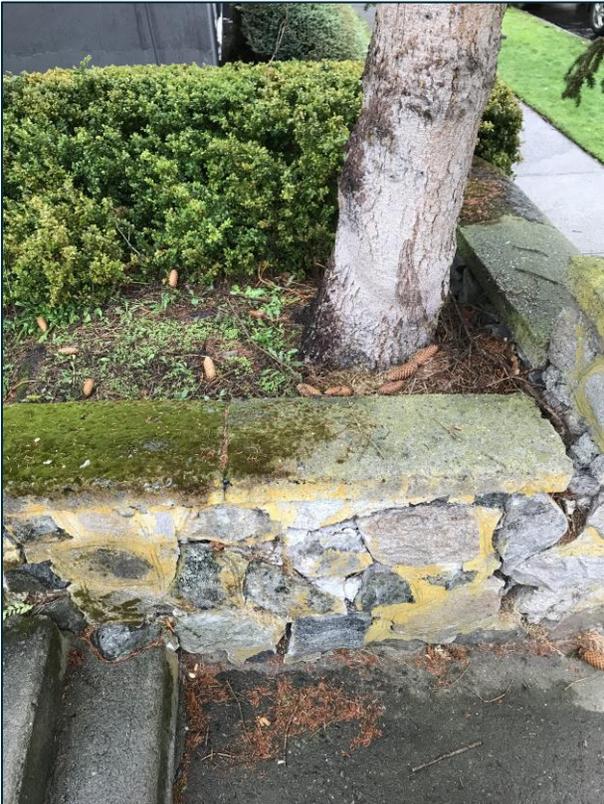
Photographs 1-3: Existing site conditions (October 2023) within the CRZs of bylaw-protected on-site trees #84 (above, arrow) and 85 (below). Note existing driveway to be left in place until the end of the demolition phase (near #84) and retaining wall/stairs to be left in place until the BP phase (within the CRZ of #85).

- The existing driveway should be left in place until the end of the demolition phase, to act as primary site access and root armour for **English Holly (*Ilex aquifolium*) #84**. Once demolition nears completion, removal of the existing concrete within the CRZ of this tree shall be completed with the supervision of the project arborist, as large roots may be encountered during extraction.
- To minimize impacts to **Norway Spruce (*Picea abies*) #85**, we recommend the existing retaining wall (sections within the CRZ) and stairway are left in place until the building permit phase.

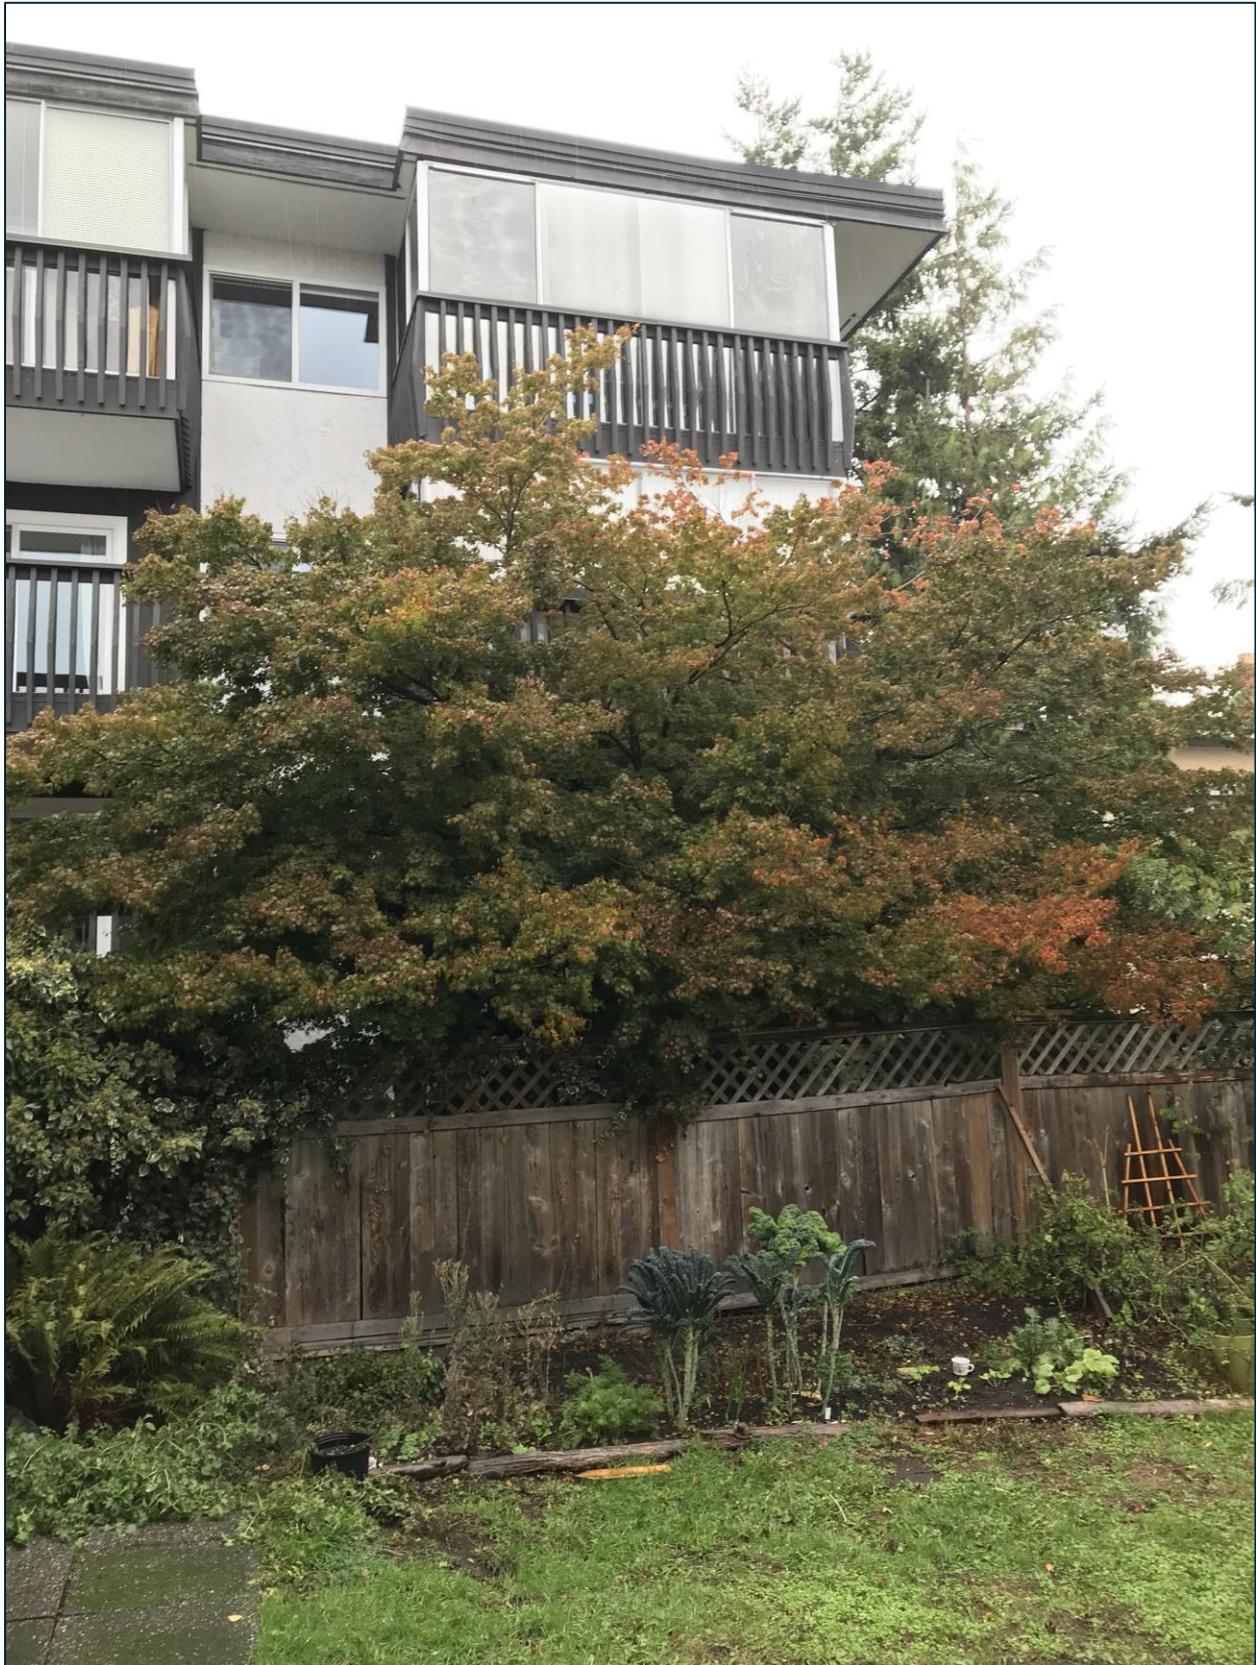
Japanese Maple (*Acer palmatum*) NT1 (31cm DBH according to multi-stem calculation) is located on the north neighbouring property at 1035 McClure St. and is rooted approximately 1.8m north of the boundary with the subject property:

It should be noted that this tree's location has not been verified by a professional surveyor. However, during a previous site visit, we measured the tree's location at 1.3m north of the existing fence, which is 0.5m north of the property line (according to the site survey). From review of the preliminary shoring/cut-slope plan, all roots encountered are likely to require pruning at the property boundary, which will result in a disturbance of less than 20% of the CRZ. We do not anticipate significant impacts to the health or stability of this tree based on the required root pruning.

Photograph 4: Existing site conditions (October 2023) within the CRZ of off-site bylaw-protected tree NT1, proposed for retention.

- Underground parking is proposed within the CRZ, which could require an extensive excavation (at least 3m deep, according to the elevation plan). To retain this tree, excavation must be limited to the property line and alternative slope stabilizing techniques should be utilized to minimize the use of cut-slopes and over-excavation. The project arborist shall supervise all excavations within the CRZ.

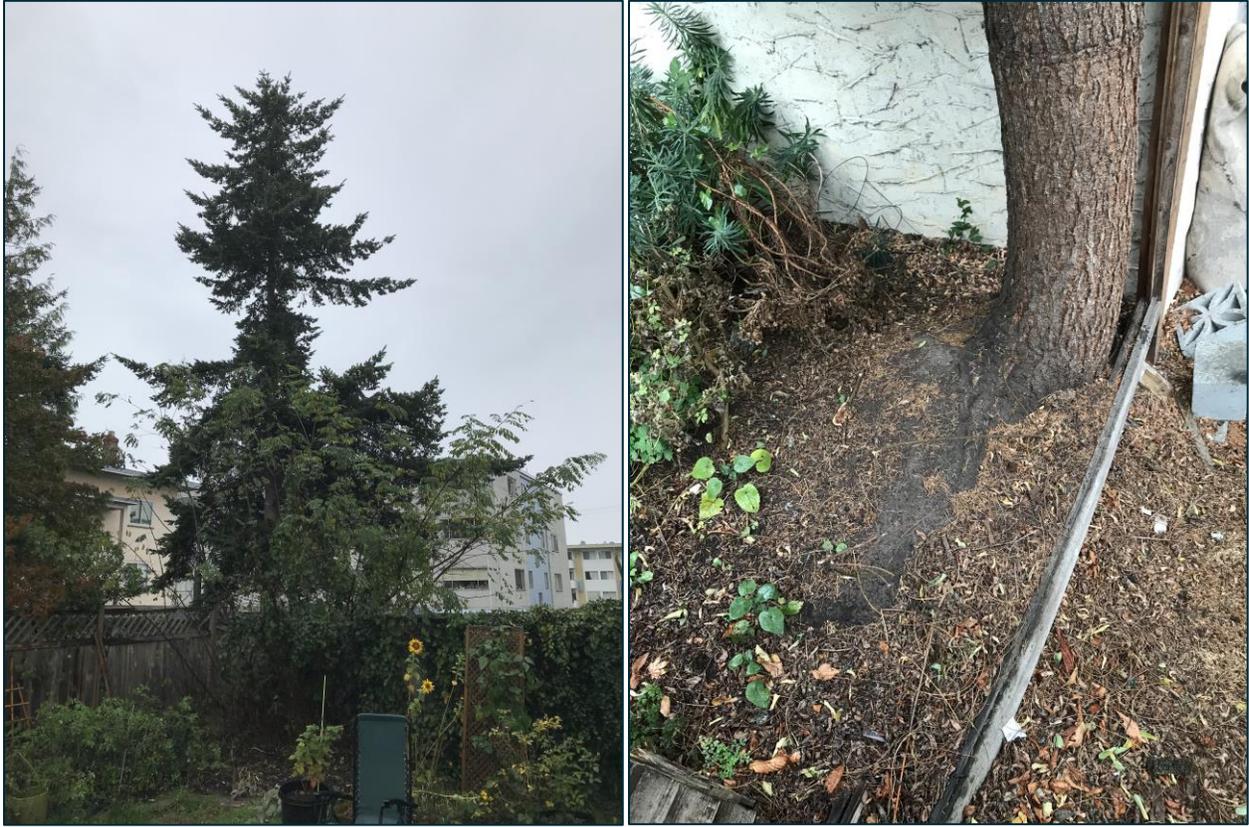
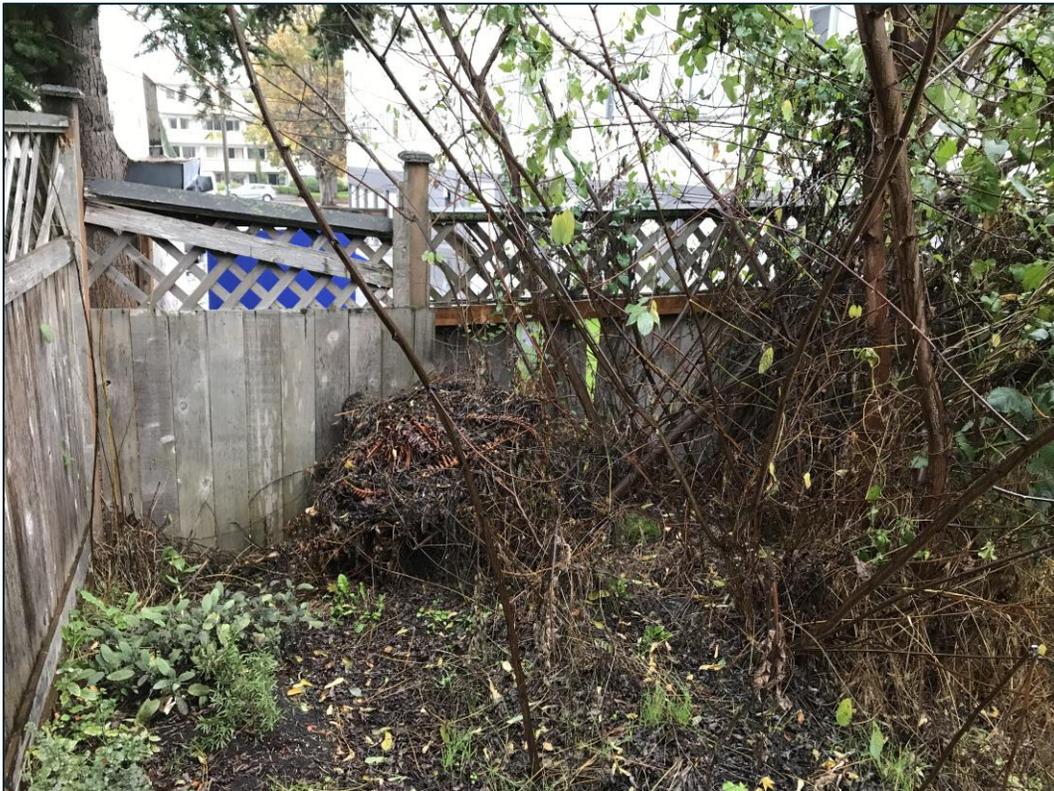
Douglas-fir (*Pseudotsuga menziesii*) NT8 (~35cm DBH) is located on the neighbouring property at 1045 McClure Street and is rooted approximately 1.7m from the existing fence near the east boundary of the subject property. According to the site survey, this fence is located 1m east of the property line:

Based on the existing site conditions, it appears that the trunk of #79 was severed just above natural grade (epicormic response growth has ensued). To minimize impacts to NT8—if possible, we recommend the stump remnants of #79 are ground below existing grade. If the stump must be removed, extraction shall be completed under the direction of the project arborist.

Photographs 5-7: Existing site conditions (October 2023) within the CRZ of off-site bylaw-protected tree NT8, proposed for retention. Note large surface root bends north (**upper right, left side of frame**) and stump of #79 (**below**) within the CRZ.

- The preliminary shoring plan indicates a cut-slope extending as near as 2.5m from the northeast corner of the subject property, which is within the outer edge of this tree’s CRZ. It is also likely that root growth from NT8 has been restricted in this area by the presence (historically) of a large black locust tree removed in 2021 (#79 as per our inventory). As a result, we do not anticipate significant impacts to NT8 (based on the preliminary excavation plan), though if cut-slopes are modified to encroach further within the CRZ, the project arborist should be notified.

- The landscape plan indicates a 1.5m height “solid-panel wood perimeter fence” along the subject property boundary. Based on site conditions, the tree’s large surface roots appear to curve north, away from the proposed fence. The project arborist should be contacted to review the location of the footings therein. If large roots from NT8 are encountered, the footings should be shifted to preserve them.
- This tree should be isolated from demolition/construction by erecting and maintaining protective barrier fencing to the extents of the CRZ (see tree management plan in [Appendix A](#)) and adjoin to protection barriers for NT1.

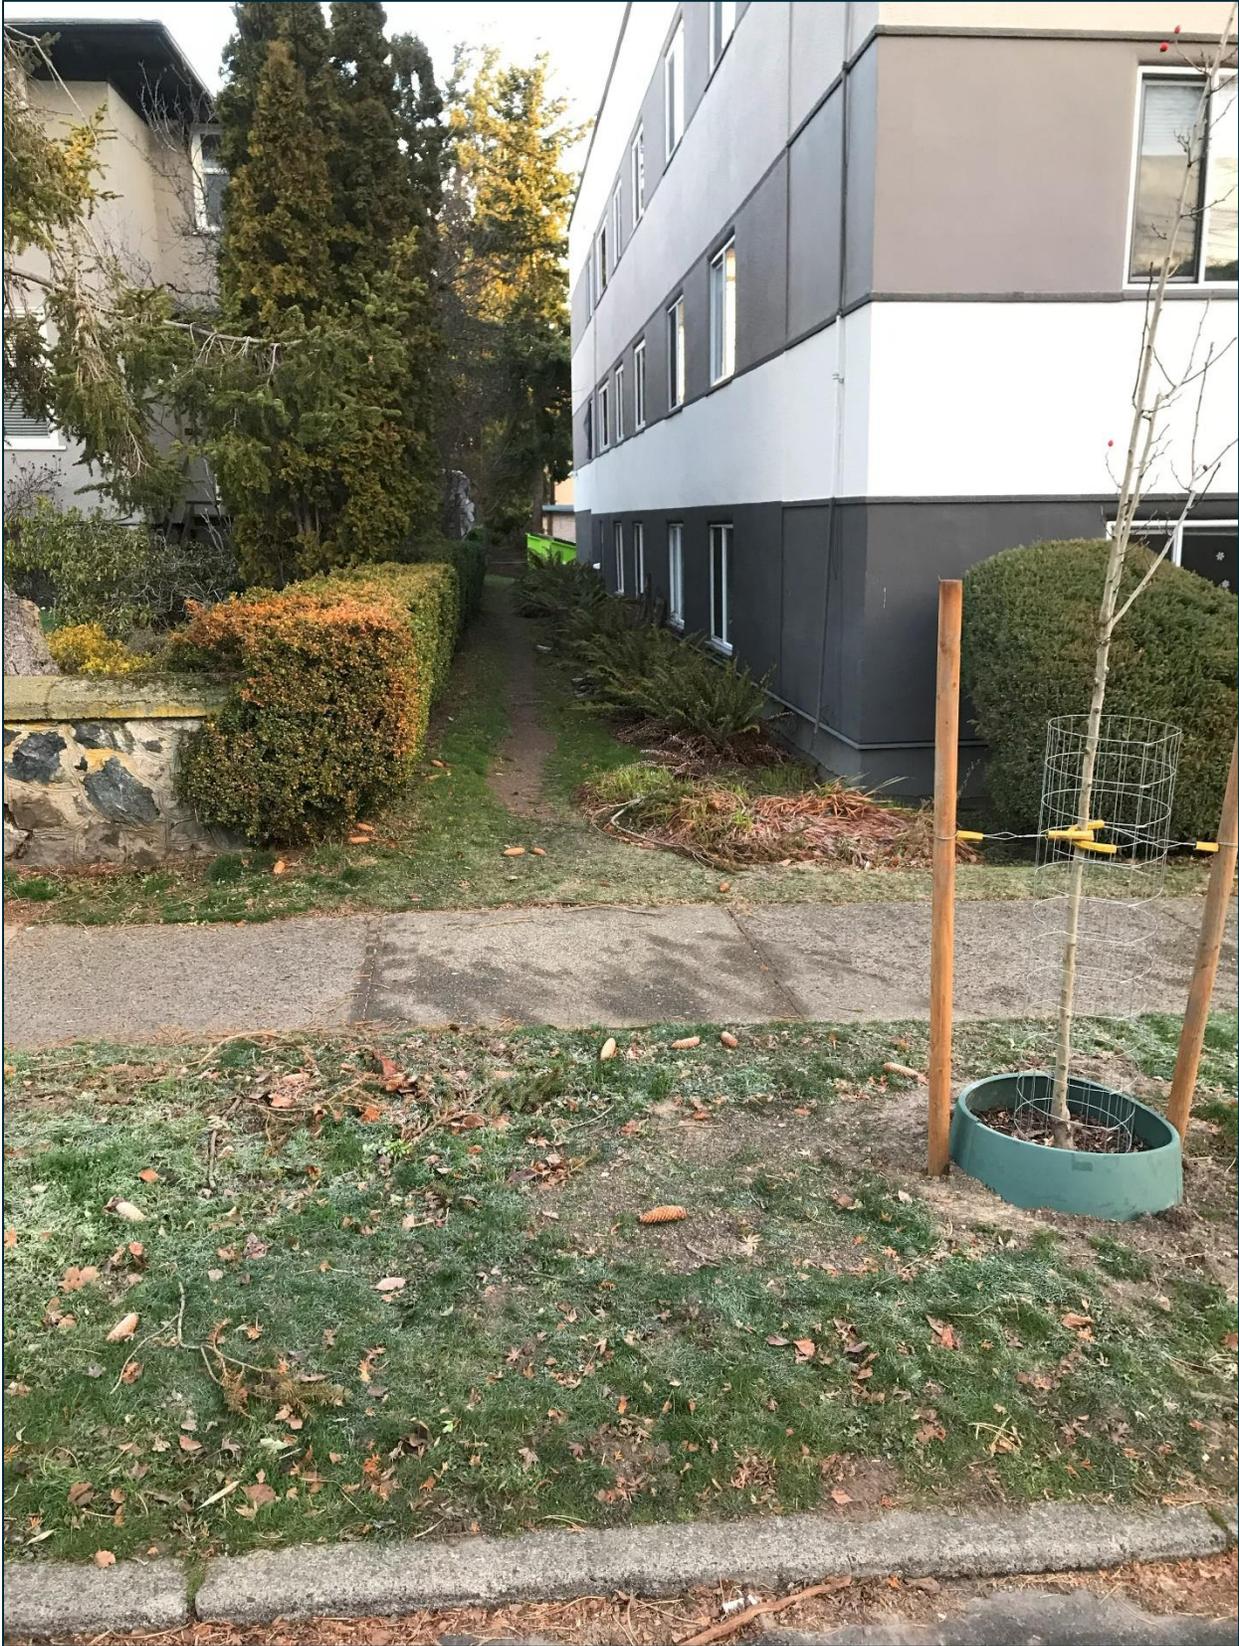
Photograph 8: Existing site conditions (January 2024) on boulevard; note existing property line between 1042/1044 Richardson Street and 1050 Richardson Street, approximately 2.4m from newly planted crabapple M1.

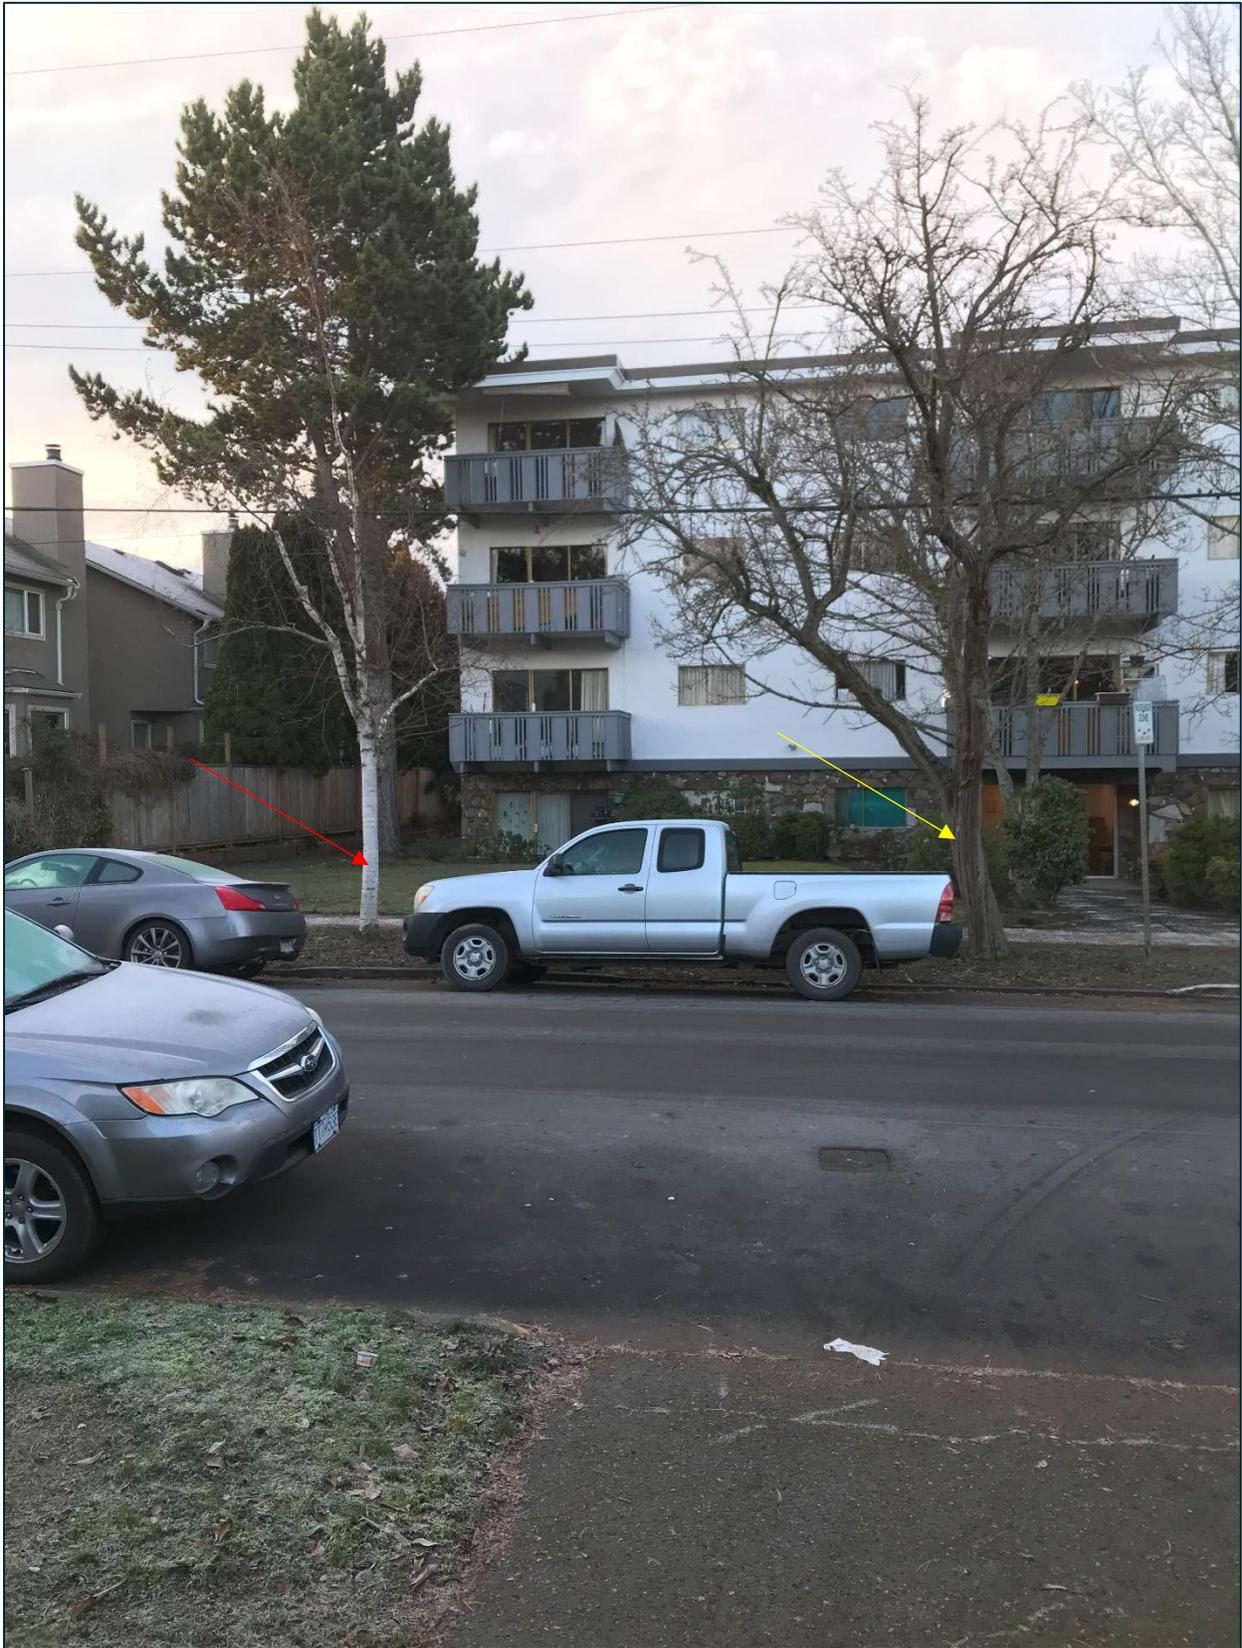
Paper Birch (*Betula papyrifera*) NT6 is located on the municipal boulevard (municipal ID# 15809) across the street from the subject property:

Photograph 8: Existing site conditions (January 2024) on boulevard across from 1042/1044 Richardson Street and 1050 Richardson Street; existing municipal trees NT6 (red arrow) & NT7 (yellow arrow).

- A new utility pole and hydro services are proposed outside the CRZ/drip line. We do not anticipate significant impacts to the roots or the canopy. To ensure this tree is isolated from construction impacts, protective barrier fencing shall be erected and maintained 2.0m from the base of the tree (to the curb and sidewalk edges).
