1055 Alston St. Victoria, BC

Construction Impact Assessment & Tree Management Plan

DATE OF ISSUANCE: July 7th, 2023
*Updated copy: January 30th, 2024

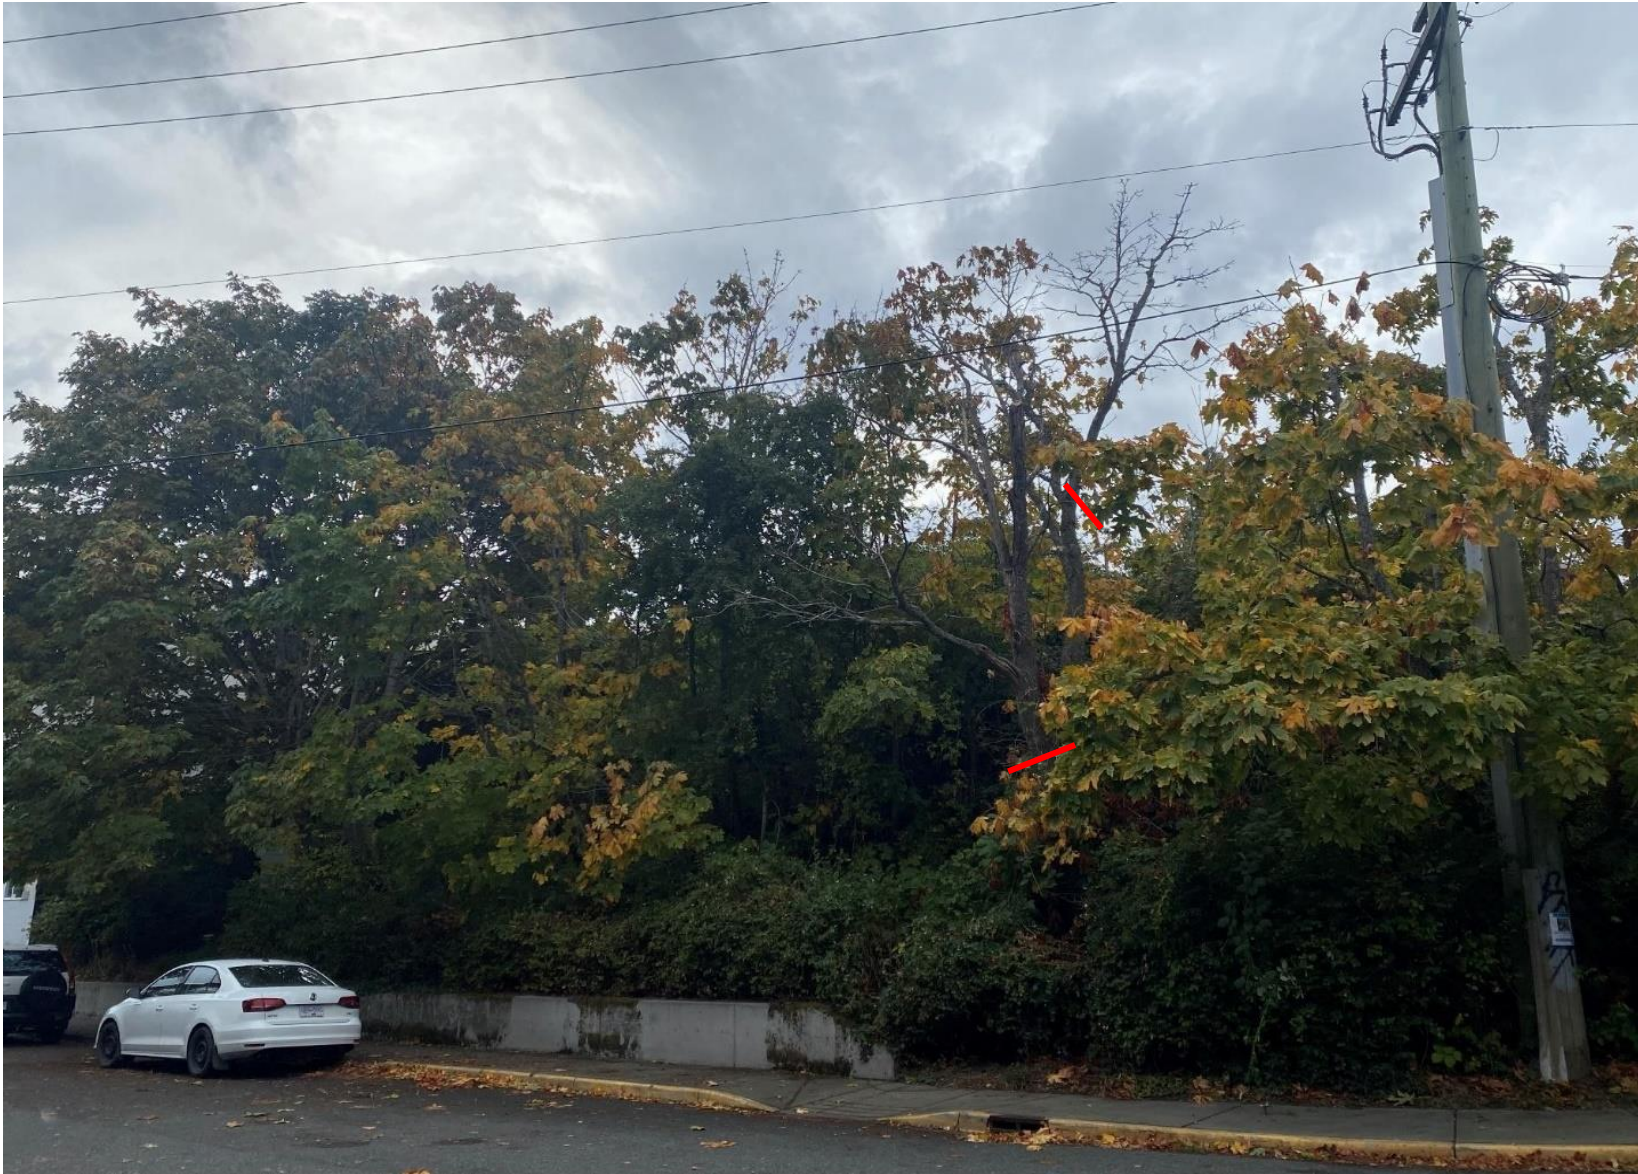
Tree OS1 is a codominant bigleaf maple with several large diameter dead stems/branches, a large cavity with associated decay near the union of the co-dominant stems and has been previously hydro pruned. To our understanding the homeowner does not want this tree to be removed, however we recommend they be notified of its pre-existing health condition, and associated risk.

Figure 2: Proposed risk reduction pruning for Maple OS1 (largest dead top and dead stem with multiple cavities leaning over sidewalk proposed for removal).

Pruning of off-site tree OS1 is required to provide clearance for the proposed construction. See image 7 for the recommended pruning to provide clearance for the proposed construction.

It is our recommendation that OS1 be modified or removed to eliminate any potential risk of failure as a result of its poor condition, during and following construction activities. Due to limitations with replacement requirements and ownership of the tree, it is our understanding that removal is not a possibility. As an alternative to removal, we recommend the pruning outlined below be completed. The purpose of this pruning is to centralize the weight distribution of the crown on the stem and removing dead tissue in order to reduce the likelihood of failure (for a limited time frame). This risk mitigation recommendation is in anticipation of the proposed project resulting in changes to the occupancy of the targets within striking distance of this tree throughout the proposed construction activity. All limbs proposed for reduction are dead, however this pruning will require a pruning permit from the city, and consent from the tree owner prior to performing the work. This work is to be completed by a certified utility arborist (due to proximity with primary electrical lines) and an ISA certified arborist according to industry best practices. It should be understood by the City and the client that this pruning is considered a short-term solution and eventually this tree will fail as a result of its deteriorating structure. This pruning has been devised in an effort to extend the amount of time before this inevitability occurs. Further analysis of its associated risk by means of a level 3 tree risk assessment may be used to predict the time frame in which the ultimate failure can be expected. We are limited to a visual level 1 inspection of this tree in the recording and analysis of its structural defects discussed herein. There may be additional defects discovered by the project arborist during the excavation supervision that may change its retention status outside the scope of this project that should be brought to the attention of the tree owner, as they are the manager of all risks associated with this tree.

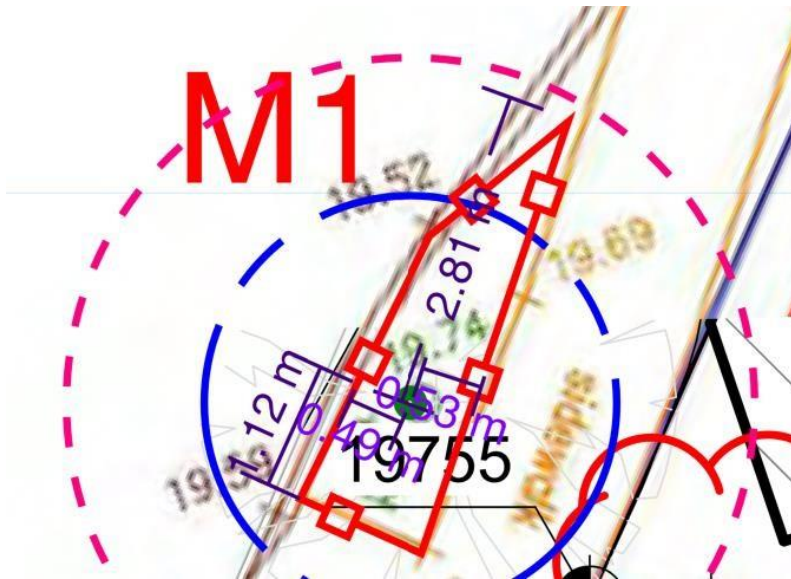
Figure 5: Tree protection fencing around municipal tree M1 proposed for retention (follows line of curb and sidewalk).

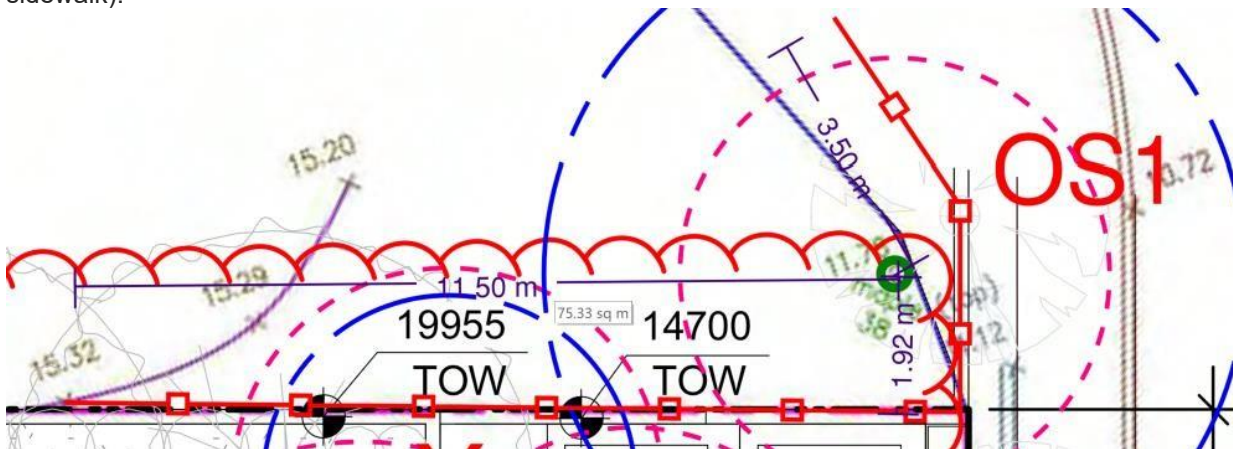
Figure 6: Tree protection fencing around offsite tree OS1 proposed for retention.

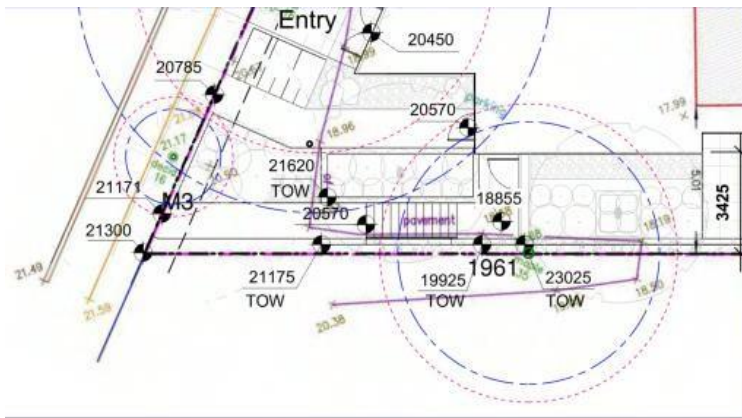
Figure 7: Grading information of built structures proposed in CRZ of shared tree #1961

The existing grade at the base of tree #1961 in the survey provided is 18.88m. The finished grade at the top of the retaining wall proposed on the landscape bed located in the CRZ of #1961 is 23.02. There is a staircase located along the Southern property margin, adjacent to #1961. It leads down to the bike storage area within CRZ of #1961. The finished grade of the top of the floor in the bike storage area is 18.85m. The excavation for the floor of the bike storage and the Southern structural wall of the bike storage located under the landscape retaining wall would likely remove roughly 50% of the roots of #1961. Due to the lean of the stem of 1961 toward the subject site, building a 4.1m tall wall right beside the stem would likely result in significant crown and stem tissue damage. The anticipated root and crown/stem impacts from the proposed structures located in the CRZ of this tree are not conducive to its survival and therefore it is necessary for removal.

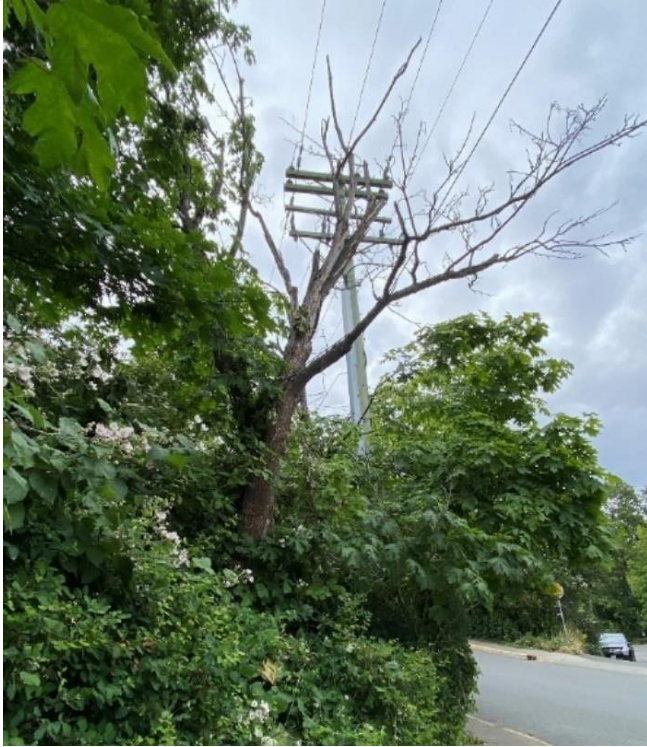
Image 1- Crown of offsite tree OS1

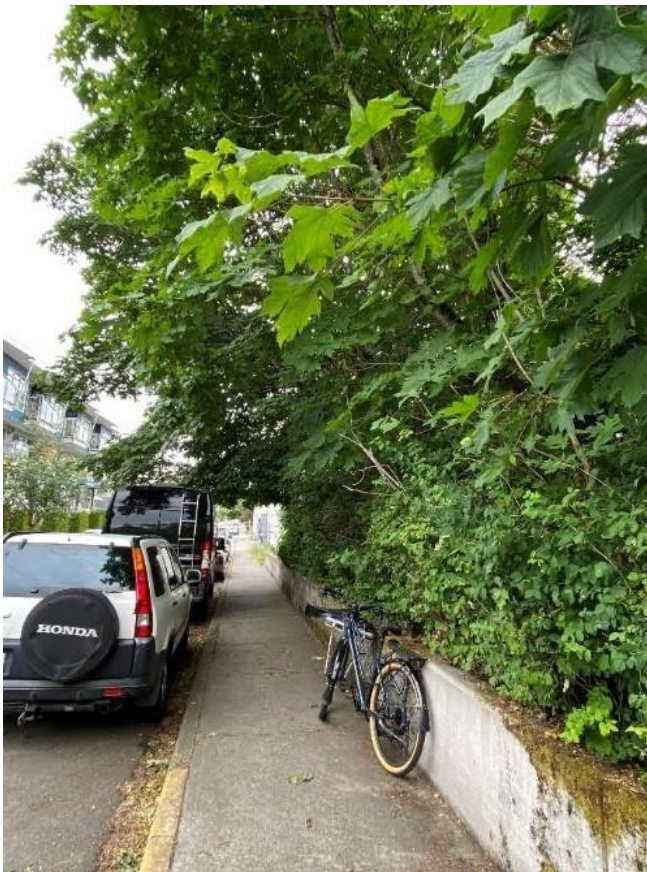
Image 2- Collection of on-site trees along Tyee frontage (property line behind retaining wall pictured)

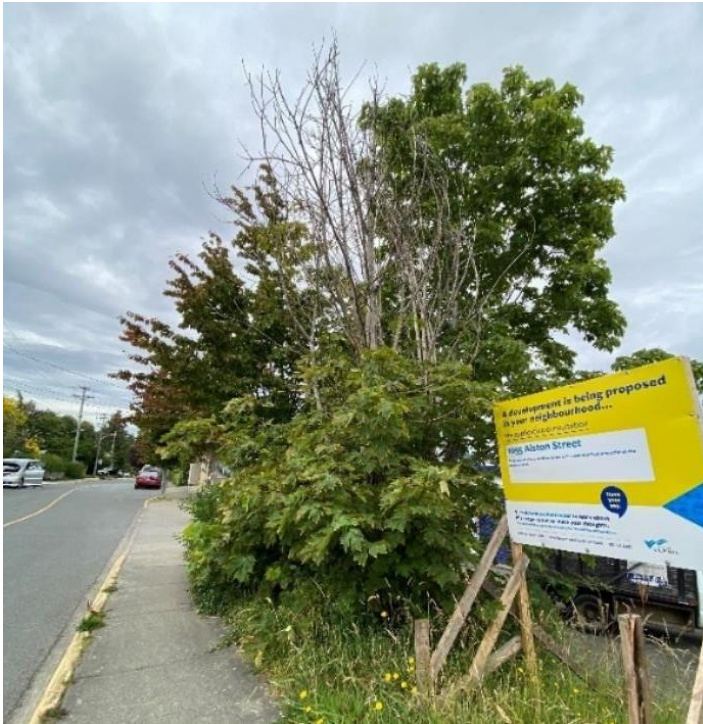
Image 3- Clump of trees along Alston Street frontage including municipal tree M2 and on-site Bigleaf maples 1959, & 1960

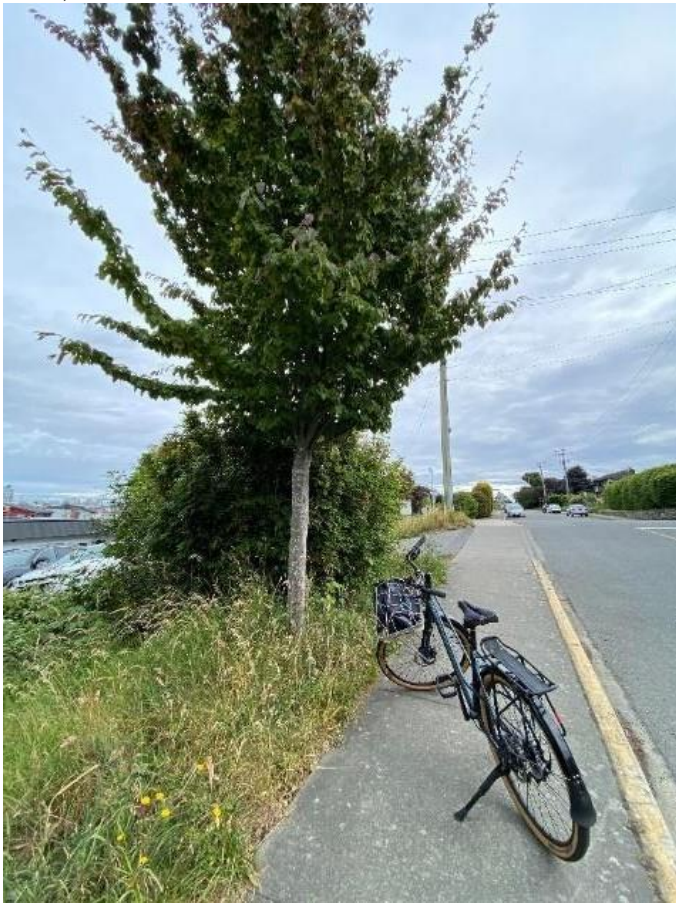
Image 4- Municipal tree M3 along Alston Street frontage.

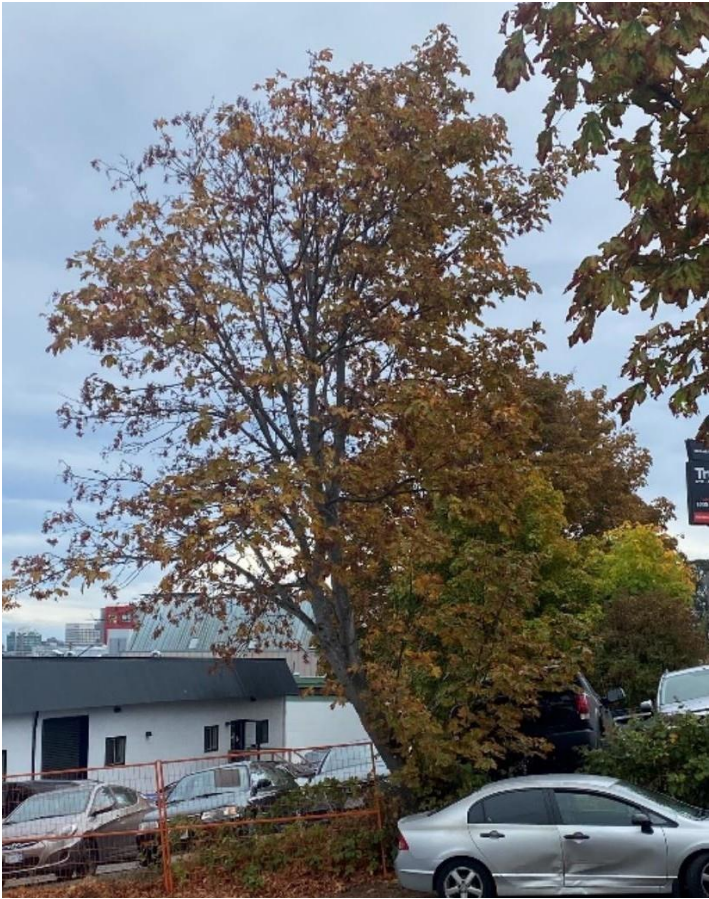
The shared offsite protected tree #1961 is necessary for removal due to the proposed bike storage located in this tree's CRZ. Upon request for additional information from the Parks review comments, the grading details for the proposed bike storage located in the CRZ of this tree are provided below.

Image 5- shared tree 1961

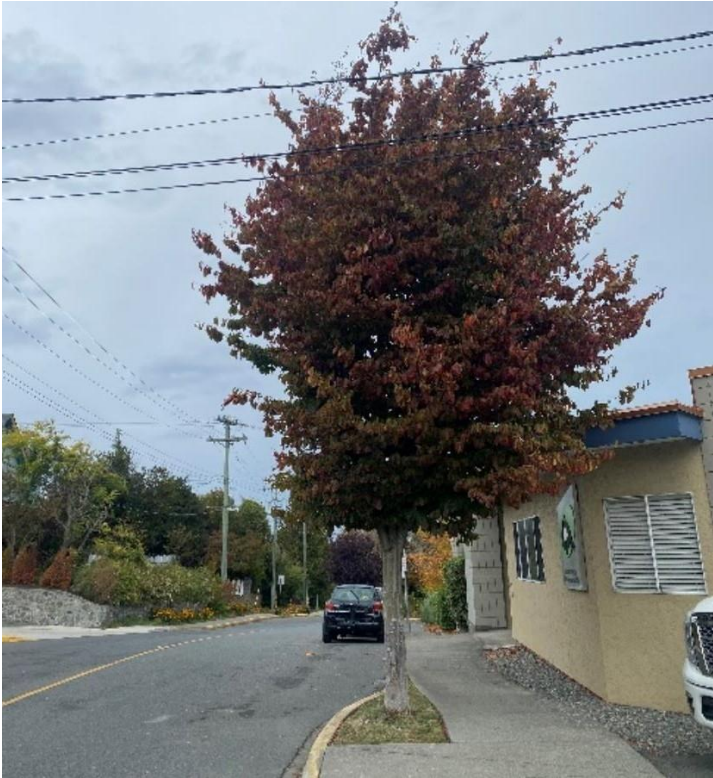
Image 6- Municipal tree M1 along Alston Street.

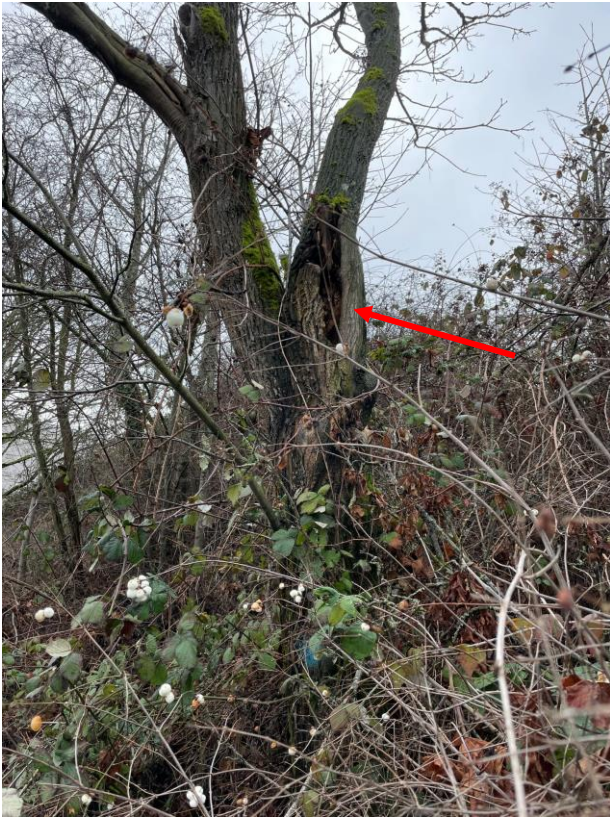
Image 7- Large cavity with associated decay in tree OS1 (red arrow)

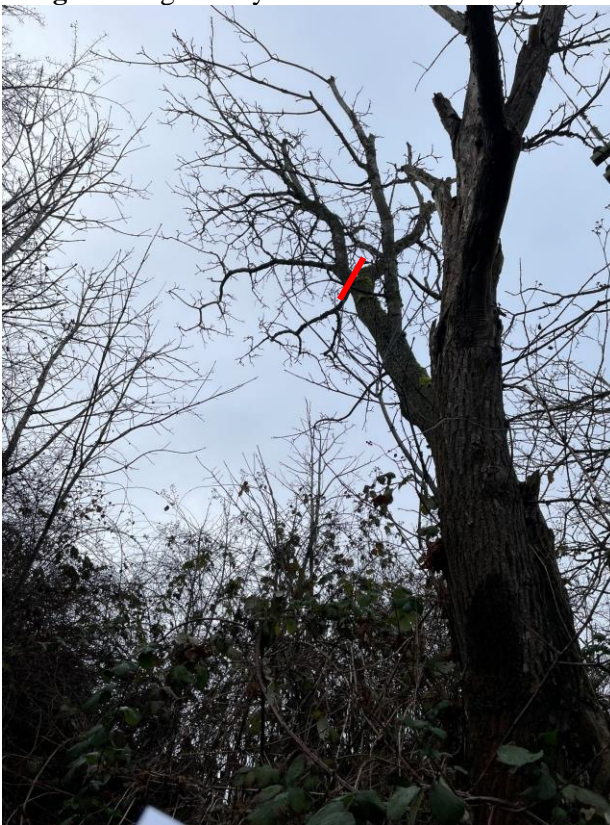
Image 8- Crown of OS1, required pruning to provide clearance for proposed construction (red slash)
