# SCOTT BUILDING

2659 DOUGLAS STREET, VICTORIA, BC

## CONSERVATION PLAN

AUGUST 2019

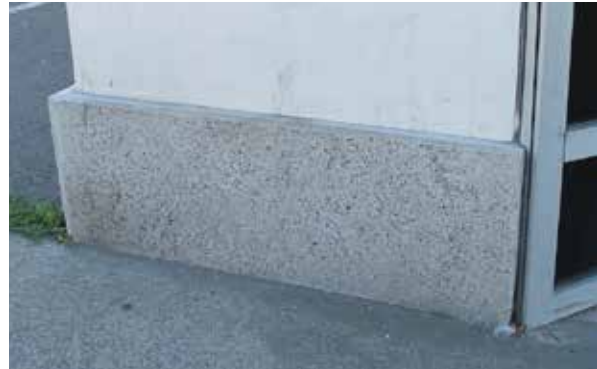
**Above:** Original grey granite base of northeast corner.

- Preserve the intact grey granite bases.
- Undertake complete condition survey of condition of all granite surfaces.
- All cleaning and repair specifications to be reviewed by Heritage Consultant.
- Overall cleaning of the granite shall only be carried out if necessary. Do not use any abrasive methods that may damage the face of the stone. In areas where cleaning is required, use a soft natural bristle brush and mild water rinse. Only approved chemical restoration cleaners may be used. Sandblasting or any other abrasive cleaning method of any kind is

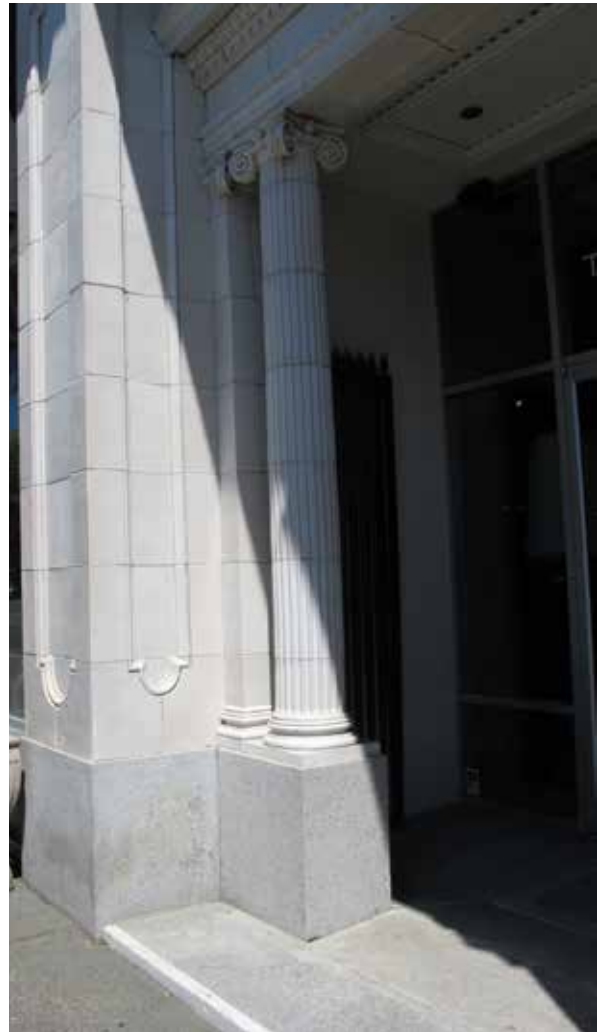
**Below:** Grey granite base at columns and step of portico. Localized chips and staining on granite.

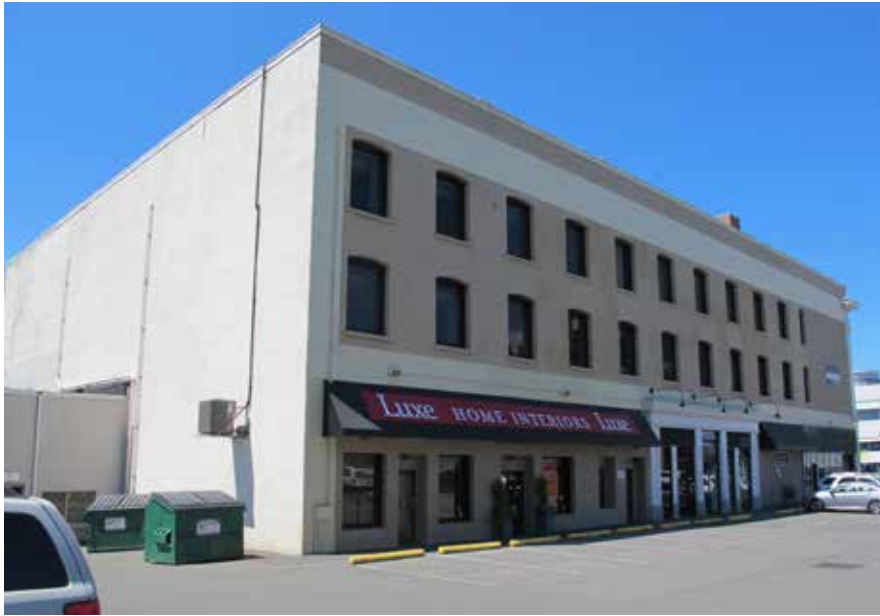
**Left:** East and south façades have parging. Unknown if brick is underneath parging and what its condition is, further investigation required. These façades were parged originally and existing parging is in good condition. Painted bands at storefront and parapet cornice heights are not original.

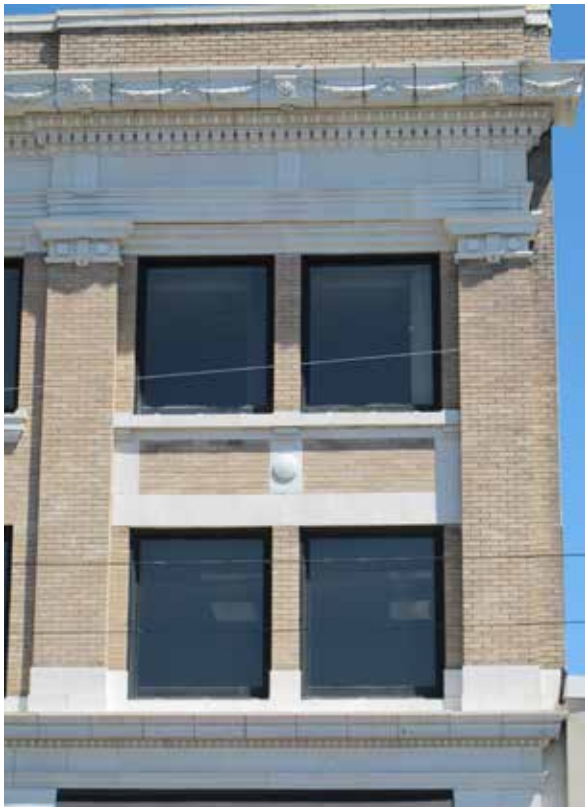
**Above Left:** Brick pilasters of upper floors. Localized mortar loss, staining, organics present on both primary façades.

the bases of the pilasters that separate the upper floor window openings. The mortar joints display localized mortar loss, again, to a greater degree at the parapet. Past unsympathetic repointing is also present on the parapet. The condition and method of anchorage have not yet been fully evaluated, further investigation is necessary. Detailed investigation will be needed to confirm appropriate remedial measures, and it is expected that seismic related interventions should be designed in a manner that is not visible to the exterior and with as minimal

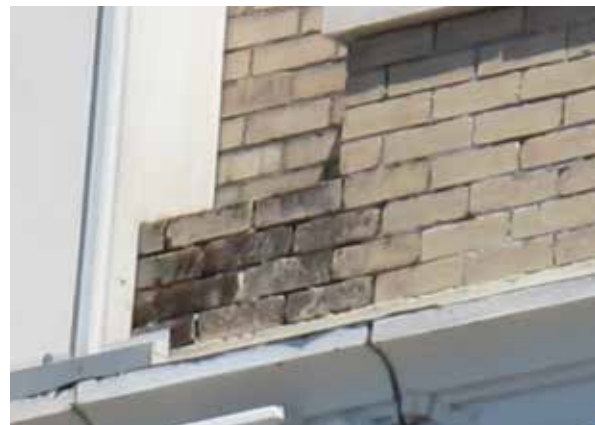
**Above Right:** Example of mortar loss, staining and organics at parapet level.

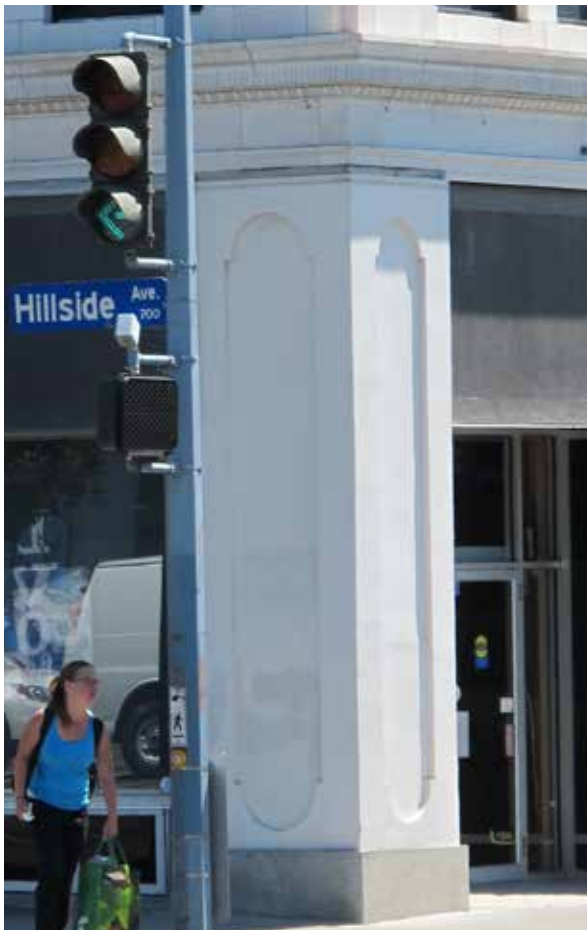
**Above:** Column at northwest corner rebuilt. Materials and design do not match archival drawings or historic photos. Recommend column be rehabilitated to reflect original.

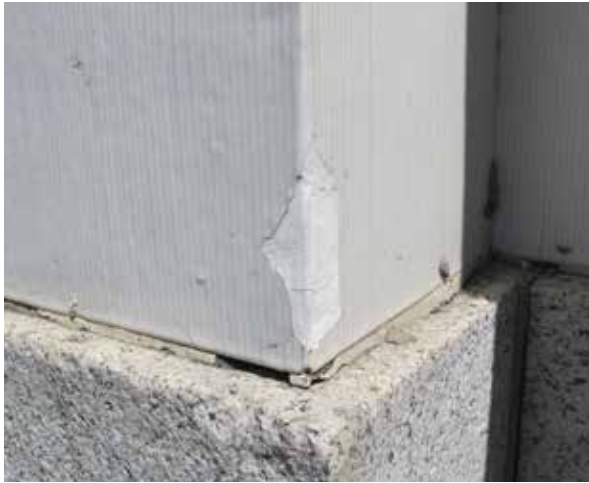
**Above:** Example of combed finish of terra cotta. Finish has been damaged exposing biscuit underneath. Mortar loss also present throughout.

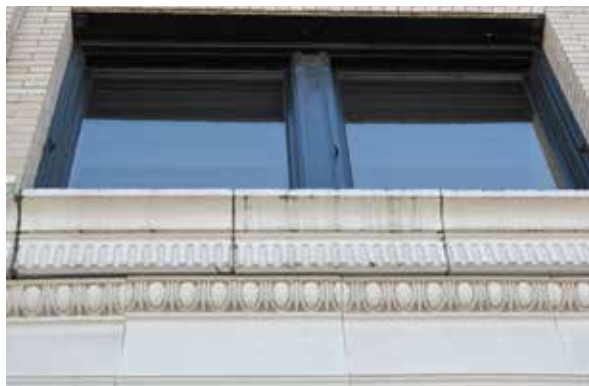
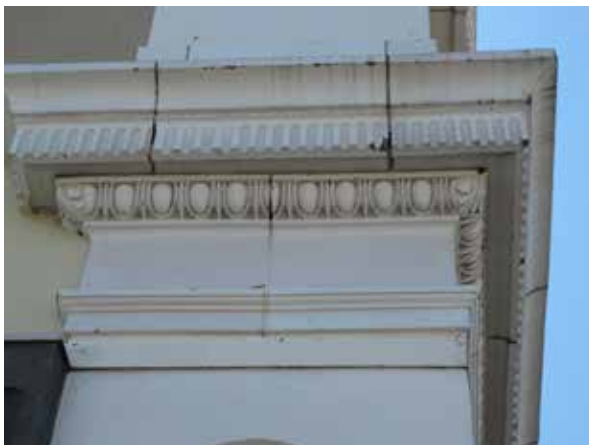
**Above and Below:** Glazed terra cotta storefront level cornice. Plain frieze with egg and dart and flute mouldings. Staining, chips to finish, mortar loss and discoloured mortar typical of storefront cornice.

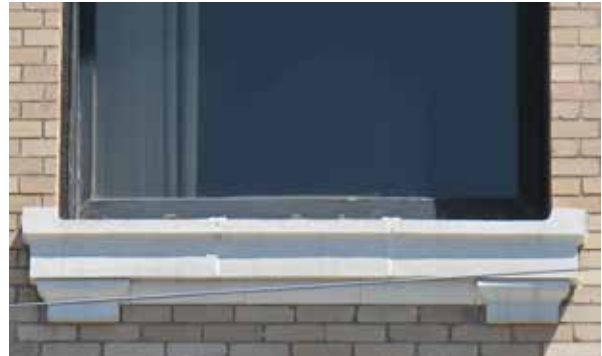
**Above:** Glazed terra cotta window sill typical of third floor windows on primary façades. Sills in good condition. Some sills appear to have been unsympathetically repointed in the past.

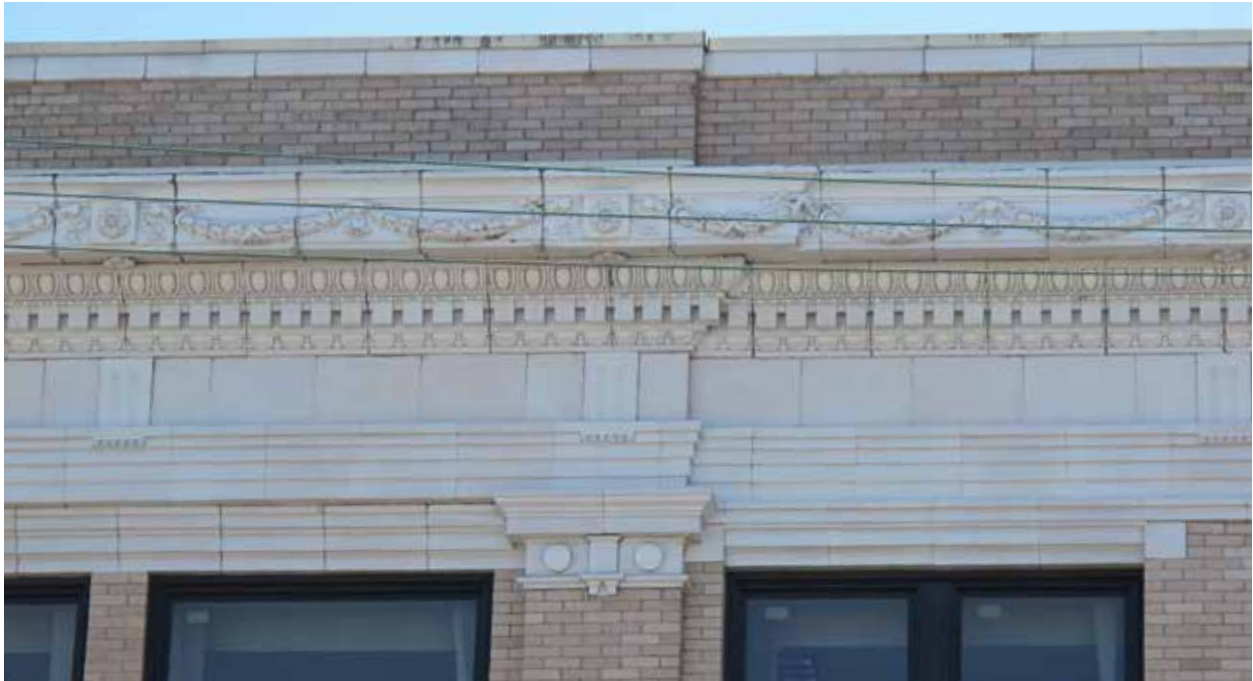
**Above:** Glazed terra cotta cornice at parapet level includes frieze with combed surface finish punctuated by triglyphs with guttae. The upper extent of the cornice includes leaf motif, dentils, bead band, egg and dart, and projecting upper element with garlands with ribbons and floral motifs on the face separated by floral rosettes .

rosettes. Both rosettes align with the triglyphs of the frieze. The parapet cornice possesses a range of types of deterioration including: chips, cracks, damage to the glazed surface finish, mortar loss, organic deposits, staining particularly of the mortar joints and adjacent to the joints, unsympathetic past repointing, and installation of cap flashing.

are to be preserved. Further investigation of the glazed terra cotta elements on the primary (north and west) façades of the Scott Building is required to evaluate the condition and method of anchorage used. Through this investigation the appropriate level of remedial measures can be determined. It is expected that seismic anchorage will occur in a manner not visible to the exterior.

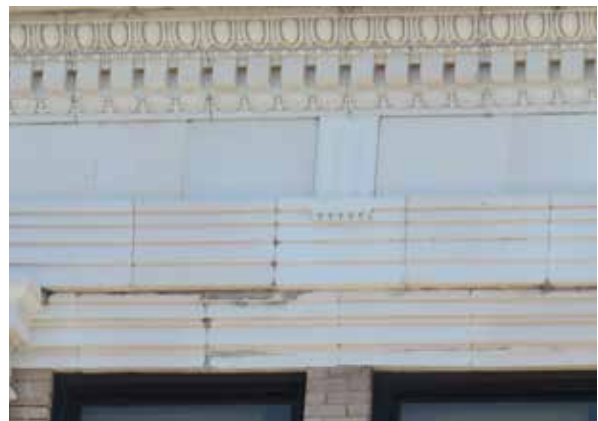
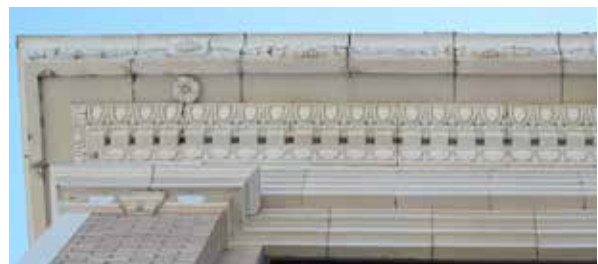
**Above and Below:** Mortar loss and staining present on façade and underside of parapet cornice.

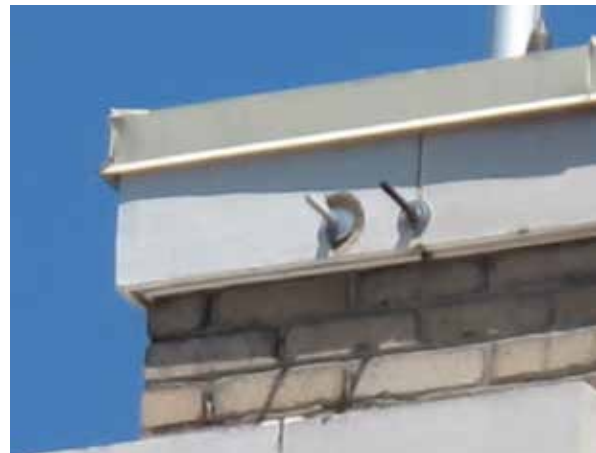
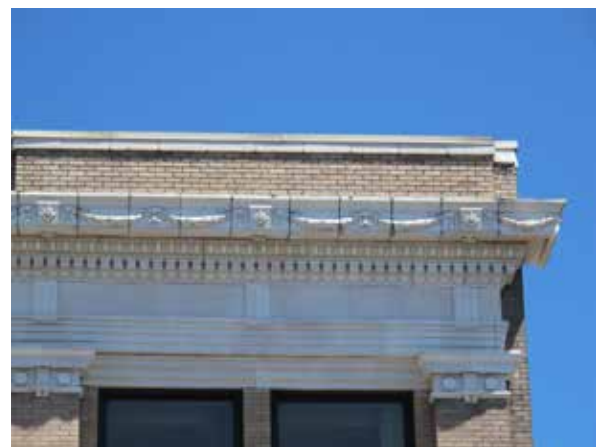
Metal cap flashing has been installed over the original glazed terra cotta cap on the parapet. The metal cap flashing is a later intervention to the building. Review of the metal cap flashing from the

**Above and Below:** Metal cap flashing added to glazed terra cotta parapet cap. Metal flashing is a later intervention.

- Evaluate the overall condition of the parapet cap flashing to determine whether more protection, maintenance, and/or limited repair or replacement in kind is required.
- Remove corrosion that may be discovered upon closer inspection, patch and repair, caulk joints as required and apply appropriate primer for galvanized surface.
- Repair or replace deteriorated flashing, as required. Repairs should be physically and visually compatible.
- If new flashings are installed, ensure that the colour is compatible with the overall colour scheme.

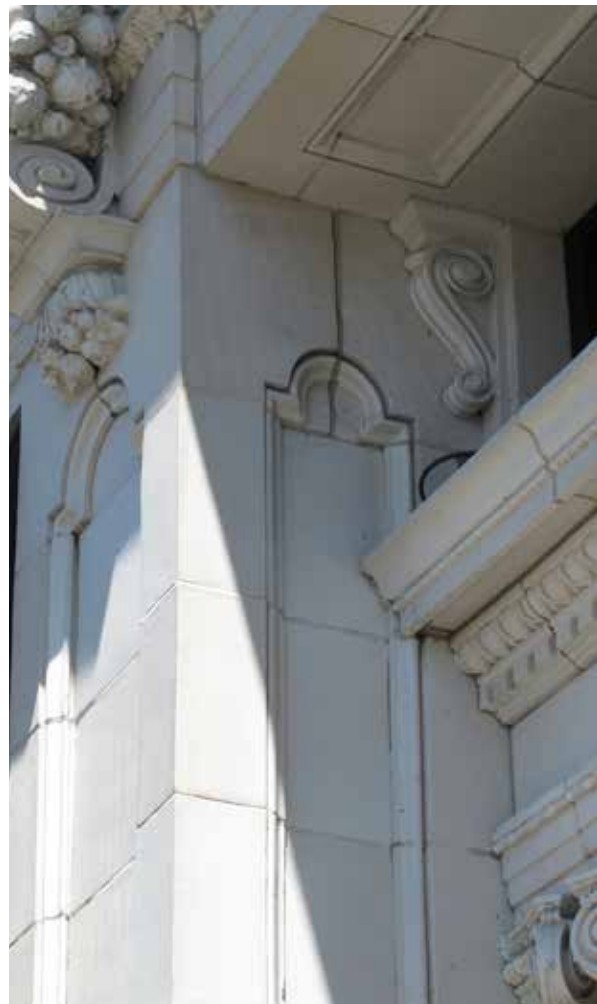
**Above:** Terra cotta cladding on column at Douglas Street entry. Columns have sunk panels on front and inside faces. Hairline cracks present in some of the terra cotta pieces. Mortar loss and stained mortar joints present.

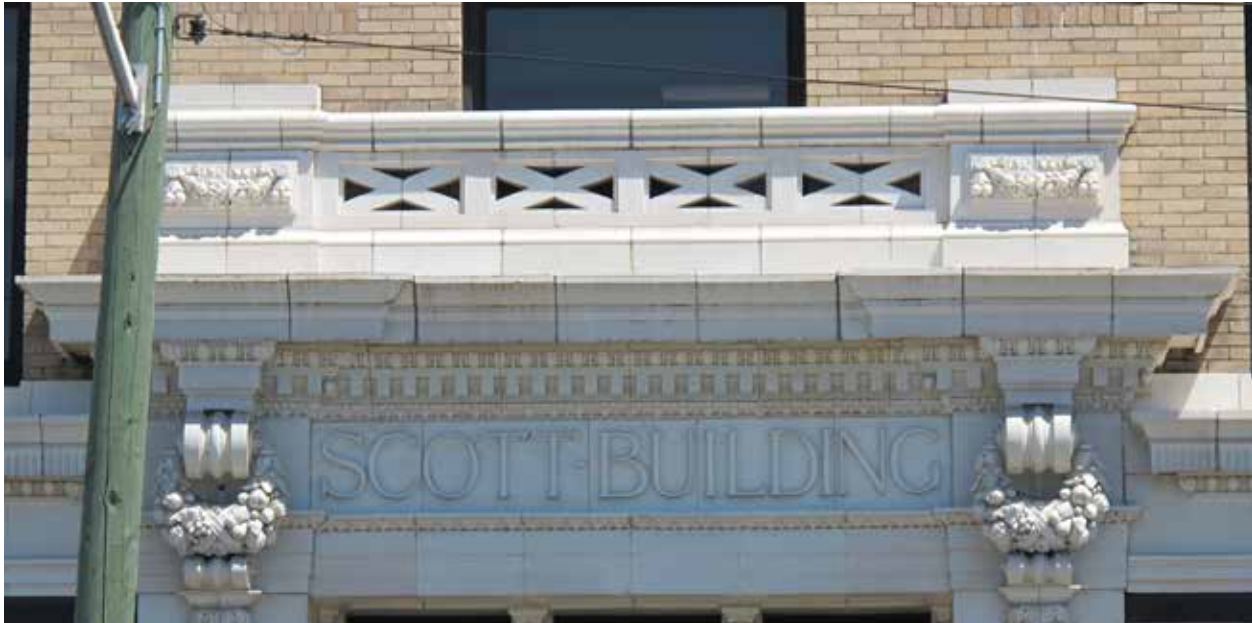
**Above:** Upper portion of the portico with similar terra cotta mouldings (dentil, egg and dart) as seen below leaded glass panels. Staining, mortar loss, and discoloured mortar joints typical. Low decorative balustrade present on top of portico original to building and in good condition.

this investigation the appropriate level of remedial measures can be determined.

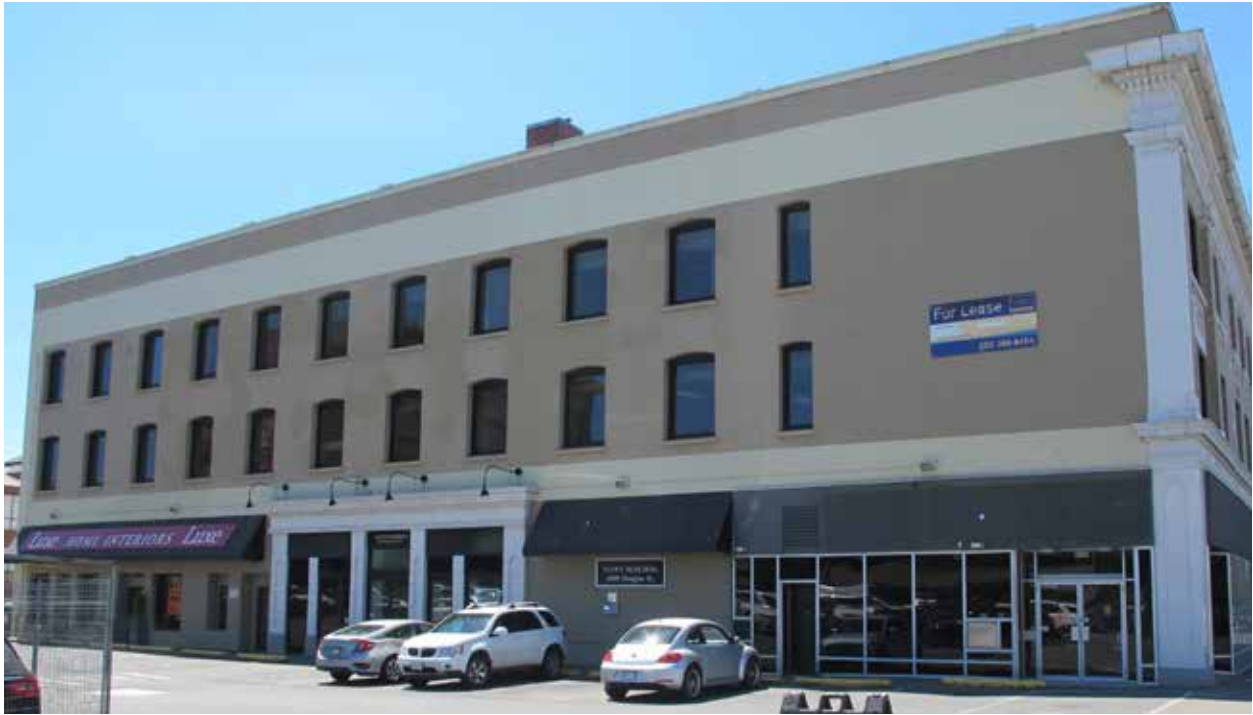
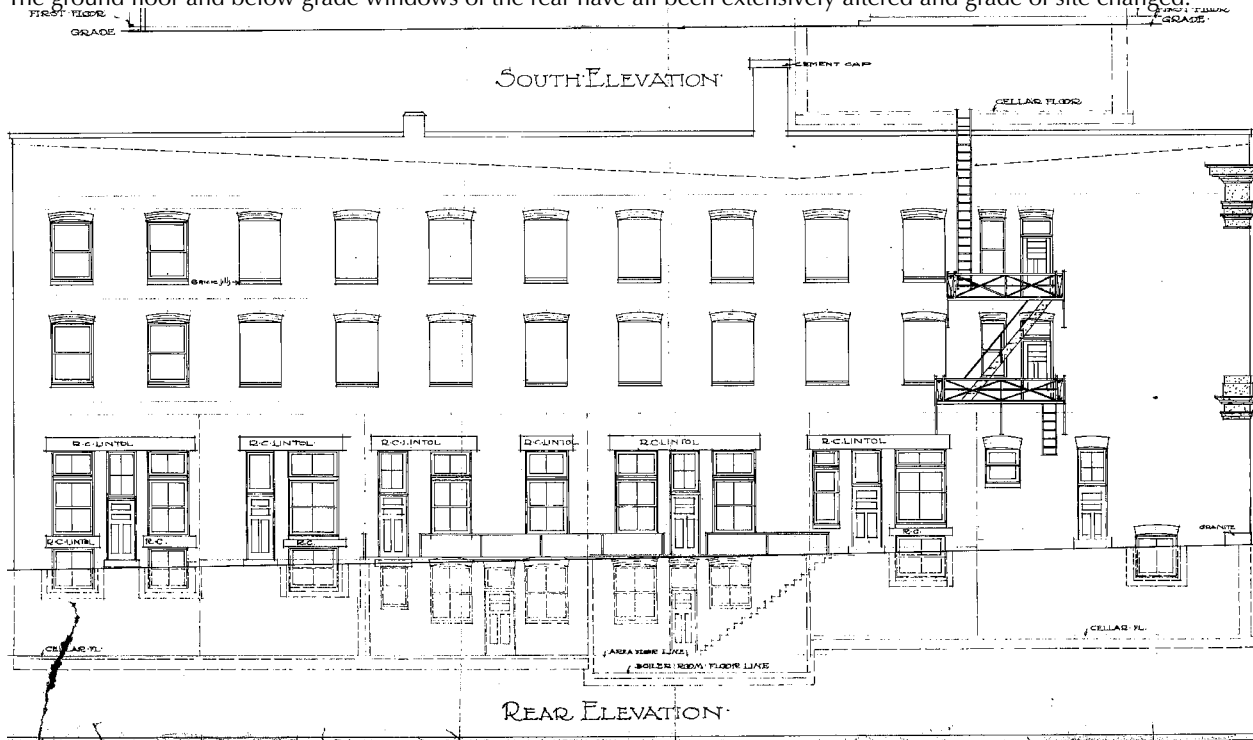
**Above and Below:** Current condition of windows on the rear façade with fixed single light windows on second and third floors. Original windows of upper floors were 1-over-1 wood sash windows, as shown in architectural drawings below. The ground floor and below grade windows of the rear have all been extensively altered and grade of site changed.

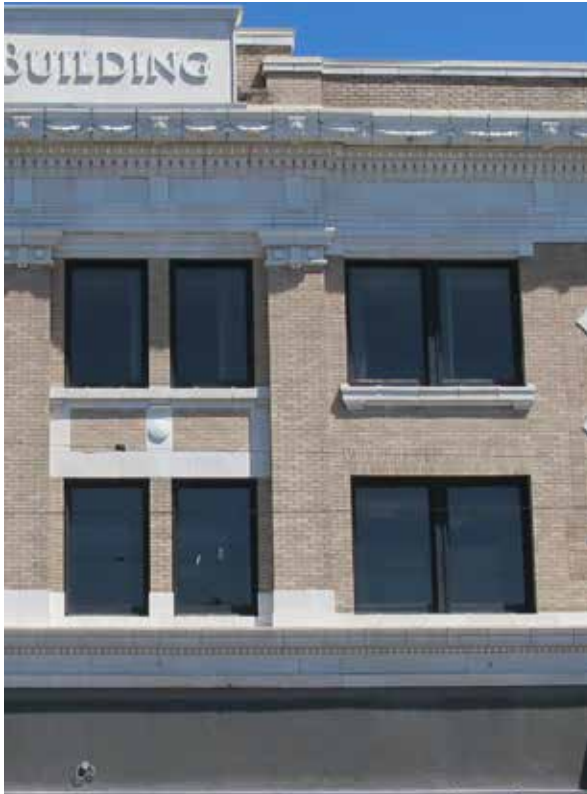
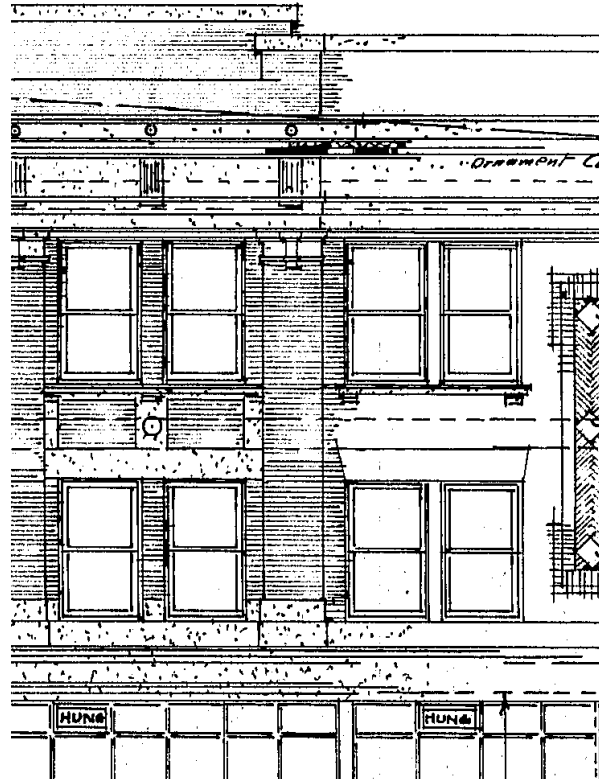
**Above Left and Right:** Window sashes of second and third floors of primary façades have been removed (left). Wood frames, mullions, and brick mould are intact with localized deterioration and paint failure present. Archival architectural drawing (right) show upper floor windows were 1-over-1 wood sash windows.

of 1-over-1 configuration should be installed in second and third floor windows on the north, south, and west façades. New wood sashes are to be solid Douglas Fir and through mortise and tendon construction with double glazing. Existing wood frames are to be preserved and milled to suit new sashes, if possible. The ground floor fenestration of the rear façade have been heavily altered. Archival drawings and photographs can be used as a guide for the replacement window sashes.

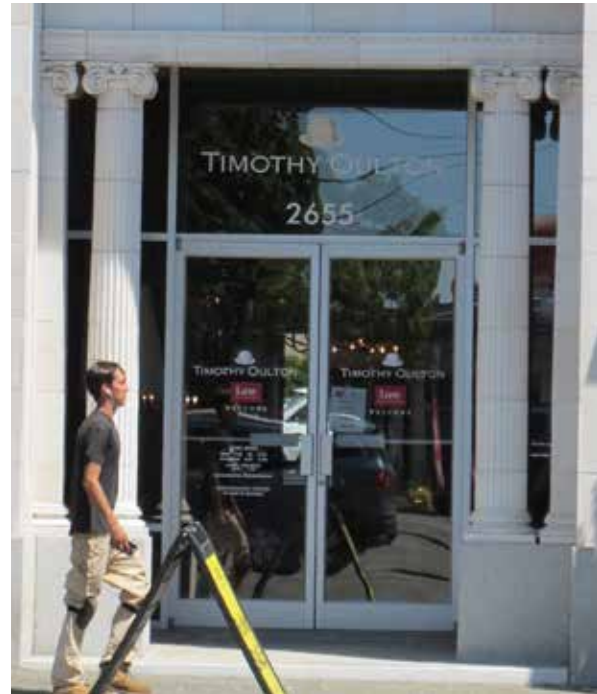
**Left:** Replacement aluminum door assembly of Douglas Street entry. New wood door assembly should be installed and existing aluminum assembly removed.

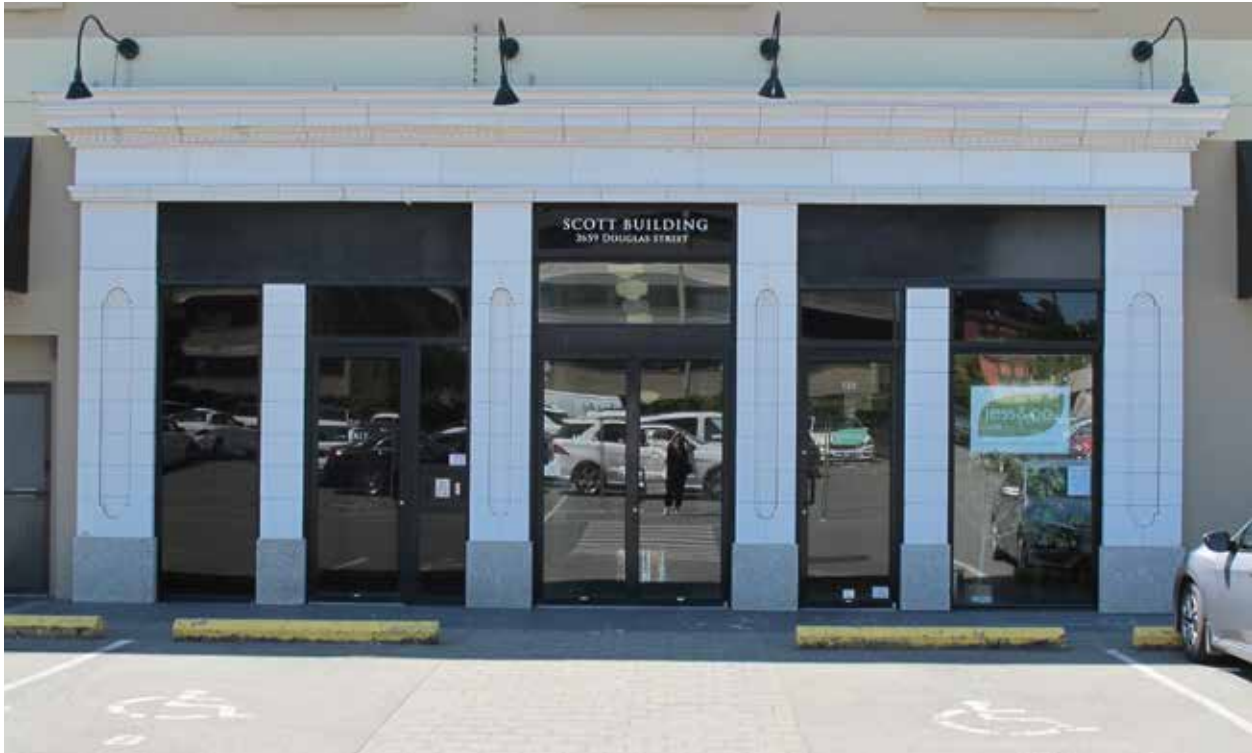
**Above:** Later added entry at rear (east) of building. No original assemblies have been integrated into this later intervention to the Scott Building.

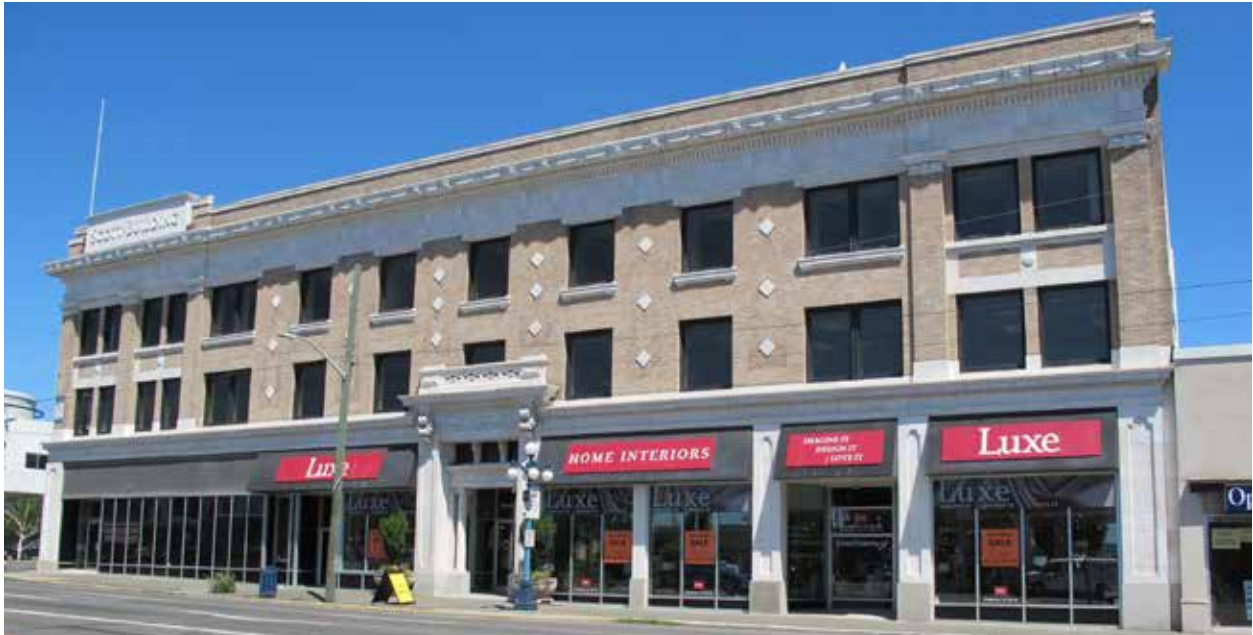
**Above:** Current configuration of the storefront of the Douglas Street façade of the Scott Building. Original storefront assemblies have been removed or boarded over. Further investigation of the boarding over the transom should be carried out to determine if any original elements of the transom remain.

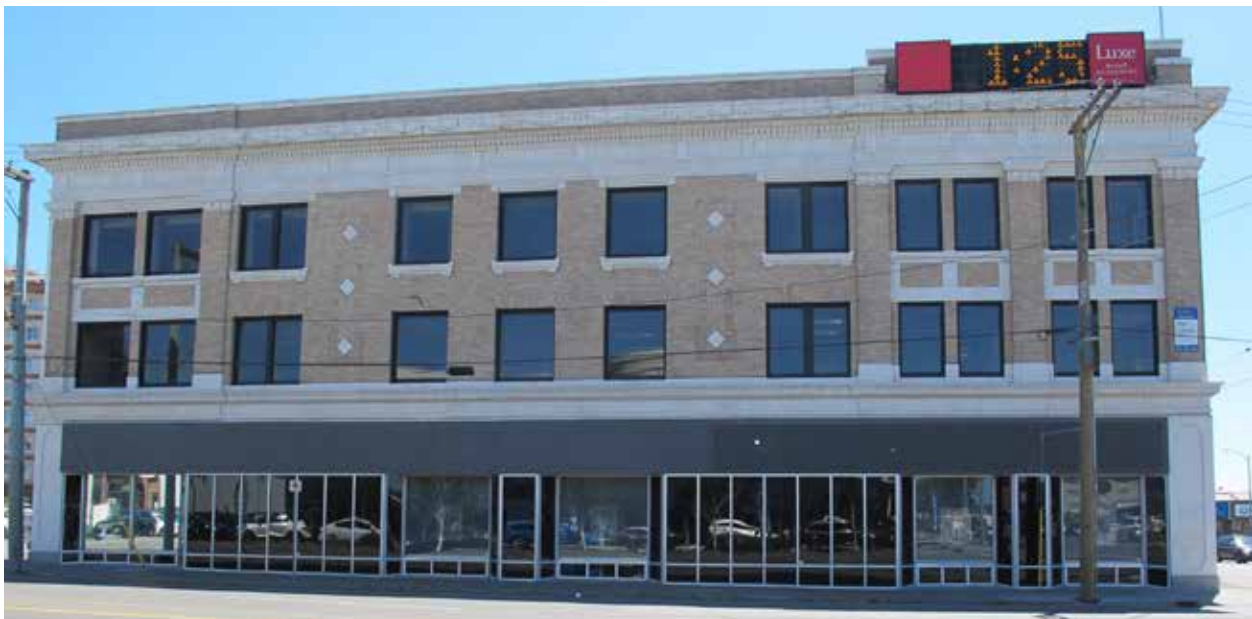
**Below:** Current configuration of the ground floor of the Scott Building's north façade. The original design and materials of the storefront have been removed and replaced with aluminum and glass storefront. The rehabilitated storefront of both the Hillside Avenue and Douglas Street façades should reflect the original design and assembly (wood and glass) of the original storefront.
