Heritage Alteration Permit Application for 700 Government Street (Lower Causeway)

Location | Lower Causeway

**Proposal | Repair and replace existing paving material along apron**

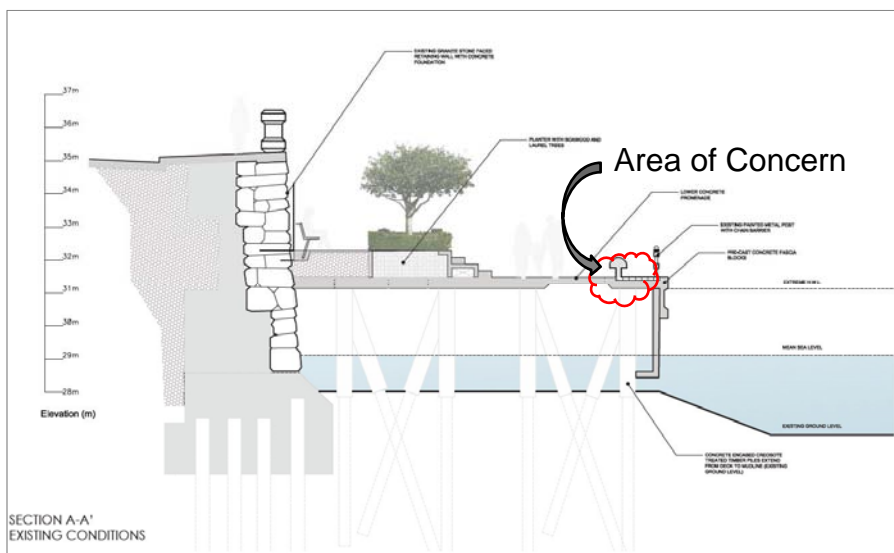
Existing Conditions | Lower level edge paving and lights

Repairs Required | Lower level edge paving and mushroom lights

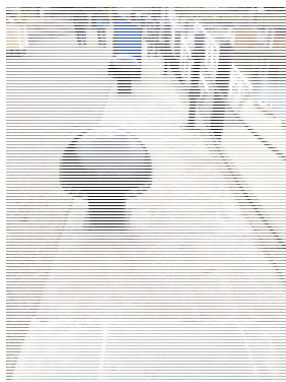
Unbonded quartz tile

It is recommended that these pavers are removed and replaced with a concrete screed topping. A bonding agent such as Sikadur 32 Hi-Mod can be used to protect the existing reinforcing and to ensure a proper bond between the existing concrete and the new topping.

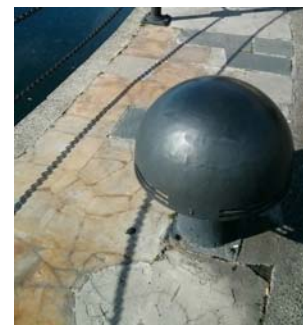
Previous repairs

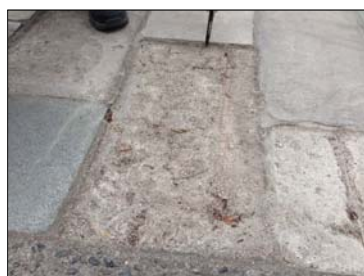
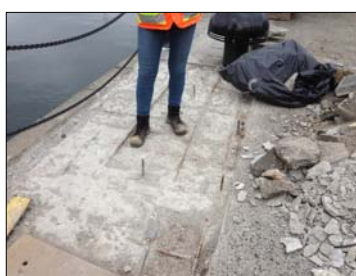
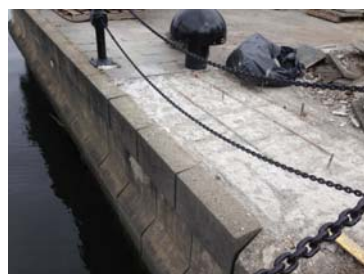
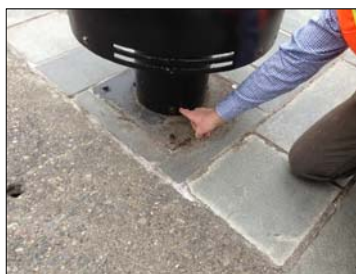
Repairs Required | Lower-level edge paving and mushroom lights

Damaged lights

As part of this replacement the "mushroom" light bases can be replaced with aluminum bases, as per details previously used by GVHA. Crack control details can be utilized at each side of the existing "mushroom" lights, to reduce concrete cracking.

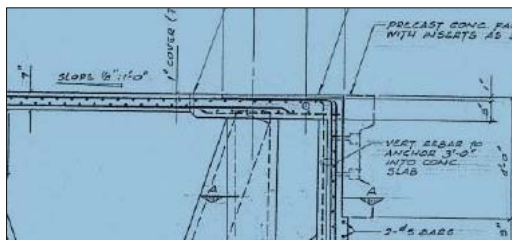
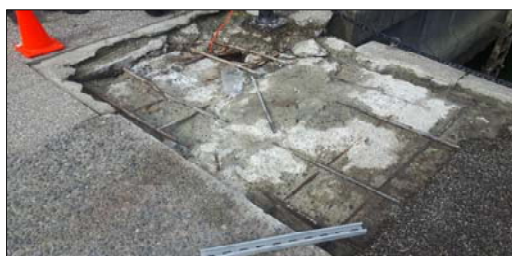
Section Detail | 1973 Causeway construction

The 1" slab depression does not allow for installation of a 3/4" paver, which would fare better in this high traffic area than the 1/2" pavers that have been used. The top reinforcing in the concrete slab does not have adequate protection from chlorides and freeze thaw, and may be contributing to these tiles becoming un-bonded.

The issues with the pavers at the lower causeway are most likely attributed to the original construction detail that was used in 1973. The 1" slab depression does not allow for installation of a 3/4" paver, which would fare better in this high traffic area than the 1/2" pavers that have been used. The top reinforcing in the concrete slab does not have adequate protection from chlorides and freeze thaw, and may be contributing to these tiles becoming un-bonded.
