Re: Exploratory excavation for Western Red cedar at 1358/1360 Thurlow Road

Picture Page – June 14, 2017

Exploratory Excavation for Garage Footprint

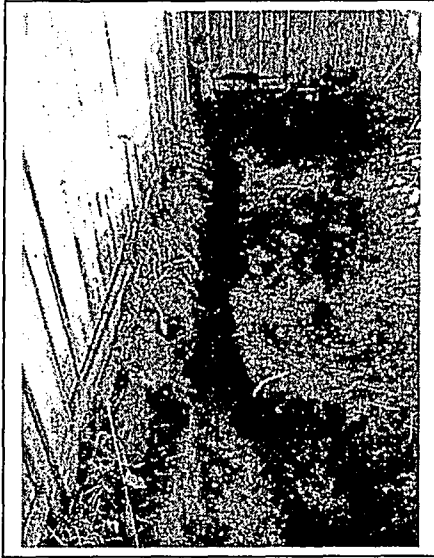
Exposed trench

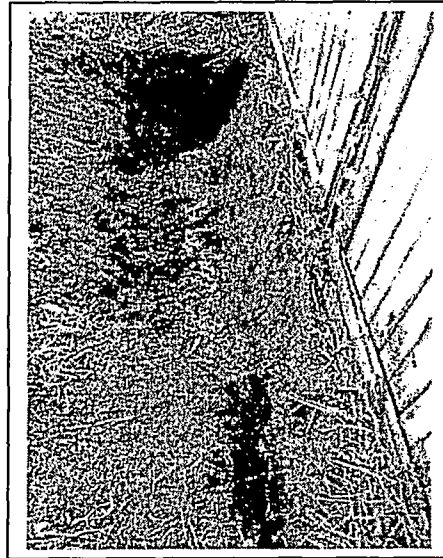
Exposed trench

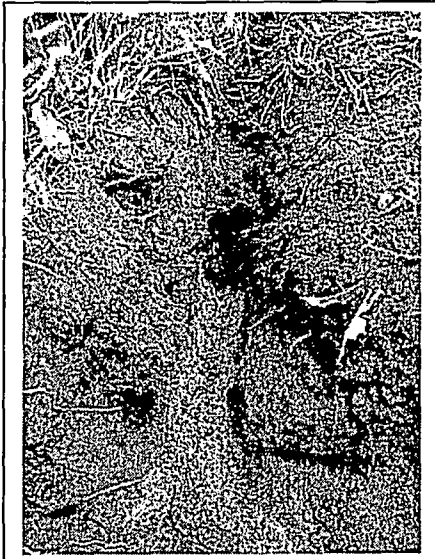
The excavation commenced near the north property boundary approximately 4 metres from the cedar tree, at the edge of the canopy dripline, and extended in a southerly direction along this proposed footprint. The excavation to a bearing level of soil approximately 40 cm below the existing soil grade encountered a total of six roots larger than 1 cm in diameter:

Bearing soils

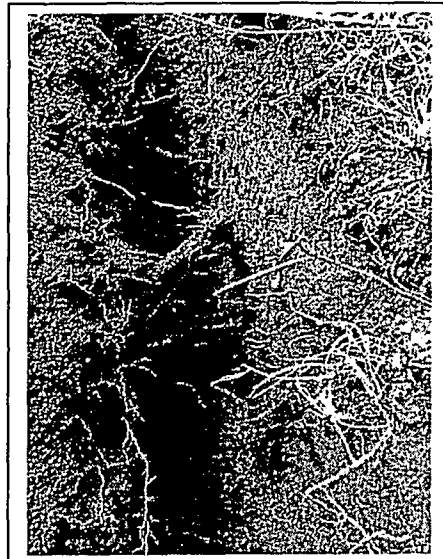
- 3 roots measuring 2.5 cm in diameter
- 1 root measuring 1.5 cm in diameter
- 2 roots measuring 4.0 cm in diameter

In our opinion, the roots that were encountered are not critical to the health or stability of the cedar tree, and could be removed without having a detrimental impact on its survival. Reducing the size of the garage or relocating it slightly further to the east is unlikely to reduce the impacts on the tree or its root system significantly.

Exposed 1.5 and 2.5 cm roots
