# Edibella Organic Landscapes Inc.

March 10, 2017

Tree report for the City of Victoria,  
re. development proposal of 750 Pemberton

This report has been prepared for the client by Michael Cowan of Edibella Organic Landscapes Inc. ISA Certified Arborist PN 5963-A

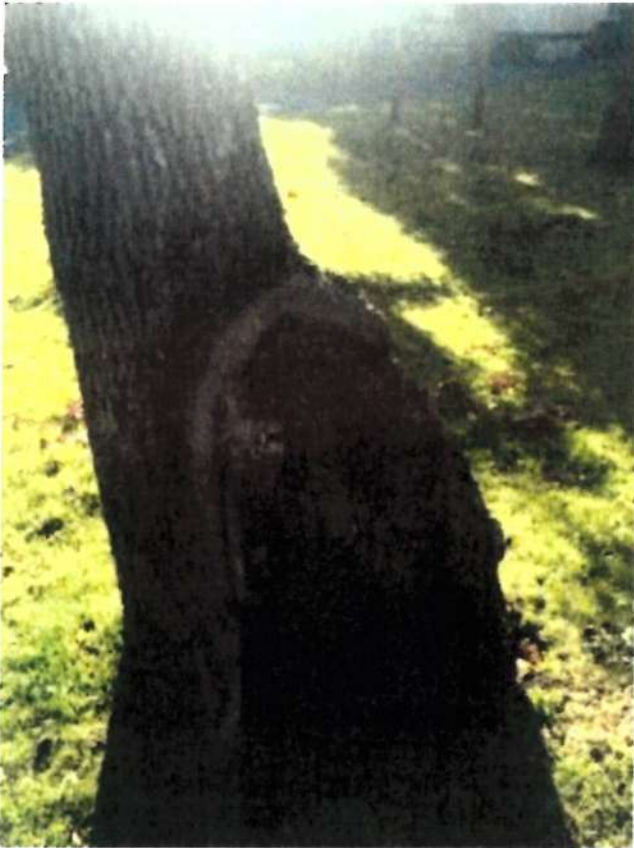
1), 2), 3), and 4) Garry oaks on City Boulevard

1) 54cm DBH 2) 45cm DBH 3) 64cm DBH 4) 54cm DBH

All appear healthy. One, (tree #2) has significant decay at the base from previous, (15 years ago at least), large pruning wound. These trees are all well outside the construction zone and well inside the 13.6m front yard setback, however I would recommend a tree protection fence, starting at the northern edge of the driveway, 10.5m from the road and heading to the north property line.

| Tree # | d.b.h. cm | PRZ m | CRZ m | Species | Crown Spread | Condition Health | Condition Structure | Relative Tolerance | Remarks/Recommendations |
|---|---|---|---|---|---|---|---|---|---|
| 2 | 45 | 9 | 5.4 | Garry Oak | 8 | Good | Poor | Good | Municipal Tree, Well outside of construction zone, Large wound at the base see photo |

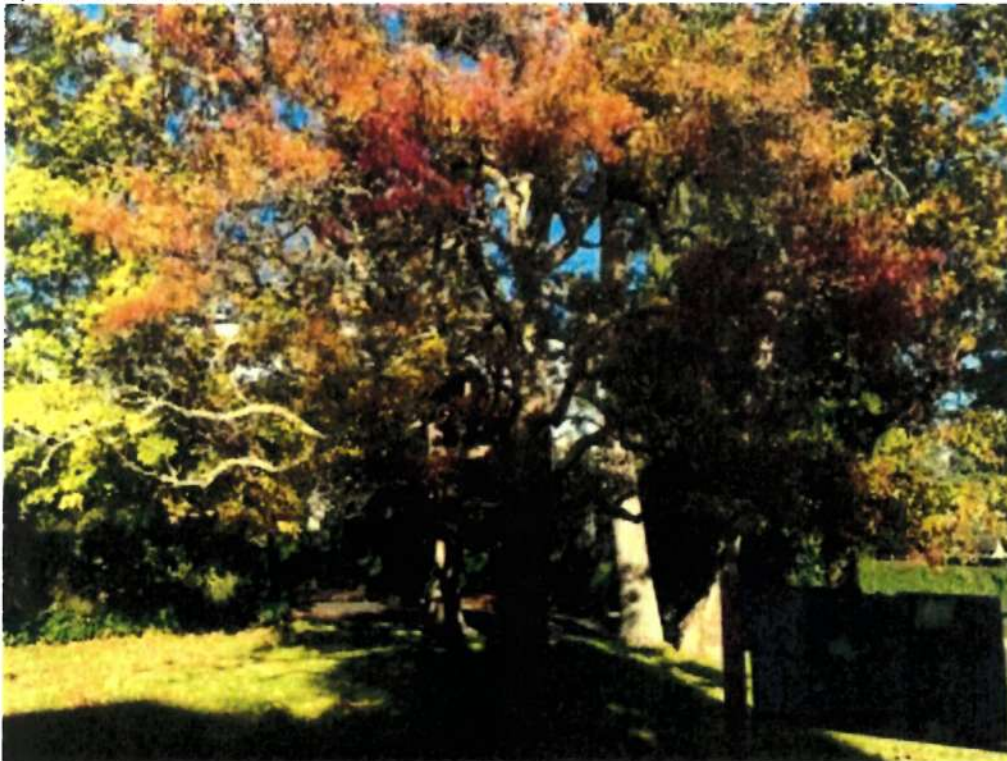
**5) Pear tree 'winter nelis'?**

48cm DBH

Healthy and grafted.

This tree is well outside the construction zone and well inside the 13.6m front yard set back  
The tree protection fence mentioned above will include this pear tree

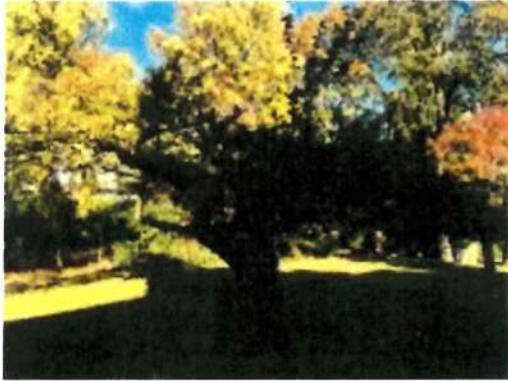
**6) Apple tree 'Cox's Orange Pippin'**

61cm DBH. Tree is well under 5m in height

Massive wound (51cm in diameter) at 8'

Lots of conks and wounds. Tree was likely planted at the time the original house was built. Common and favourite British apple at the time the tree was planted. Tree fruited well this year and though old, still shows signs of vigour, with shoots sprouting out of old wounds, not epicormic. This tree is nearing the end of its life, (150 years is the usual lifespan of an apple). This tree could be maintained but tree protection fence will need to be constructed at the dripline of the tree.

| Tree # | d.b.h. cm | PRZ m | CRZ m | Species | Crown Spread | Condition Health | Condition Structure | Relative Tolerance | Remarks/Recommendations |
|---|---|---|---|---|---|---|---|---|---|
| 6 | 61 | 7 | 7.32 | Apple Tree | 5 | Poor | Poor | Good | Old, damaged Cox Orange Pippin Apple, likely planted with original house |

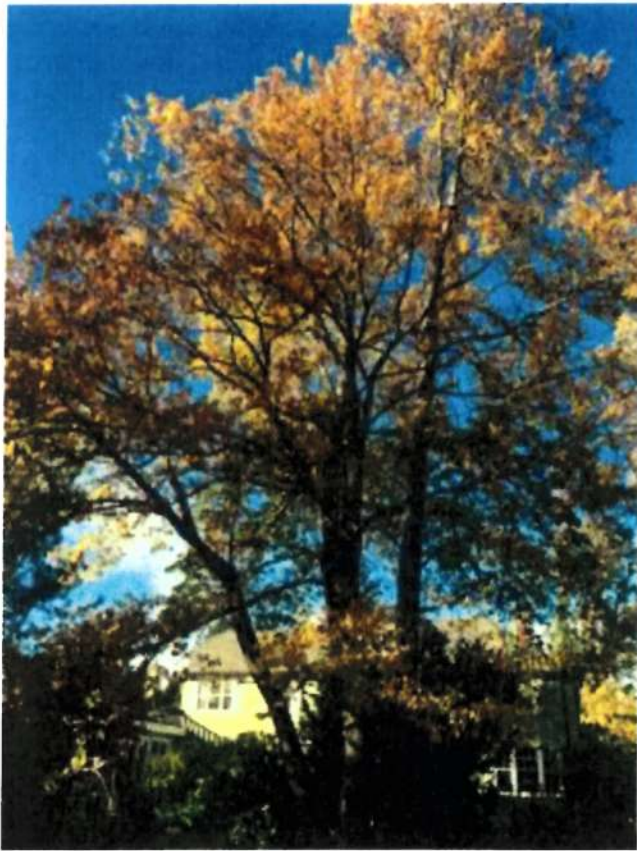
**7) Elm tree(s) a multi stem tree**

54cm, 54cm, 45.5cm, and 71cm DBH for each of the trunks equals a total DBH of 163cm  
Four stems from the ground up. Only one/two stem are co-dominant w/ included bark. Very healthy looking tree

| Tree # | d.b.h. cm | PRZ m | CRZ m | Species | Crown Spread | Condition Health | Condition Structure | Relative Tolerance | Remarks/Recommendations |
|---|---|---|---|---|---|---|---|---|---|
| 7 | 54,54,4 | 11.2 | 6.72 | Elm tree (multi stem | 15 | Good | Good | Good | Multi Stem tree, one co-dom, w/included bark. Very healthy tree |

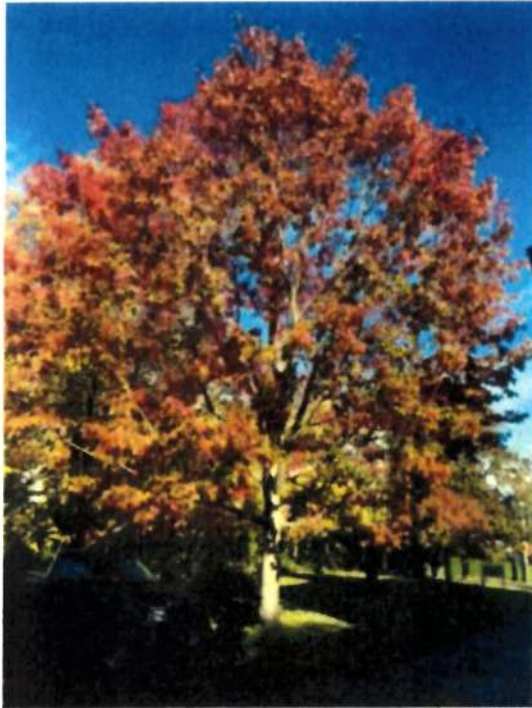
**8) Red Oak**

53cm DBH

Very healthy tree, but is too close to the cottage and will have hardscape all around its roots if it were to be maintained. I recommend this tree be removed for those reasons

**Building Footprints:** The footprint of Unit 1 Family Cottage, will impact the rootzone of tree #8 so much that it is recommended that this tree be removed for the construction of the dwelling at its current location on the property. The pine tree on the neighbours property will have about 15% of its PRZ impacted by this dwelling as well. I recommend that the excavation for this Unit 1 be observed by the project arborist to ensure no major roots of neighbouring tree are affected by the excavation process. Strata lot A with its construction of a foundation will slightly impact the PRZ of trees #10, #11. Excavations should be observed by an arborist. The strata lot B had been well situated between the PRZ's of trees #'s 15 and 16. There is still the chance of root damage in the excavation process so I would recommend exploratory digging prior to the excavations and the excavation work be observed by an arborist.

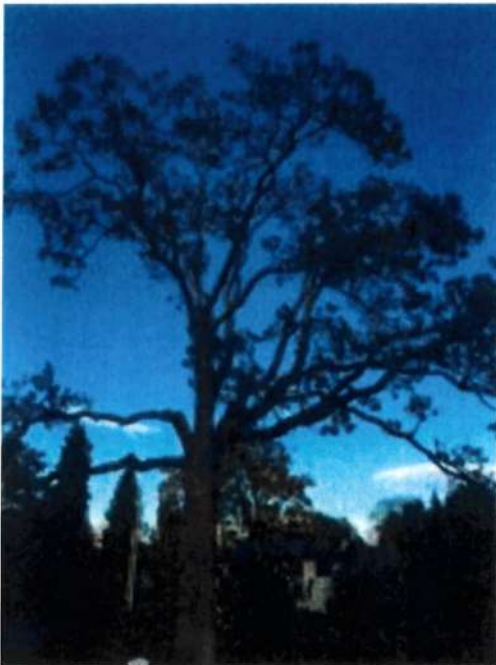
#### **16) Large Garry Oak on eastern property line.**

96.5cm DBH. Large tree, the crown was not as full as I would expect from a tree that size, a lot of past pruning has been done on this tree but the wounds had healed over well.

| 16 | 96.5 | 19.3 | 11.52 | Garry Oak | 15 | Fair | Good | Good | A sparse canopy for tree of that size, a lot of previous pruning but wounds have healed well. |

An 8m x 8m Tree protection zone should be constructed around the tree from the property line outward with the trunk at the center. A 15cm layer of coarse bark/wood shavings should be laid

from the outside edge of the fence to the edge of the drip line to prevent compaction from excavators and other machinery.
