Planning and Land Use Committee Report

Subject: **606-620 Humboldt Street/801-807 Government Street**
Heritage Alteration Permit #00182
Proposal to replace the balance of the existing windows and repair the terra cotta on the Humboldt and Government Street facades
Heritage designated building
Within DPA 1 (HC) - Historic Core
Zoned: CA-3C - Old Town District

Belmont Building - Historic Repairs

Design Development Report

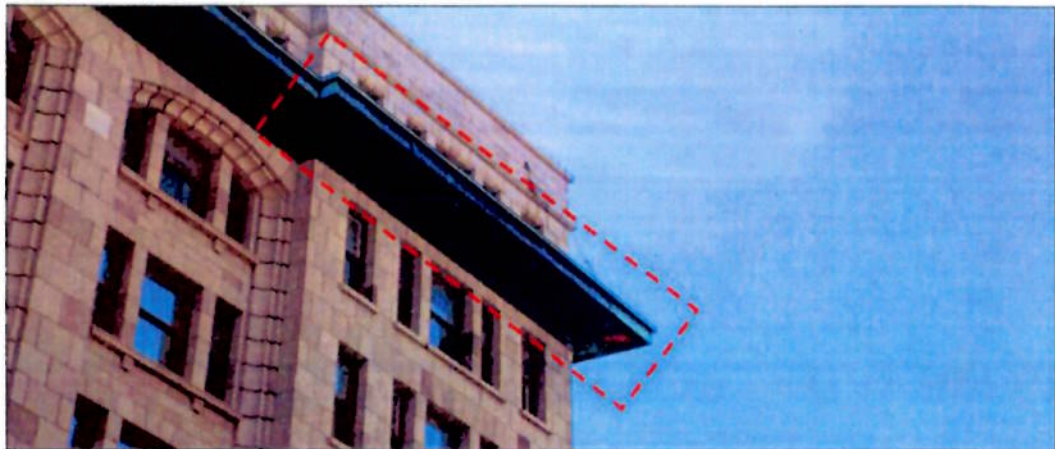
Photo 1 - North East Cornice

On July 17, 2013, RJC visited the site with Lorne James of Jawl Properties to complete a visual review of the cornice. Subsequent to this review, RJC visited the site on July 23, 2013 to review portions of removed interior wall, exposing the backside of the exterior masonry wall adjacent to the cornice.

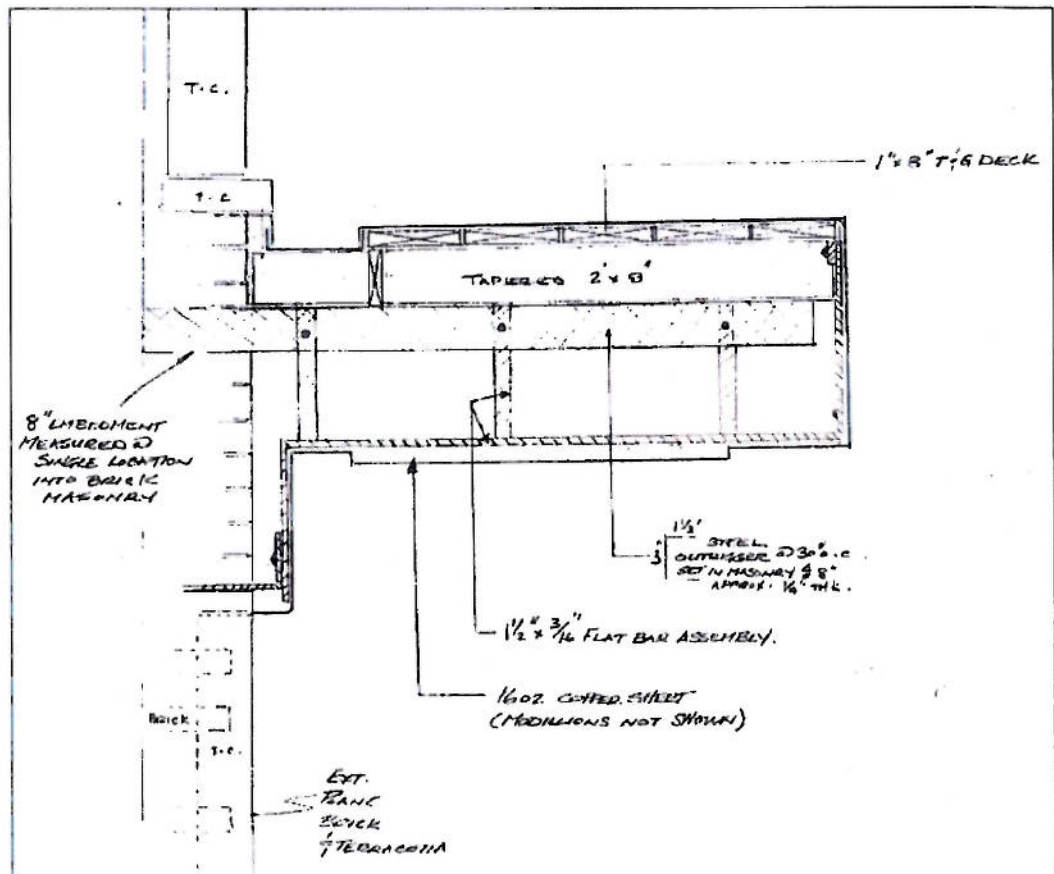
Figure 1 - Typical Cornice Section - Source: The Church Group Consultants Ltd.

From the ground level, areas of cracked, fractured, and spalling terra cotta within the area of the cornice are visible. The terra cotta does not extend up the wall into the cornice cavity (refer to Figure 1). From the 8th floor window, the terra cotta joints on the wall surface are thin, and appear to be in generally good condition. The joint where the copper sheet for the cornice is integrated into the terra cotta appears to be in poor condition. Sealants have been applied to this area in an attempt to mitigate leakage.

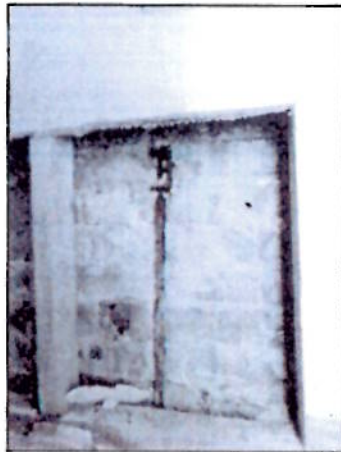
Photo 2- Tension Rod

The steel outrigger was visible to the inside, as was the reinforcing steel. The outrigger has corroded, and has experienced a loss of section of approximately 50% and spalling brick was observed adjacent to the steel outrigger section. RJC has confirmed the original reinforcing steel ties shown in the 1972 drawings prepared by Cooper, Tanner, and Associates Ltd. are present. These ties were not noted during the investigation completed by Church in 1997.

It is apparent that water has been able to penetrate the cornice for quite some time and penetrate the porous masonry brick wall, resulting in corrosion of the steel outriggers. As the steel corrodes, it expands and causes the masonry confining the steel to crack, and the masonry joints to open. This process further increases the frequency of water penetration and advances the corrosion process. The reinforcing ties attached to the channels have also corroded, and spalling masonry is present at the interior face of the masonry wall. Although not confirmed, it is suspected that the reinforcing steel ties may be embedded within the structural concrete floor slab. Section loss of approximately 50% was also observed at the tie locations.

The current assembly relies on the compressive strength of the masonry brick wall, and the tensile resistance of the embedded steel rod to restrain the steel outrigger. Over time, water has been able to penetrate the roof cornice, and enter the masonry wall. This has resulted in corrosion of the steel member, which has resulted in cracked masonry units, and failed/displaced mortar joints. Given the general condition of the masonry brick wall, it is recommended that the new system not rely on the masonry to resist compressive loads unless the wall is re-pointed, and/or re built as required. The steel outrigger section has undergone significant section loss due to corrosion, and no longer has the capacity required to resist the required design loads. Replacement of the steel outrigger is required.

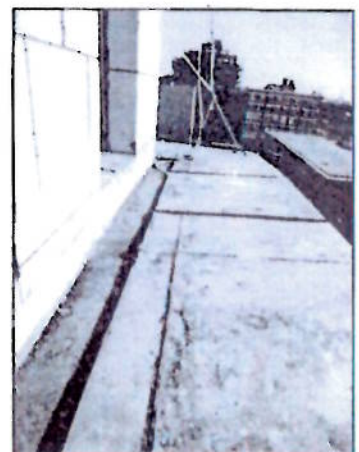
Photo 4- Northeast Cornice

As evident in the video provided by Grist Tile and Slate Ltd., several of the steel outriggers have lost their structural capacity; as a result, the cornice roof has sagged at the northeast corner. The 45 degree outrigger identified within the video is loose, and does not appear to be attracting load.

During our interior review, a previously attempted remedial repair to correct a sagging outrigger was observed. At this location on the northeast corner, a red-iron steel angle had been installed. The angle is welded to the end of the steel outrigger, and bolted into the floor slab. The bolt was observed to be very loose, and the effectiveness of this repair is questionable. It is anticipated that this repair may have been completed at other locations along the cornice.
