Governance and Priorities Committee Report

Subject: Project Update for Fire Station #1 and Point Ellice Bridge

Inspection & Repair Options Report

Hindi Engineering Ltd. was retained by the City of Victoria to carry out a condition visual inspection of the structural steel superstructure and the concrete deck of Point Ellice Bridge. The structure is located in Victoria, BC.

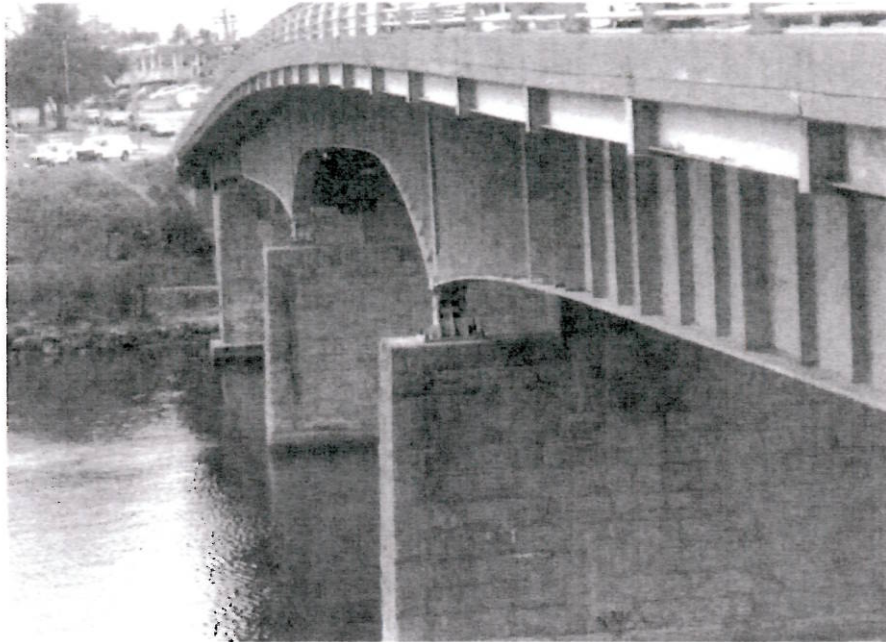
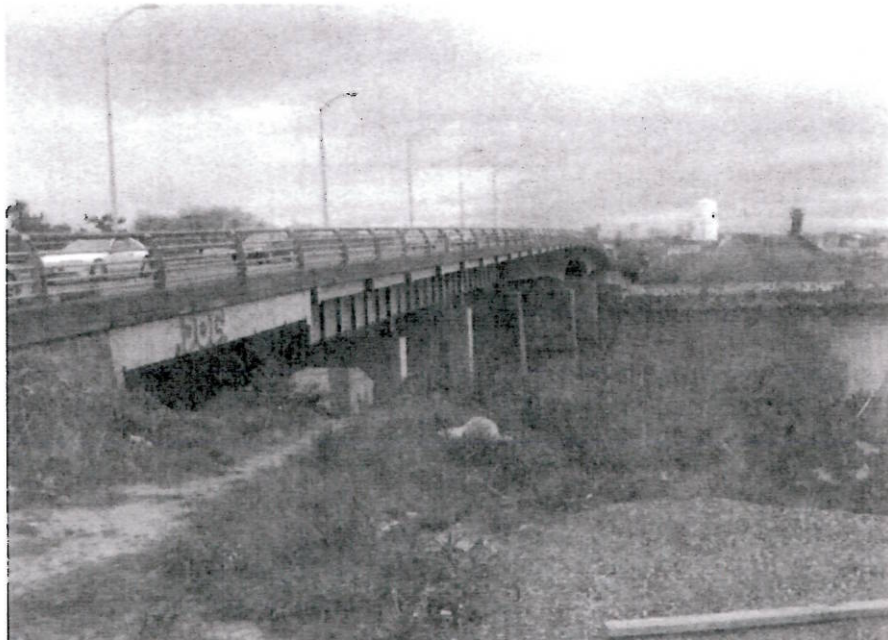
Photos 1

An overview of the bridge structure is shown in Photos #1. The Point Ellice (Bay Street) Bridge is a two-lane steel structure over the Gorge in the City of Victoria. The bridge is 187m long and 10.7m wide. The total bridge width out-to-out of the concrete slab is 11.775m. The three granite masonry faced piers and abutments were built in 1902-3 to support a low span truss bridge. In 1956, the present bridge was erected on the old piers and concrete erosion at the base of the piers was repaired. Additional concrete bents were installed in the West span.

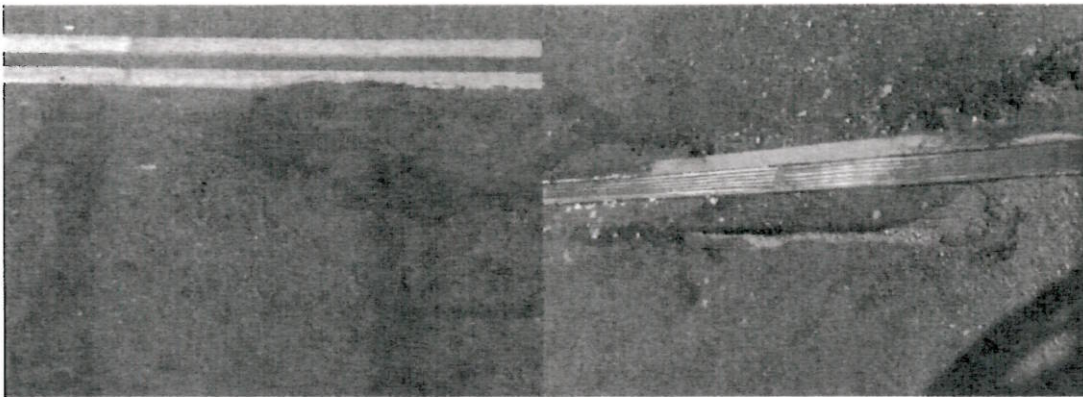
The concrete deck is covered by a 50 mm thick asphalt wearing surface that is in fair condition. The wearing surface over the concrete deck joints were recently repaired by the City staff and mostly performing well. There are some areas that need special attention, as shown.

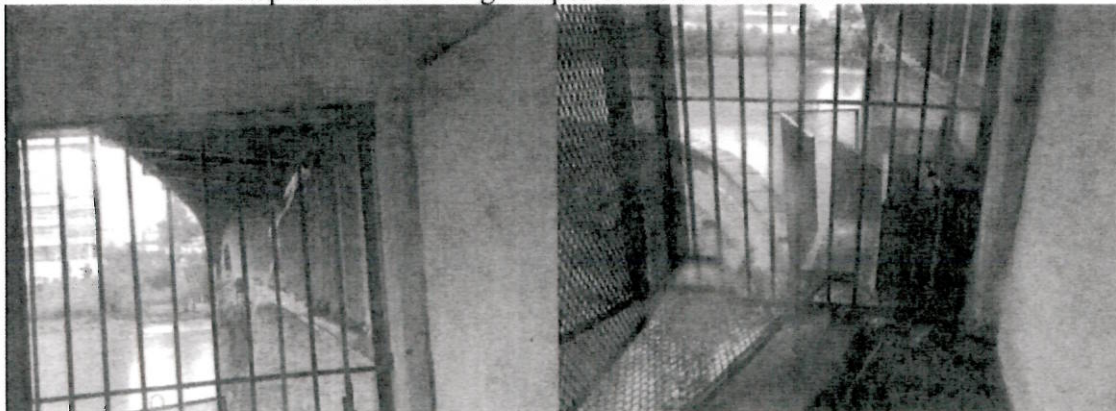
The deck drains are clogged and they need to be cleaned regularly. There were only few deck drains that are working, see below. The drain at the abutments needs to be redirected or extended to stop the water of being dumped on the concrete abutment.

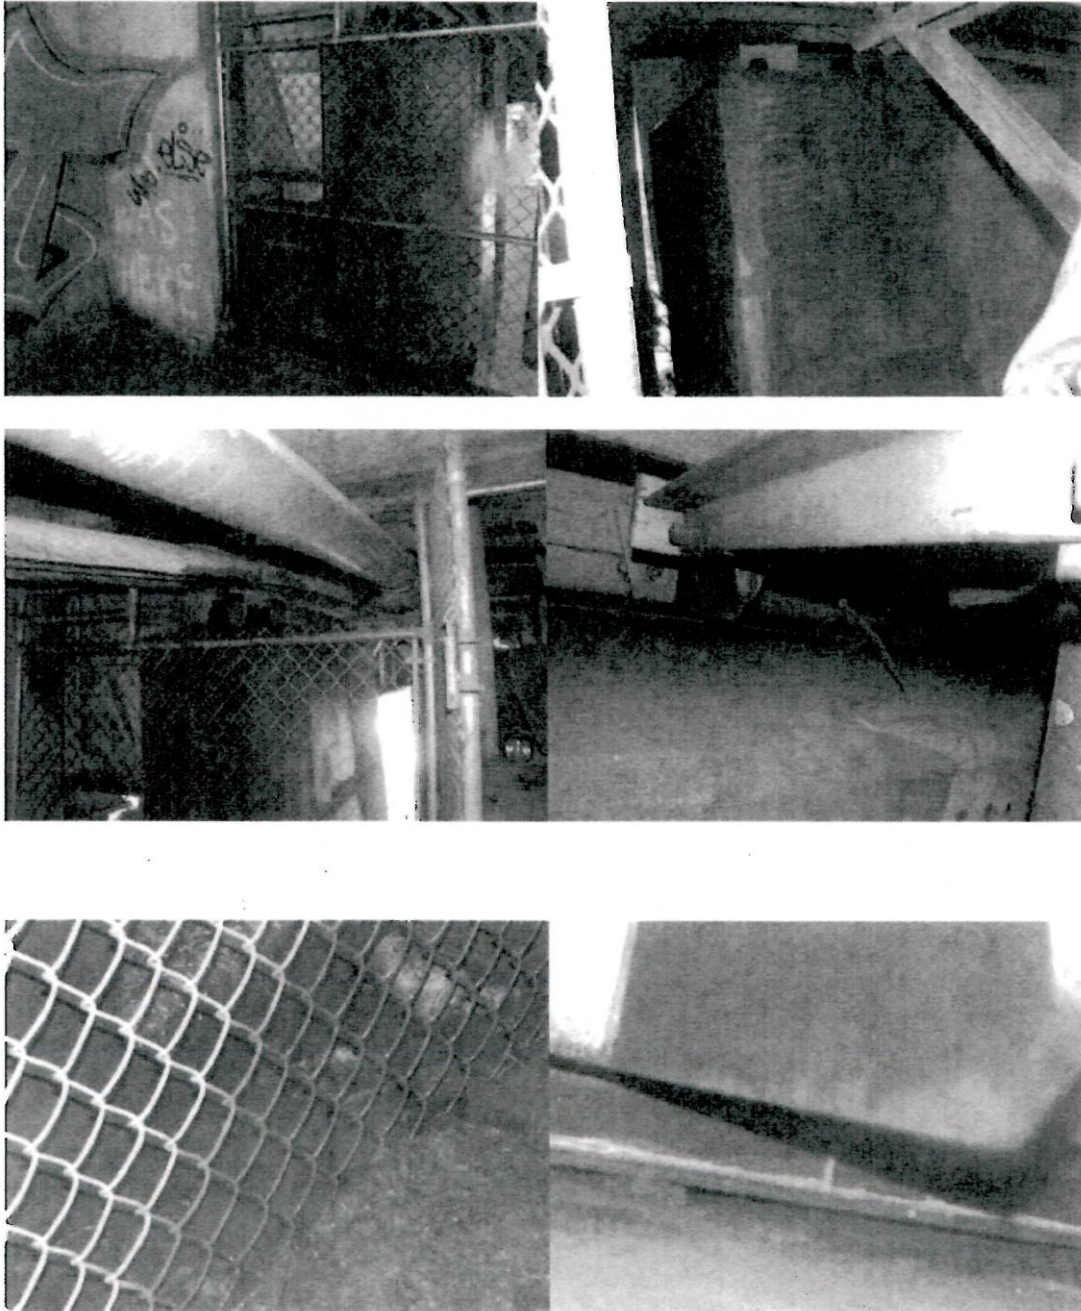
Expansion rubber joints were used in the two expansion joints at the abutments. These joints were recently replaced but they are performing poorly. Although, these types of joints are

designed as watertight, much leak is taking place, as shown.

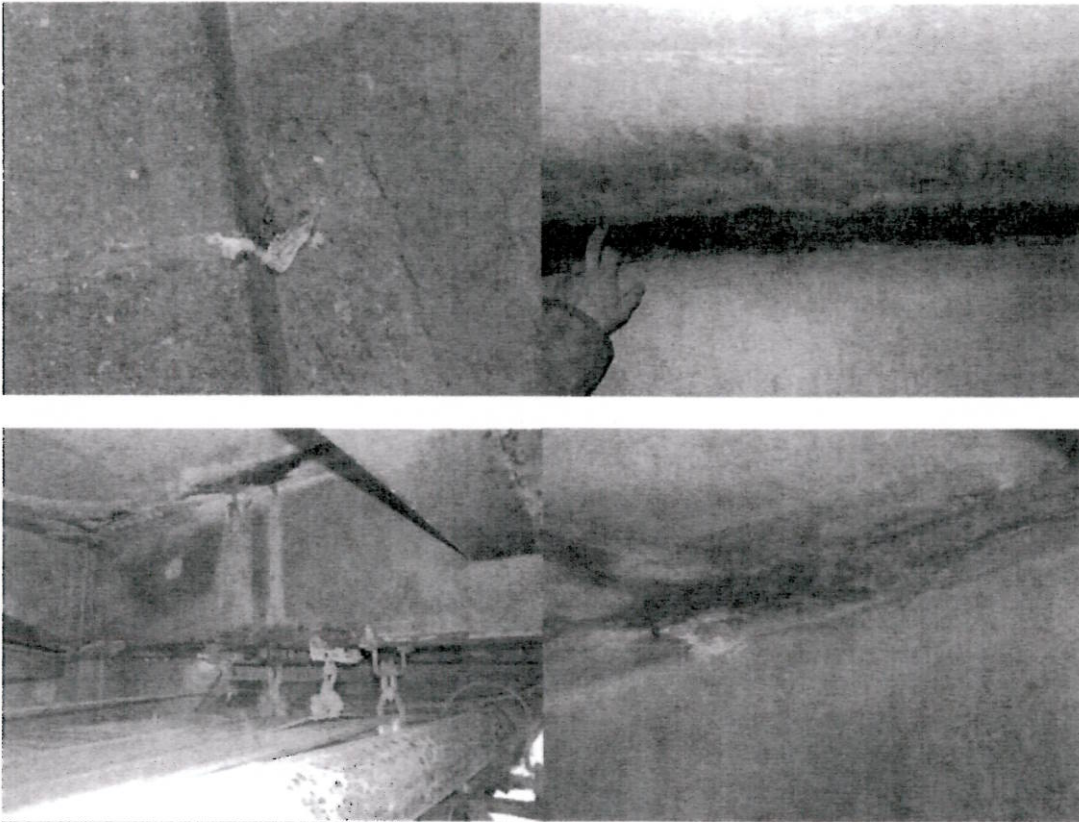
The deck has a lateral construction (cold) joint at each floor beam with 4" rubber water-stop. Most of the joints are performing well but few of these joints are failing, especially the joints above Pier 1, and causing the water to leak to the steel superstructure as shown. This is causing deterioration to the concrete deck and the steel superstructure. There is concrete cracking and spalling at the leaky joints.

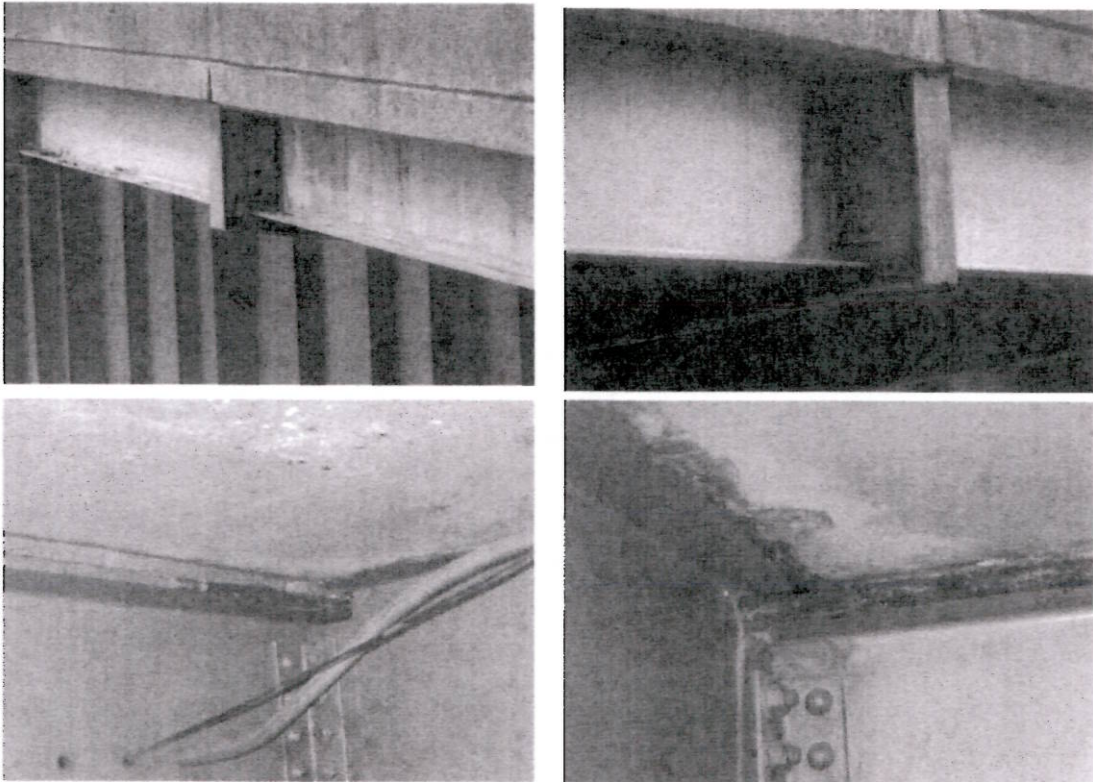
Photos 2

The steel stringers are in fair to poor condition. They have no signs of local buckling or noticeable out-of-plane distortion. Most of the outside surfaces of the exterior stringers have corrosion spots along web and bottom flanges as shown in Photos 2. Most of the stringer ends are corroded at locations close to the deck joints and at supports, as shown in Photos #2.

No fatigue cracks were found on either the steel stringers or the connections between the steel stringers and the diaphragms. However, it is usually difficult to visually detect fatigue cracks on corroded or painted steel surfaces without removing the corrosion rust or the paint. Due to the extent of the girder corrosion at the deck joint locations, it was not feasible to remove all rust or paint needed to properly inspect for fatigue cracks.

The protective system (paint) has failed at areas of corrosion.

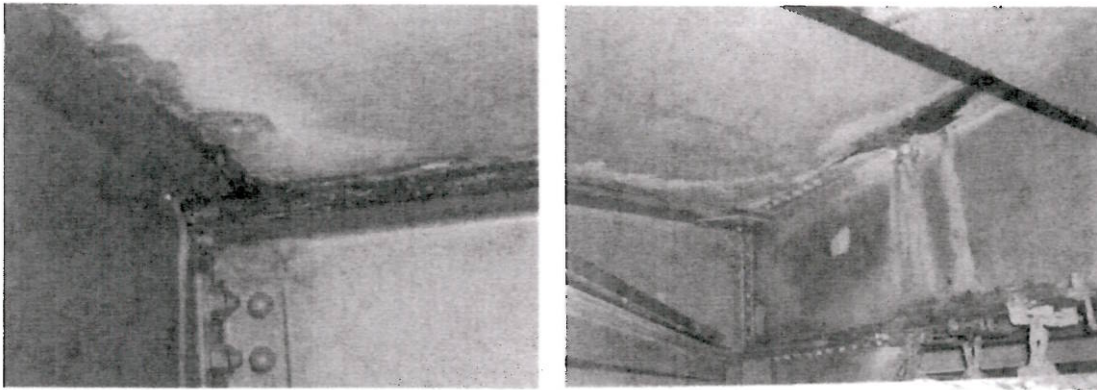
Photos 3

Most of the floor beams are in fair condition but a few are in poor condition. They display no signs of either local buckling or noticeable out-of-plane distortion. Limited areas of surfaces of the floor beams have corrosion as shown in Photos 3. Intermediate floor beams are generally corroded under the deck cold joints. No fatigue cracks were found on the steel floor beams, either in the span or at the connections. However, as stated previously, it is usually difficult to visually detect fatigue cracks on corroded or painted steel surfaces without removing the corrosion or paint.

The protective system (paint) has failed at areas of corrosion.

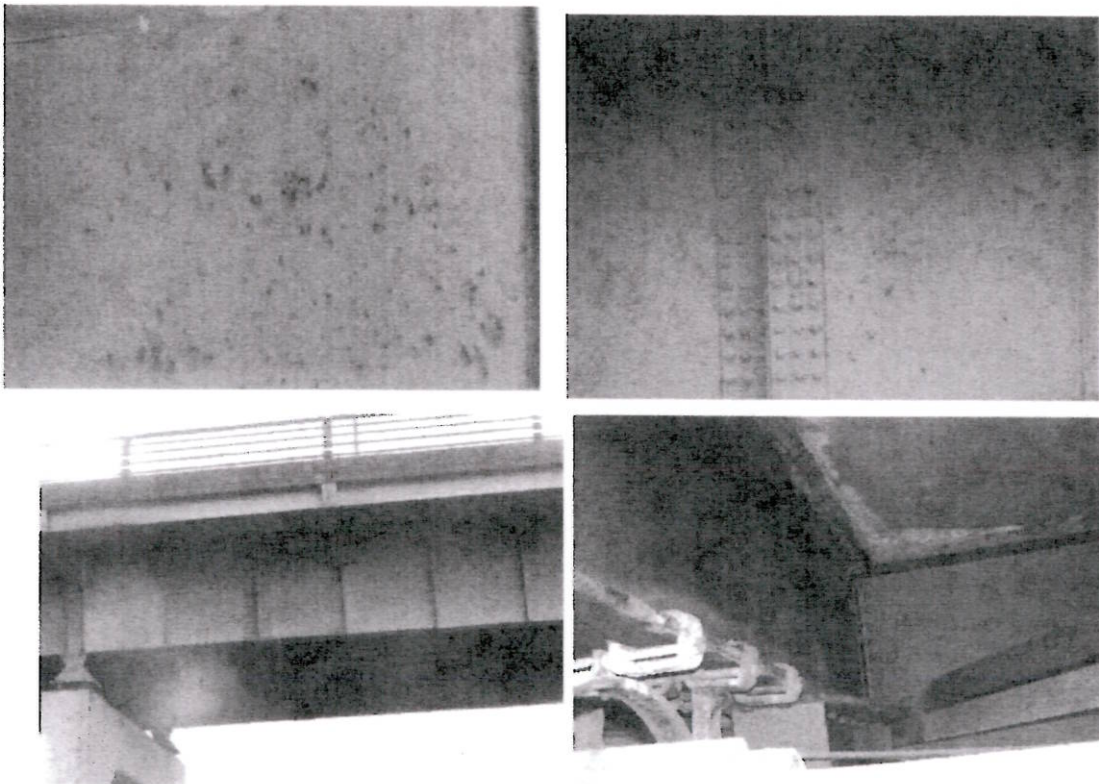
Photos 4

Most of the girders are in fair condition but limited areas are in poor condition. They display no signs of either local buckling or noticeable out-of-plane distortion. Some areas of surfaces of the girders have corrosion such as the top flanges at the deck cold joints and the south faces of the girders that have pitting corrosion as shown in Photos 4. No fatigue cracks were found on the steel girders, either in the span or at the connections. However, as stated previously, it is usually difficult to visually detect fatigue cracks on corroded or painted steel surfaces without removing the corrosion or paint.

The protective system (paint) has failed at areas of corrosion.

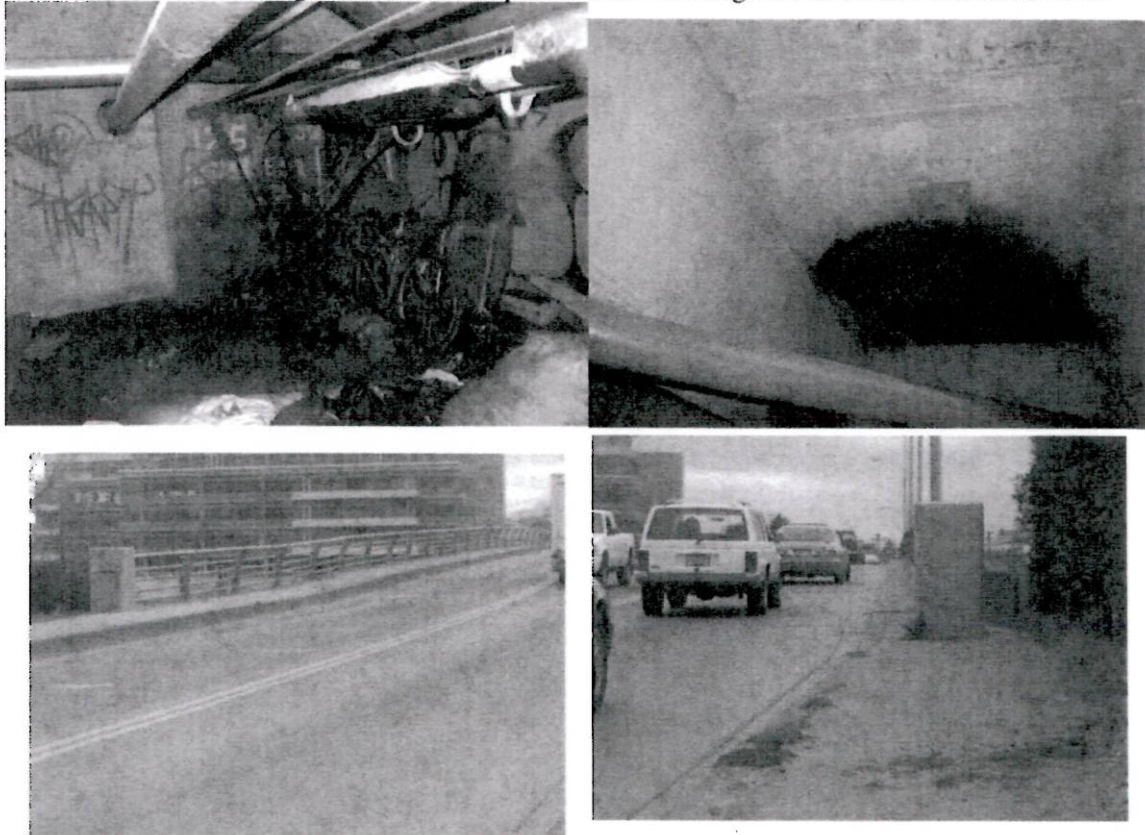
Photos 5

The east abutment is in poor condition since the abutment is settling on both south and north sides, as shown in Photos 5. Due to the settlement, the abutments is experiencing cracking and changes to the load path, as shown in Photos 6. Most of the above-noted settlement may have been caused by the water from the road through the unconnected manhole, as shown and/or from the high load of the soil piles beside the bridge on both north and south sides.
