November 20, 2015

MH Ref. 5150481.00

**Re: Chequers Pavilion, 500 Douglas Street, Victoria, BC
 Facility Condition Assessment Report**

SR Alexander Engineering Ltd. Report

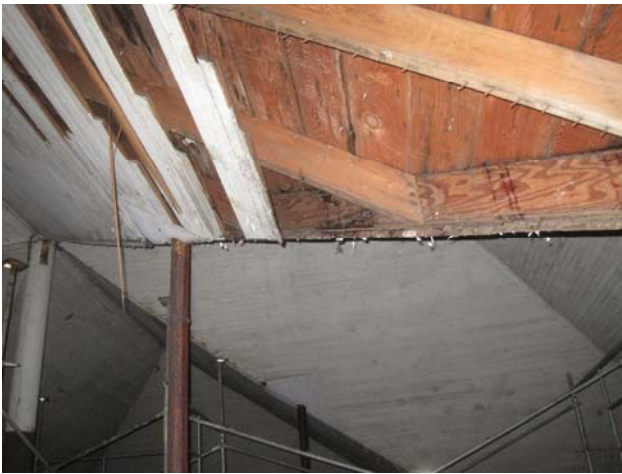
Since the roof has both hips and valleys the roof pitch changes, alternating between what appears to be a 5 in 12 pitch and a 6 in 12 pitch. The framing members of the roof, as mentioned above are constructed out of 2x6 materials. The hips and valleys have roughly similar spans of 19 feet and rafters span a maximum of 13 feet. Using prescribed snow loads in the BCBC 2012 these members are well over capacity. The hip beams are more than an order of magnitude over capacity, the valley beams would not be expected to perform as well as the hip beams due to snow accumulation. Although the valleys have had supports added inside the building, with the 3.5" O.D. posts, the members would still be more than 4 times over capacity with the design snow loads. There are clear signs of deflection and can be observed inside the building (Photo No. 1). In addition, around the exterior you can see areas of the roof which have undergone permanent deflection. There are signs of fire and water damage to the roof framing. However, as the majority of soffit material is present, it is not possible to make an accurate assessment of all the framing members. The central bearing post and its connection to the roof framing can be expected to be undersized/under engineered (Photo No.2). The rafter tails bear directly on a 4x6 header above the windows; there are no collar ties or any outward thrust reducing elements of note around the perimeter of the structure. The 4x6 is oriented 90 degrees to its strong axis

No. 1 – Valley Span Deflection

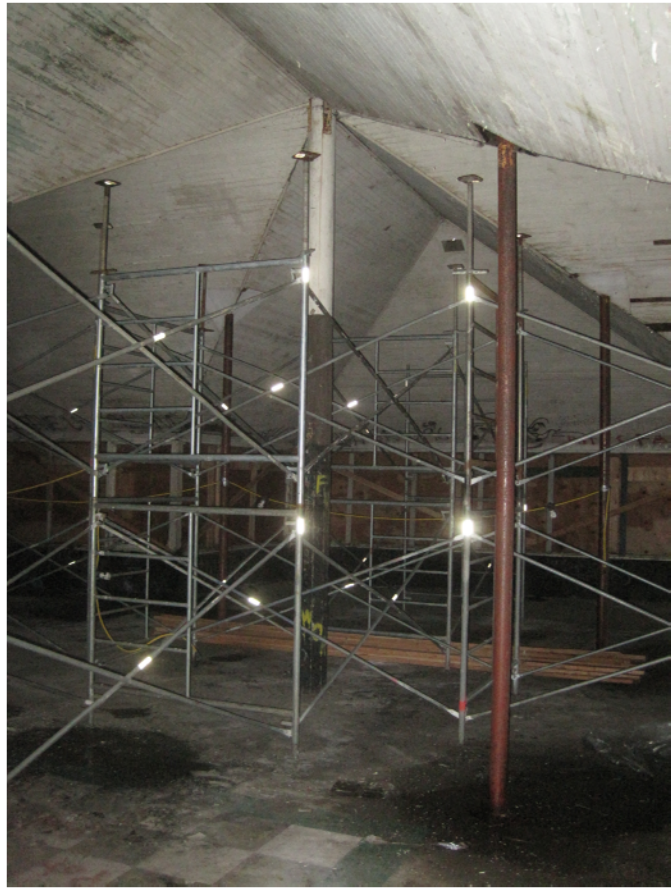
- Steel posts have been added at the roof framing to provide additional support. Scaffold was set up in the middle of the structure. The purpose of the scaffold was not confirmed; however, it did not extend to the ceiling height or tie into any of the structure.

No. 2 – Center Support Pole

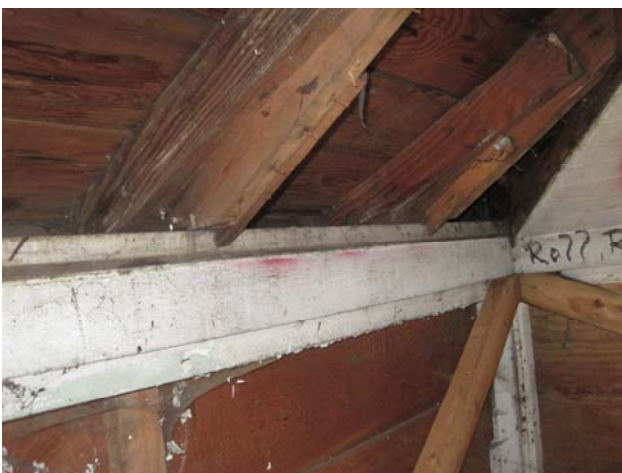
which may have been a method to resist outward thrust to the outer walls, with minimal results. Past the 4x6 header are short pieces of 2x4 material, sistered and blocked to the rafter tails they create the exterior eve of the building (Photos 3 & 4). While the roof is intact it is not considered safe under normal loading condition, this includes snow as well as heavy wind and rain. While the schematic plan and construction have sound layout, the elements used are well undersized, and the lack of any lateral resisting system is of concern.

No. 3 – Header over window and rafter tails

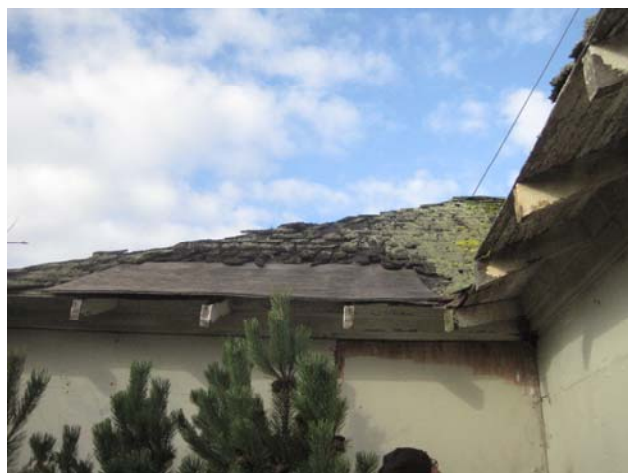
No. 4 – Eve construction

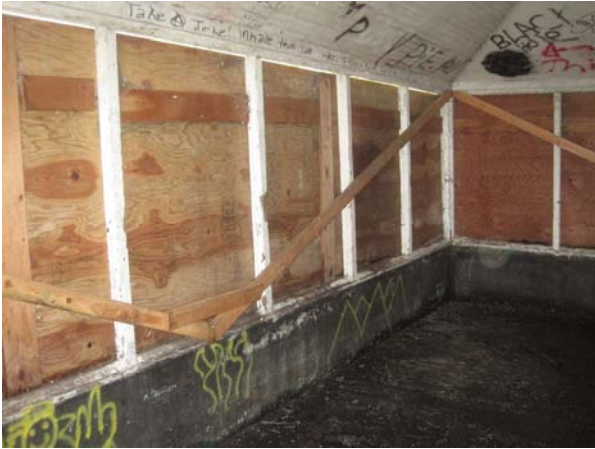
The existing walls show signs of racking and thrust due to the combination of factors (Photos 5-9). These factors include: The lack of any thrust reducing elements or system (collar ties, floor diaphragm, etc.) and the lack of any lateral force reducing system to account for wind and seismic forces prescribed by the building code. It is reasonable to assume that the sheathing of the exterior walls and the limited amount of interior bracing across the window mullions are the main elements holding the structure intact. Both the design and construction of these systems are life safety concerns and are not part of the scope of this report, but required by the BCBC 2012 for any accessible space. Such work would require an adequate design period and construction phase. From a constructability point of view, due to the condition of the walls a secondary support system would be required to simply work on any elements within or on the structure. In current construction practices, moment frames made from structural steel are installed in walls with large openings in order to account for shear forces the building is exposed to, there are currently no elements that account for such forces in the pavilion.

No. 5 – Interior wall bracing

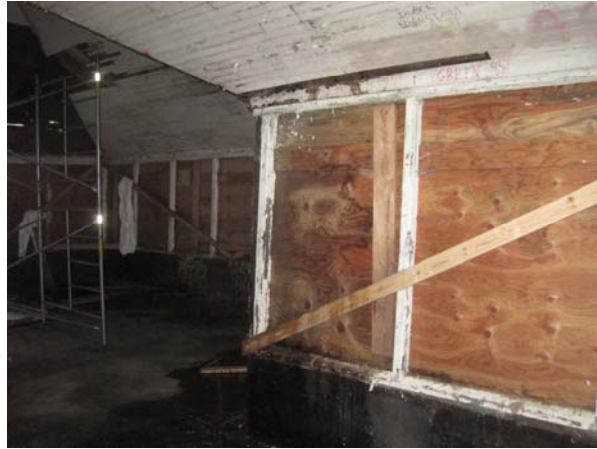
The posts which break up the window spans or rabbeted jam are constructed out of 2 ½" x 2 ½" and spaced 3-4 feet apart. As many of these posts are out of plumb and racked further than allowed by the BCBC 2012 they are do not have adequate design strength and are capable of having less capacity the more they deviate from plumb.

No. 6 – Wall bracing, racking and outward thrust

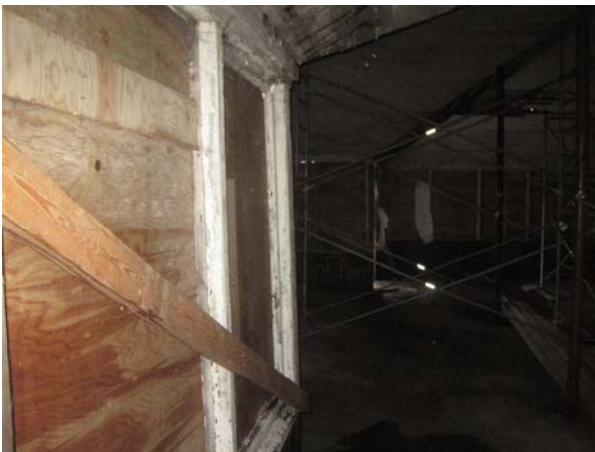
No. 7 – Wall bracing, racking and outward thrust

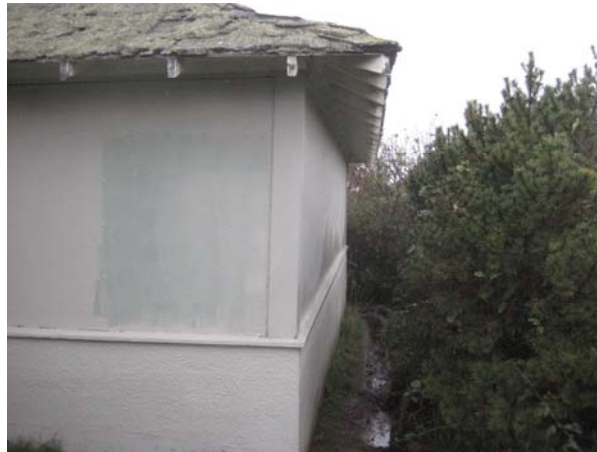
No. 8 – Wall bracing, racking and outward thrust

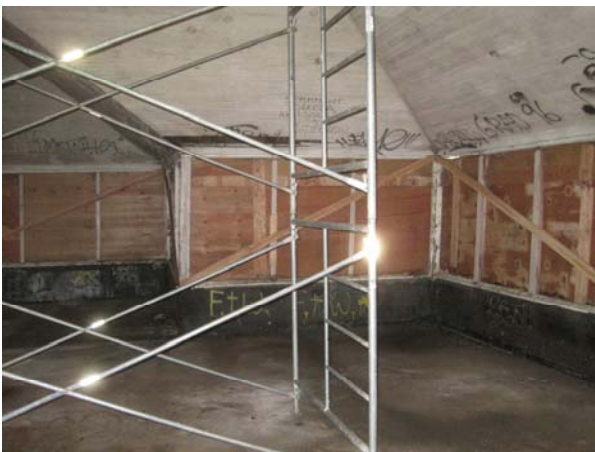
No. 9 – Wall bracing, racking and outward thrust

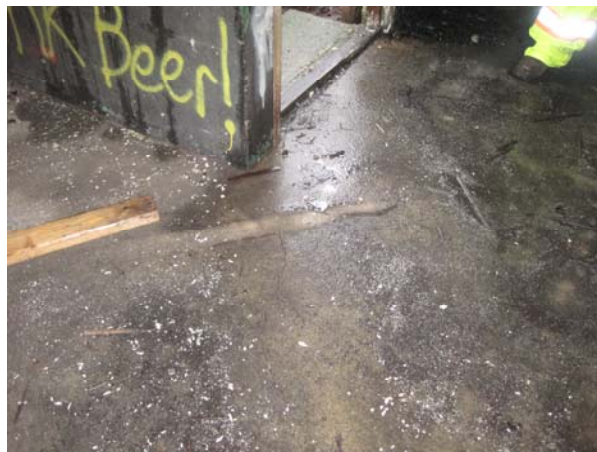
The concrete slab shows evidence of a cracking and potential settlement (Photo No. 10). The thickness of the slab cannot be determined from the design drawing; it does appear to be substantially thick in which case a crack of this nature would be a sign of settlement. A proper soils report should be conducted to evaluate the amount of consolidation which has taken place and if there is more expected. Any settlement issue combined with a lateral force event like an earthquake has the potential render the building unrepairable.

No. 10 – Slab cracking

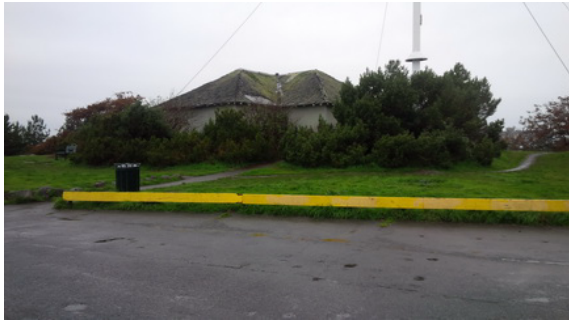
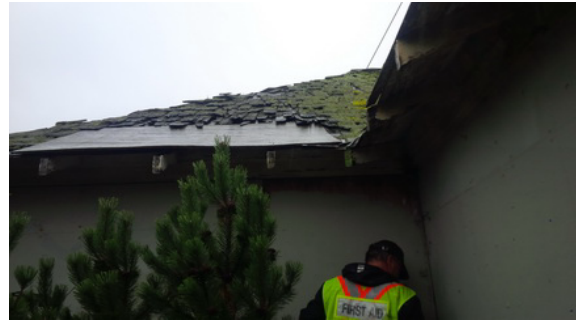
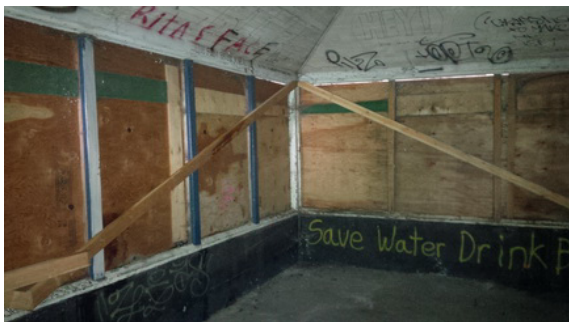
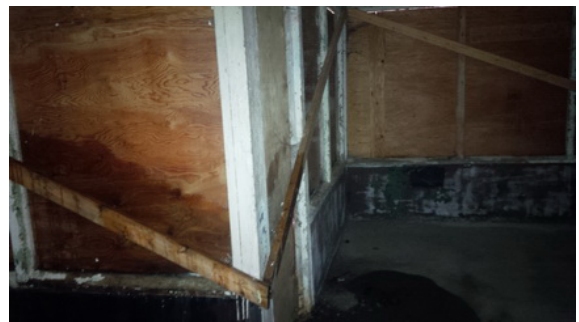
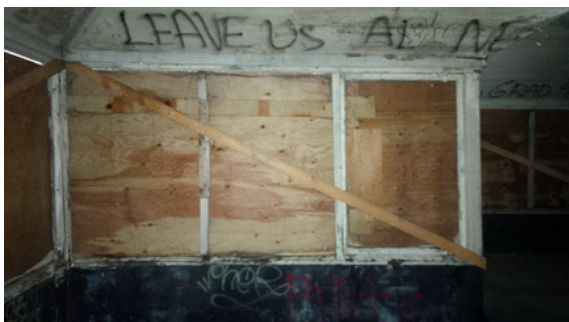
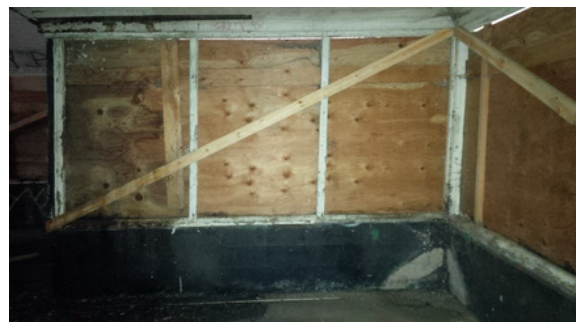
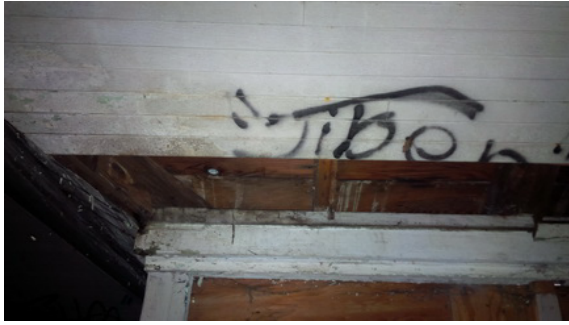
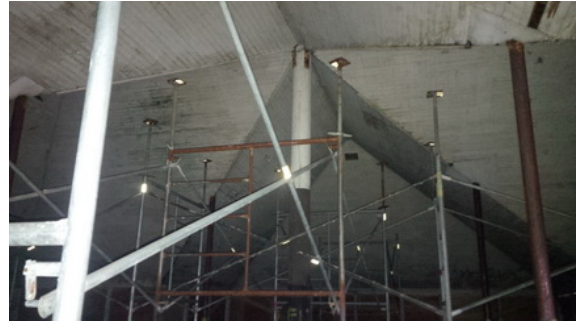
Refer to Photos 1 through 8 in Appendix B for a general overview photos.
