The City of Victoria
Facility Condition Assessment and Capital Plan
Fernwood Community Association, 1921-1923 Fernwood Rd., Victoria

PROPERTY DESCRIPTION

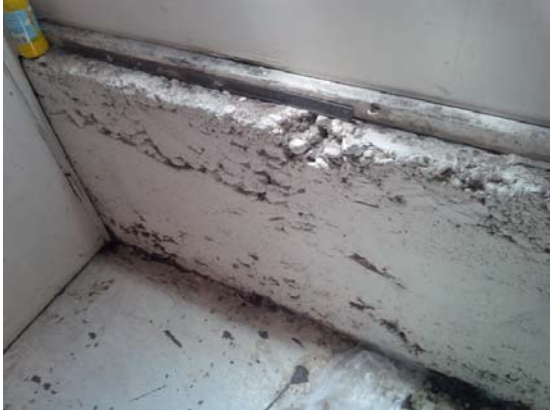
Photo 01

2	A10 Foundations	Replace	01	Where reviewed the foundations, footings and walls, were cast in place concrete. The foundation wall extends above grade at all elevations. No evidence of major settlement or heaving was reported or observed. The age of the original foundation is not know. The age of the west addition is approximately 1914.	Fair	1914	102	100	25	The foundations are expected to last the life of the building. No major capital expenditures are expected to be required.	Repair Allowance	3 - Future Renewal	Yes	No	Yes	No																				
	3	A1030 Slab on Grade	Repair	01	The floor is concrete slab-on-grade. We noted normal, isolated, narrow cracking. No evidence of major settlement or heaving was reported or observed.	Fair	1914	102	5	5	Budget for repairs at isolated locations on a periodic basis. City staff confirmed that this work would be completed through the facility maintenance program. Costs associated with this work have not been included in the cash flow tables.	Repair Allowance	3 - Future Renewal	Yes	N/A	Yes	No

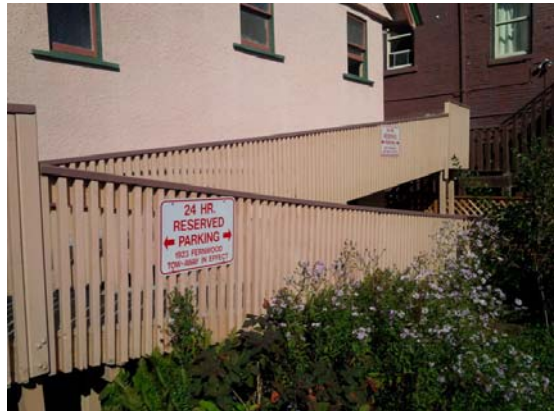
Photo 04

7	B101005 Ramps - Wood Framed Access Ramp and Stairs	Rear of Building - Replacement	04	An accessible ramp is provided at the rear of the building for access to the main level. The ramp is wood framed, supported by 4x4 posts and covered with plywood sheathing. Wood framed guardrails and pickets are provided for the ramp. The replacement of the waterproofing membrane located on the sheathing is addressed in a separate line item. The wood elements of the ramp are beginning to show signs of deterioration. Guardrail attachment to the ramp is loose at a number of locations. From measurements taken on site it was determined that the slope of the ramp does not meet current code requirements. The original ramp was constructed in 1979 and has been repaired as required since. Facility staff confirmed the last major upgrade took place in 2007.	Fair	2007	9	15	6	Replacement of the accessible ramp and adjacent egress stairs. Localized repairs to be included in the maintenance budget.	Repair Allowance	3 - Future Renewal	No	Yes	No	No			1	\$18,000	LS	\$18,000	0%	15%	15%		\$24,000					\$24,000

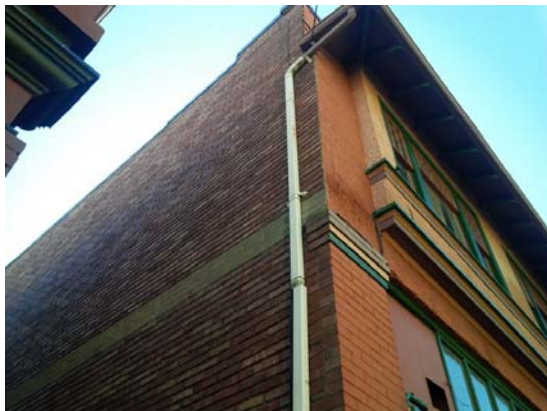
Photo 05

8	ENVELOPE																																			
	9	B2010 Exterior Walls - Brick	Throughout - Replacement	05	The walls are brick at the exterior and gypsum board over wood framing. The brick veneer walls are supported by the foundation walls, no provision for drainage is present. Facility staff confirmed repointing work was undertaken in 2010. Isolated areas of deterioration of mortar joints were noted on the South elevation.	Fair	1909	107	20	7	The masonry walls are expected to last the life of the building. A contingency has been included for localized brick replacement and mortar joint repointing.	Repair Allowance	3 - Future Renewal	Yes	No	Yes	No			2310	\$7	SF	\$15,015	10%	15%	15%		\$22,000						\$22,000			
	10	B2010 Exterior Walls - Stucco	West Elevation - Replacement	06	Stucco is used on the second floor of the west elevation. Cracking and bulging of the stucco was noted on this elevation. We assume this stucco is original to the building.	Fair	1914	102	50	15	Replace face-seal stucco system with rain screen stucco system.	Replacement	3 - Future Renewal	No	Yes	Yes	Yes			440	\$35	SF	\$15,400	10%	15%	15%		\$23,000

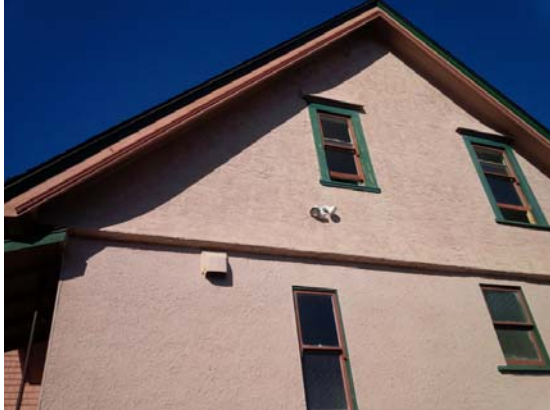
Photo 07

11	B2010 Exterior Walls - Stucco	East Addition - Replacement	07	Stucco is used predominantly as cladding on the east building addition at the rear of the building. This stucco at appears to be in fair condition no issues observed ore reported. No information was available on the age of this cladding system, the year new has been assumed.	Fair	1960	56	50	15	Replace face-seal stucco system with rain screen stucco system.	Replacement	3 - Future Renewal	Yes	No	Yes	No			1790	\$35	SF	\$62,650	10%	15%	15%		\$92,000									
	12	B2010 Exterior Walls - Cedar Siding	Rear of Building - Cedar Shingle Replacement	08	Cedar shingle cladding is utilized at the rear of the building. The cladding has been recently painted and is in fair condition. Minor areas of cracking and cupping were noted. No information was available on the age of this cladding system, the year new has been assumed.	Fair	1990	26	35	9	Replace shingles at the end of their service life.	Replacement	3 - Future Renewal	No	No	Yes	No			700	\$25	SF	\$17,500	10%	15%	15%		\$26,000							\$26,000

17	B201010 Exterior Coatings	Stucco Cladding - Recoat	07	No issues with this item were noted. Facility staff reported that the stucco walls were repainted in 2010.	Fair	2010	6	10	4	Recoat all stucco cladding at the end of its service life.	Repair Allowance	3 - Future Renewal	No	No	No	No			2250	\$3	SF	\$6,750	0%	15%	15%		\$9,000						\$9,000			
	18	B201010 Exterior Coatings	Cedar Siding (shake and lapped) - Paint	13	Some deterioration of the paint on the wood cladding was noted. Facility staff reported that the cladding was repainted in 2010.	Fair	2010	6	10	4	Repaint all cedar siding and trim (prep and 2-coats) on an as required basis.	Repair Allowance	3 - Future Renewal	No	No	No	No			1100	\$3	SF	\$3,300	0%	15%	15%		\$5,000						\$5,000			
	19	B201011 Joint Sealant	Throughout - Replacement	14	Sealant joints located around the building fenestration. The sealant is in various stages of deterioration.	Poor	2000	16	10	2	City staff confirmed that this work would be completed through the facility maintenance program. Costs associated with this work have not been included in the cash flow tables.	Replacement	2b - Exceeded Service Life	No	Yes	No	No			1000	\$6	LF	\$6,000	0%	15%	15%		\$8,000

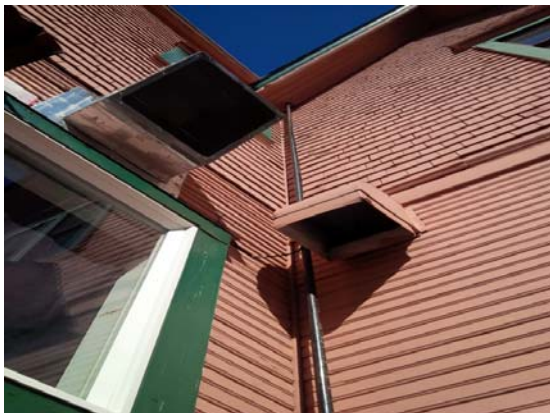
Photo 09

13	B2010 Exterior Walls - Cedar Siding	Rear of Building - Lapped Siding Replacement	09	There is a small area of horizontally lapped wood cladding located at the southeast corner of the building. The cladding has been recently painted and is in fair condition. Minor areas of cracking were noted.	Good	1960	56	35	9	Replace lapped siding at the end of their service life.	Replacement	3 - Future Renewal	No	No	Yes	No			400	\$25	SF	\$10,000	10%	15%	15%		\$15,000								\$15,000	
	14	B2010 Exterior Walls - Metal Cladding and Roof	West Parapet Walls - Replacement	10	Sheet metal panels have been installed, as faux shingles, above the upper canopy and on the canopy on the west elevation. The cladding appears to be in fair condition, however, a lack of proper detailing at outside corners has caused the adjacent panels to bend out of shape allowing potential water ingress. Furthermore, some loose panels were noted on the south elevation. No information was available on the age of this cladding system, the year new has been assumed.	Fair	1960	56	50	9	Install new metal panels, in a similar orientation, at the end of its service life. Complete immediate repairs where required to seal off wall. It is assumed this will be completed as part of the buildings ongoing maintenance.	Replacement	3 - Future Renewal	No	No	Yes	No			1	\$10,000	LS	\$10,000	10%	15%	15%		\$15,000								\$15,000

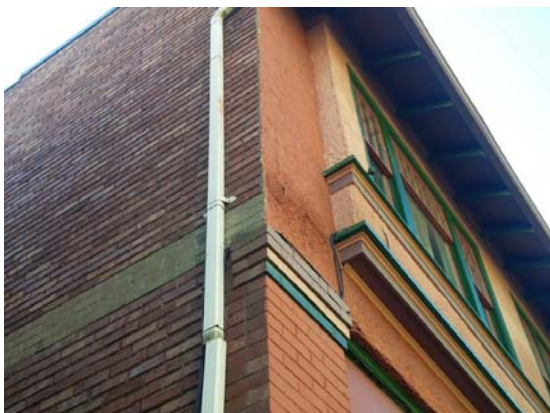
Photo 11

15	B201008 Exterior Soffits	Repainting	11	Painted wood soffits exist at the roof edge and under canopies. No issues with this item were noted. Facility staff reported that the soffit was repainted in 2010.	Fair	2010	6	20	14	A budget has been provided for repainting all soffits. Repainting of soffits assumed to take place at the same time as cladding painting. Costs associated with this item fall below the threshold provided and have not been carried into the cash flow tables.	Repair Allowance	3 - Future Renewal	No	No	No	No			380	\$3	SF	\$1,292	0%	15%	15%		\$2,000									
	16	B201010 Exterior Coatings	Brick Cladding - Paint	12	The brick has been painted. Facility staff reported that the brick was repainted in 2010.	Fair	2010	6	10	4	Repaint all brick cladding on an as required basis.	Repair Allowance	3 - Future Renewal	No	No	No	No			2310	\$3	SF	\$6,930	0%	15%	15%		\$10,000							\$10,000

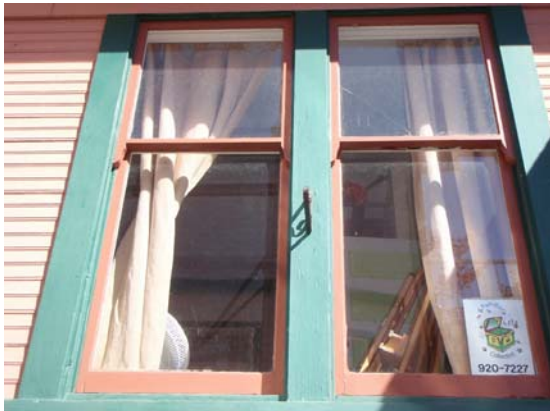
Photo 15

20	B202001 Punched Windows	Repair and Replacement	15	Original wood framed windows are present throughout the building. Issues with the operable were noted by some of the upper floor tenants and damage to the wood components of some of the windows, including the frame and the interior and exterior wood trim, was noted. Facility staff confirmed on window assembly on the west elevation was remediated.	Poor	1914	102	35	2	Refurbish and/or replace windows, to match existing, at the end of its service life.	Replacement	2b - Exceeded Service Life	Yes	Yes	Yes	No			22	\$2,500	Ea	\$55,000	10%	15%	15%		\$81,000		\$81,000							
	21	B202001 Windows	Level 1 Upper Strip Windows - West Elev. - Replace	16 / 17	Single paned metal framed strip windows are present on the west elevation servicing the office and the Little Fernwood Gallery. Facility staff confirmed that these windows were refurbished in 2010.	Good	2010	6	30	24	Refurbish and/or replace windows, to match existing, at the end of its service life.	Replacement	4a - Discretionary Renewal (Upgrade)	Yes	No	Yes	No			100	\$150	SF	\$15,000	10%	15%	15%		\$22,000

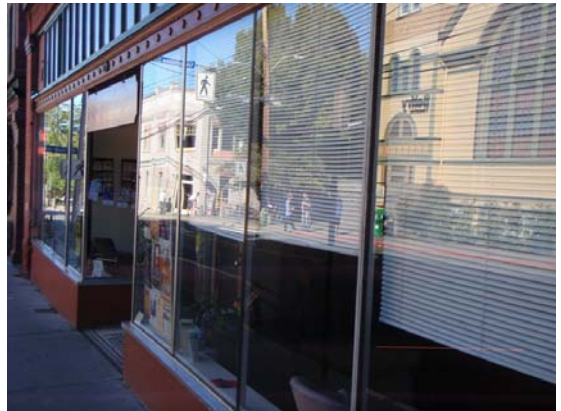
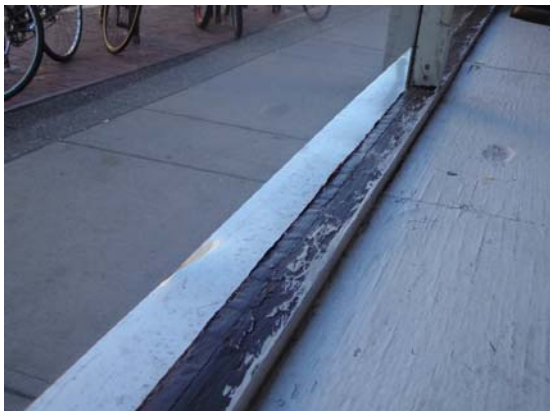
22	B202001 Windows	Level 1 Lower Strip Windows - West Elev. - Replace	16 / 17	Single paned metal framed strip windows are present on the west elevation servicing the office and the Little Fernwood Gallery. The beauty cap has fallen off the window mullions at several locations and the wood trim is showing signs of deterioration. The age of these assemblies is unknown. The last major upgrade took place in 1979.	Fair	1979	37	35	5	Refurbish and/or replace windows, to match existing, at the end of its service life.	Replacement	4a - Discretionary Renewal (Upgrade)	Yes	No	Yes	No			550	\$80	SF	\$44,000	10%	15%	15%		\$65,000						\$65,000			
	23	B203001 Exterior Solid Doors	Throughout - Replacement	18	Solid wood doors without glazing were installed on the south and east elevations. Mechanical damage to the wood doors and frames as well as the hardware was typically noted.	Fair	1914	102	25	11	Replace doors at end of service life. Replace weatherstripping and complete minor repairs and adjustment as part of maintenance.	Replacement	3 - Future Renewal	Yes	No	No	No			6	\$2,000	EA	\$12,000	10%	15%	15%		\$18,000

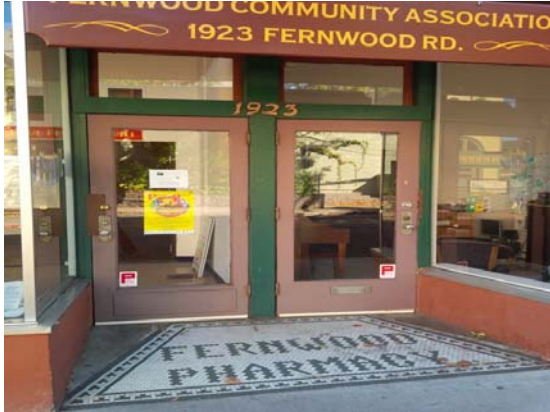
Photo 19

24	B203001 Single Exterior Solid Wood Doors with glazing	West Elev. - Replacement	19	Original heritage doors are utilized as entry doors to the office, Gallery and second floor tenants. Some mechanical damage to the wood frames was observed though operation of the assembly appears to be unaffected.	Fair	1914	102	25	8	Replace doors at end of service life. Replace weatherstripping and complete minor repairs and adjustment as part of maintenance.	Replacement	3 - Future Renewal	Yes	No	No	No			3	\$2,000	EA	\$6,000	0%	15%	15%		\$8,000							\$8,000

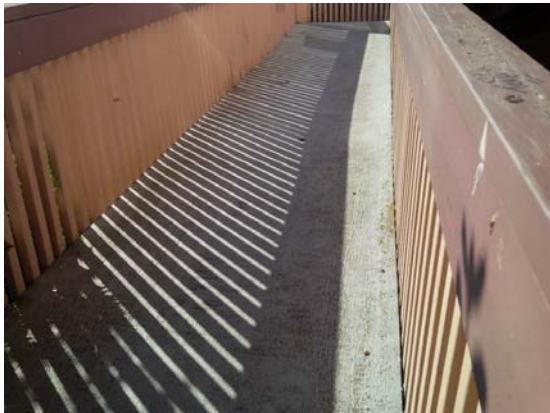
Photo 21

28	B301002 Roofing - Walkway Coating	Liquid Applied Membrane - Replacement	21	Liquid applied membrane is installed on the accessible ramp located at the rear of the building. The wood sheathing is exposed/unprotected at several locations. We assume this item was replaced in 1995.	Poor	2007	9	10	1	Install new liquid applied membrane traffic coating, with anti-skid coat.	Replacement	2b - Exceeded Service Life	No	Yes	No	No	400	\$15	SF	\$6,000	10%	15%	15%	\$9,000	\$9,000																														
	29	B301005 Gutters and Downspouts	East Roof - Replacement	22	Gutters and associated downspouts service the sloped asphalt shingle roof. Some debris accumulation in the gutters was observed. Facility staff confirmed that the guttes were replaced in 2000.	Fair	2000	16	25	9	Replace gutters and downspouts at the end of service life.	Replacement	3 - Future Renewal	No	Yes	No	No	1	\$3,500	LS	\$3,500	0%	15%	15%	\$5,000											\$5,000

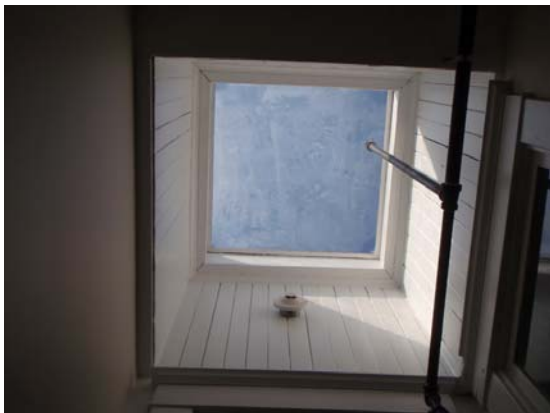
Photo 23

30	B301006 Roof Openings- Skylights	Throughout - Replacement	23	4'x4' skylights are located in both the sloped and flat roof assemblies. No staining or other water related issues were noted or observed with this item from the building interior. Facility staff confirmed that the skylights were replaced in 2007.	Fair	2007	9	20	11	Replace existing skylights at the end of their service life with new 4x4 insulated units.	Replacement	3 - Future Renewal	Yes	Yes	Yes	No	3	\$1,000	EA	\$3,000	10%	15%	15%	\$5,000																															
	31	B301006 Roof Openings- Skylights	Flat Roof - Replacement	24	A larger 7'x7' (assumed) skylight is centrally located in the low sloped roof. No evidence of leaks was observed and no other issues were noted with this item from the building interior. Facility staff confirmed that the skylights were replaced in 2007.	Fair	2007	9	20	11	Replace existing skylights at the end of its service life with a new 7x7 insulated unit.	Replacement	3 - Future Renewal	No	Yes	No	No	1	\$4,500	EA	\$4,500	10%	15%	15%	\$7,000

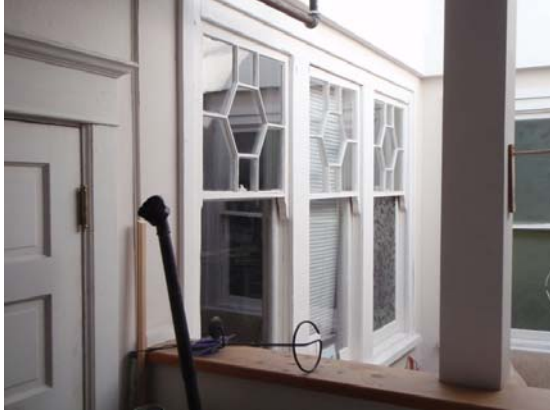
Photo 25

32	INTERIORS																																																						
	33	C101005 - Interior Windows	Second Floor - Replacement	25	Interior windows are located predominantly on the second floor. Some mechanical damage to the window finish, trim and hardware was noted, though they appear to be in serviceable condition.	Fair	1914	102	10	5	A contingency has been provided for the repair of the window finish and hardware on an as required basis.	Contingency	4b - Discretionary Renewal (Aesthetic)	Yes	No	No	Yes	1	\$3,000	LS	\$3,000	0%	15%	15%	\$4,000																															
	34	C102001 Standard Interior Doors	Heritage Doors - Replacement	26	Interior heritage doors are located throughout the building, however, are predominantly found on the second floor. Several of these doors are provided with a transom. Mechanical damage to the wood doors and frames as well as the paint was noted.	Fair	1914	102	5	5	With proper maintenance doors are expected to last the life of the building. However, a budget is provided for selective door replacement and localized repairs on an as required basis.	Replacement	4b - Discretionary Renewal (Aesthetic)	Yes	No	No	Yes	1	\$3,000	LS	\$3,000	0%	15%	15%	\$4,000

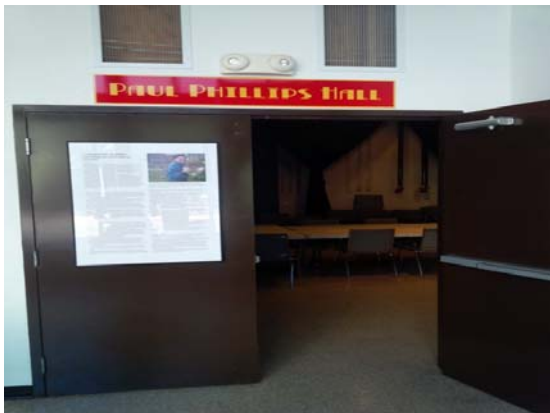
Photo 27

35	C102001 Standard Interior Doors	Swing Doors - Replacement	27	Newer interior doors are located throughout the complex in the basement and first floor. Doors, finish and hardware are in various stages of deterioration. We assume this item was replaced in 1990.	Fair	1990	26	10	5	Doors are expected to last the life of the building. However, a budget is provided for some door replacement and localized repairs.	Replacement	4b - Discretionary Renewal (Aesthetic)	Yes	No	No	Yes	1	\$3,000	LS	\$3,000	0%	15%	15%	\$4,000																															
	36	C11 Washrooms	Level 1 Washroom	28	Newer washrooms are located in the Paul Phillips Hall and the fixtures consist of a lavatory provided with hot and cold water and a toilet. The finishes are typically resilient flooring, and painted gypsum wall and ceiling.	Fair	2009	7	20	13	Refurbishment of the washrooms including replacement of the fixtures and finishes on an as required basis.	Replacement	4a - Discretionary Renewal (Upgrade)	Yes	No	No	No	2	\$15,000	EA	\$30,000	0%	15%	15%	\$40,000

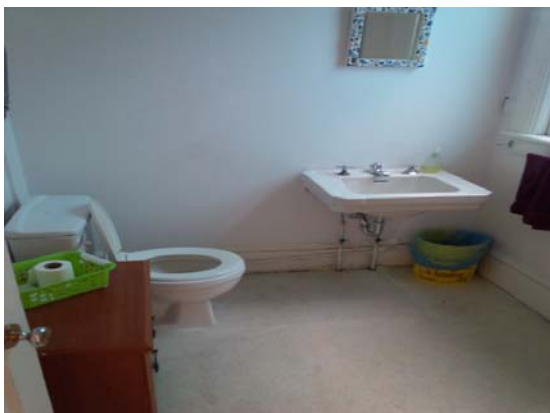
Photo 29

37	C11 Washrooms	Level 2 Washroom	29	Older washrooms are located on the upper floor and the east addition. The complex and the fixtures consist of a lavatory provided with hot and cold water and a toilet. The finishes are typically resilient flooring and painted gypsum wall and ceiling.	Fair	2000	16	20	4	Refurbishment of the washrooms including replacement of the fixtures and finishes on an as required basis.	Replacement	4a - Discretionary Renewal (Upgrade)	Yes	No	No	No	3	\$15,000	EA	\$45,000	0%	15%	15%	\$60,000																															
	38	C12 Theatre	Refurbishment	30 / 31	Paul Phillips Hall occupies a significant portion of the west section of the building. The hall includes a wood framed stage located at the front of the room and the gallery at the rear. The gallery has lower cabinets, counters, a sink provided with both hot and cold water and a small fridge. A lighting structure is suspended from the ceiling. The finishes consist of resilient flooring and painted ceiling and walls. Facility staff confirmed that this area was updated in 2010.	Fair	2010	6	15	9	Complete refurbishment of the Paul Phillips Hall and all associated fixtures and finishes, on an as required basis.	Replacement	4a - Discretionary Renewal (Upgrade)	Yes	No	No	No	1	\$25,000	LS	\$25,000	0%	15%	15%	\$34,000

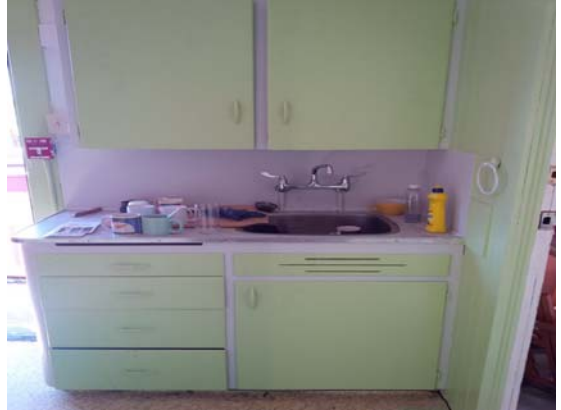
Photo 32

39	C12 Kitchen	Refurbishment	32	Kitchens are located on the main floor in the east wing, on the upper floor and in the Paul Phillips Hall (which has been included in the previous line item). The kitchens have upper and lower cabinets, counters, and a sink. Facility staff confirmed that the kitchens were updated in 2000.	Fair	2000	16	25	9	Complete refurbishment of the kitchens and all associated fixtures and finishes, on an as required basis.	Replacement	4a - Discretionary Renewal (Upgrade)	Yes	No	No	No	2	\$15,000	LS	\$30,000	0%	15%	15%	\$40,000																															
	40	C302004 Resilient Floor Finishes	Resilient - Replacement	33	Located predominantly on the main floor of the west section and present in both tile and sheet form. No issues with this item were noted.	Fair	2010	6	25	19	Replace resilient sheet and tile flooring on an as required basis. Replacement of the floors in the theatre is covered under the theatre rehab.	Replacement	4b - Discretionary Renewal (Aesthetic)	Yes	No	No	No	650	\$5	SF	\$3,250	0%	15%	15%	\$5,000

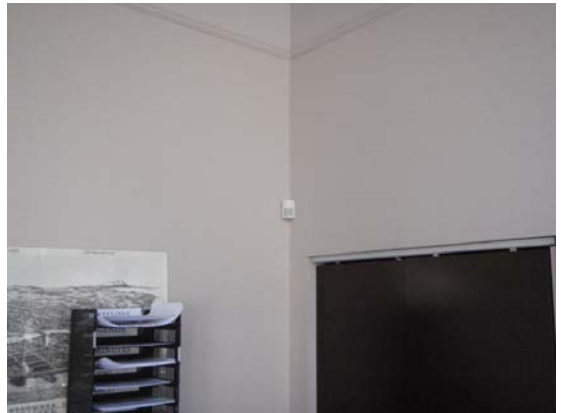
Photo 34

41	C301005 Wall Finishes - Gypsum Board	Paint	34	The typical finish located throughout the building is painted gypsum board. Some damage to the underlying gypsum and the finish was noted at several locations. Facility staff confirmed that interior painting was completed on an as required ongoing basis.	Fair	2010	6	5	1	Repaint interior walls on an as require basis. Repainting in the washrooms, theatre and kitchens is included in their respective rehabilitations. This line item is phased over 5 years.	Replacement	4b - Discretionary Renewal (Aesthetic)	Yes	No	No	No	3750	\$2	SF	\$7,500	0%	15%	15%	\$10,000	\$2,000	\$2,000	\$2,000	\$2,000	\$2,000	\$2,000	\$2,000	\$2,000	\$2,000	\$2,000																					
	42	C302005 Carpeting	Replacement	35	Carpet is located predominantly on the upper level. No issues with this item were observed. Facility staff confirmed that the carpet was last replaced in 2010.	Fair	2010	6	20	14	Replace carpeting, on an as required basis.	Replacement	4b - Discretionary Renewal (Aesthetic)	Yes	No	No	No	800	\$5	SF	\$3,800	0%	15%	15%	\$6,000

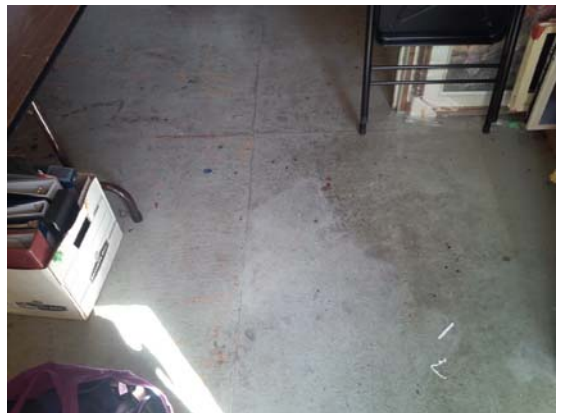
Photo 36

43	C302007 Painting and Staining Floors	Paint	36	On the main floor of the east section the painted floor sheathing acts as the floor finish. The paint has worn off exposing the sheathing below.	Fair	2010	6	10	4	Repaint / restain wood flooring on an as required basis. Costs associated with this item fall below the threshold provided and have not been carried into the cash flow tables.	Replacement	4b - Discretionary Renewal (Aesthetic)	Yes	No	No	No	300	\$5	SF	\$1,500	0%	15%	15%	\$2,000																															
	44	C303003 Gypsum Board Ceiling Finishes	Paint	37	Typical finish located throughout the building. No issues with this item were noted. Facility staff confirmed that interior painting was completed on an as required ongoing basis.	Fair	2010	6	20	14	Repaint gypsum ceilings, on an as required basis. Repainting in the washrooms, theatre and kitchens is included in their respective rehabilitations	Replacement	4b - Discretionary Renewal (Aesthetic)	Yes	No	No	No	2500	\$3	SF	\$7,500	0%	15%	15%	\$10,000

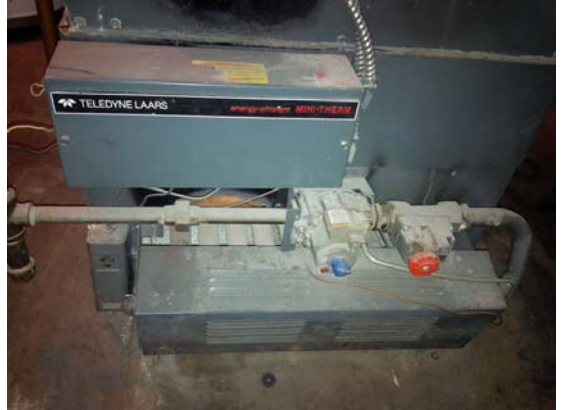
Photo 38

46	HVAC Systems																																				
	47	D302002 Hot Water Boilers	Hydronic Heat	38	The building is equipped with a single Teledyne Laars Mini-Therm II gas-fired boiler with a max output of 323 MBTU, and one small expansion tank. The age of this boiler was not known and has been assumed.	Fair	1994	22	30	8	Replace the heating boiler at the end of its lifespan.	Replacement	3 - Future Renewal	No	No	Yes	No		1	\$20,000	EA	\$20,000	0%	15%	15%	\$27,000								\$27,000				
	47	D302002 Piping, Valves, Hydronic Heat	Building wide	39	The original hydronic heat piping. Existing hydronic piping has likely exceeded the expected lifespan. Based on the information provided it is our understanding the last major upgrade took place in 1979.	Fair	1979	37	10	5	Replace hydronic piping and valves as required. A contingency has been included for isolated replacement.	Contingency	2b - Exceeded Service Life	Yes	No	No	No		1	\$5,000	LS	\$5,000	0%	15%	15%	\$7,000					\$7,000

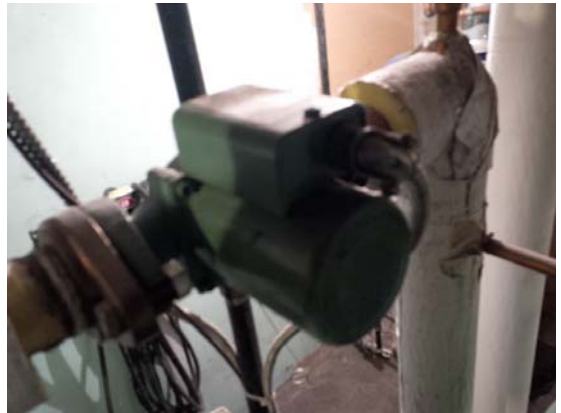
Photo 40

48	D302002 Hot Water Boilers	Circulating Pumps	40	The hydronic system has two pumps. Based on the information provided it is our understanding the last major upgrade took place in 1979.	Fair	1979	37	10	3	Replace hot water recirculating pumps at end of service life.	Replacement	3 - Future Renewal	Yes	No	No	No		2	\$800	EA	\$1,600	0%	15%	15%	\$3,000				\$3,000								
	49	D305004 Fin Tube Radiation	Convective rads	41	The building is heated by convective radiators connected to the heating hot water loop. Based on the information provided it is our understanding the last major upgrade took place in 1979.	Fair	1979	37	10	5	Replace convective radiators as required. A contingency has been included for isolated replacement.	Replacement	2b - Exceeded Service Life	Yes	No	No	No		1	\$5,000	LS	\$5,000	0%	15%	15%	\$7,000					\$7,000							
	51	D305004 Fin Tube Radiation	Ceiling mounted fan-coil	42	High ceiling utility areas are heated by fan-coil units connected to the hydronic heat loop. The age of this assembly is unknown and has been assumed.	Good	2000	16	25	11	Replace fan-coil ceiling heaters as required.	Replacement	3 - Future Renewal	Yes	No	No	No		2	\$1,500	EA	\$3,000	0%	15%	15%	\$4,000

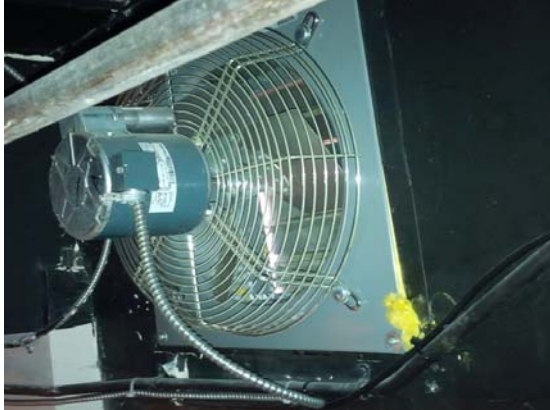
Photo 43

52	D304007 Exhaust Systems	Sidewall exhaust	43	Small sidewall axial exhaust fan provides exhaust from the common area. The age of this assembly is unknown and has been assumed.	Good	2000	16	25	11	Replace exhaust fan at end of service life. Costs associated with this item fall below the threshold provided and have not been carried into the cash flow tables.	Replacement	3 - Future Renewal	No	No	No	No		1	\$1,500	EA	\$1,500	0%	15%	15%	\$2,000												
	53	Plumbing Systems																																				
	53	D202001 Pipes and Fittings	Backflow preventers	44	Backflow preventer was noted on the main incoming domestic water line. The age of this assembly is unknown and has been assumed.	Good	1990	26	35	2	Replace backflow preventer as required.	Replacement	3 - Future Renewal	No	No	No	No		1	\$4,500	LS	\$4,500	0%	15%	15%	\$6,000		\$6,000										
	54	D202001 Pipes and Fittings	Main water distribution	45	Water distribution piping is primarily copper where observed. Based on the information provided it is our understanding the last major upgrade took placing in 1979.	Good	1979	37	50	5	Complete localized repairs to water piping as may be necessary as the building ages.	Contingency	3 - Future Renewal	Yes	No	No	No		1	\$10,000	LS	\$10,000	0%	15%	15%	\$14,000					\$14,000

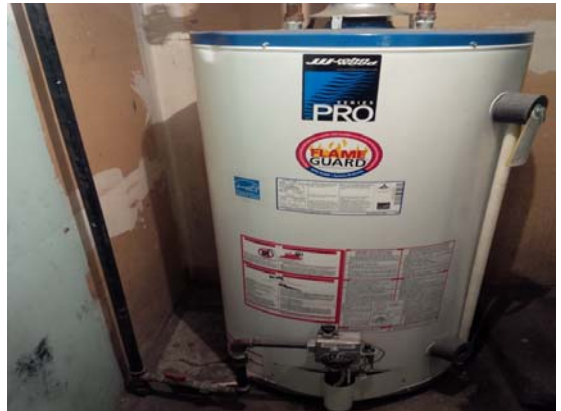
Photo 46

55	D202003 Domestic Water Equipment - heater	Hot Water Heaters	46	One gas-fired John Woods 45 US gal water heater provides domestic hot water to the building.	Good	2010	6	15	9	Replace tanks at the end of its service life. City staff confirmed that this work would be completed through the facility maintenance program. Costs associated with this work have not been included in the cash flow tables.	Replacement	3 - Future Renewal	No	No	No	No		1	\$2,500	EA	\$2,500	0%	15%	15%	\$4,000									\$4,000			
	57	D203001 Waste Pipe and Fittings	Throughout building	47	Sanitary sewer piping was largely cast iron where reviewed. Based on the information provided it is our understanding the last major upgrade took placing in 1979.	Good	1979	37	50	5	Complete localized repairs as may be necessary as the building ages.	Contingency	3 - Future Renewal	Yes	No	No	No		1	\$5,000	LS	\$5,000	0%	15%	15%	\$7,000					\$7,000

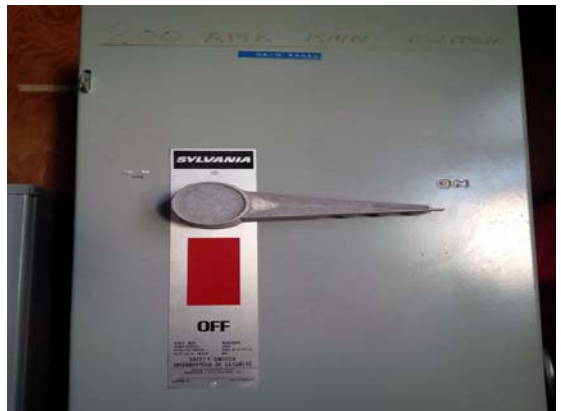
Photo 48

58	ELECTRICAL SYSTEMS																																				
	58	D501003 Main and Secondary Switchgear	Replacement	48	The main Sylvania disconnect is rated at 200A, 120/208V. Several secondary distribution panels (Westinghouse and Square D) are present in 200 and 100 amp capacities. Based on the information provided it is our understanding the last major upgrade took placing in 1979.	Good	1979	37	45	14	Replace main and distribution switches at end of reliable service life, or as IR scans deem necessary.	Replacement	3 - Future Renewal	No	No	Yes	No		1	\$20,000	LS	\$20,000	0%	15%	15%	\$27,000												
	59	D501004 Interior Branch Wiring	Contingency	49	The building appears to be wired with copper wiring throughout, with no issues reported. Based on the information provided it is our understanding the last major upgrade took placing in 1979.	Good	1979	37	15	5	Replace branch wiring and related switches and receptacle as required. A contingency has been included for isolated replacement.	Contingency	3 - Future Renewal	Yes	No	Yes	No		1	\$5,000	LS	\$5,000	0%	15%	15%	\$7,000					\$7,000

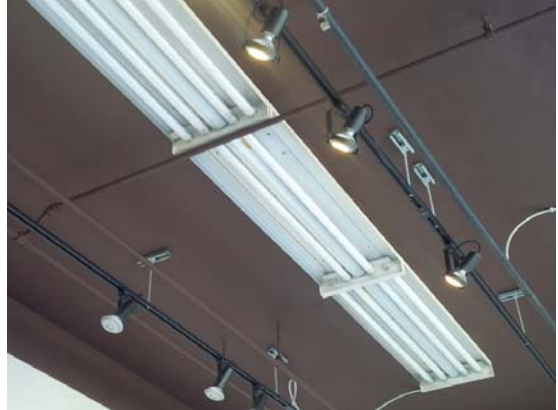
Photo 50

60	D502002 Interior Lighting Equipment	Upgrade	50	Interior lighting is primarily T-8 surface mounted fluorescent fixtures, with some incandescent track lighting. The age of this assembly is unknown and has been assumed.	Good	2000	16	30	14	Replace fixtures at end of lifespan or upgrade to LED units or lamps.	Upgrade	3 - Future Renewal	Yes	No	No	No		1	\$35,000	LS	\$35,000	0%	15%	15%	\$47,000												
	62	D503008 Security Systems	Motion sensors	51	The building is equipped with a remotely monitored DSC security system. Facility staff confirmed that this system was replaced in 2010.	Good	2010	6	25	19	Replace or upgrade security system at end of service life.	Replacement	3 - Future Renewal	No	No	No	No		1	\$4,500	LS	\$4,500	0%	15%	15%	\$6,000												
	63	FIRE AND LIFE SAFETY SYSTEMS																																				
	64	D503001 Fire Alarm Systems	Addressable	52	The building is protected by a Notifier NFW-50 fire alarm system. The age of this assembly is unknown and has been assumed. Facility staff confirmed that this system was replaced in 2010.	Good	2010	6	25	19	Replace the fire alarm panel at the end of its lifespan, including an allowance to replace some wiring and devices.	Replacement	3 - Future Renewal	No	No	Yes	No		1	\$28,000	LS	\$28,000	0%	15%	15%	\$38,000

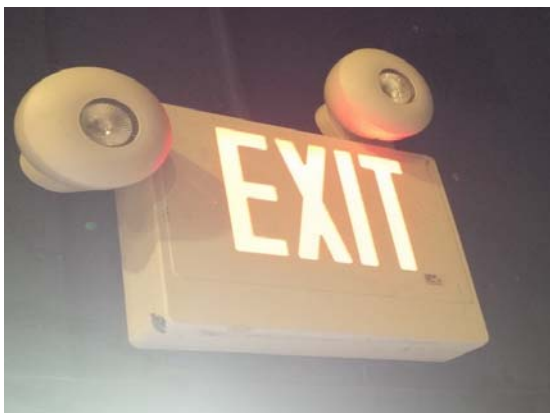
Photo 53

64	D509002 Emergency Lighting and Power	Emergency Lighting	53	Emergency lighting with battery packs and exit signage located throughout the building. Facility staff confirmed that this system was replaced in 2010.	Good	2010	6	20	14	Replace emergency lights and exit signs at end of service life.	Replacement	3 - Future Renewal	Yes	No	No	No		1	5000	LS	\$5,000	0%	15%	15%	\$7,000												
	66	D401002 Sprinkler Water Supply and Piping	Wet and dry systems	54	The building is protected by a wet sprinkler system, with a dry system protecting outdoor (unheated) areas. Facility staff confirmed that this system was replaced in 2010.	Good	2010	6	45	39	Maintain a contingency for capital repairs or partial replacement of equipment or piping.	Contingency	3 - Future Renewal	Yes	No	Yes	No		1	30000	LS	\$30,000	0%	15%	15%	\$40,000
