**City of Victoria - Crystal Pool
& Fitness Centre – Life Cycle
Upgrades Design Report**

Prepared for:
The City of Victoria

January 9, 2015

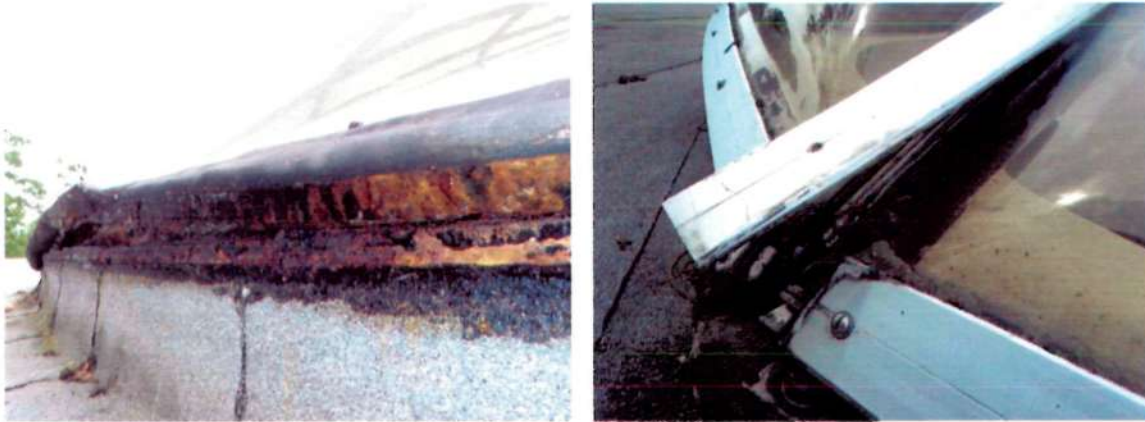
Figure 3: Photos showing poor condition of existing domes

The pool domes have deterioration, leakage and condensation identified as far back in time as 1976, owing to environmental and mechanical stresses on sealant and flashings. The 2011 CEI building assessment and the Stantec Crystal Pool Dome Feasibility report completed on June 3, 2013, echo the problems regarding the domes. Organic growth is occurring at the aluminum battens, batten fasteners are showing evidence of corrosion, maintenance ladders are non-operational, flashings and sealants are deficient and condensation control is failing. Moisture to the interior is resulting in condensation to the underside of the panels and as a result is causing deterioration to the main steel ring structure. There are areas of water ingress that is finding its way into the roof structure and interior stucco bulkheads. Presently one original dome panel is cracked and another three, non-original panels are in immediate need of replacement.

The new dome replacements will include new acrylic panels, battens, spacers, sealant, and curved dome structures to replicate the existing form and character. We currently plan to re-furbish the existing steel ring beams and use them for supporting the new domes. New flashings and membranes will be provided around the perimeter of the existing ring beams.

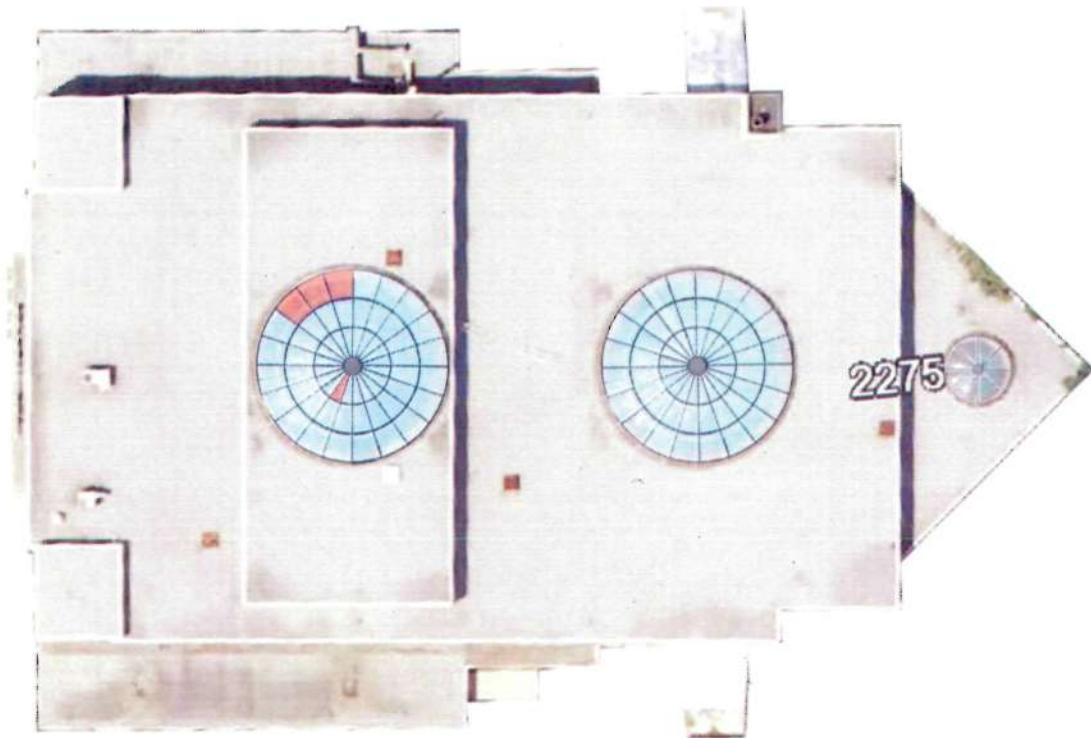
Figure 4: Damaged dome panels in need of replacement (highlighted in red)

The replacement of the acrylic panels identified in OPTION-1 represents the most economical approach. However, the pool will continue to experience water damage from excessive condensation, poor ventilation at the domes, and leakage from an inadequate dome assembly.

Replacement of the 4 damaged acrylic panels will include the design of distributed combination loads to include the panel dead, live and wind loads in accordance with BCBC 2012.

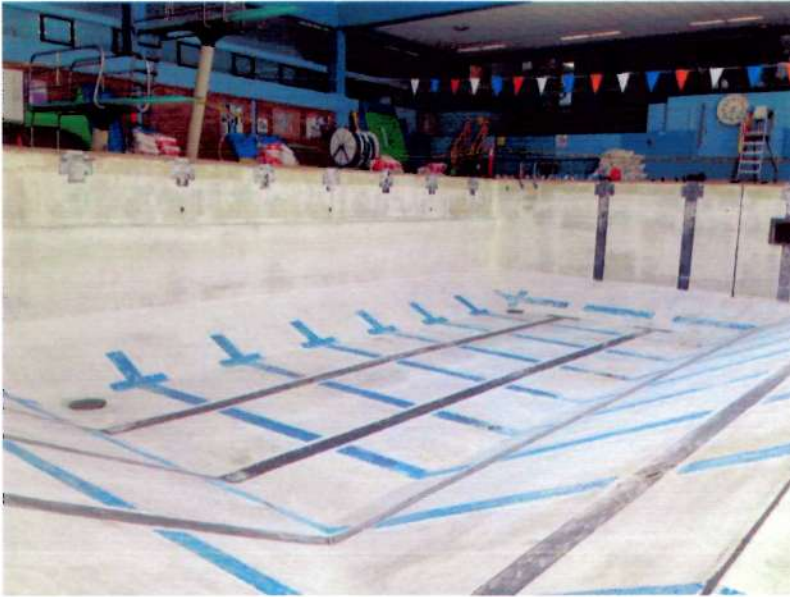
Figure 7: Pool (deep end)

A condition assessment of the pool marcite (pool basin coating) was prepared and submitted by Goal Engineering to the City of Victoria on September 9, 2014. The report outlines extensive etching, crazing, and debondment of the pool marcite surface. The report's major recommendation entails a thorough marcite finish removal and replacement. Further observations include corroded support brackets in the filter room, copper staining at drainage pipes, painted tiles, and a loss of tile surface texture.

All marcite and tile surfacing at the main pool floors and walls will be removed to the concrete substrate, replaced by a new installation of marcite to all surfaces. Tile will be added as a new 300mm high mosaic tile band at the water's edge, and 300mm wide mosaic lane markers at the pool floor. Tile depth markings will be installed around the perimeter deck. A new ramp and stair will be provided at the pool south-east corner, finished with tile.

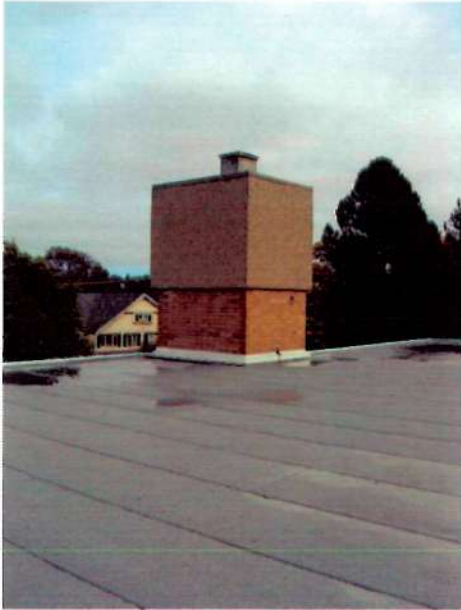
Figure 9: Boiler flue to be replaced

The existing masonry exhaust flue extending from the basement level mechanical room to above the roof is exhibiting cracks. In addition, although not required, the flue does not meet current seismic standards and should be replaced. If new condensing boilers are installed, then without question due to technical requirements, the concrete masonry unit flue will need to be removed and replaced (with a ULC listed metal boiler flue assembly). A new shaftwall assembly, with prefinished metal cladding, weather barrier, and non-combustible sheathing above the roof line would form the new chimney system for the boiler flue. The new flue assembly would be seismically braced to meet current requirements. As per the dome repair, a repair to affected roof areas consisting of rigid insulation, sheathing board, and a SBS roof membrane will be provided.

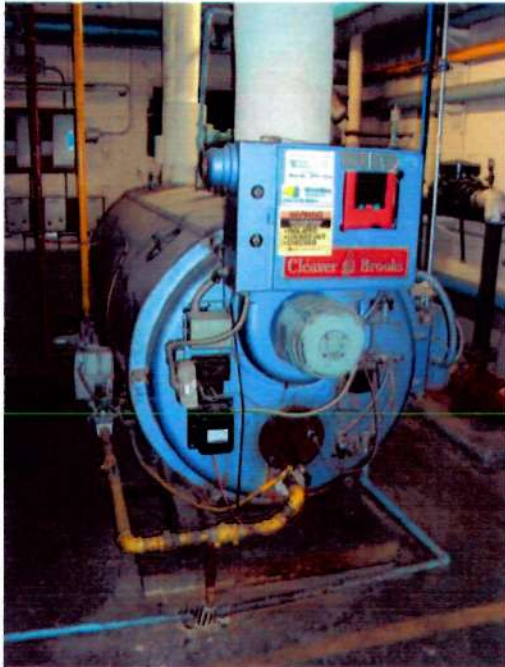
Figure 10: One of three existing boilers

The existing 40+ year old Cleaver Brooks Fire Tube Boilers were evaluated in 2012 by the mechanical maintenance company of that time. We understand that they have not been inspected (opened up) since then. In 2012, the boilers were in good condition and efficiency tests indicated that they were running at between 82% - 84% efficiency. This is a good result for this era of boiler, and implies that they are in good shape. These were top quality boilers in their day, and experience with other installation on the island show they have longevity.

Maintenance personnel indicate that the main boilers #1 and #2 are cycled to have relatively equal hours of operation. The smaller boiler #3 is essentially used for the summer (low demand) season.

- The existing boilers be retained and only a controls upgrade be implemented if a fitness expansion is not contemplated
- The existing boilers be removed and replaced with high efficiency boilers and controls if a family change room, universal washroom renovation and fitness expansion is contemplated

Finally, if the existing boilers are to remain, it is recommended that they be inspected (opened up) before a final decision is made on keep or replace.

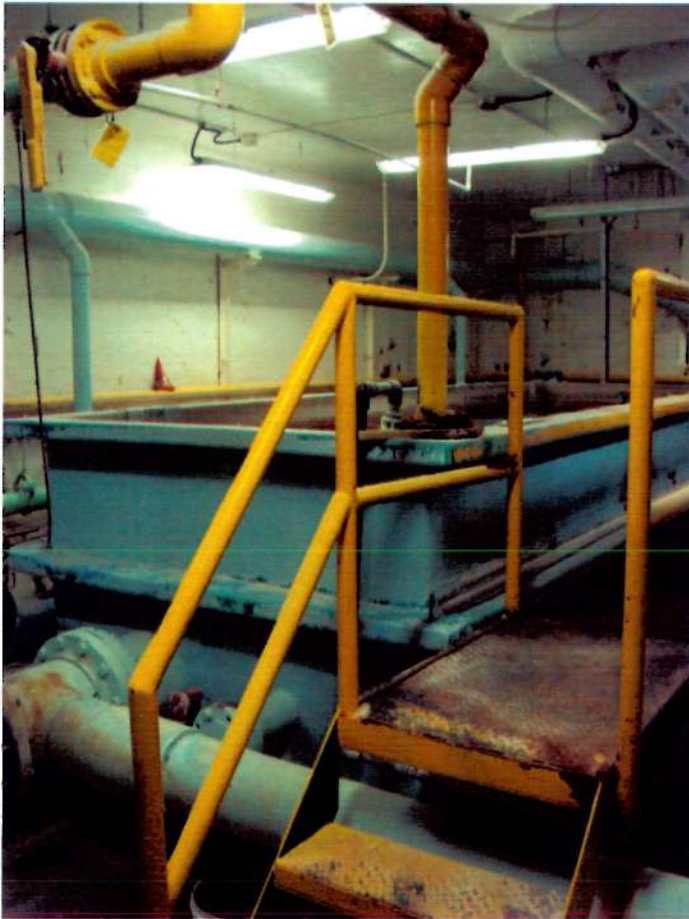
Figure 11: Existing Main Pool filter tank

The current antiquated and corroded filter room equipment, tanks and derelict ozone treatment equipment will be demolished and removed. The equipment is at end of life, and some maintenance procedures necessary on the old equipment and infrastructure are questionable. The new system will consist of open DE filter tanks, UV treatment and chlorine gas injection. This new system of filtration and treatment was chosen based on experience, proven effectiveness and maintenance staff familiarity with the systems.

Above the filter tanks on the ceiling, it is recommended to install a linear crane to assist operational staff with filter maintenance procedures. Each filter cassette that needs to be lifted out is approximately 400 pounds. This will assist with compliance to modern Worksafe requirements.
