# **Report on Point Ellice Bridge Maintenance and Enhancement Proposals**

City of Victoria

**Final**

December 1, 2014

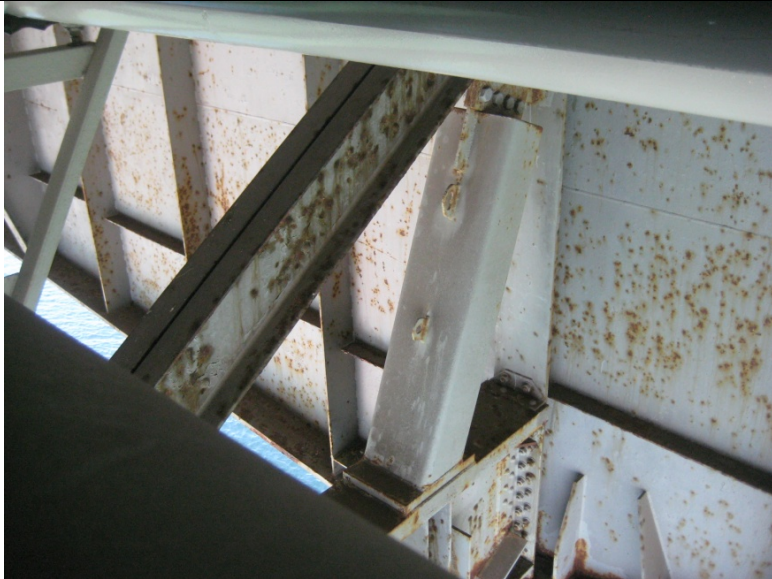
Photo 5 – Interior view of the North Girder near Pier #1. Surface corrosion and pitting is visible on steel elements.

Rust products observed on many of the steel superstructure members indicate that a re-painting effort is soon required.

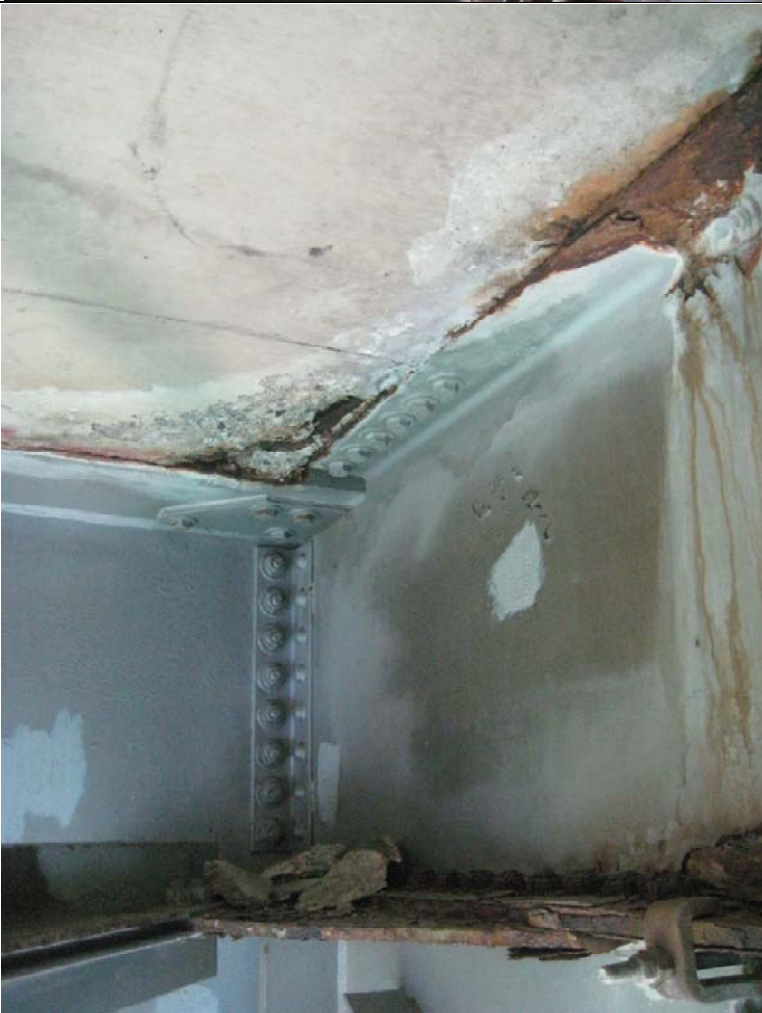
Photo 6 – Concrete spalling observed at the connection point of the cross beam and stringer

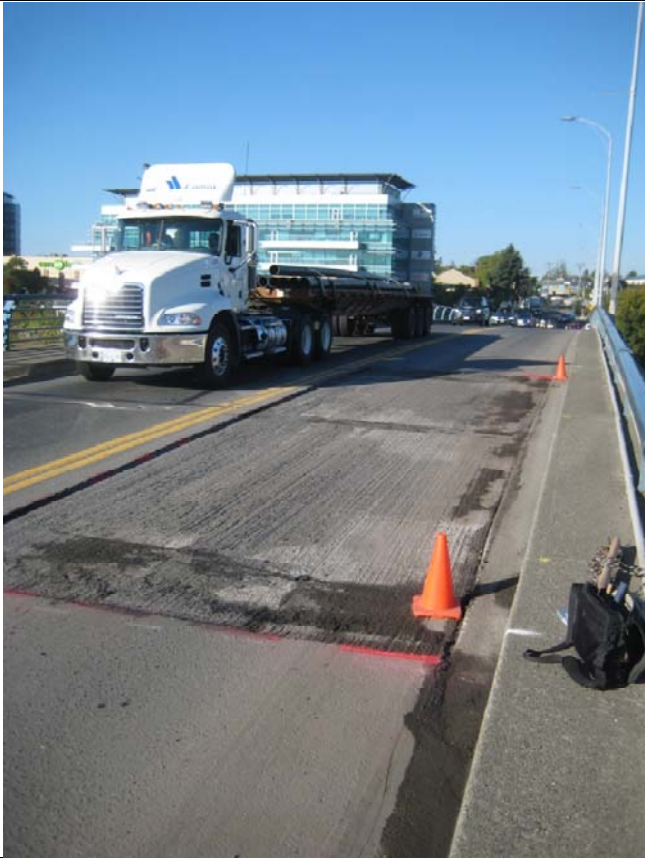
Following the removal of the asphalt surface from the concrete deck, a visual and sounding survey was conducted to identify locations of debondment. No loose or debonded concrete was identified in the test area (See the appended drawing for the location of the test area surveyed).

Photo 7 – View of the asphalt removal test patch. The test patch was centrally located over Pier #1 in the West bound lane of traffic.

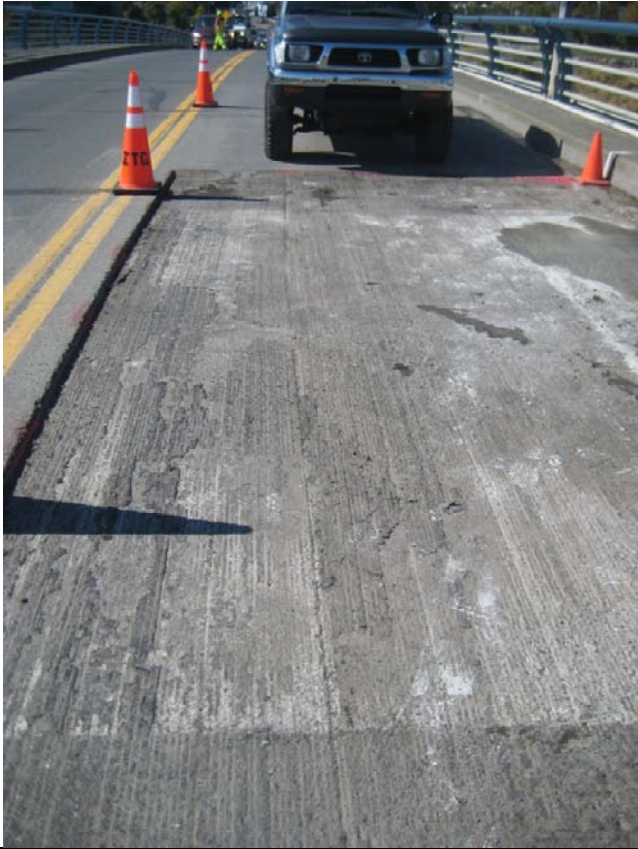
Photo 9 – Close view of the concrete deck. Grooves can be observed from the milling process.

No locations of concrete debondment were noted.
