Talbot Mackenzie & Associates

## Re: Proposed subdivision at 1322 Rockland Avenue.

**Assignment:** To review the location of the proposed new driveway off Royal Terrace (see attached site plan) and provide recommendations for mitigating any potential impacts to Garry oak number 373.

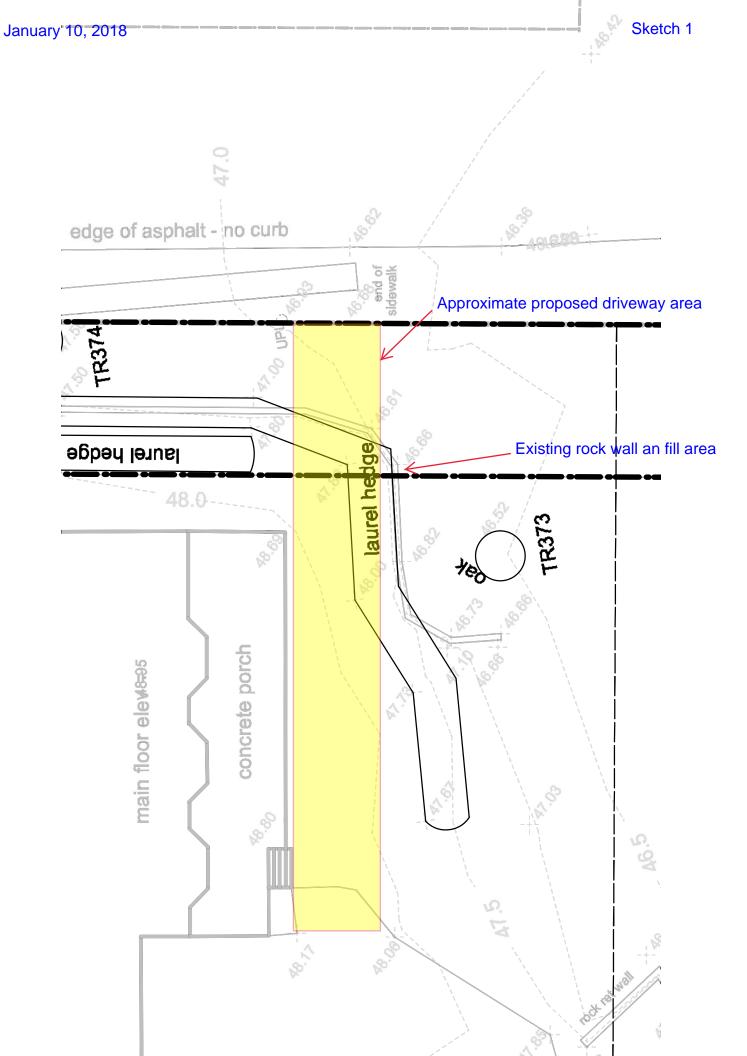
**Observations:** The majority of the proposed driveway will be located within an area that has had a retaining wall installed, fill soil added, and a laurel hedge planted (see attached sketch 1). There will be a portion of the driveway nearest the road on municipal property that will be installed where there is no existing retaining wall.
