**HERITAGE REVITALIZATION AGREEMENT  
(251 ESQUIMALT ROAD) BYLAW**

# E & N NATIONAL HISTORIC SITE VICTORIA, BC

## 2.1 ROUNDHOUSE

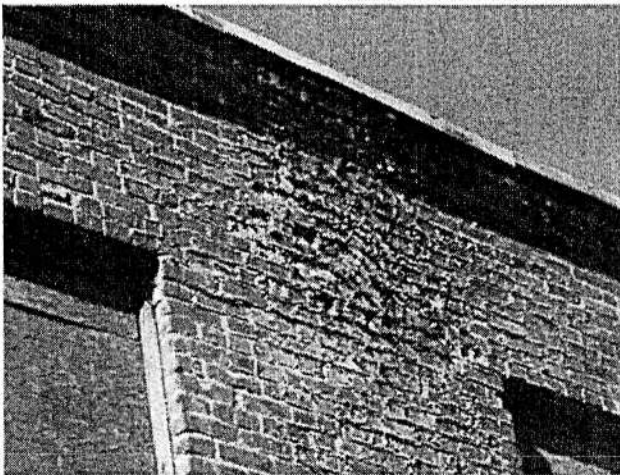
- i. **Observations** – The exterior masonry is in relatively good condition. The mortar, whose composition includes Portland cement, has a compressive strength of approximately 6 to 12 Mpa (megapascals). (By contrast, some older brick buildings in Victoria that used a soft lime <sup>2</sup>mortar have a compressive strength of about 1 to 2 Mpa.) The shear resistance of the brick masonry has not been tested. There are some areas on the exterior surface where the mortar has been etched by water running over the surface.

1.3. Water damage to brickwork on east side  
(2006 August 04)

ii. **Remediations** – Testing will be required of the compressive strength of the brick to ensure that it is of higher Mpa than the existing and proposed pointing mortars. The areas where the mortar has been damaged will require repointing. As well as repointing there are a number of areas where spalled bricks will have to be replaced.

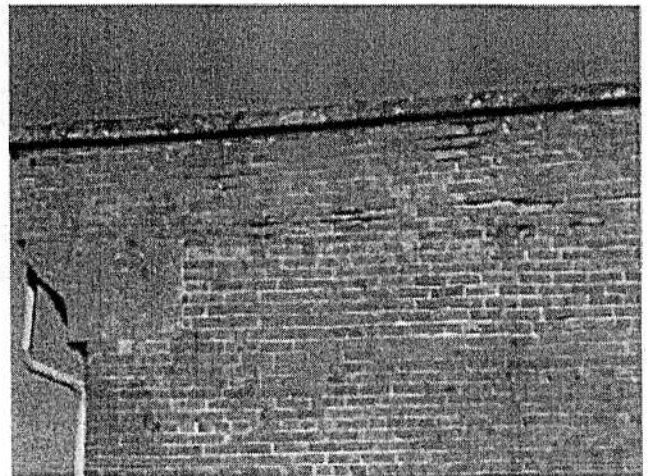
1.4. Weather damage to brickwork (2014 February 05)

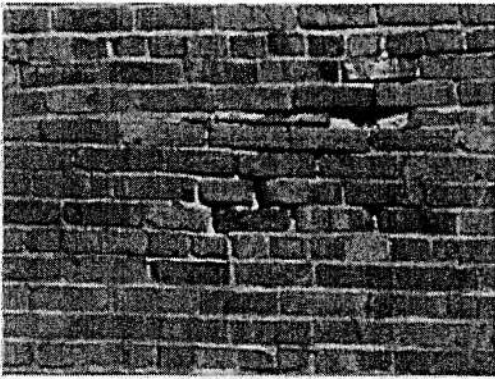
1.5. Detail of weather damage to brickwork (2014 February 05)

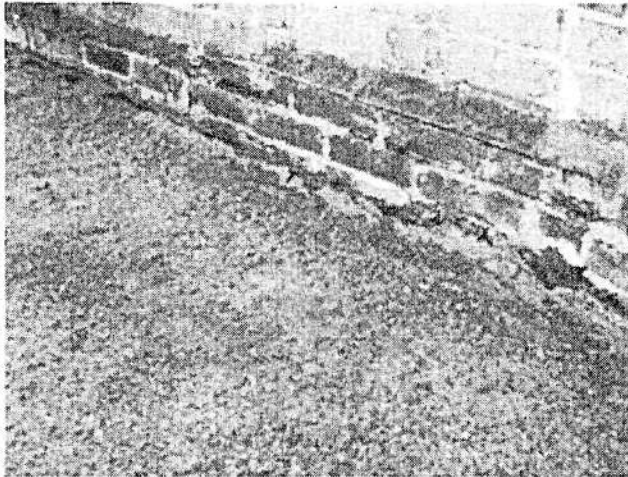
i. **Observations** - There are five (5) parapet walls to the Roundhouse, two at the exterior and three above the dividing walls of the bays sections. The capping of concrete is in poor condition. The brickwork to the walls is damaged where the original flashings for the roof was located. This damage has been aggravated by the failure of the roof membrane in these locations. From the observations made in 2006, 2009, and 2014, it was established that the brickwork and the concrete coping has

been compromised due mainly to the failure of the associated flashings.

1.6. Parapet wall at roof level (2006 Jan 20)

- ii. **Remediations** - The brickwork to the demising parapet walls at the roof level will be repaired with bricks to match the existing, pointed with appropriate mortar and new sheet metal cap and counter flashings. The concrete capping will be repaired using an appropriate Jahn concrete repair product. Full mortar mix details will be provided at the Building Permit stage.

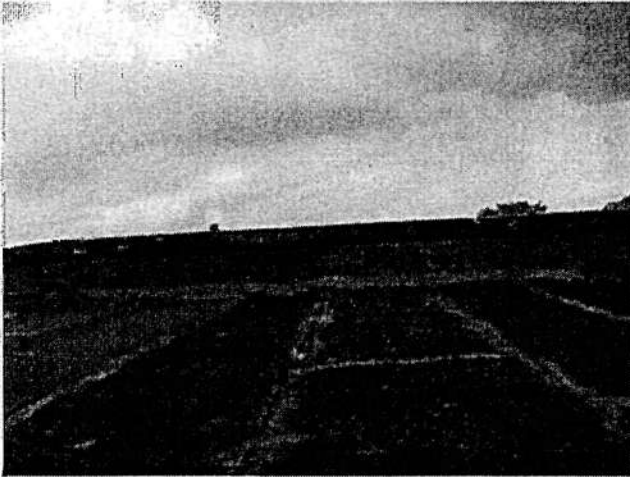
- i. **Observations** – The original roof construction consisted of 4-inch decking supported on heavy timber beams that had deteriorated very badly by the early 2000's.

1.9. Roof condition (2003 May 21)

**Remediations** – The temporary framed roof construction is to be removed in its entirety and replaced with new T G & V jointed

decking to match the original. The decking will be placed on the existing heavy timber framework, beams and posts that have been repaired and upgraded – see clause 2.1.1.2

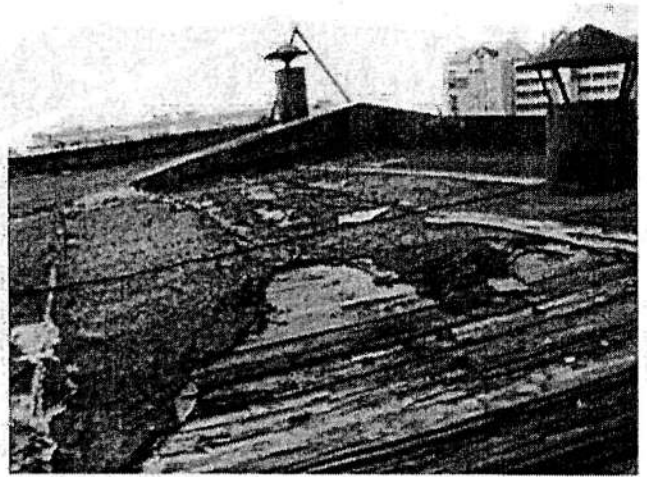
1.10. Roof, skylight & vent stacks. (2003 May 21)

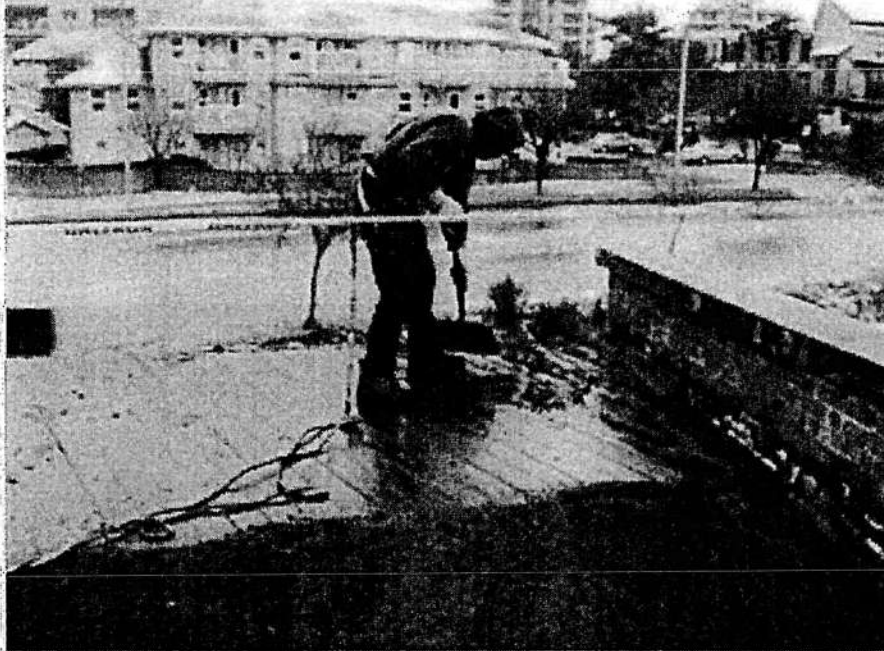
1.11 Roof condition, exposure of decking below tar & gravel (2006 Jan 20)

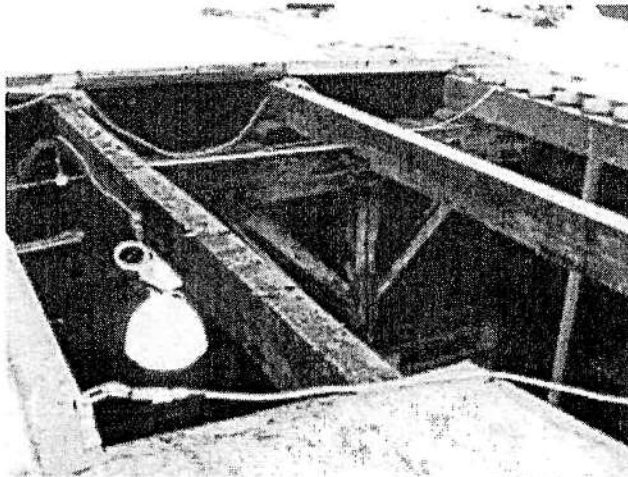
parapets were replaced with new flashings in some locations. Some roof deck locations are severely decayed.

1.12. Decking removed  
(2009 Jan 06)

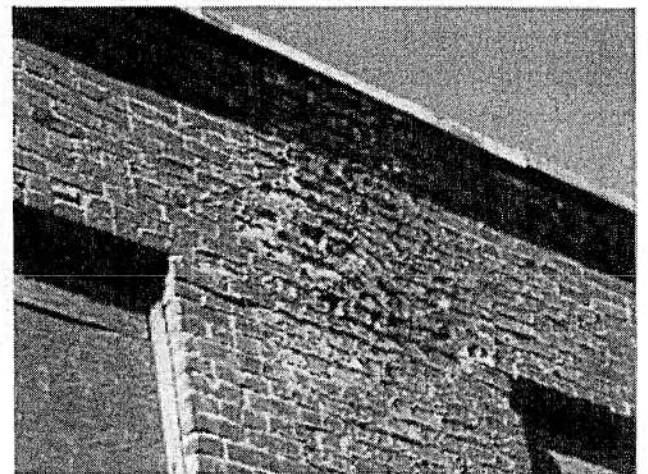
1.15. Water damage from missing gutter (2006 Aug 04)

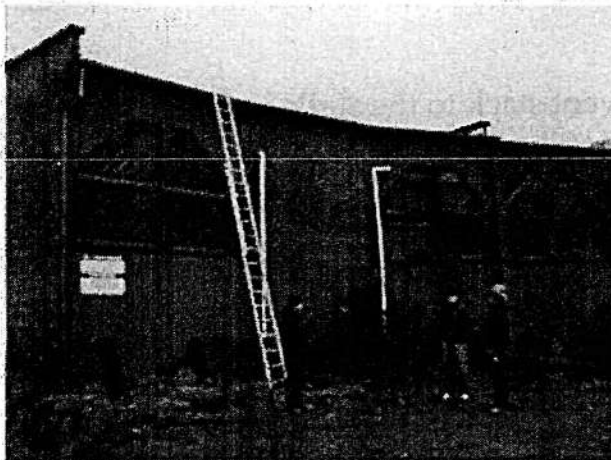
- i. **Observations** – At the present time the original gutters and down pipes have long since been removed. This was replaced in 2009 with a temporary system of aluminum gutter connected to aluminum and ABS down pipes

1.16. Temporary gutters & downpipes (2009 Feb 13)

- ii. **Remediations** - The temporary gutters to both sides of the mono pitch roof will be removed and replaced with new galvanized sheet metal profiled gutters to match the original. This will include the replacement of the existing temporary fascia board with new wooden board to replicate the size and profile of the original. Rainwater down pipes will be of galvanized steel to match the original based on archival research
- iii. **Proposed Interventions** - None.

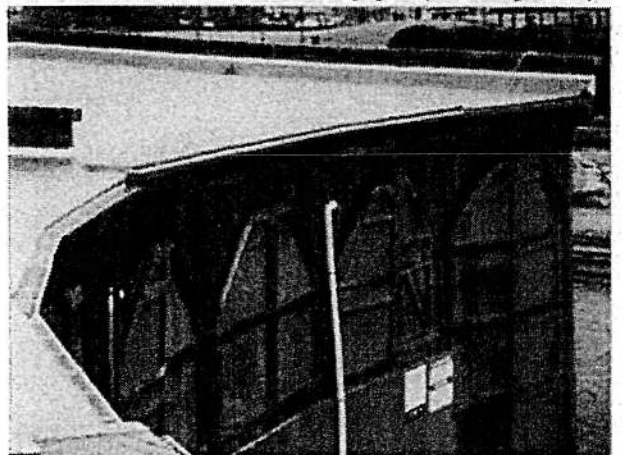
1.19 Temporary gutters (2009 Feb 13)

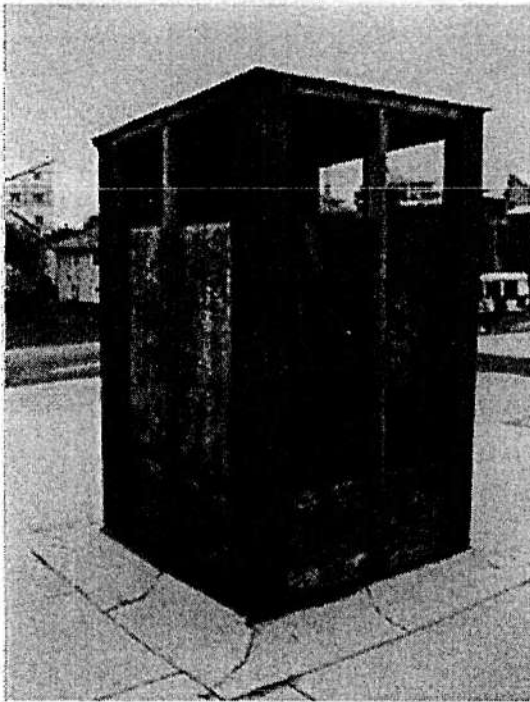
1.26. Temporary roofing & square vent stack (2009 Feb 13)

ii. **Remediations** – To replicate the missing square smoke stacks to follow the size and pattern of the remaining unit and in addition to archival photographs F-05352, F-05359 and 1.25 and 1.26 of this Report

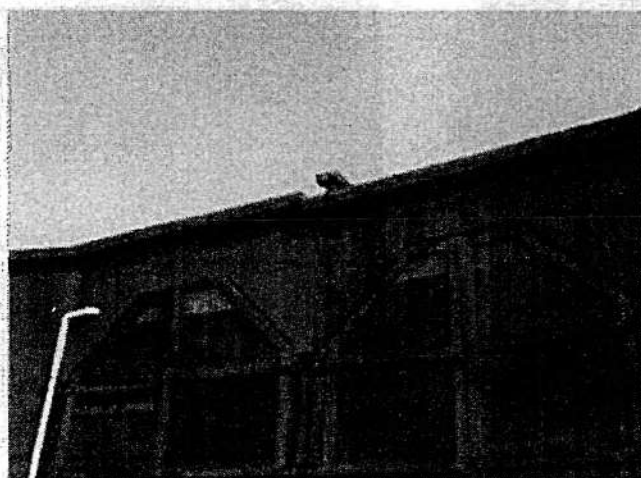
- i. **Observations** – Around the 10 main stall doors is a combination of heavy timber and framing clad on the exterior with vertical 4" T G & V jointed boards. In many areas these vertical boards have been covered up with sheets of plywood thus by the condition of the areas that are exposed it is assumed that this condition is throughout.

1.29. Vertical T & G siding above doors (2012 April 18)

- ii. **Remediations** – To remove all the protective plywood in order to assess the condition of the rotten and damaged with new material of same profile and type. All exterior woodwork will be re-painted to an approved paint system to MPI standards. Colours of all surfaces will be determined by onsite paint analysis. Actual colours that are proposed to be used will be submitted after this analysis.
- iii. **Proposed Interventions** – none.

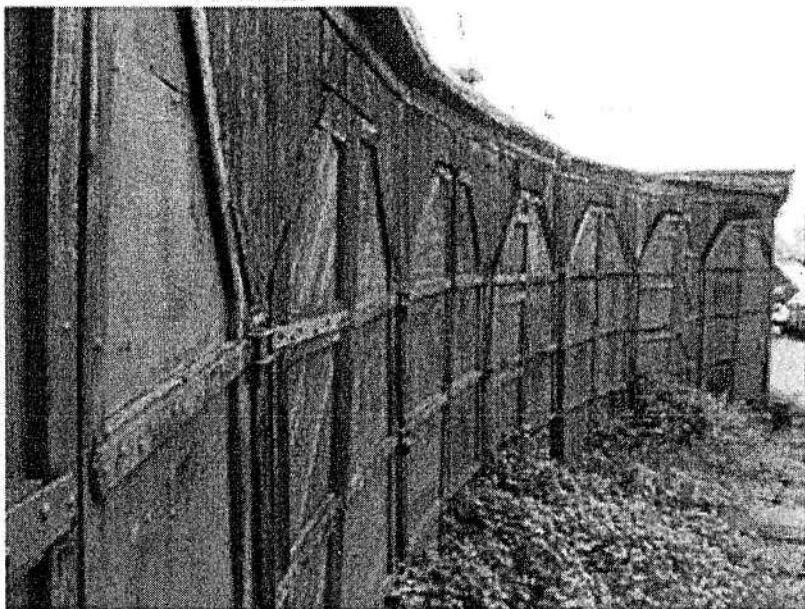
- i. **Observations** – The 10 stall doors are in poor condition. They are suffering from some decay and are sagging on their hinges. These doors are the major Character-Defining Elements CDE of the historic site and require careful consideration.

1.31. Doors for tracks 7 to 1

- ii. **Remediations** – The doors will be taken down and stripped so they can be inspected and repaired, where necessary, to bring them back to operational condition. Where hardware is missing, it will be replicated. Those that have been replaced (the number is uncertain, because several are boarded up) should be reconstructed to resemble the original doors. It may also be necessary to replace the main posts that support the door hinges, so that the doors can be properly set.

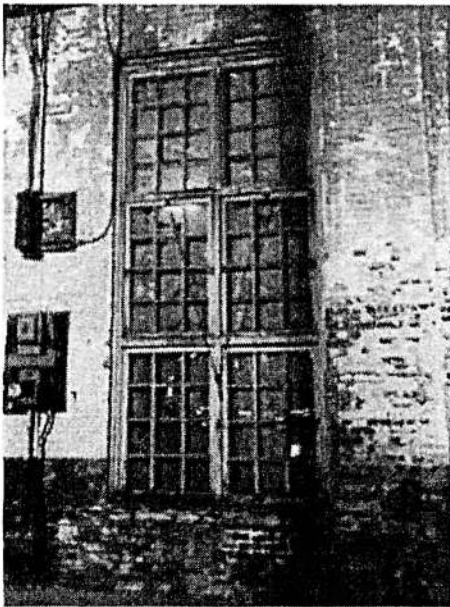
- i. **Observations** – The wood window frames and sashes have some areas of decay, particularly at the sills, but in general are considered to be in repairable condition. Vintage Woodworks carried out a basic on-site investigation in July 2011 that confirmed that all can be repaired. There are 63 windows, including the Boiler Shop, and 220 multi-lite sashes. Of these approximately 70 sashes will require extensive restoration. – see Appendix B for copy of this report.

1.47 Interior of window- track 4 (2014 Feb 05)

- ii. **Remediations** – These should be removed, sanded, repaired and then repainted. The frames at 13 windows will require this. Most of the glazing is broken, so the windows will have to be re-glazed as needed. The wood frames and sashes of all the windows will be refurbished, and where required, new material incorporated. The existing glass will be retained and, where missing, replaced with glass matched to the same thickness.

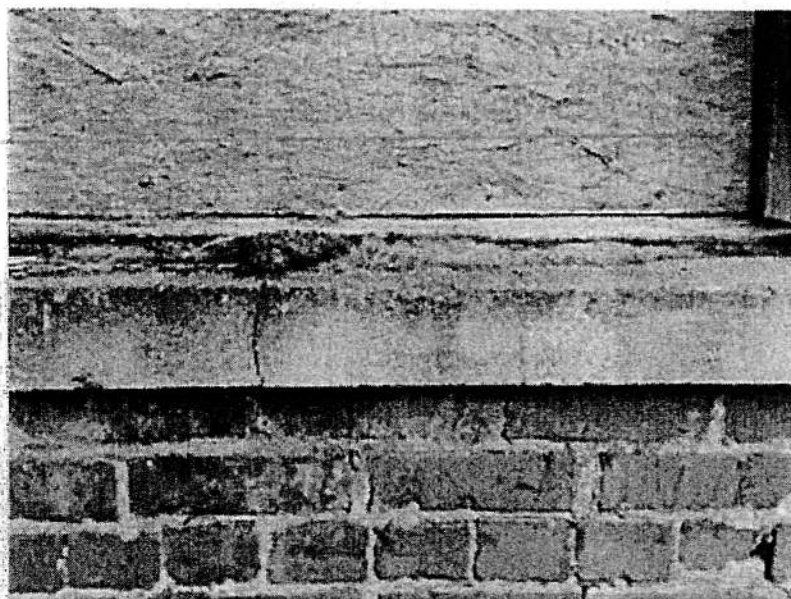
- i. **Observations** – The sills are of solid concrete and are substantial in fair condition, however a number of them are cracked and deformed.

1.53 Cracked concrete sill

- ii. **Remediations** - The concrete sills are to either be repaired in-situ or replaced where that damage is beyond repair. Appropriate Jahn concrete repair products will be used.

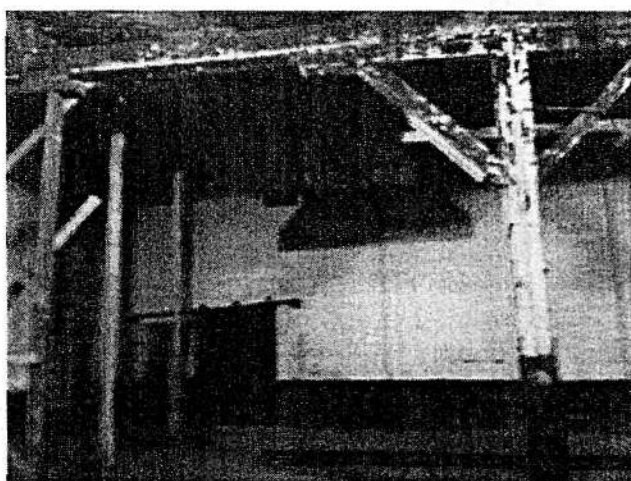
- i. **Observations** - The interior post-and-beam structure appears to be in serviceable condition. However, there are some areas of decay that must be repaired. The beam-ends are all supported in pockets in the masonry walls. It appears that there is typically one brick wythe covering the end of each beam and protecting

from the weather. The beam-ends have not yet been inspected for decay. Decay is currently visible at 6 beams in masonry pockets and 5 beams at doorposts. Connectors between timber framing members are often loose, likely because of timber shrinkage.

1.54 Structure & smoke stack – track 8 (2014 Feb 05)

- ii. **Remedations** – Due to lack of maintenance over a long period of time, a large portion of the original 4" T&G roof deck was rotten and was removed in 2007 and replaced with a temporary 2" x 6" joisted roof, with plywood decking and a membrane roofing system. This temporary roof system will be removed and replaced with a 4" T&G decked roof to match the original.

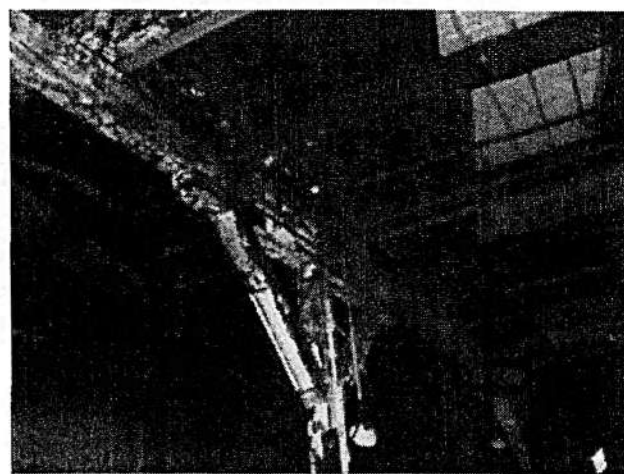
1.55 Post, beam & decking (2014 Feb 05)

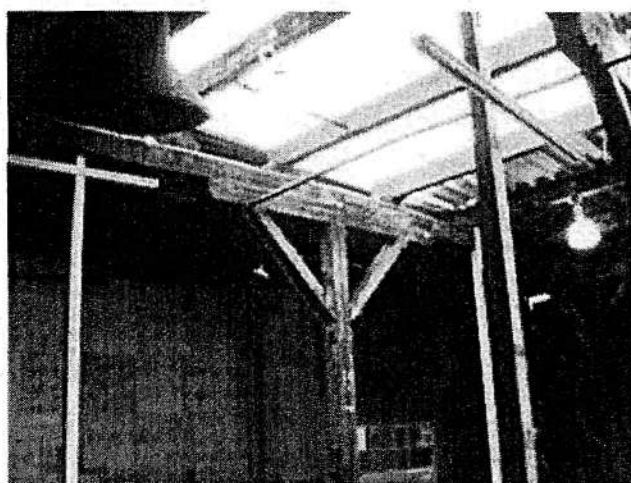
1.56 Roof removal-tracks 2 & 3 (2009 Jan 06)

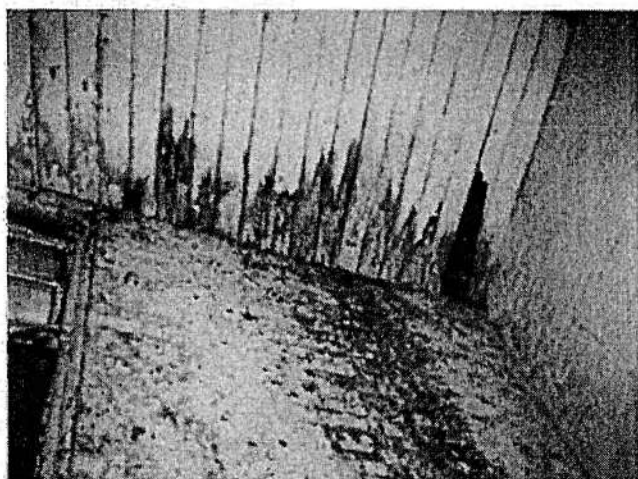
- i. **Observations** - The internal surfaces of both the exterior brick walls and those of the interior dividing walls are all in good condition. The only area to which there is damage to the interior brickwork is on the east wall between tracks 5 and 6 where a former roof fracture has lead to ingress of water to the upper areas of the interior wall. The finish to the wall surfaces is a combination of a dado of black paint up to a height of approximately 4 feet, above which the brickwork is coated with lime wash (original?) and further coats of which paint.

1.58 Water damage to brickwork & decking (2003 May 21)

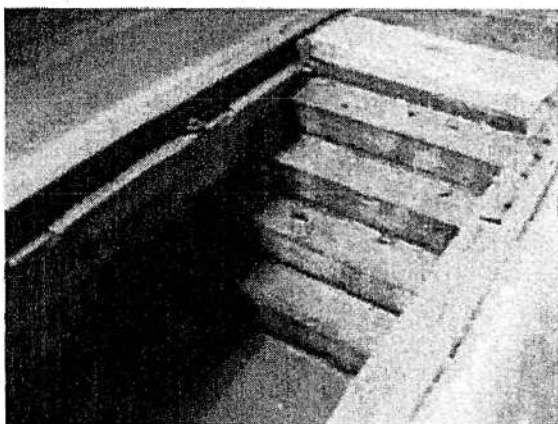
- i. **Observations** - Minor damage to the concrete rail beams has occurred at some locations. The damage is the result of corrosion of the rail anchor.

1.59 Inspection pit

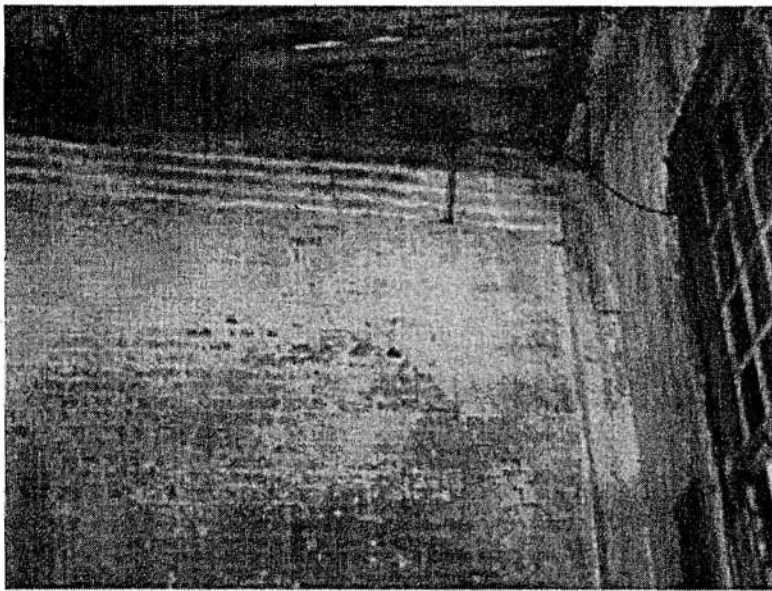
1.62 Paint on brickwork & u/s of decking

- ii. **Remedations** – While the paint and whitewash are in only fair condition, they are important to the heritage character and ambiance because they retain the patina of their original use – whitewashed walls and black, smoke-stained ceilings, which were painted to cover the staining. It will be necessary to discuss the pros and cons of leaving the surfaces as they are, for interpretive purposes; or stripping the paint to enable further treatment of the wood and masonry surfaces.

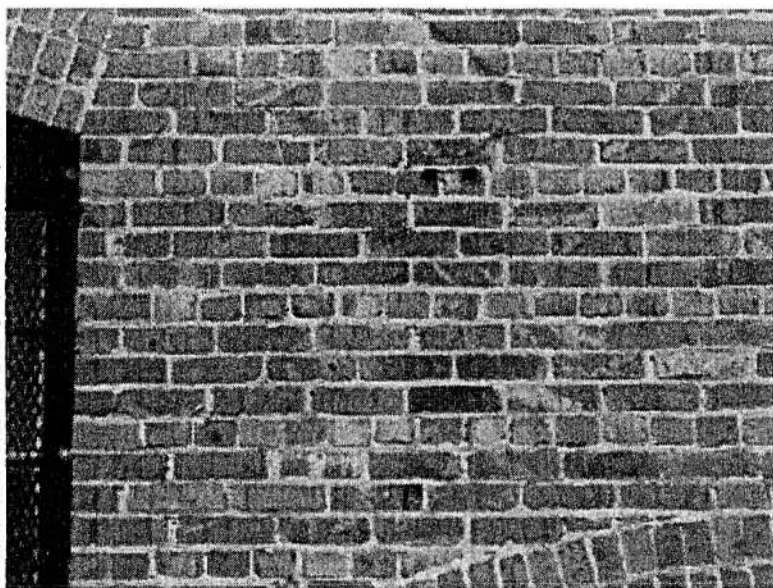
- i. **Observations** – The exterior masonry is in relatively good condition. The mortar has a compressive strength of approximately 6 to 12 Mpa. There are some areas on the exterior surface where the mortar has been etched by water running over the surface. Some softer salmon-coloured brick units occur; these have failed in some areas.

2.5 Condition of exterior brickwork

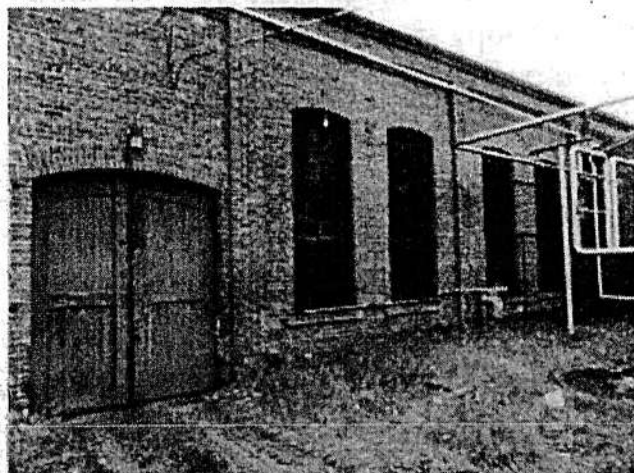
- i. **Conditions** – The wood window frames and sashes have some areas of decay, but in general are considered to be in repairable condition. Many glazing bars and several panes are broken on the south wall. Some windows have been boarded up from the exterior for protection.

2.6 Windows & door on north side (2014 Jan 21)

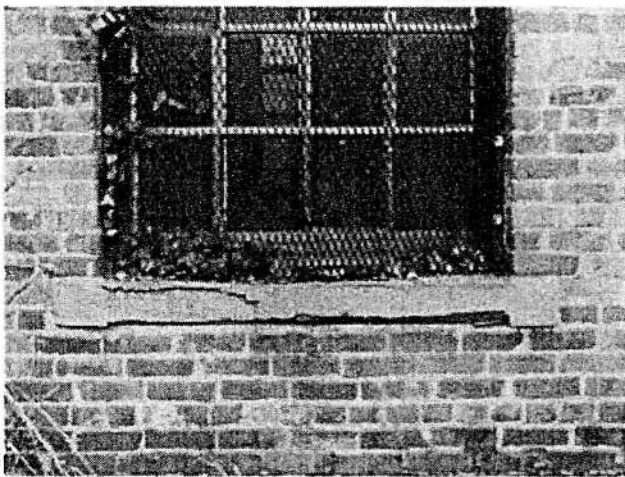
- i. **Conditions** – The sandstone window sills (35 in all) have failed in some locations.

2.9 Widow & stone sill (2014 Jan 21)

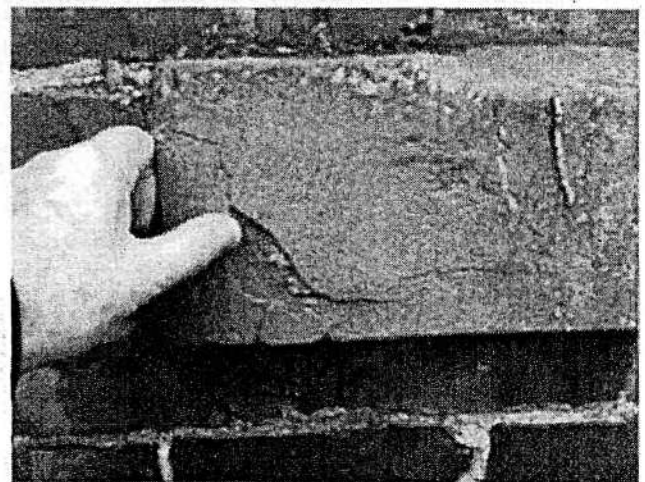
2.12 Failing stone sill-detail (2014 Jan 21)

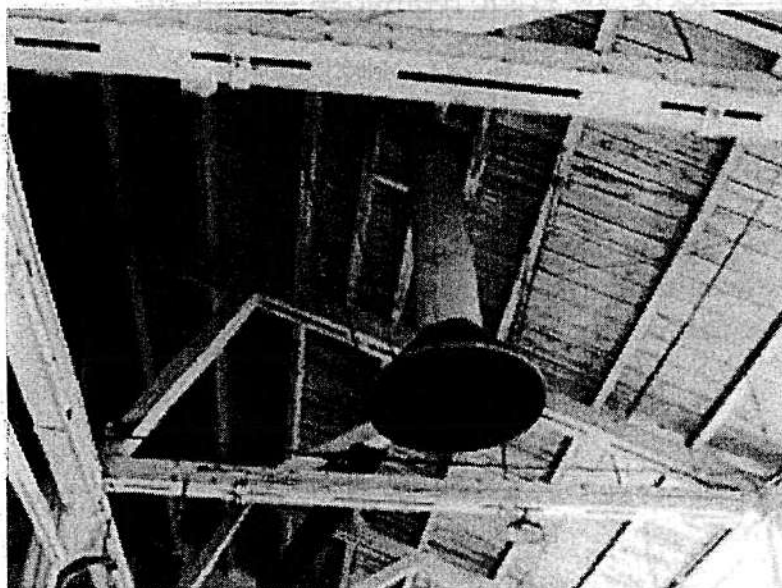
- i. **Conditions** - The support structure consists of exterior URM wall supporting large timber trusses that are also supported on a series of wood columns. In the area of the 5-ton hoist the structure reverts to steel. All elements appear to be in satisfactory condition but there is some localized rot to a number of the beam pockets.

2.13 Timber trusses & vent stack

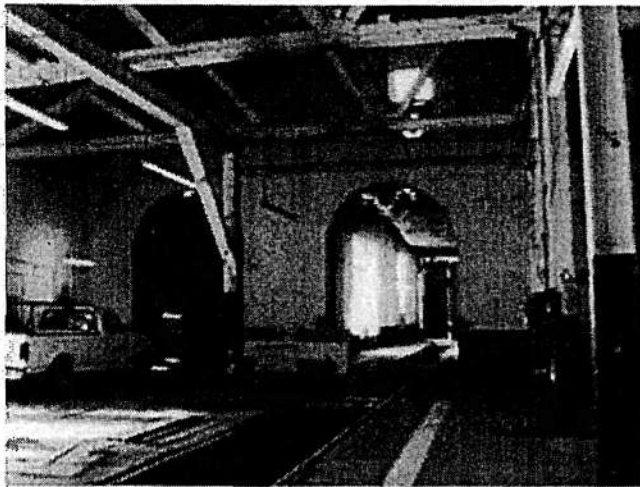
- i. **Conditions** – The paint is peeling from the interior timber structure. The paint would appear to originally have been lime wash, but more recently other paint systems have been applied.

2.15 White interior with black dado (2014 Feb 05)

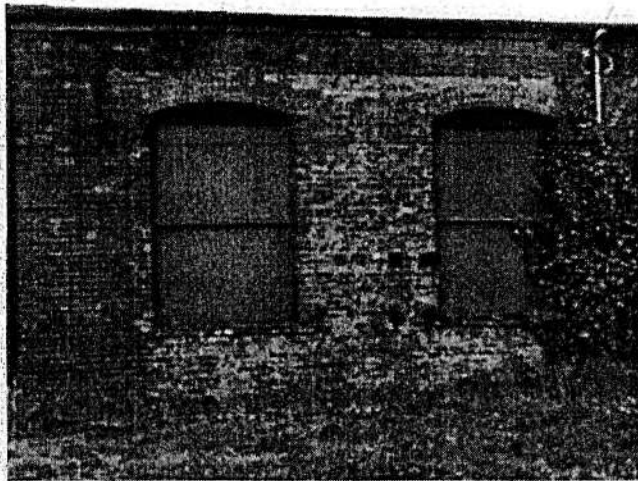
- i. **Observations** – The exterior masonry is in relatively fair condition but has suffered in a number of areas with structural cracks and settlement. The mortar has a compressive strength of approximately 6 to 12 Mpa. There are some areas on the exterior surface where the mortar has been etched by water running over the surface. Some of the softer salmon-coloured brick units have failed in some areas.

3.4 Poor brickwork around windows (2014 Jan 21)

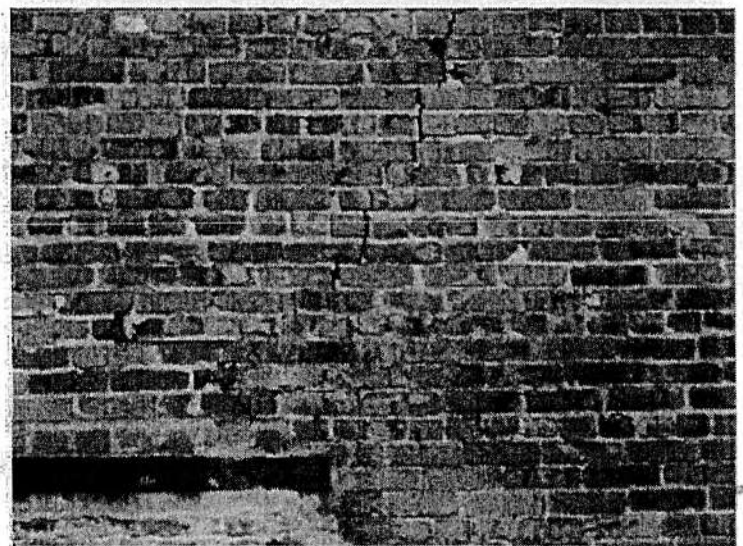
3.7 Settlement crack at head of blocked up

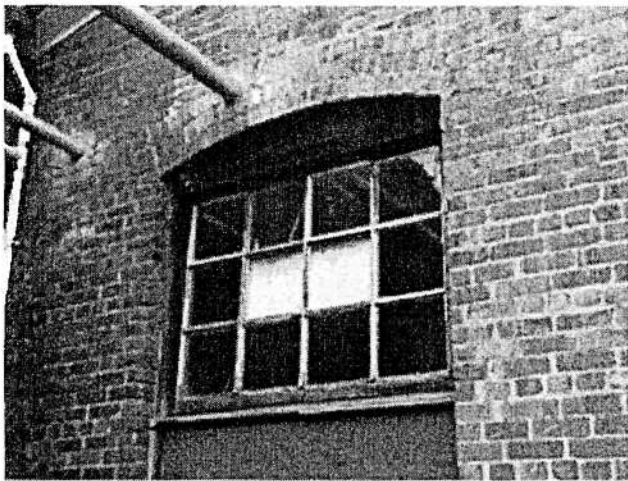
3.8 Penetrations above window (2014 Jan 21)

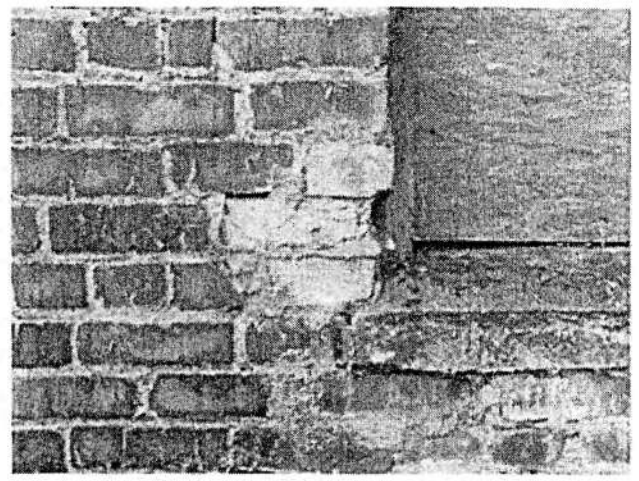
3.9 Spalling bricks at sill (2014 Jan 21)

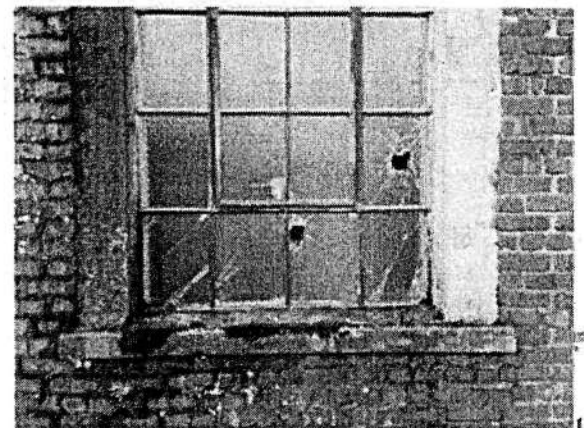
- i. **Conditions** – The steel window frames and sashes have some areas of rusting, but in general are considered to be in repairable condition. Several panes of wired glass are broken.

3.11 Broken glass to metal

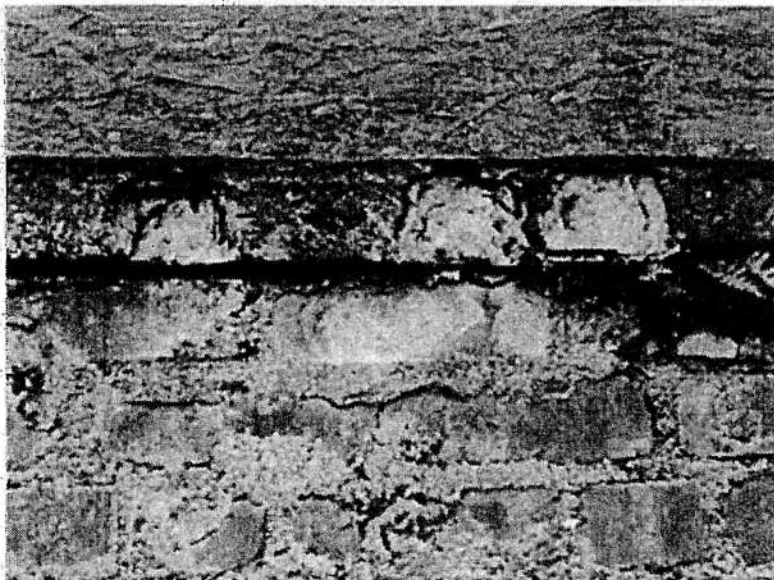
- i. **Conditions** – The parged brick window sills have failed in most locations. The front face of the sills are badly weathered with both the parging and the backup bricks are spalling due to water infiltration.
- ii. **Remediations** - Where the window sills are badly damaged, they are to be removed and replaced with new bricks of the same size as the original. Where not severely damaged, to be repaired using a cement based parging to match the colour and texture of the original.

3.10 Deteriorating parged sill.

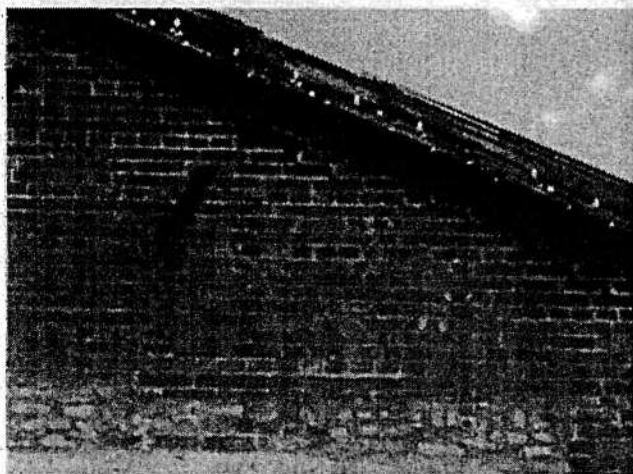
- i. **Conditions** – The exterior masonry is in relatively good condition. The mortar has a compressive strength of approximately 6 to 12 Mpa. There are some areas on the exterior surface where the mortar has been etched by water running over the surface. All present are settlement cracks adjacent to the large door on the west elevation

4.6 Cracks adjacent to purlins over west doors (2014 Feb 05)

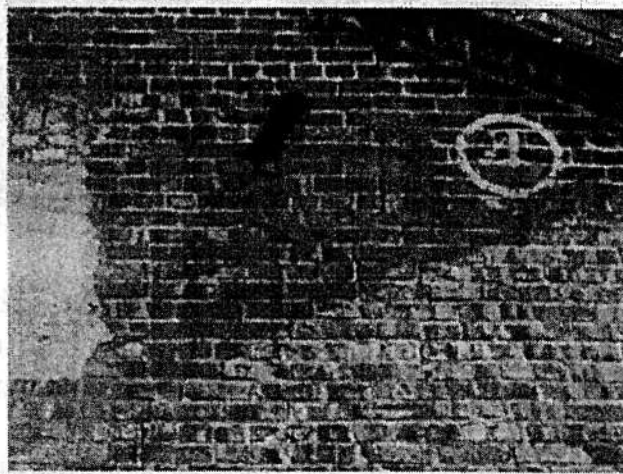
4.7 Detail-cracks to brickwork (2014 Feb 05)

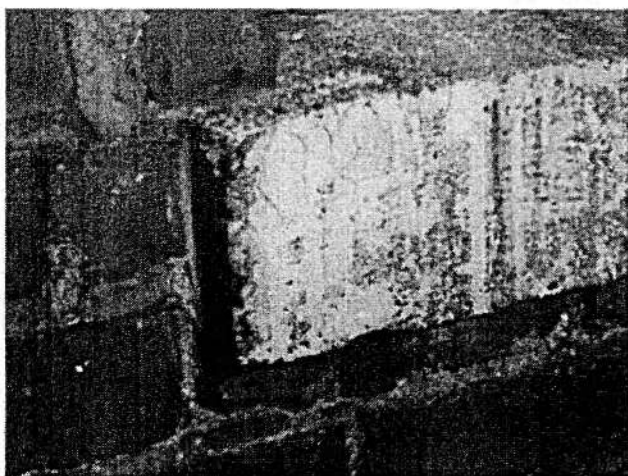
- i. **Conditions** – The concrete sills appear to be in fair condition. In some areas there are remnants of paint and discolouration of the concrete surface. Some slight cracking has occurred to some of the sills.

4.8 Paint to concrete sill (2014 Feb 05)

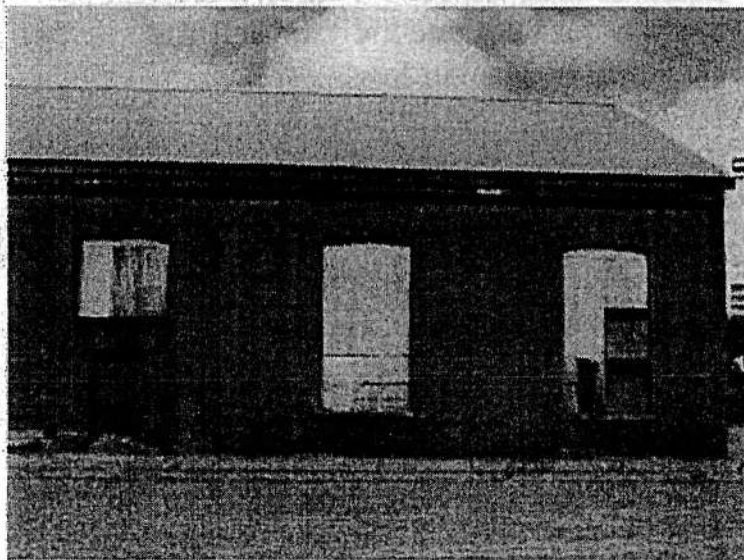
- i. **Conditions** - The wood window frames have some areas of decay, particularly at the sills, but in general are considered to be in restorable condition. All except two of the original glazing units have been removed and the windows are covered with translucent fibreglass panels.

4.9 Boarded up windows (2014 Feb 05)

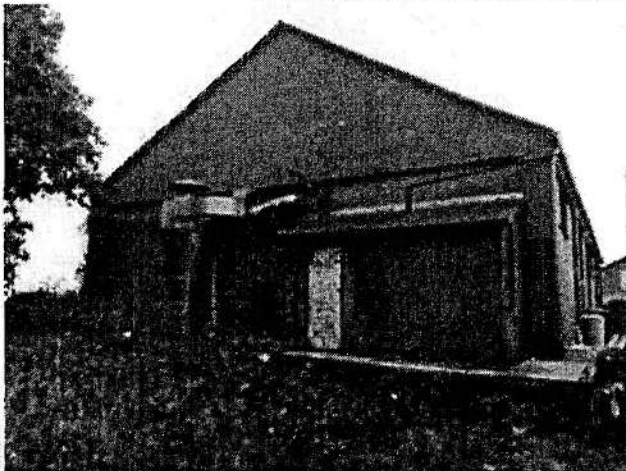
- i. **Conditions** – The masonry lean-to at the west elevation has settled away from the building, resulting in large cracks in the masonry work. This is likely the result of poor foundations beneath the lean-to. It is in a poor state of repair,

5.10 Lean-to at west
