Talbot Mackenzie & Associates

September 15, 2016

Re: Tree Impact Mitigation Report – 1303 Fairfield Road

TREE RESOURCE
for
1303 Fairfield Road

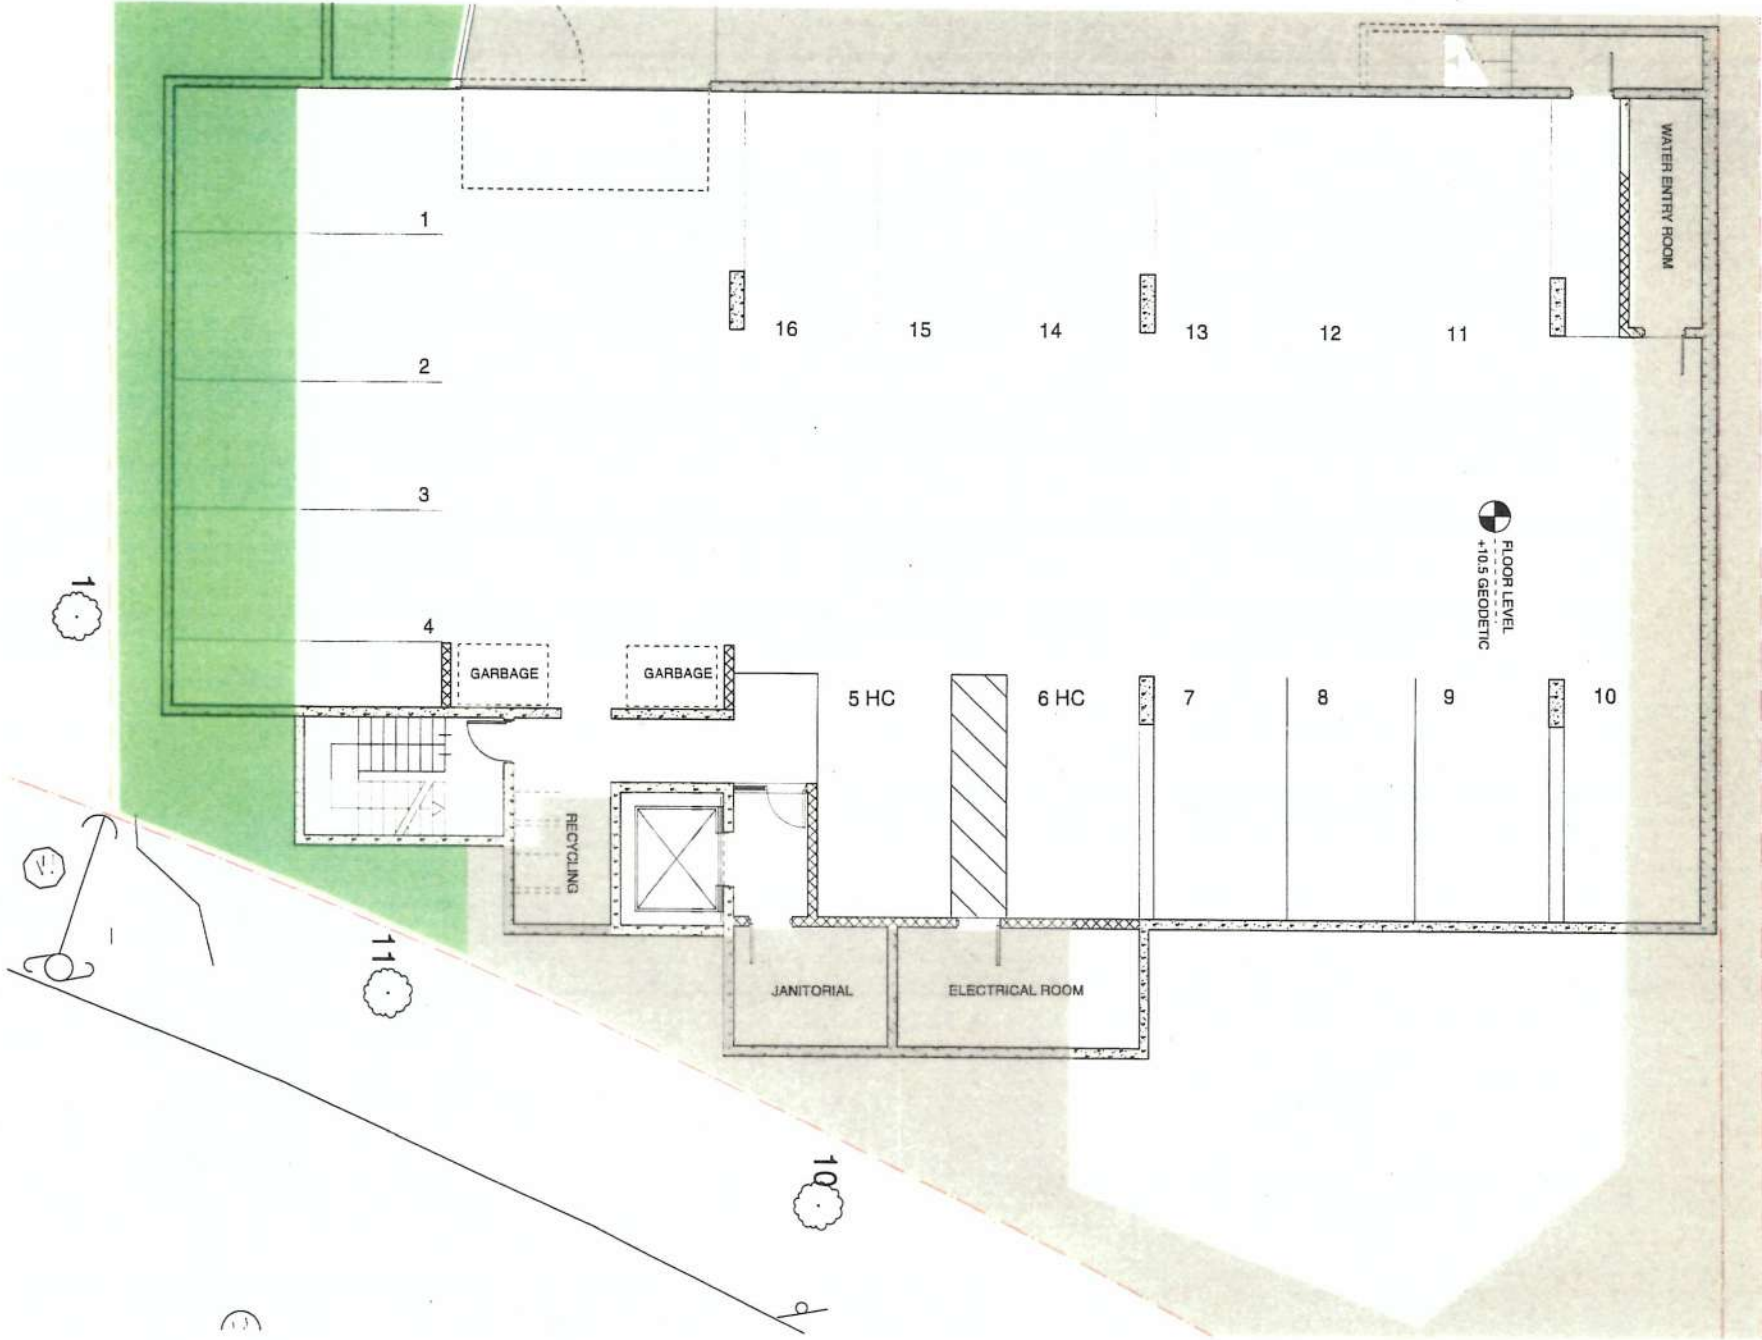
- According to the plans provided the footprint of the underground parking area encroaches within the critical root zone of the 40/55cm d.b.h. Big Leaf maple located on the neighboring property at 1311 Fairfield Road. The existing building on the subject property is located where it may be obstructing root growth toward the footprint of the proposed underground parking area. While it may be possible to retain this tree if impacts can be mitigated, this tree has outgrown its growing location, has existing structural defects, and in our opinion, it would be most prudent to offer a replacement tree, planted in a more suitable growing location, rather than attempting to this tree. If this tree is to be retained, we recommend the following course of action:

- According to the plans provided, the footprint of the proposed entrance/exit ramp to the underground parking area encroaches within the critical root zones of the 45cm d.b.h. laburnum located on the neighbouring property at 1311 Fairfield Road, and the 50cm d.b.h. Rhobinia located on the neighbouring property at 339 Moss Street. If these trees are to be retained, we recommend the following course of action:

- Excavation to remove the portion of the foundation of the existing building that encroaches within the critical root zone of this tree be removed under arborist supervision.

- Depending on the soil conditions encountered, shoring may be required to stabilize the embankment, within the critical root zone of this tree, as opposed to cutslope excavation.

- Space will likely be limited to form the walls of the underground parking area and install perimeter drains and waterproofing, and if it is found that there isn't sufficient working room, between the tree and the building foundation, this tree will likely require removal.

- The project arborist supervise excavation for the portion of the footprint of the proposed underground entrance/exit ramp that encroaches within the critical root zones of these trees. If significant structural roots are encountered during excavation that cannot be retained, we may recommend that trees be removed.

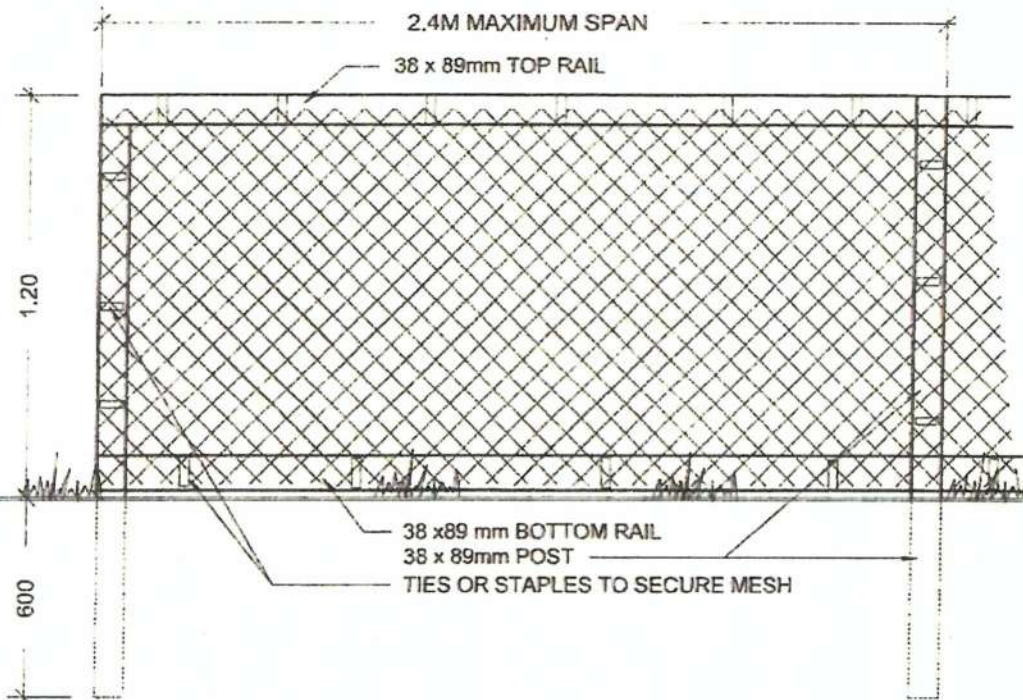
TREE PROTECTION FENCING
 FENCE WILL BE CONTRUCTED USING
 38 X 89 mm (2"X4") WOOD FRAME:
 TOP, BOTTOM AND POSTS. *
 USE ORANGE SNOW-FENCING MESH AND
 SECURE TO THE WOOD FRAME WITH
 "ZIP" TIES OR GALVANZIED STAPLES

* IN ROCKY AREAS, METAL POSTS (T-BAR
 OR REBAR) DRILLED INTO ROCK WILL BE
 ACCEPTED

Barrier fencing: The areas, surrounding the trees to be retained, should be isolated from the construction activity by erecting protective barrier fencing. Where possible, the fencing should be erected at the perimeter of the critical root zones. If the 40/55 cm d.b.h. Big Leaf maple is to be retained, we recommend that solid hording be used to protect its trunk from mechanical injury. The barrier fencing to be erected must be a minimum of 4 feet in height, of solid frame construction that is attached to wooden or metal posts. A solid board or rail must run between the posts at the top and the bottom of the fencing. This solid frame can then be covered with plywood, or flexible snow fencing (see attached diagram). The fencing must be erected prior to the start of any construction activity on site (i.e. demolition, excavation, construction), and remain in place through completion of the project. Signs should be posted around the protection zone to declare it off limits to all construction related activity. The project arborist must be consulted before this fencing is removed or moved for any purpose.
