Arborist Impact Assessment **and Root Mapping**  
Re: Proposed Rezoning, Development, and Construction  
at 3106 Washington Ave., Victoria, BC

Author: Ryan Senechal MUFL, ISA TRAQ/ON-1272AT, BC WDTA  
May 9<sup>th</sup>, 2024

**Revised: January 29<sup>th</sup>, 2025**

For Danielle and Todd Buchanan  
3106 Washington Ave. Victoria BC V9A 1P6  
Re. Arborist Impact Assessment at 3106 Washington Ave.

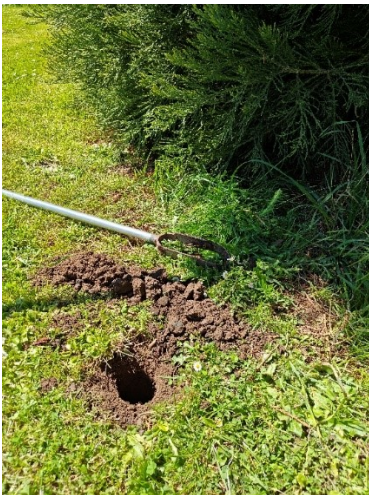
A soil auger was used to draw a 45 cm depth sample to determine relative texture and moisture **during my site visit on May 3<sup>rd</sup>, 2024**. I was able to easily reach 45 cm depth by taking two plugs with a Dutch auger, and the combined plugs were a sandy loam texture (*Figure 1-2*). Moisture through the sample was even. Rainfall for the month of April **2024** amounted to 29.2 mm<sup>1</sup> which is well below the 2000-2024 average of 77mm<sup>2</sup>.

Figure 1. Soil auger sample location (150° heading at dripline)

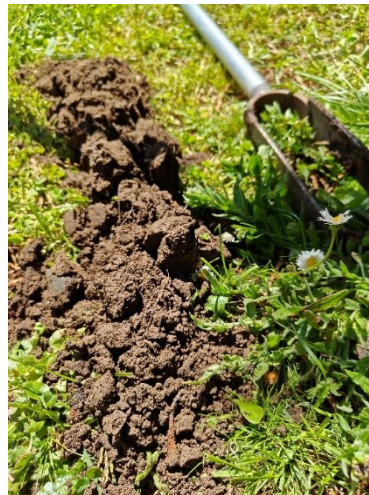
Figure 2. Soil texture and moisture sample

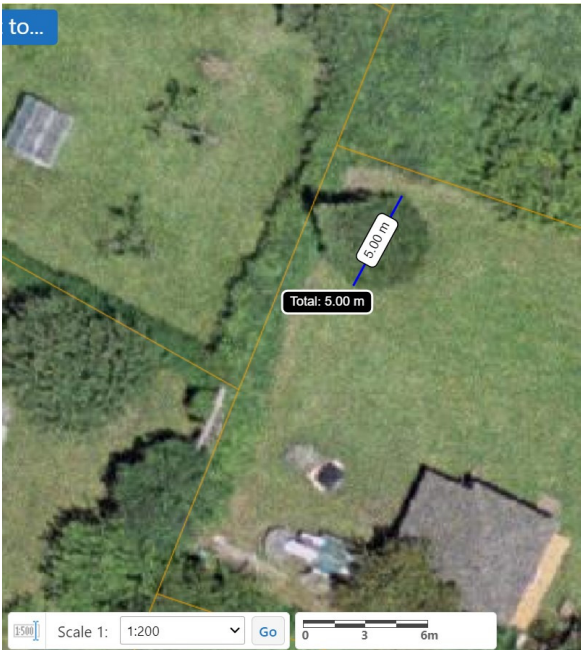
Comparative analysis of Victoria Maps orthographic images from 2005 and 2023 suggests the age class of tree #201 is semi-mature, or a tree that has lived less than 40% of its expected lifespan). Using GIS

Figure 3. 2005 Ortho Imagery (Victoria Maps)

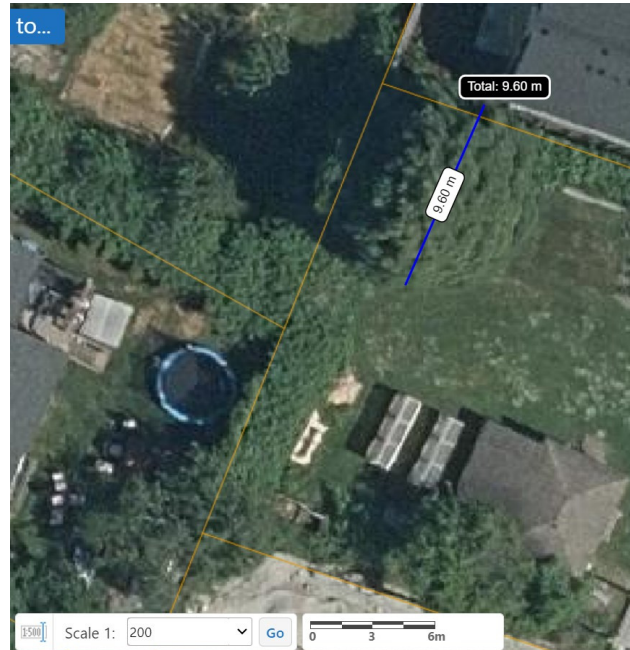
Figure 4. 2023 Ortho Imagery (Victoria Maps)

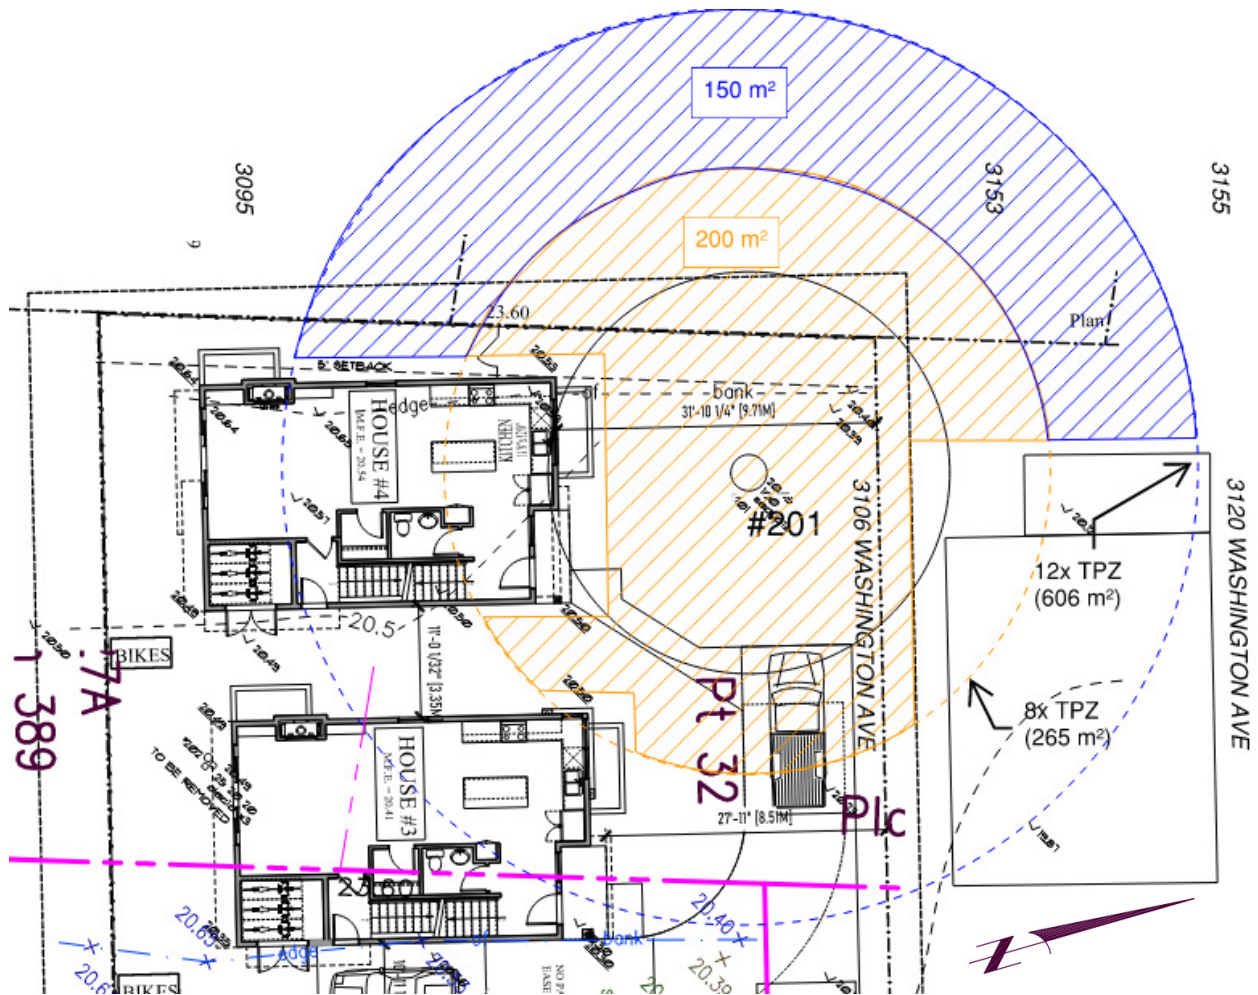
Figure 9. Specified Tree Protection Zone (hatched areas), tree #201

Relative to House #4 and driveway designs provided to us, the subject Sequoia's species profile, the species tolerance to construction and pruning, the present growing conditions, and current tree vitality have all been evaluated. A 12x multiplication TPZ factor applied as a full circle covers an area of 606 m<sup>2</sup>. Using the STPZ approach (Figure 9) with the existing Tree Management Plan will preserve 350 m<sup>2</sup> or 57%

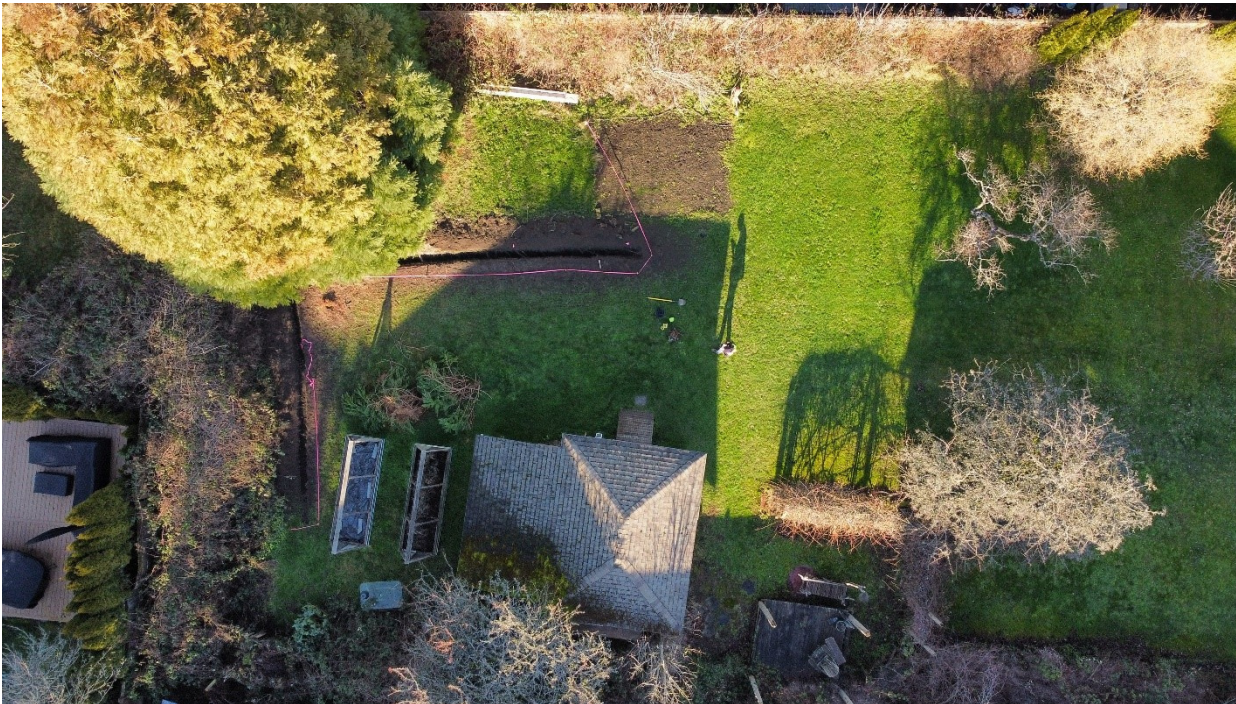
Exploratory excavation (i.e., root mapping) was conducted on January 24<sup>th</sup>, 2025, using pneumatic soil excavation to locate roots and determine the root location, size, and quantity. Layout of the survey area was primarily focused on the edge of a proposed excavation cut north side of proposed houses #3 and 4, running from east to west, 8 m from the north property line. Low branch pruning was conducted to enable the technician to access the trench layout within the dripline of the tree. The locations of the two exploratory trenches are referenced in *Figure 10* and *Figure 13*.

Figure 10. Aerial photo of exploratory excavation (obtained January 29, 2025).

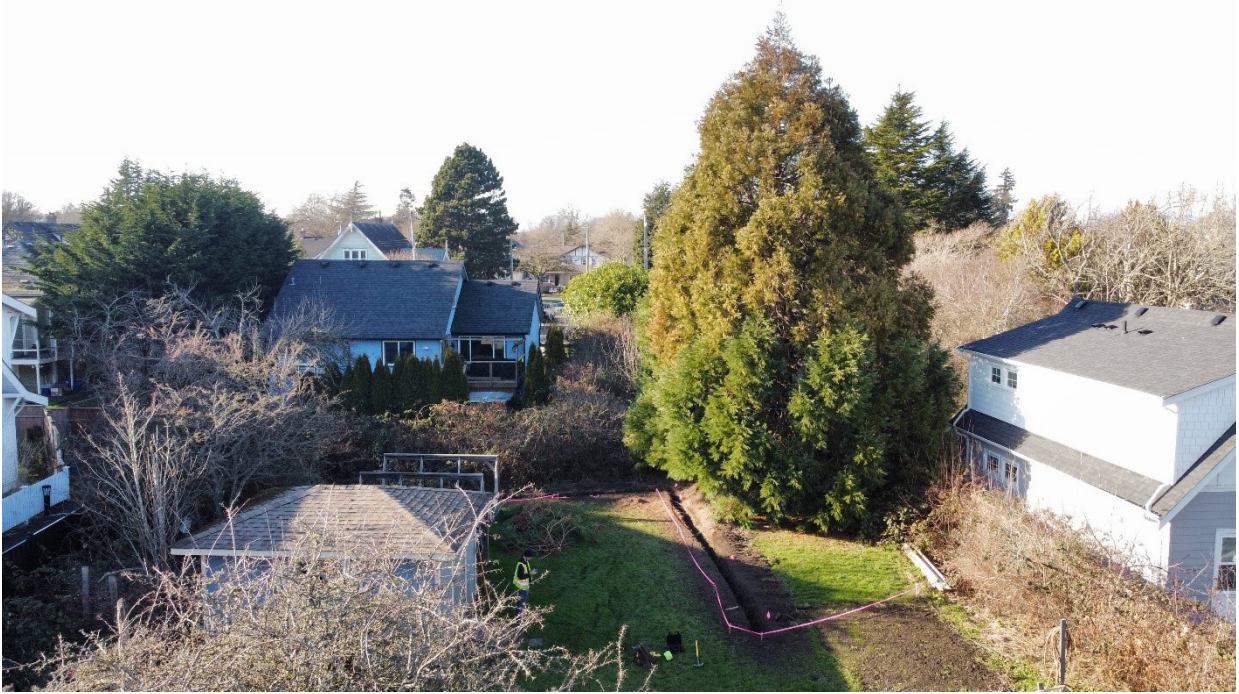
Figure 11. Aerial photo of exploratory excavation (obtained January 29, 2025) facing west.

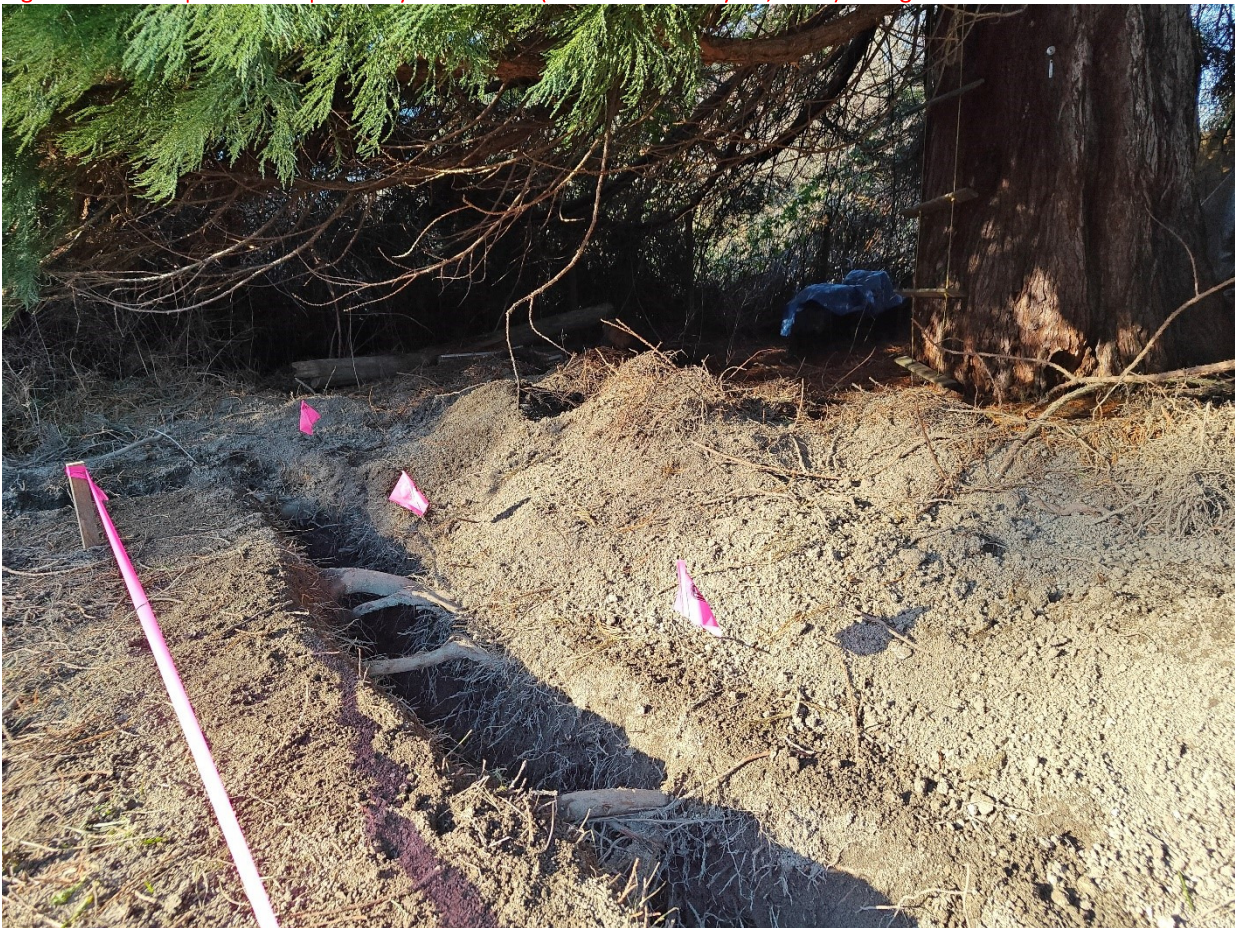
All roots larger than 2.5 cm  $\varnothing$  exposed were geolocated (*Figure 13*) and inventoried in *Table 3*. The maximum depth of exploratory excavation was 60 cm as the bulk of fibrous and structural roots were observed in the upper 45 cm of the soil profile. Small fibrous roots were quite dense within the tree's dripline, and relatively few larger roots (>2.5 cm  $\varnothing$ ) were encountered across the 12 m trench span running from east to west. A second trench was exposed running 9 m in length from north to south, and only fibrous roots were observed.

Figure 12. View of west side of exploratory trench and root locations 9, 8, and 7 (from left to right).

Based on the limited abundance and relatively small size of roots exposed, root pruning to accommodate proposed House #4 (as designed) is anticipated to have minimal effect on tree health and tree stability. A total of 3 roots exposed were larger than 5 cm ø at the point where pruning would be required. The largest of those roots exposed was 10 cm ø. Site soil depth and volume appears to be ideal for the Sequoia to respond to this minimal amount of root pruning.

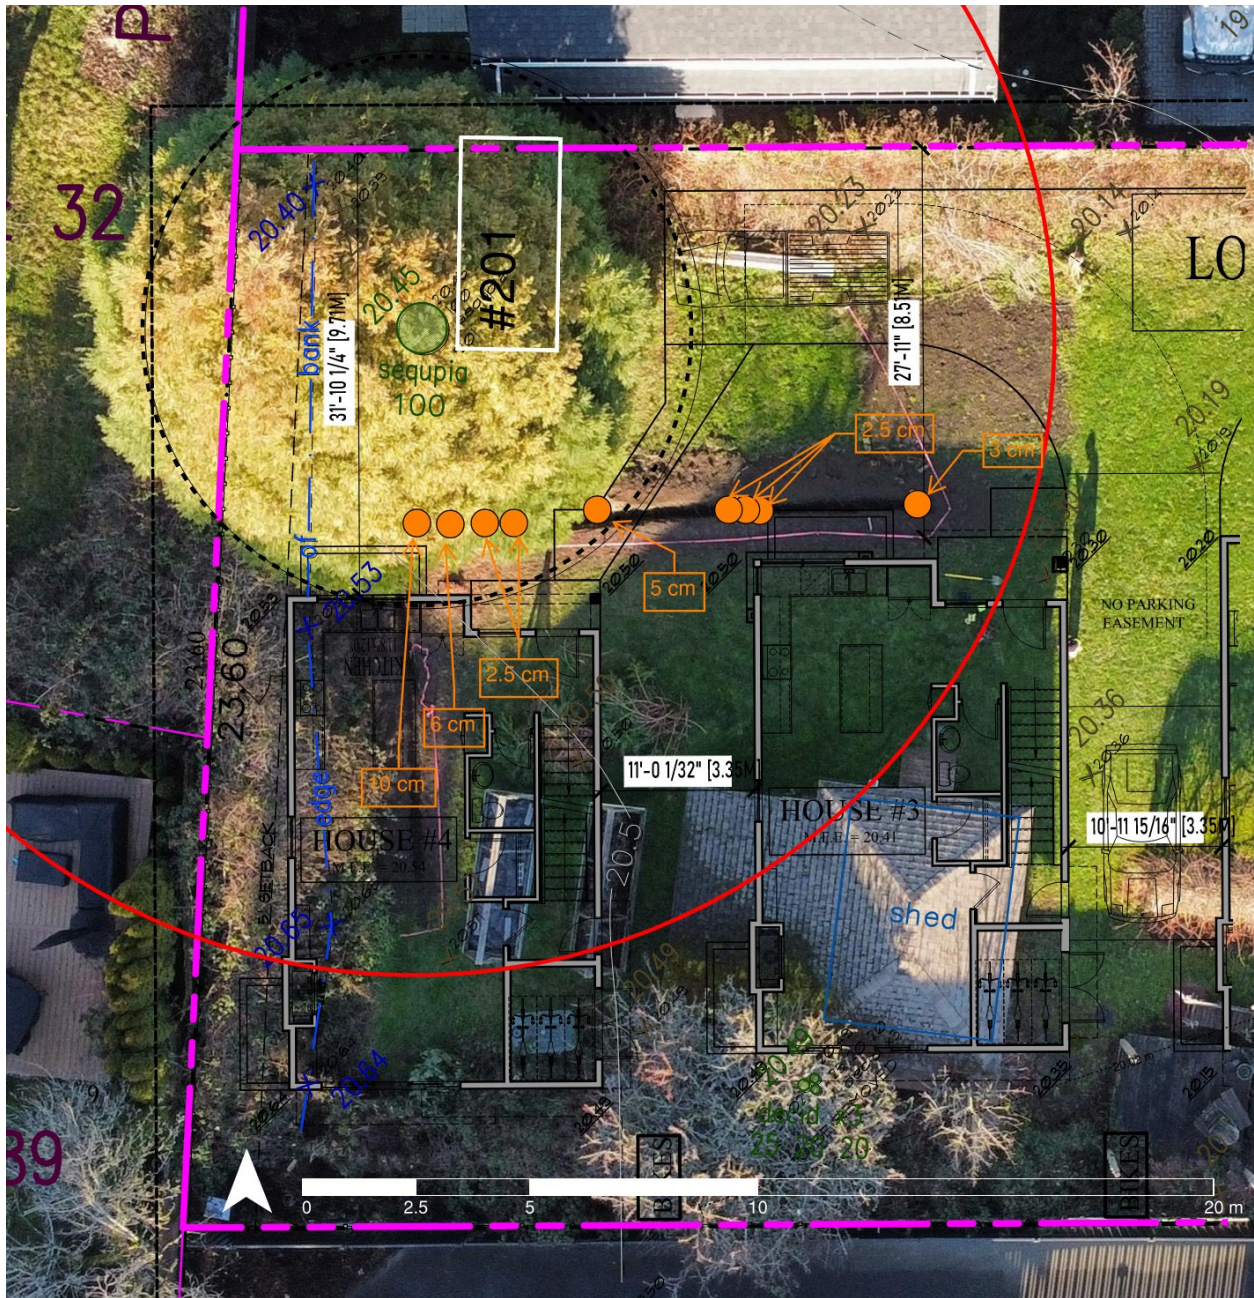
Figure 13. Aerial photo of exploratory excavation (obtained January 29, 2025), root locations, and root size.

Root #	Root heading from trunk (°)	Root ø (cm)	Distance of root to trunk (m)	Approximate CTPZ factor
1	110	3	10.6	9
2	120	2.5	7.5	6.5
3	120	2.5	7.3	6.5
4	120	2.5	7	6
5	135	5	4.6	4
6	160	2.5	3.8	3.5
7	160	2.5	3.6	3
8	180	6	3.4	3
9	180	10	3.4	3
