**Arborist Report for Development Purposes**  
**Re: Proposed Redevelopment, and Construction**

**Site Location: 2501 Blanshard St.**  
**Ryan Senechal ON-1272AT, TRAQ, BC WDTA 3013P**  
**June 24th, 2024**

For D’AMBROSIO architecture + urbanism  
 2960 Jutland Road, Victoria, BC V8T 5K2  
 Attn. Julie Brown  
 Re: Proposed Rezoning and redevelopment at 2501 Blanshard St.

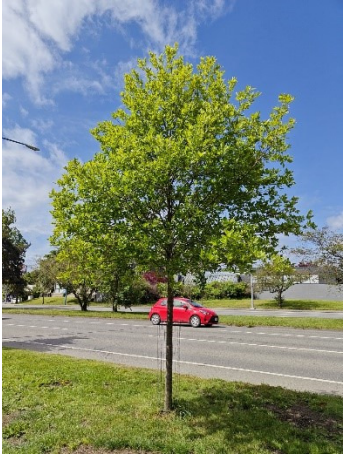
M9	<i>Prunus cerasifera</i>	73	9	11	9	Fair	Fair	Yes	TBD	Minor deadwood (<5 cm in diameter).	
M10	<i>Nyssa sylvatica</i>	9	5	2	1	Good	Good	TBD	TBD	Sun injury on west side of trunk.	
M11	<i>Prunus cerasifera</i>	26	6	4	3	Fair	Fair	Yes	TBD	/	
M12	<i>Prunus subhirtella</i>	56	8	9	7	Poor	Fair	Yes	TBD	Crown health is in decline, substantial water sprouts on the lower trunk.	
M13	<i>Prunus cerasifera</i>	19	5	3	2	Poor	Poor	Yes	TBD	Crown health is in severe decline. Mechanical injury at base of trunk.	
M14	<i>Nyssa sylvatica</i>	7	4	1	1	Good	Good	TBD	TBD	/	
M15	<i>Prunus cerasifera</i>	52	9	12	6	Fair	Good	Yes	TBD	/	
M16	<i>Prunus subhirtella</i>	67	8	7	8	Poor	Poor	Yes	TBD	Canopy die back. Deadwood up to 12 cm in diameter at attachment. Mechanical damage to exposed roots on the northeast side.	
M17	<i>Prunus cerasifera</i>	41	10	13	5	Fair	Good	Yes	TBD	Minor deadwood. Mechanical wounding on trunk. Minor bark sloughing on the northeast side.

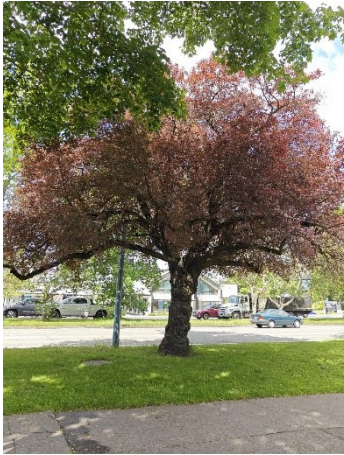
M18	<i>Prunus subhirtella</i>	36	8	12	4	Fair	Fair	Yes	TBD	/	
M19	<i>Prunus cerasifera</i>	72	10	11	9	Fair	Good	Yes	TBD	Ganoderma is present in three locations of the trunk. South side at 15 cm height, the northwest side at 1 m height, and on the north side at 0.5 m height.	
M20	<i>Prunus subhirtella</i>	24	6	5	3	Fair	Fair	Yes	TBD	Minor deadwood. Foliage density is poor.	
M21	<i>Prunus cerasifera</i>	44	9	9	5	Fair	Good	Yes	TBD	/	
M22	<i>Nyssa sylvatica</i>	7	3	1	1	Good	Good	TBD	TBD	/	
M23	<i>Prunus cerasifera</i>	42	7	11	5	Fair	Good	Yes	TBD	/	
M24	<i>Nyssa sylvatica</i>	3	2	1	1	Poor	Fair	TBD	TBD	Previous broken top (tear out). Foliage density is poor.	
M25	<i>Prunus cerasifera</i>	65	6	9	8	Fair	Fair	Yes	TBD	Minor deadwood on the southwest and northeast sides of the canopy. Ganoderma is present on the southeast side at the base of the trunk.

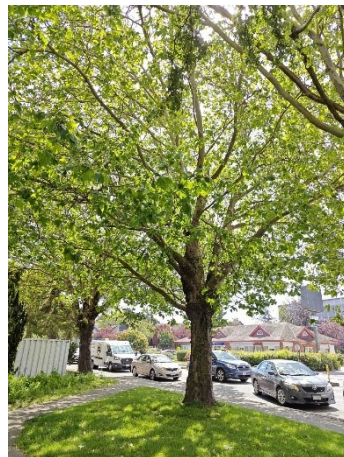
#	Species	DBH (cm)	Height (m)	Width (m)	PRZ (m)	Structural Condition	Health Condition	Bylaw protected	Action	Condition Notes
M26	<i>Platanus x acerifolia</i>	53	20	22	6	Fair	Good	Yes	TBD	Deadwood above the sidewalk closest to buildings (<5 cm diameter).
M27	<i>Platanus x acerifolia</i>	63	20	22	8	Fair	Good	Yes	TBD	/
M28	<i>Platanus x acerifolia</i>	61	19	22	7	Fair	Good	Yes	TBD	Minor deadwood (<5 cm diameter).
M29	<i>Larix decidua 'Pendula'</i>	45	14	9	5	Fair	Fair	Yes	TBD	Shaded out on the west side by neighboring London plane.
M30	<i>Acer pseudoplatanus</i>	87	14	11	10	Poor	Fair	Yes	TBD	Multi stem measured at 28 cm, 27 cm, and 32 cm diameter.
M31	<i>Platanus x acerifolia</i>	79	16	20	9	Fair	Good	Yes	TBD	Root heaving asphalt sidewalk by ~10 cm.
M32	<i>Platanus x acerifolia</i>	67	14	20	8	Fair	Good	Yes	TBD	Minor deadwood (<5 cm diameter).
90	<i>Thuja plicata 'zebrina'</i>	58	14	9	7	Fair	Good	Yes	TBD	Quad stem above DBH, raised significantly to approximately 6 meters.

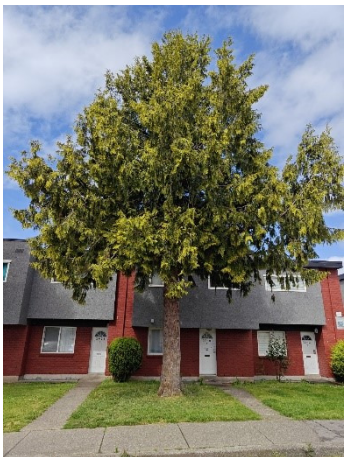
91	<i>Thuja plicata 'zebrina'</i>	55	14	14	7	Fair		Yes	TBD	No tag. Raised significantly for building and road clearances. Stub cuts and flush cuts are present.
98	<i>Thuja plicata</i>	37	14	12	4	Good	Fair	Yes	TBD	Crown density fair. Debris and soil piled up around the base of trunk.
100	<i>Gleditsia triacanthos</i>	65	30	24	8	Fair	Fair	Yes	TBD	Excessive thinning and lions tailing pruning. Epicormic growth on the trunk. A recent limb failure occurred on the northeast side (~15 cm diameter at failure point).
101	<i>Gleditsia triacanthos</i>	65	20	18	8	Fair	Fair	Yes	TBD	Exposed root flare with mechanical damage. Trunk lean of ~10°. Deadwood (<5 cm diameter). Over extended branches, and past canopy thinning observed.
103	<i>Thuja occidentalis</i>	24	3	2	3	Fair	Fair	TBD	Remove	Maintained as shrub, multi stem w included bark (14 cm, 10 cm diameter)
104	<i>Juniperus virginiana</i>	23	8	9	3	Fair	Fair	TBD	Remove	Crown dieback (minor) on Blanshard side. Located at proposed building entry.

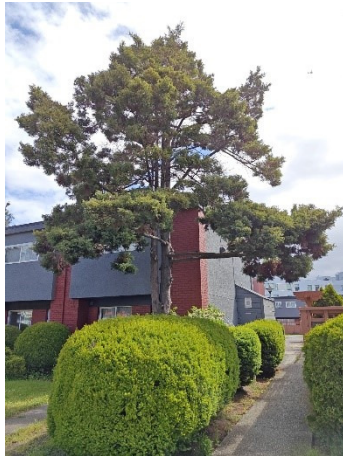
105	<i>Juniperus virginiana</i>	37	13	9	4	Fair	Fair	Yes	TBD	Canopy thinned and raised. Lions tailing pruning visible.
106	<i>Liquidambar styraciflua</i>	46	20	16	6	Fair	Good	Yes	Remove	Codominant stems at ~4 m height. Included bark on multiple stems. Dense canopy (visibility limited). Located at proposed building entry. Located at proposed parkade footprint.
107	<i>Thuja plicata</i>	67	17	9	8	Poor	Fair	Yes	Remove	Large stem previously removed at 1 m resulting in a 35 cm height wound. Mechanical damage present on trunk. Located at proposed pathway.
108	<i>Thuja plicata</i>	59	16	7	7	Fair	Fair	Yes	Remove	Multiple codominants at 2 m height with included bark. Clearance pruning from building. Asymmetrical canopy. Mechanical injury on trunk. Located at proposed pathway.
109	<i>Sorbus intermedia</i>	30	4	1	4	Poor	Poor	Yes	TBD	No live foliage remaining in canopy. Basal water sprouts are only remaining live growth. Pollarded in past.

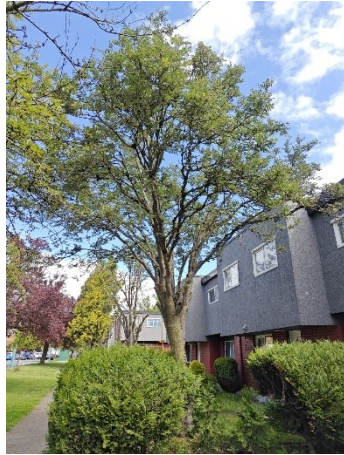
110	<i>Sorbus intermedia</i>	33	9	5	4	Poor	Poor	Yes	Remove	Crown density is poor. Deadwood (<5 cm diameter). Pruning stubs present in canopy. Located at proposed building entry.
111	<i>Sorbus intermedia</i>	35	10	8	4	Fair	Poor	Yes	TBD	Health in decline, crown density sparse. Deadwood up to 3 cm.
112	<i>Sorbus intermedia</i>	34	10	7	4	Fair	Poor	Yes	TBD	Mechanical wound at 30 cm height approximately 20 x 10 cm located on the northwest side. Health is in decline, and foliage density declining. Deadwood up to 5 cm.

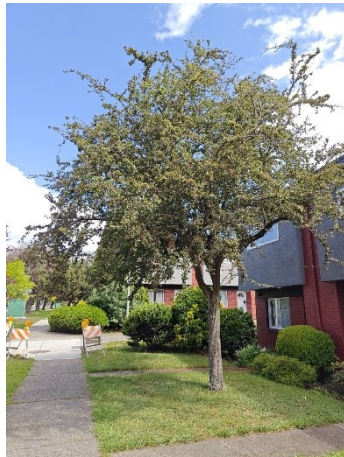
#	Species	DBH (cm)	Height (m)	Width (m)	PRZ (m)	Structural Condition	Health Condition	Bylaw protected	Action	Condition Notes
113	<i>Thuja occidentalis</i>	46	10	2	6	Fair	Good	Yes	TBD	Multi stem measured at 17, 15 and 14 cm. Columnar form.
115	<i>Crataegus laevigata</i>	28	7	4	3	Fair	Good	TBD	TBD	Excessive end weight and density on primary branches.
116	<i>Crataegus laevigata</i>	26	6	8	3	Fair	Good	TBD	TBD	Multiple codominants with included bark. Excessive end weight on primary branches.
117	<i>Crataegus laevigata</i>	26	8	8	3	Poor	Fair	TBD	Remove	Large basal cavity, poor wound response observed. Located at proposed building entry.
118	<i>Fraxinus pennsylvanica</i>	55	18	18	7	Fair	Good	Yes	TBD	Previously topped, raised and thinned. Exposed root system and mechanical injury visible.
119	<i>Fraxinus pennsylvanica</i>	58	17	11	7	Fair	Good	Yes	TBD	Previously topped, raised and thinned. Exposed root system and mechanical injury visible.

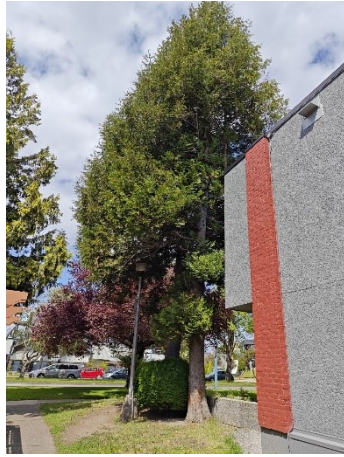
131	<i>Thuja plicata</i> 'Zebrina'	53	16	9	6	Fair	Good	Yes	TBD	Exposed root flare with mechanical injury.
132	<i>Thuja plicata</i>	40	16	13	5	Fair	Good	Yes	Remove	Sharing canopy space with ID133. Located within proposed building footprint.
133	<i>Thuja plicata</i>	47	16	13	6	Fair	Good	Yes	Remove	Located within proposed building footprint.
134	<i>Thuja plicata</i> 'Zebrina'	50	16	13	6	Fair	Good	Yes	TBD	/
135	<i>Crataegus laevigata</i>	34	3	1	4	Poor	Fair	Yes	Remove	Previously topped. Located within proposed building footprint.
136	<i>Crataegus laevigata</i>	23	3	1	3	Poor	Fair	TBD	Remove	Previously topped. Located within proposed parkade footprint.
137	<i>Crataegus laevigata</i>	25	3	2	3	Poor	Fair	TBD	Remove	Previously topped. Located within proposed parkade footprint.
138	<i>Acer rubrum</i>	34	11	12	4	Fair	Fair	Yes	Remove	Located within proposed building footprint.
139	<i>Thuja plicata</i>	47	14	8	6	Poor	Good	Yes	TBD	Previously topped at 7 m height. Over extended branches.

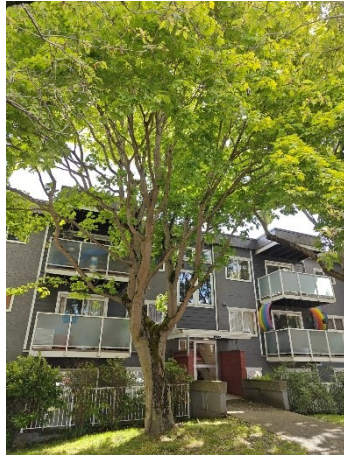
140	<i>Acer platanoides</i>	51	18	20	6	Fair	Good	Yes	TBD	Exposed root flare with mechanical injuries.
141	<i>Acer platanoides</i>	56	18	19	7	Fair	Good	Yes	TBD	Thinned and raised with lions tailed branches. Mechanical damage approximately 10 cm height located on the west side of the trunk.
142	<i>Acer rubrum</i>	78	18	20	9	Fair	Good	Yes	TBD	Thinned, raised, and lions tailed branches.
143	<i>Acer platanoides</i>	75	16	16	9	Fair	Good	Yes	TBD	/
144	<i>Acer platanoides</i>	54	15	13	6	Fair	Good	Yes	TBD	Canopy raised and thinned. Dead stem ~8 cm diameter.

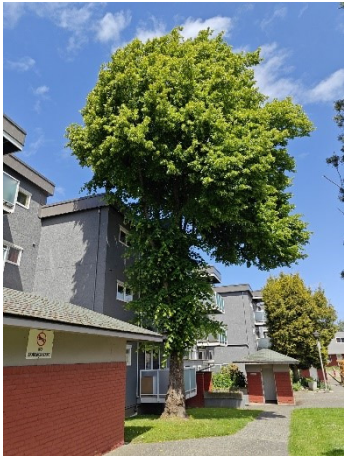
153	<i>Tillia cordata</i>	50	18	9	6	Fair	Fair	Yes	Remove	Water sprouts at the base. Crown excessively raised for building clearance. Previously topped. Included bark at codominant stems at 5 m height. Located within proposed building footprint.
154	<i>Thuja plicata</i>	52	10	7	6	Fair	Good	Yes	Remove	Codominant stems at 1.5 m height with included bark. Driveway conflict.
155	<i>Carpinus betulus</i> 'Fastigiata'	57	16	17	7	Fair	Fair	Yes	TBD	Girdling roots observed. Within 20 cm of an adjacent raised concrete, and planter heaving has occurred on 2 sides. Abundant epicormic growth.
156	<i>Carpinus betulus</i> 'Fastigiata'	39	16	17	5	Fair	Good	Yes	TBD	Girdling roots at the base. Included seam at ~2.5 m in height. Canopy thinned and raised.
157	<i>Carpinus betulus</i> 'Fastigiata'	48	16	17	6	Fair	Good	Yes	TBD	Girdling roots, included seam at 2.5 m height.
158	<i>Carpinus betulus</i> 'Fastigiata'	32	16	18	4	Fair	Good	Yes	TBD	Buried root collar.

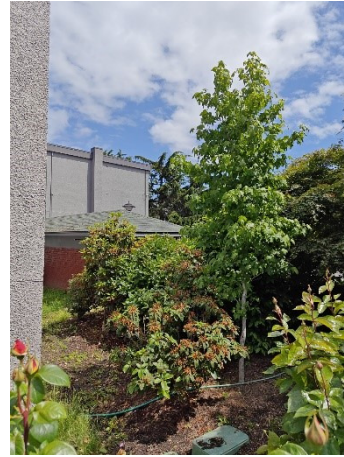
159	<i>Carpinus betulus</i> 'Fastigiata'	59	16	18	7	Fair	Good	Yes	TBD	Exposed roots and girdling roots at base.
160	<i>Thuja plicata</i>	22	2	2	3	Fair	Fair	TBD	Remove	Maintained formally (topiary). Located within proposed building footprint.
161	<i>Liquidambar styraciflua</i>	4	4	1.5	1	Good	Good	TBD	Remove	Located within proposed building footprint.
171	<i>Thuja plicata</i>	61	13	9	7	Fair	Fair	TBD	Remove	Multi stem at base measured at 19 cm, 20 cm, and 22 cm diameter. Included bark. Located within proposed bus stop location.
179	<i>Cornus</i> 'Eddies White Wonder'	14	3	3	2	Good	Fair	TBD	Remove	Multi stem. Dieback in upper crown (<10 cm diameter).
181	<i>Cornus</i> 'Eddies White Wonder'	7	3	2	1	Fair	Fair	TBD	Remove	Maintained as a shrub. Multi stem 3 cm, 2 cm, and 2cm diameter.
183	<i>Thuja plicata</i>	62	5	4	7	Poor	Good	Yes	Remove	Multi stem measured at 23 cm, 24 cm, and 15 cm diameter.
184	<i>Thuja plicata</i>	68	5	4	8	Poor	Good	Yes	Remove	Multi stem measured at 26 cm, 28 cm, and 24 cm diameter.

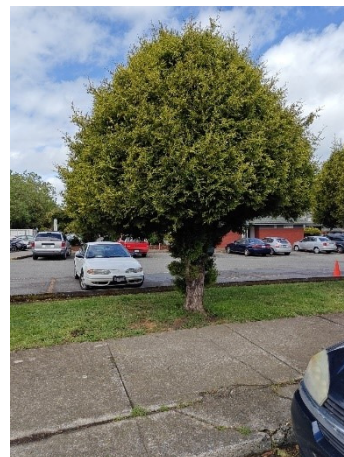
185	<i>Thuja plicata</i>	56	5	4	7	Poor	Good	Yes	Remove	Multi stem measured at 17 and 39 cm diameter.

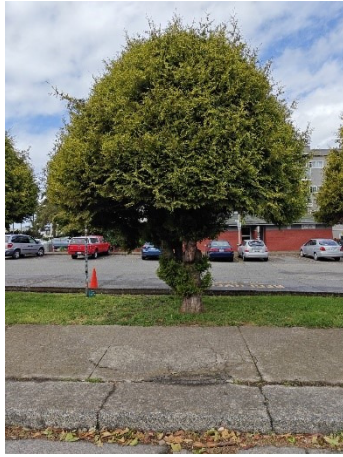
#	Species	DBH (cm)	Height (m)	Width (m)	PRZ (m)	Structural Condition	Health Condition	Bylaw protected	Action	Condition Notes
186	<i>Thuja plicata</i>	44	5	4	5	Poor	Good	Yes	Remove	Multi stem measured at 29 and 15 cm diameter.
187	<i>Thuja plicata</i>	61	5	4	7	Poor	Good	Yes	Remove	Multi stem measured at 23 cm, 20 cm, and 18 cm diameter. Mechanical damage to stem at 1 m height (east side).
188	<i>Thuja plicata</i>	53	5	4	6	Poor	Good	Yes	Remove	Multi-stem measured at 19 cm, 19 cm, and 15 cm diameter. Topped and hedged. Canopy raised over the sidewalk.
189	<i>Cedrus deodara</i>	78	16	15	9	Poor	Fair	Yes	TBD	Topped, canopy raised, and pruned for clearance from building. Pruning flush and stub cuts remain. Deadwood in canopy (<5 cm diameter).
190	<i>Cedrus deodara</i>	84	18	16	10	Fair	Fair	Yes	TBD	Topped in the past. Deadwood in canopy (<5 cm diameter).
191	<i>Cupressus spp.</i>	22	4	3	3	Fair	Fair	TBD	TBD	Maintained as shrub. Multi stem 8 cm, 8 cm, and 6 cm diameter.

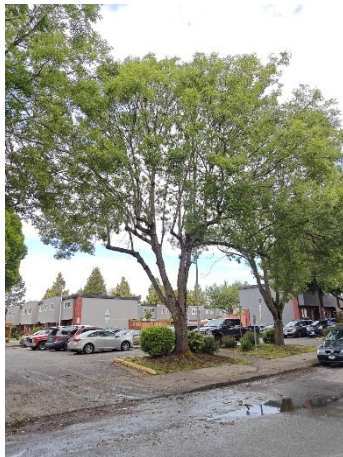
192	<i>Fraxinus pennsylvanica</i>	63	16	18	8	Fair	Fair	Yes	TBD	Thinned, canopy raised, and topped in the past. Deadwood in canopy (<5 cm diameter).
193	<i>Fraxinus pennsylvanica</i>	68	16	18	8	Fair	Fair	Yes	TBD	Thinned, canopy raised, and topped in the past. Deadwood in canopy (<5 cm diameter). Exposed root flare on the northeast sidewalk side with mechanical injuries.
194	<i>Fraxinus pennsylvanica</i>	53	17	10	6	Fair	Fair	Yes	Remove	Buried root collar. Deadwood in canopy (<5 cm diameter). Infrastructure conflict.
195	<i>Fraxinus pennsylvanica</i>	60	16	16	7	Fair	Good	Yes	TBD	Girdling roots. Codominant stems at ~3 m height with included bark. Deadwood in canopy (<5 cm diameter).
196	<i>Cedrus deodara</i>	100	18	13	12	Poor	Good	Yes	TBD	Topped in the past. Flush cuts visible. Codominant stems with included bark at ~4 m height. Two branches with sheer plane cracks on northwest side over residence walkway (Unit 2520). One is ~13 cm in diameter and is resting on top of the other cracked branch that is ~20 cm in diameter.

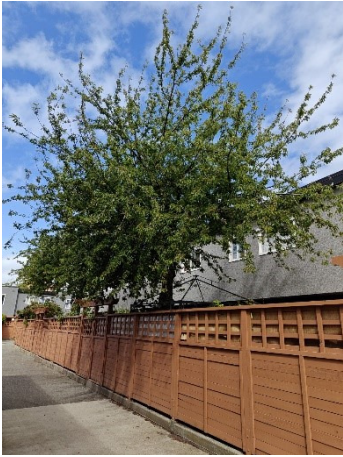
197	<i>Thuja plicata</i> 'Zebrina'	49	14	10	6	Fair	Fair	Yes	TBD	Canopy raised to 5 m height. Pruning stubs and flush cuts remain. Exposed roots with mechanical injuries.
198	<i>Prunus avium</i>	40	10	9	5	Fair	Good	Yes	Remove	Previously topped, and canopy raised/thinned. Estimated DBH: access to private yard not authorized. Located within proposed building footprint.
199	<i>Prunus avium</i>	40	10	9	5	Fair	Good	Yes	Remove	Estimated DBH: access to private yard not authorized. Located within proposed building footprint.
200	<i>Acer rubrum</i>	36	10	11	4	Fair	Fair	Yes	Remove	Previously raised and thinned. Flush cuts, and stub cuts. Presence of girdling roots with mechanical injury. Located within proposed building footprint.
201	<i>Cercidiphyllum japonicum</i>	37	11	9	4	Fair	Good	Yes	Remove	Multiple codominant stems at 2.5 m height with included bark. Located within proposed building footprint.
202	<i>Acer rubrum</i>	39	12	8	5	Fair	Fair	Yes	Remove	Mechanical injury at base. Included bark at ~5 m height. Located within proposed parkade footprint.
