Arborist Report

1249 Finlayson Street, Victoria

Date of Report: July 2, 2017
Date of Field Work: June 9, 2017

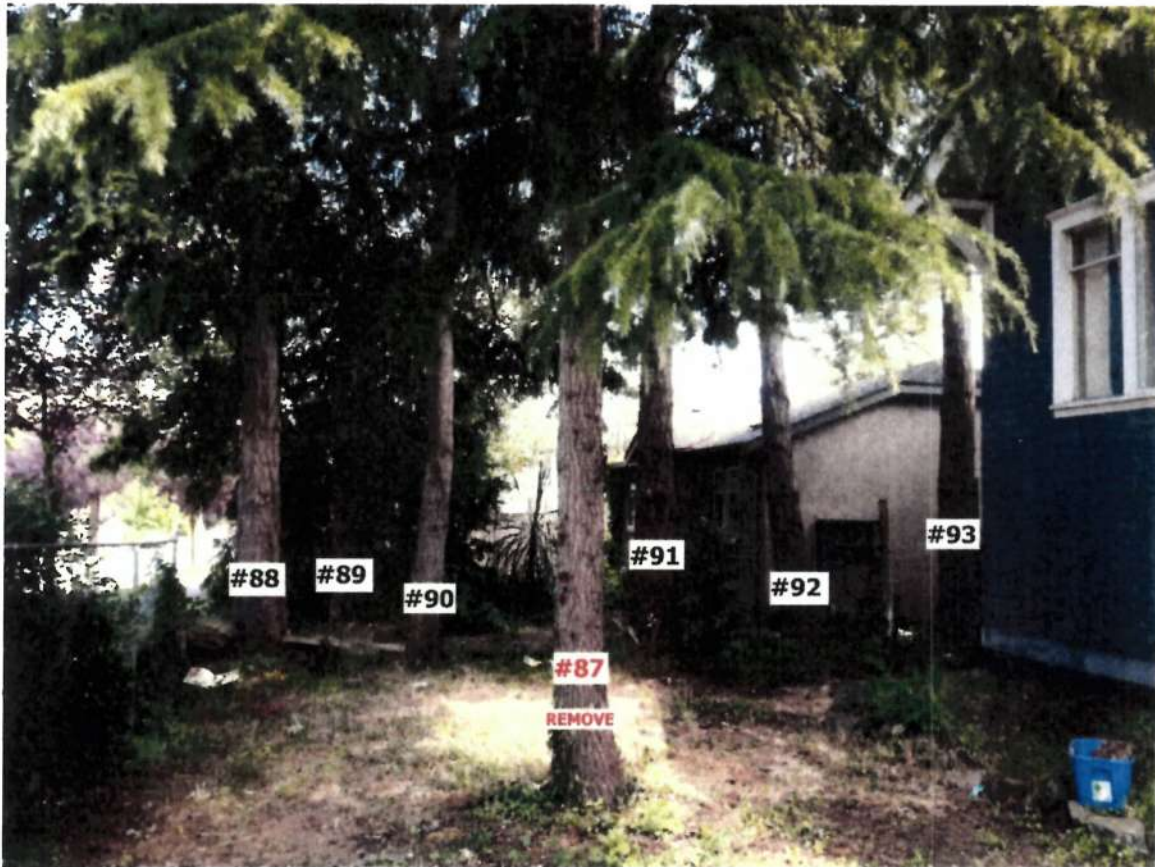
Two trees located in the front yard--Garry Oak #86 and Deodar Cedar #87--will be significantly impacted by the new house site, driveway and underground services and are therefore proposed for removal. Due to a combination of poor condition and a siting conflict with the new underground service lines for proposed Lot "B", the green ash and the cherry trees are also proposed for removal.

Fig-2 Front yard. Tree #87 proposed for removal

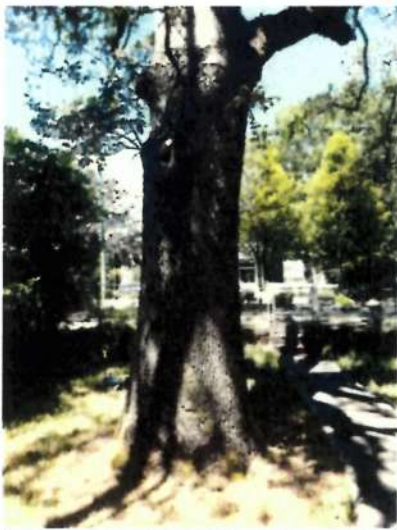
The main structural roots of the tree appear well-distributed around the base of the tree. There is no visual evidence of decay or injury around the root crown. The Protected Root Zone radius is calculated to be 13m,

extending into approximately 50% of the site. Approximately 50% of the PRZ is covered by impervious surfaces (the house, parking area and portions of Highview and Finlayson streets that encroach into the PRZ). Given the well-draining soils in which the tree is growing, however, it is likely that both the non-woody absorption roots and the woody conductive roots are vertically distributed deep within the soil column and therefore less affected by the parking area and streets. The near corner of the house has a foundation wall that is approximately 60cm deep, making it possible, given the site's soil texture, that some roots from the oak may have migrated under the house and are accessing soil moisture from the deeper soils beneath.

The root crown and stem of the tree appear structurally robust, despite the presence of a limited internal column of decay. The condition of the crown of the tree is typical of a tree of this age and species and is readily managed with periodic pruning and tree care. The health of the tree is a concern due to the impact of successive years of defoliation by caterpillars.

Potential factors accounting for this reduction in relative vigour include less productive growing conditions, observed biological stressors (defoliating caterpillars) and the age of the tree.

The risk potential of the subject oak to adjacent targets is rated as low.

The species, age, size, conformation, structure and health potential of the subject tree make it worthy of consideration for preservation, if possible. **The size and location of the subject tree, however, present a significant constraint to increasing the development footprint on this site, as the attached site plan makes clear. Further constraints are presented by the row of mature Douglas Fir trees along the east property boundary.**

Fig-1 Image of the subject Garry ok trunk (view from the South)

If Oak #86 is retained, we recommend that the following measures to improve the health and sustainability of the tree:

- apply a non-chemical insecticide, such as *Bacillus thurengiensis* 'kurstaki' (BTK), to the canopy of the tree during years of heavy caterpillar infestation;
- mulch the root zone beneath the canopy of the tree with oak leaf or tree chip mulch;
- irrigate the tree during the dry summer months;
- inoculating the root system of the tree with spores of several of the beneficial mycorrhizal fungi species found in native Garry Oak woodlands of the Pacific Northwest will aid in restoring and supporting the future health of the tree.²

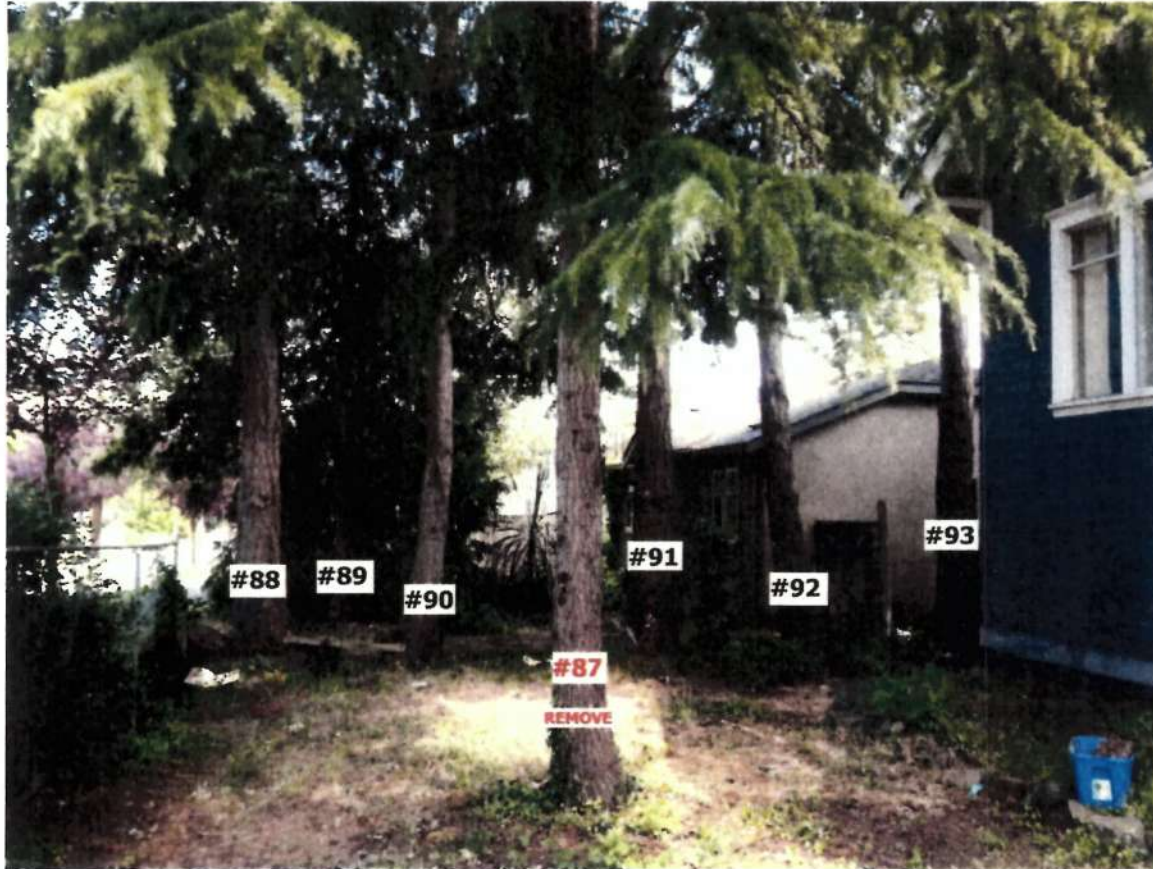
Two trees located in the front yard—Garry Oak #86 and Deodar Cedar #87—will be significantly impacted by the new house site, driveway and underground services. Given the proposed site plan, both trees are recommended for removal. Due to a combination of poor condition and a siting conflict with the new underground service lines for proposed Lot “B”, the green ash and the cherry trees are also proposed for removal.

Fig-2 Front yard. Tree #87 proposed for removal
