1314, 1316-1318 Wharf Street HAPI

June 12, 2018

TABLE OF CONTENTS

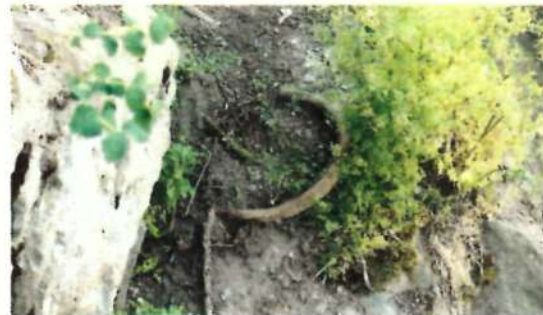
Mooring Ring

One existing early mooring ring has been identified, attached to exposed rock, and adjacent to the waterfront at the west side of the site; the date of the installation of the ring is unknown. It will not be affected by the current proposal, and will be retained in situ. It is unknown if there are any other similar historic features adjacent to the waterfront, as much of the escarpment is overgrown and inaccessible, but the waterfront area will be examined when possible.

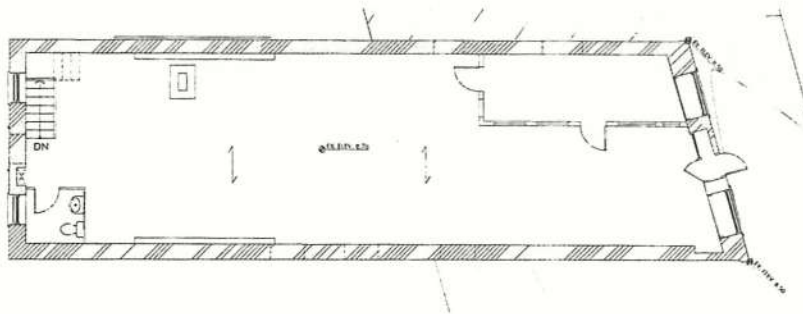
Existing Main Floor Plan

- Waterfront facing window designs will match the existing tall, narrow six paned windows unless noted otherwise. Original timber windows are in poor condition; the windows will be replicated / re-created to match existing. Security steel bars to be carefully removed, avoiding potential damage to existing openings.

- Restore west wall masonry, stonework, and mortar as indicated as per the Standards and Guidelines for the Conservation of Historic Places in Canada, as per this Conservation plan, and as per the Heritage Consultant. Carefully rake out the mortar of deteriorated joints by using hand tools or appropriate means to avoid further damage to the masonry. New mortar to match original mortar joints in colour, texture, width and joint profile and must be compatible in strength, porosity, absorption and vapour permeability with existing. All new restoration work to be coordinated and reviewed by the structural consultant prior to starting work.

- Preserve all existing masonry and replace damaged and deteriorated masonry with reused masonry salvaged from the buildings. Existing mortar to be repointed and new mortar is to match original mortar joints in colour, texture, width and joint profile and must be compatible in strength, porosity, absorption and vapour permeability with existing.

- Existing sandstone lintels and sills to be preserved. If elements are beyond reasonable repair, re-creation of these elements may be required to match the original design intent (see proposed elevations).

- Restoration of the decorative elements will be carried out on the facade. External detailing such as brick chimneys, parapets, and brick cornices to be retained and restored. Where these elements are beyond repair, they will be replaced with new re-created elements matching the existing.

- All existing interior partitions, millwork, plumbing, mechanical and electrical equipment / conduit to be removed, unless otherwise noted. Hazardous materials report required to review and properly remove all hazardous materials including asbestos.

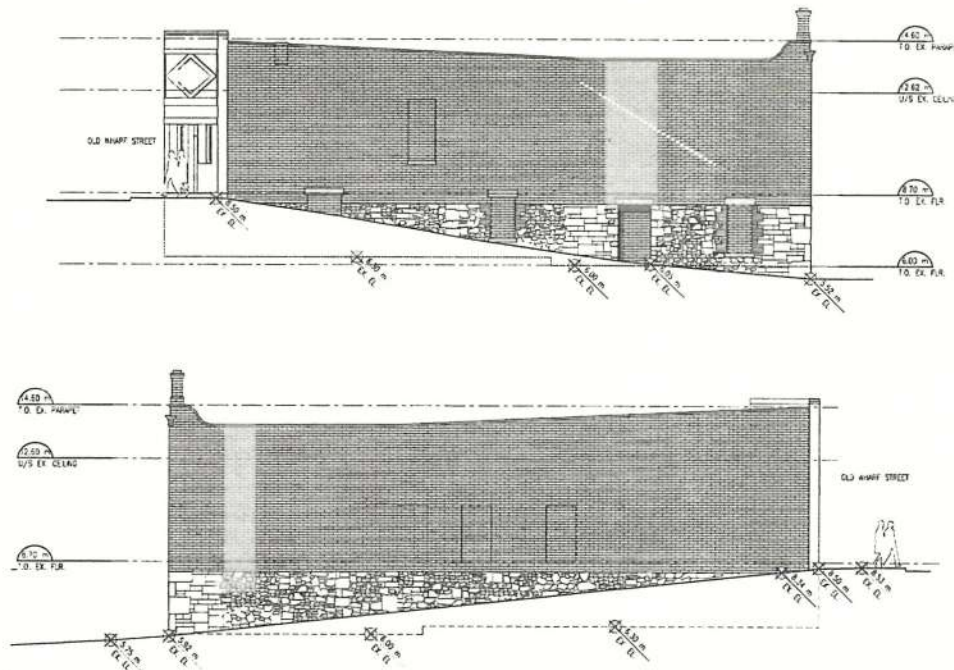
Existing North & South Elevations

- Existing rubble stone foundation walls were once painted, likely used for waterproofing. Test samples will be conducted to determine the feasibility of paint removal. If paint can not be feasibly removed, it will be painted an appropriate colour.

- Investigative work to be carried out to safely remove later stucco finish.
- Preserve all existing masonry and replace damaged and deteriorated masonry with reused masonry salvaged from the buildings. Existing mortar to be repointed and new mortar is to match original mortar joints in colour, texture, width and joint profile and must be compatible in strength, porosity, absorption and vapour permeability with existing.

- Remove existing graffiti using techniques that avoids damage to the building and existing materials.
- All brick infilled windows and/or door openings to be restored or rehabilitated to suit the new design intent (see proposed elevations). Restoration and rehabilitation of the original masonry openings to be as per the Standards and Guidelines for the Conservation of Historic Places in Canada. Carefully remove all infill brick within original openings and store for reuse as required.

- Replace wood lintels and sills with sandstone to match if feasible, or select substitute material to be visually and physically compatible with the historical fabric to suit the new design intent.

- Existing sandstone lintels and sills to be preserved. If elements are beyond reasonable repair, re-creation of these elements may be required to match the original design intent.

- Restoration of the decorative elements will be carried out on the facade. External detailing such as brick chimneys, parapets, and brick cornices to be retained and restored. Where these elements are beyond repair, they will be replaced with new re-created elements matching the existing.

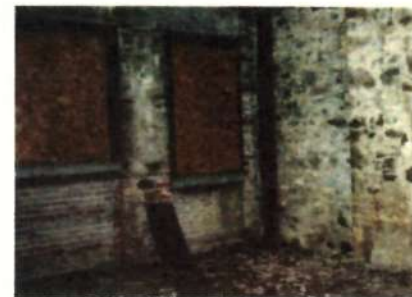
Partial brick filled windows and fireplace

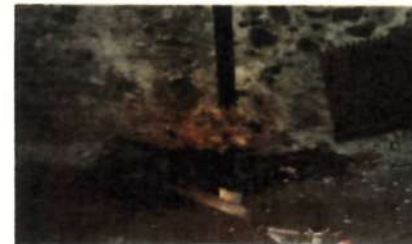
Structurally damaged wood floor and column

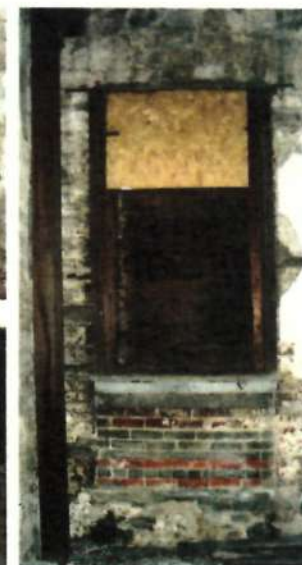
Partial brick filled window with new conc. sill

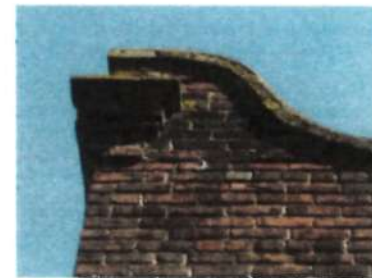
The cap flashings on the Caire & Grancini Warehouse are limited and only visible on the front façade. Other parapet locations, and chimney do not indicate that flashing have been installed to shed water and protect the masonry façade or interface with the roof assembly. The existing cap flashings on the front elevation are oversized, are not sympathetic to the existing building, and are in a significant state of decay and should be replaced. In locations where the flashings are absent, new flashings should be installed to protect the brickwork, prevent water ingress into the interior of the building, and be in compliance with conservation requirements and guidelines.

Parapet at Rear of Building - No Cap Flashing Noted

The roof area and upper assembly conditions of the warehouse were not accessible. Further review of the conditions will be required to clarify what the appropriate profile and finishes should be for restoration. A mock-up of the flashing should be provided to the heritage consultant for review in situ.

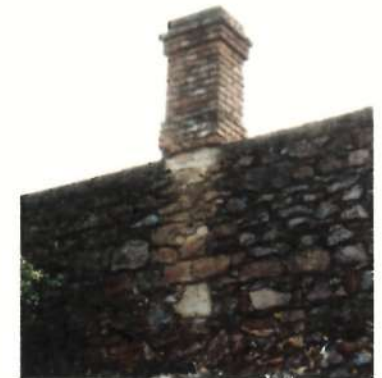
The cap flashings on the Fraser Warehouse are limited and only visible on the front façade. Other parapet locations do not indicate that flashing have been installed to shed water and protect the

Parapet And Chimney at Rear of Building - No Cap Flashing Noted
