CONSTRUCTION IMPACT ASSESSMENT &

TREE PRESERVATION PLAN

324/328 Cook Street and 1044-1054 Pendergast Street, Victoria

DATE OF ISSUANCE: May 7, 2018

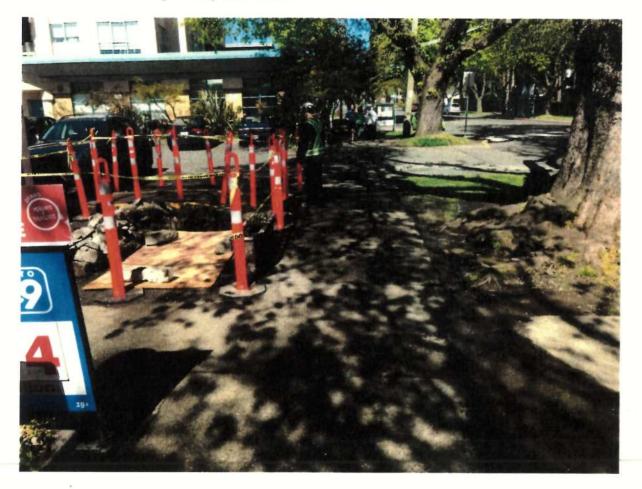
Pic. 1 – Location of exploratory excavation.

- Exploratory excavations carried out on April 10, 2018, examined an area 7.1 meters from the existing curb (5 meters from center of tree) within the subject property directly opposite NT 07(see attached pictures). The trench, hydro-excavated under our direction, was 3.6 meters long and 72 cm wide. The deepest part of the excavation was 180 cm deep and the majority of the roots encountered were between 90 cm 120 cm deep, other than some small surface roots below the concrete. The area excavated appeared to have been disturbed previously and we encountered various types of fill soil and portions of dead tree roots approximately 5 cm in diameter. The live roots encountered included: 8- 2.5 cm, 2- 5 cm and

1-4 cm, along with numerous roots less than 1 cm in diameter. Based on these findings, we do not anticipate the excavation for the proposed construction will have a significant impact on the health or stability of this tree provided the remaining critical root zone can be adequately protected and shoring and blind forming techniques are used to reduce an over excavation.
