## 210 Gorge Road East, Victoria

## Construction Impact Assessment &

## Tree Preservation Plan

210 Gorge Road East - Tree Preservation Plan

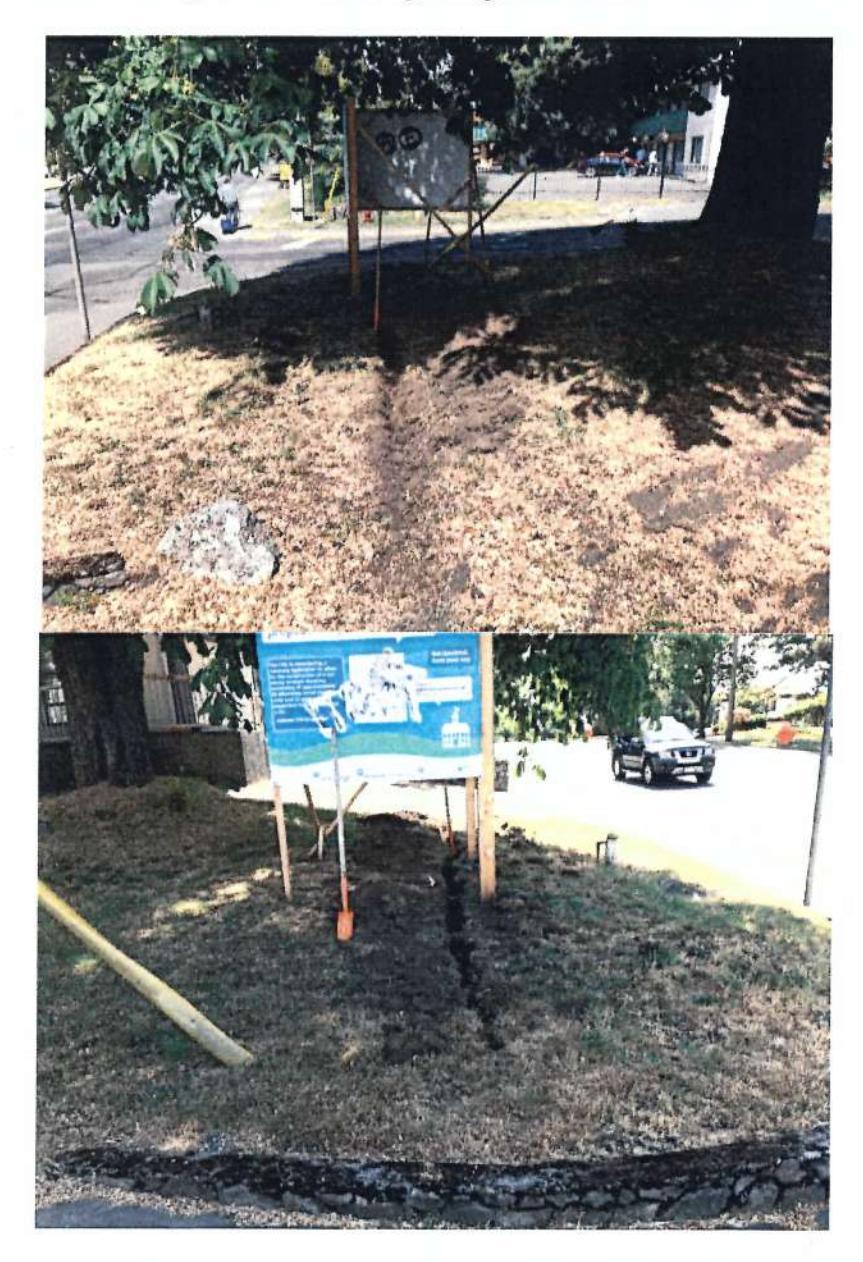
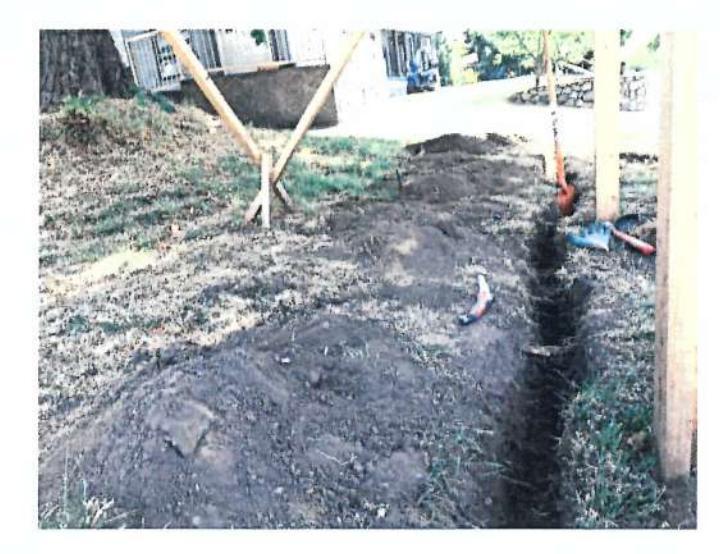
- Sidewalk: An exploratory excavation (three photos below) was conducted to assess the impacts from the updated sidewalk design, which will not allow the sidewalk to be raised above the existing grade as originally planned due to sloping requirements. We hand dug a trench 4m south from the centre of the tree in the location of the proposed sidewalk edge. A depth of approximately 30cm was reached throughout most of the trench. We attempted to retain as many roots above 2cm as possible while smaller roots were pruned back to the edge of the trench to facilitate further excavation.

Roots of the following sizes were encountered throughout the length of the trench: two 3cm roots (retained), five 2cm roots (one required removal), and eight 1cm roots. A moderate density of small fibrous roots (smaller than 1cm in diameter) were severed. One 5cm root oriented vertically was observed at the edge of the trench.

Given the amount and size of roots observed, we do not anticipate the tree will be significantly impacted by the proposed sidewalk if the excavation required is restricted to 30cm in depth. There may still be roots underneath 30cm and therefore, if the sidewalk requires excavation to a greater depth, there may be additional impacts to the health of the tree. If significant root loss is to be avoided, this may mean decreasing the depth of the sub-base and/or retaining soil rich in organic matter (and containing roots) below the sidewalk. If a curb or retaining wall is desired at this edge of the sidewalk, its foundation should "bridge" above significant roots encountered (such as by using reinforced concrete).

The project arborist should supervise the excavation associated with the sidewalk, the removal of the retaining wall and the re-grading of the area.
