Re: Wilson Walk Development Proposal

Limited Hazardous Materials Investigation

220 Wilson Street, Victoria, BC

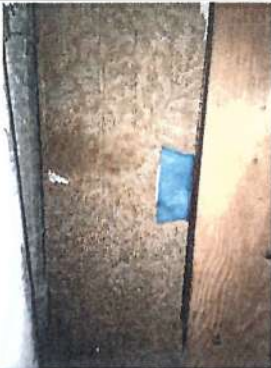
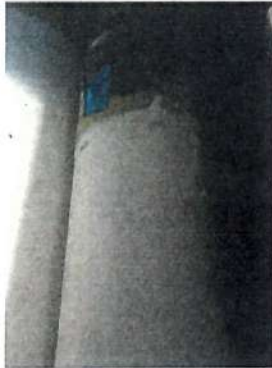
<p>Sample: 18969- 1 Location: Unit 4 - Hall closet - Smooth Description: Plaster Asbestos: None detected</p>	<p>Sample: 18969 – 2 Location: Unit 4 - Hall closet - Duct Description: Duct tape Asbestos: 80% Chrysotile</p>

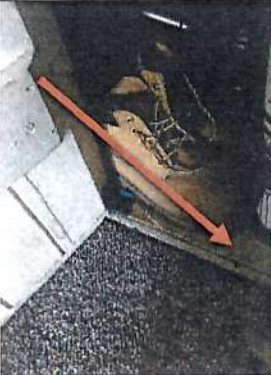
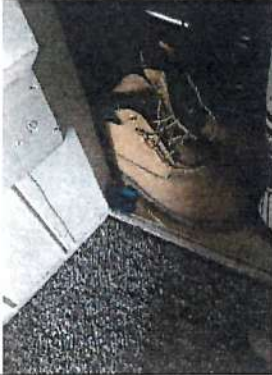
<p>Sample: 18969 - 3 Location: Unit 4 - Hall closet - Top layer Description: Sheet vinyl flooring Asbestos: None detected</p>	<p>Sample: 18969 - 4 Location: Unit 4 - Hall closet - Lower layer Description: Sheet vinyl flooring Asbestos: None detected</p>

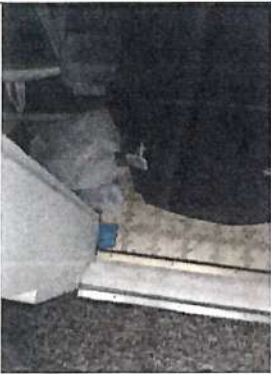
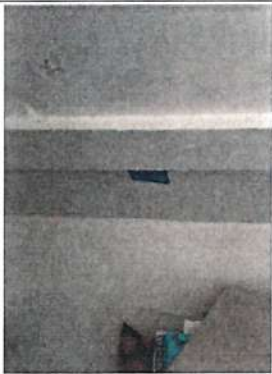
<p>Sample: 18969 - 5 Unit/Location: Unit 4 - Living room closet- 2 layers Description: Sheet vinyl flooring Asbestos: 70% Chrysotile</p>	<p>Sample: 18969 – 6 Unit/Location: Unit 4- Living room closet Description: Plaster Asbestos: None detected</p>

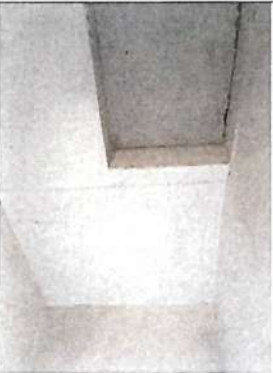
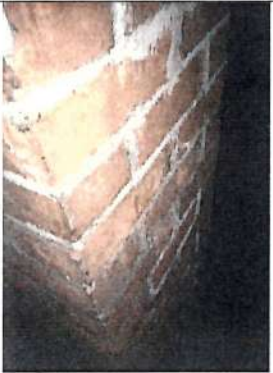
<p>Sample: 18969 - 9 Unit/Location: Unit 4 - Hall ceiling and partition wall Description: Textured ceiling Asbestos: None detected</p>	<p>Sample: 18969 - 10 Unit/Location: Attic - Centre chimney Description: Mortar Asbestos: None detected</p>

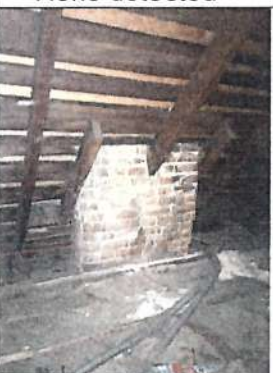
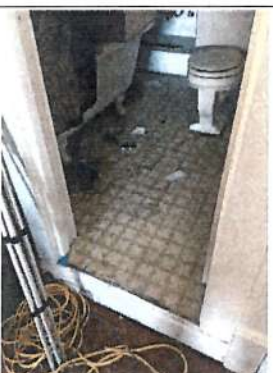
<p>Sample: 18969 - 11 Unit/Location: Attic - South chimney Description: Mortar Asbestos: None detected</p>	<p>Sample: 18969 - 12 Unit/Location: Unit 3 - Bathroom Description: Sheet vinyl flooring Asbestos: 70% Chrysotile</p>

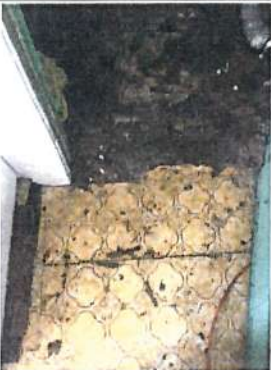
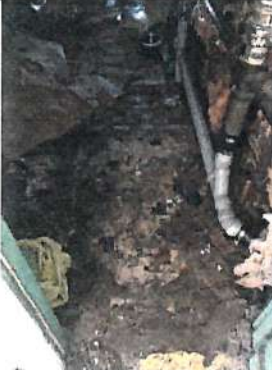
<p>Sample: 18969 - 13 Unit/Location: Unit 3 - Kitchen Description: Sheet vinyl flooring Asbestos: 70% Chrysotile</p>	<p>Sample: 18969 - 14 Unit/Location: Unit 3 - Attic off kitchen Description: Sheet vinyl flooring Asbestos: None detected</p>

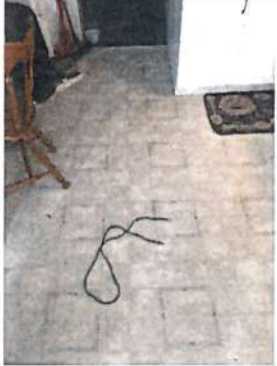
<p>Sample: 18969 - 33 Unit/Location: Unit 1 - Kitchen multiple layers Description: Sheet vinyl flooring Asbestos: 70% Chrysotile</p>	<p>Sample: 18969 - 34 Unit/Location: Unit 1 - Bedroom ceiling Description: Textured ceiling Asbestos: None detected</p>

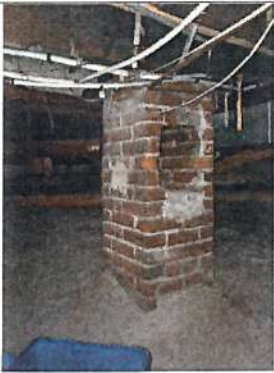
<p>Sample: 18969 - 49 Unit/Location: Crawl space - Chimney Description: Mortar Asbestos: None detected</p>	<p>Sample: 18969 - 50 Unit/Location: Crawl space - Ducting Description: Duct tape Asbestos: 80% Chrysotile</p>

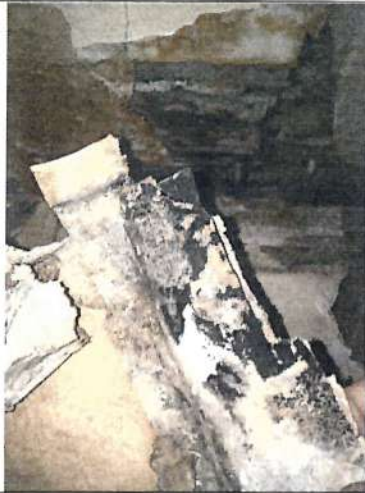
Fungal contamination was identified in Unit 3 and Unit 1. Additional unidentified fungal contamination may be present within other inaccessible/concealed areas throughout the building. It is recommended that a number of steps are followed to prevent workers and occupants from exposure to elevated concentrations of fungal spores and to remediate the identified fungal contamination in Units 3 and 1 at the above referenced site:

Sample: 18969 – M1
 Unit/Location: Unit 3 – Bathroom above ceiling tiles
 Description: Fungal growth on plaster and wallpaper
 Fungal: High levels of *Stachybotrys* and moderate levels of unidentified brown fungi

- 3) Wood framing or sheathing that is rotten or in poor condition should be removed and disposed of. Any fungal stained wood framing or sheathing that is still in good condition can be scrubbed with an abrasive pad or sanded in conjunction with HEPA vacuuming;
- 4) following the completion of remediation work, all exposed surfaces within the work area should be thoroughly cleaned with a diluted hydrogen peroxide and cleaned with a HEPA filter equipped vacuum;
- 5) The above remediation work should be conducted by an experienced and reputable remediation contractor following appropriate work procedures. These procedures should include worker use of personal protective equipment such as PAPR respirators equipped with P100/chemical cartridges, disposable coveralls with integral head and foot coverings, and work gloves.

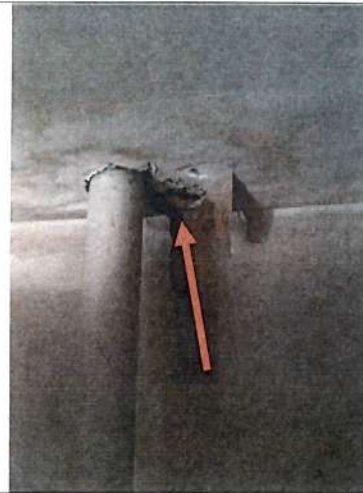
Sample: 18969 – M2
 Unit/Location: Unit 1 – Kitchen above ceiling tiles
 Description: Fungal growth on plaster and wallpaper
 Fungal: High levels of *Aspergillus*/*Penicillium* growth
