1832 Speed Ave Development, Victoria

Construction Impact Assessment & Tree Preservation Plan

Date of Issuance: TPP #1: March 15, 2019
TPP #2: May 14, 2019
TPP #3: May 15, 2019

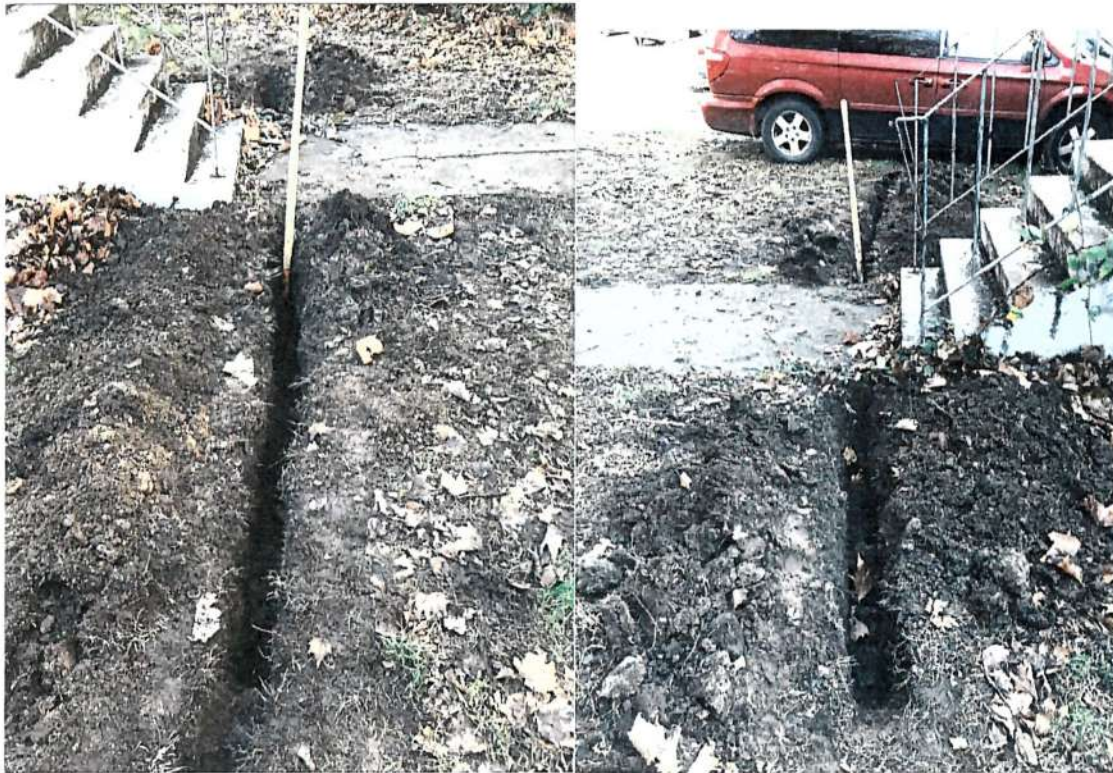
The largest roots encountered within the CRZ of London Plane #2 were three roots measuring 3-4cm in diameter. Only one 2cm root and a low density of smaller roots were encountered from London Plane #3 and one 1cm root was encountered in the trenches across from London Plane #4. Pictures #1-5 of the excavation are included at the end of this report.

Photos 1 and 2: Adjacent to London Plane #4.

If shoring or sheet-piling is used to restrict the extent of excavation to 5.5m from the property line, we do not anticipate a significant health impact to these trees as a result of the underground parkade excavation.

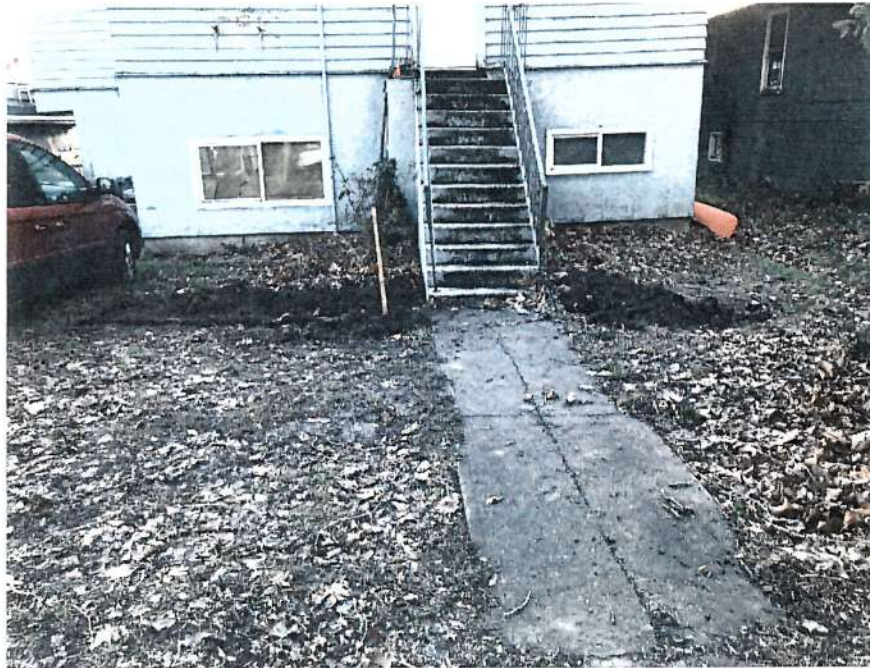
Photo 3: Adjacent to London Plane #4.

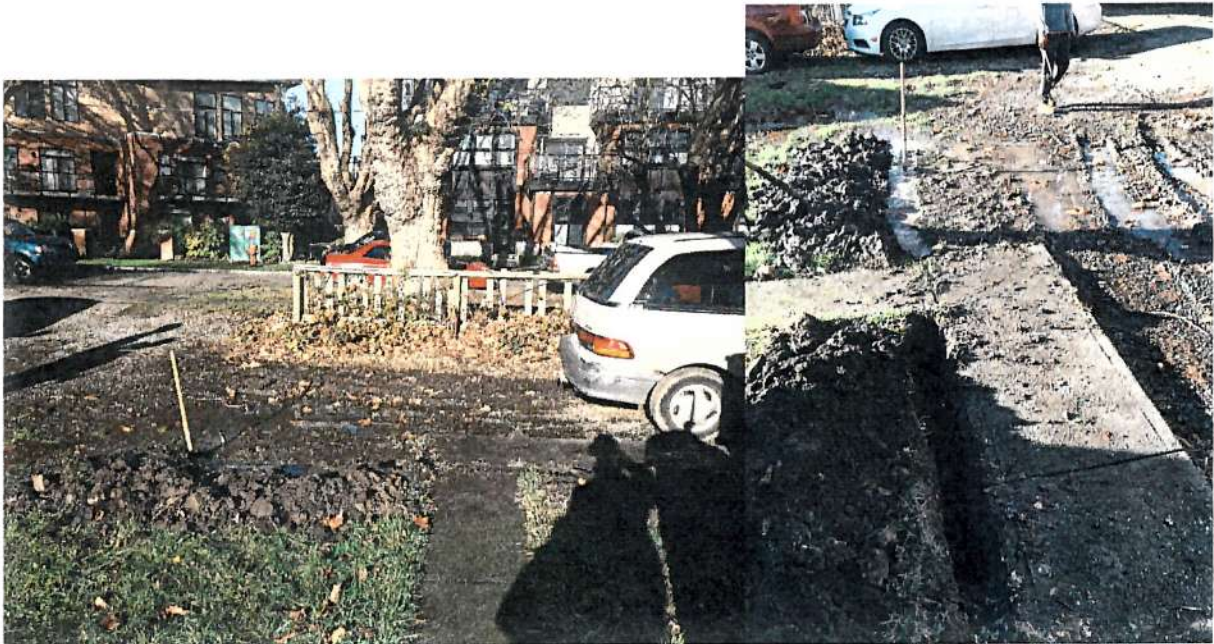
Photos 4 and 5: Excavation adjacent to London Plane #3. Compaction as a result of vehicles is already present on-site.

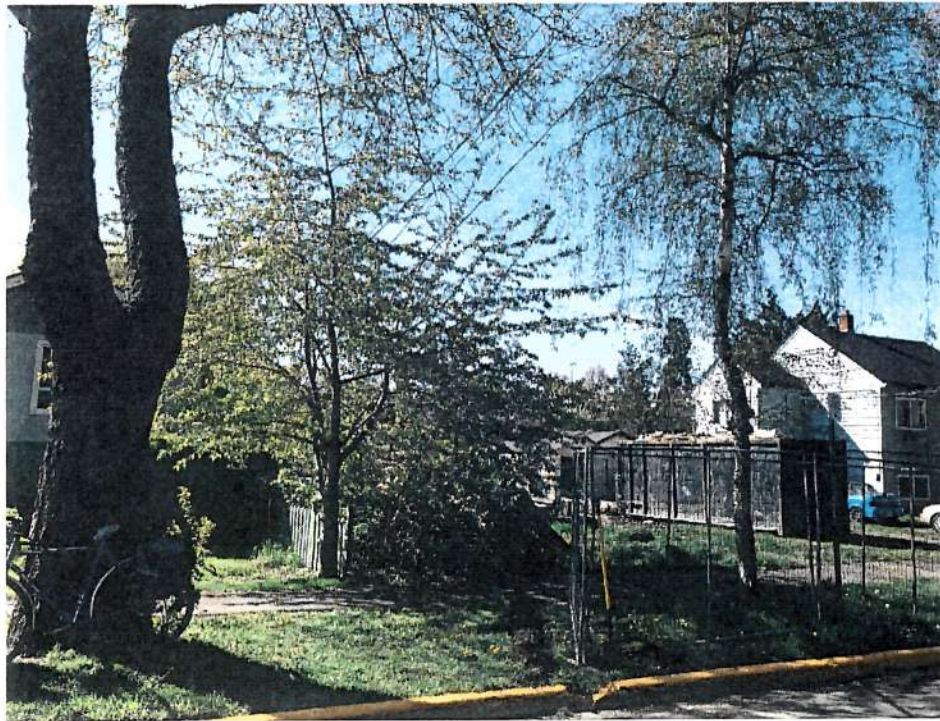
Photo #6

Excavation for the let-down is expected to be minimal as a result of the grade of the existing road and sidewalk being raised approximately 15cm. As per the City of Victoria’s Parks Department request, exploratory digging was conducted to determine the potential root loss as a result of the excavation for the driveway let-down, now shown as 5m west from the trunk (perpendicular to the roadway). Due to tree protection fencing installed for the demolition, access was restricted in this location. Therefore, exploratory digging was conducted slightly closer to the tree, at approximately the location of the dashed line shown on the site plan. A trench approximately 10cm in depth was hand-dug and no roots were encountered. Any roots encountered below, can be retained as per our recommendations in the “Paved Surfaces Above Tree Roots” section. Pictures #6-8 are included at the end of this report.

Photos #6-8: Exploratory trench for the driveway flare adjacent to London Plane #6.
