# **1442 Elford St, Victoria**

## **Construction Impact Assessment & Tree Preservation Plan**

Date of Issuance: April 4, 2019  
Revised: July 24, 2019  
Revised: October 16, 2019

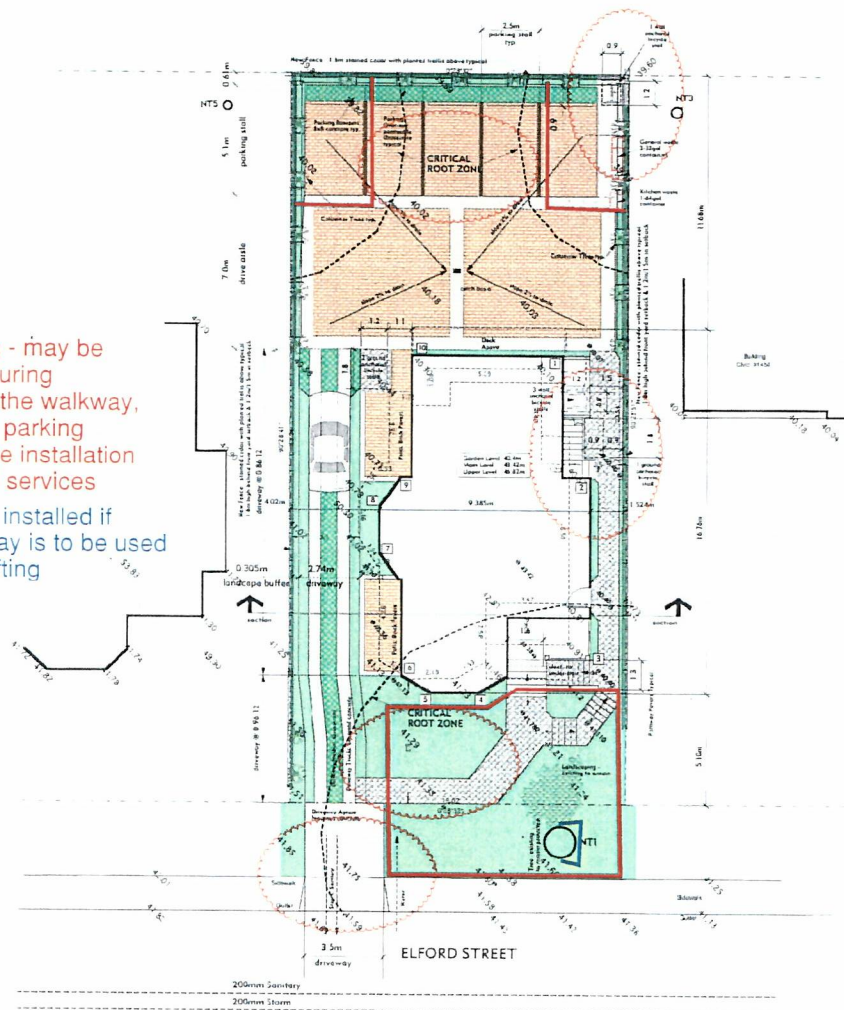
- Barrier Fencing - may be adjusted only during construction of the walkway, stairs, and rear parking area, and for the installation of underground services
- Hoarding to be installed if existing driveway is to be used during house lifting
