# **1302 Finlayson Street, Saanich**

## **Construction Impact Assessment &**

## **Tree Preservation Plan**

October 15, 2018

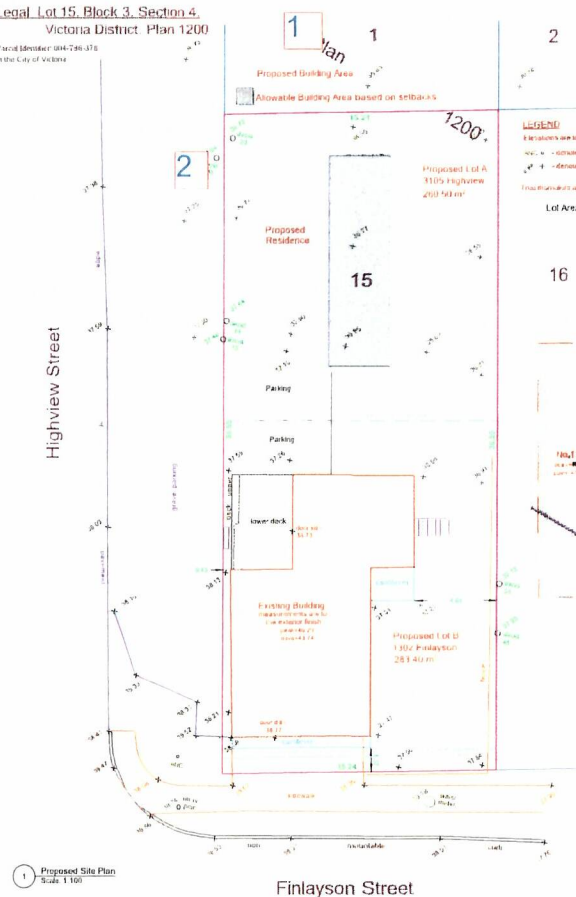
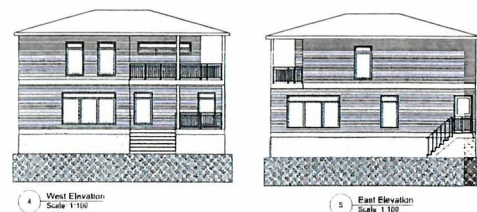
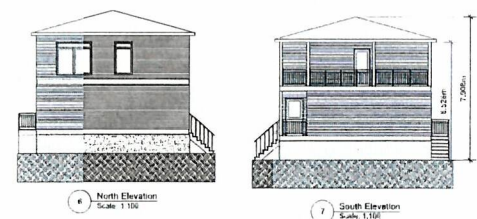
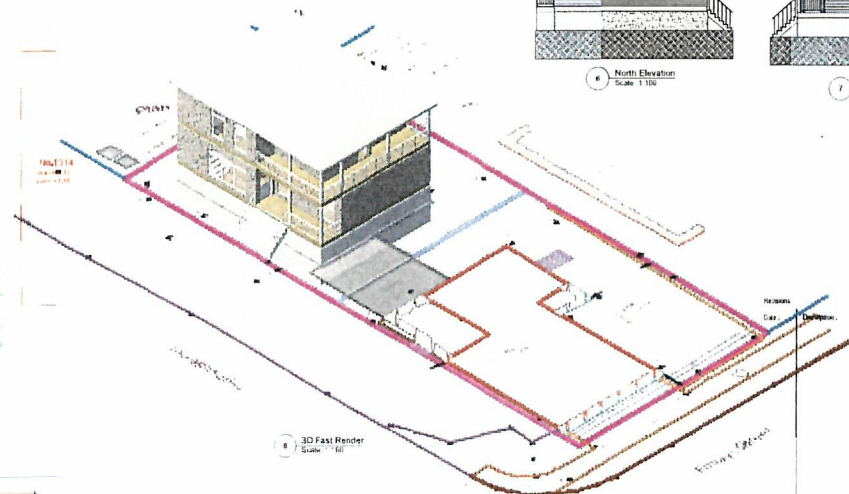
**Methodology:** We visually examined the trees on the property and prepared an inventory in the attached Tree Resource Spreadsheet. Each by-law protected tree was identified using a numeric metal tag attached to its lower trunk. Municipal trees and neighbours' trees were not tagged. Information such as tree species, DBH (1.4m), crown spread, critical root zone (CRZ), health, structure, and relative tolerance to construction impacts were included in the inventory. The by-law protected trees with their identification numbers were labelled on the attached Site Plan.

- **Barrier fencing:** The areas surrounding the trees to be retained should be isolated from the construction activity by erecting protective barrier fencing. Where possible, the fencing should be erected at the perimeter of the critical root zones. The barrier fencing must be a minimum of 4 feet in height, of solid frame construction that is attached to wooden or metal posts. A solid board or rail must run between the posts at the top and the bottom of the fencing. This solid frame can then be covered with plywood, or flexible snow fencing. The fencing must be erected prior to the start of any construction activity on site (i.e. demolition, excavation, construction), and remain in place through completion of the project. Signs should be posted around the protection zone to declare it off limits to all construction related activity. The project arborist must be consulted before this fencing is removed or moved for any purpose. As there is an existing fence between the park and the subject property, it will serve as barrier fencing. If the Ash tree is going to be retained, we recommend that the critical root zone be fenced.
