# **1913-1915 Fernwood Road, Victoria**

## **Construction Impact Assessment & Tree Preservation Plan**

DATE OF ISSUANCE: August 13, 2019

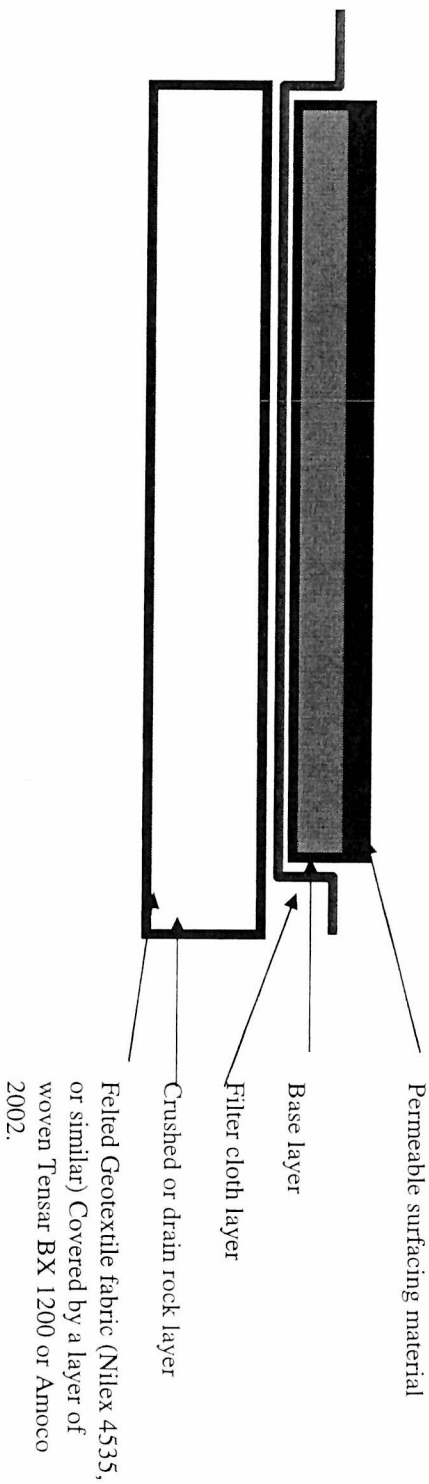
**Diagram – Site Specific Floating Driveway, Parking and Sidewalk Areas**

- **Driveway:** The attached plans indicate that a ribbon driveway with a Grasscrete centre will be constructed approximately 0.5m north of the south property boundary. A concrete parking area with four parking stalls will be constructed at the rear of the property.
  - **Cherry NT2** (~40cm DBH) is approximately 0.5m south of the property boundary and approximately 1.5m from the new driveway. If the driveway requires excavation down to bearing soil within its footprint and roots are encountered in this area, this could significantly impact the health of the tree. We recommend a raised permeable driveway be constructed in the area where the driveway crosses over the critical root zone of the tree. The “floating driveway” specifications are attached.

The objective is to avoid root loss and to instead raise the driveway and its base layer above the roots. This may result in the grade of the “floating driveway” being up to 30cm above the existing grade (depending on how close roots are to the surface and the depth of the driveway base layers). Final grading plans should take this potential change into account. This may also mean that some of the A horizon soil layer (rich in organic material and roots) will be left intact below the driveway.

1. Excavation for driveway or parking area construction must remove the sod layer only, where they encroach on the root zones of the protected trees
2. A layer of medium weight felted Geotextile fabric (Nilex 4535, or similar) is to be installed over the entire area of the critical root zone that is to be covered by the paving. Cover this Geotextile fabric with a layer of woven Amoco 2002 or Tensar BX 1200. Each piece of fabric must overlap the adjoining piece by approximately 30-cm.
3. A 10cm layer of torpedo rock, or 20-mm clean crushed drain rock, is to be used to cover the Geotextile fabric.
4. A layer of felted filter fabric is to be installed over the crushed rock layer to prevent fine particles of sand and soil from infiltrating this layer.
5. The bedding or base layer and permeable surfacing can be installed directly on top of the Geotextile fabric.
