Tree Preservation Plan Report

11 Chown Place, Victoria BC,
V9A 1H5
CJF Project: 49-19

February 7, 2020

Re: 11 Chown Place, City of Victoria: Proposed new 58 unit seniors residence
Tree Protection Plan Report.

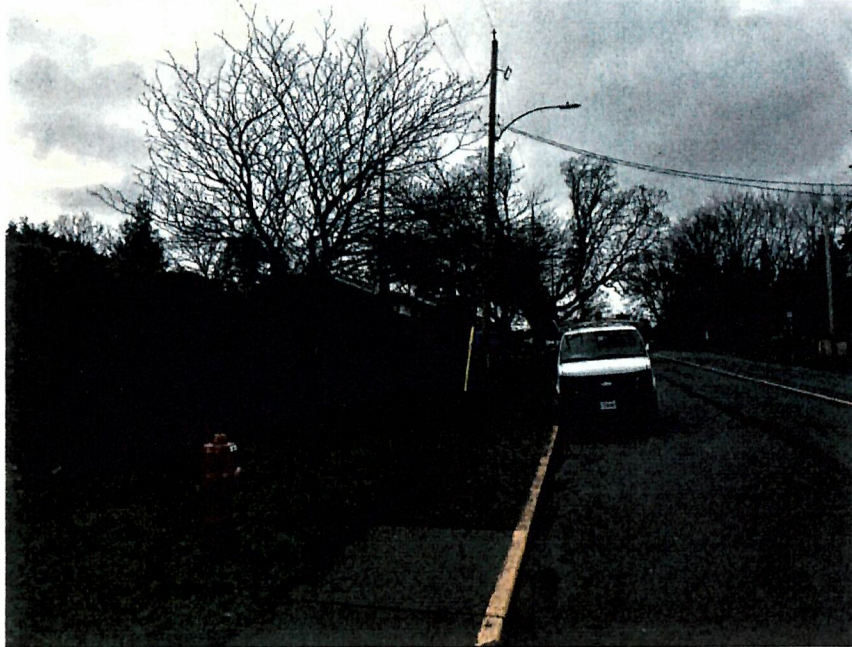
Image 4: Harriet Road Horse chestnut street trees 766, 754 south of Chown Place.

Chown place (see Images 4 and 5). Street Horse chestnut immediately north and south of Chown Place (ID tags 766, 767) will be protected from construction disturbance with Tree Protection Fencing (TPF) set outside their canopy driplines (see Appendix 2).

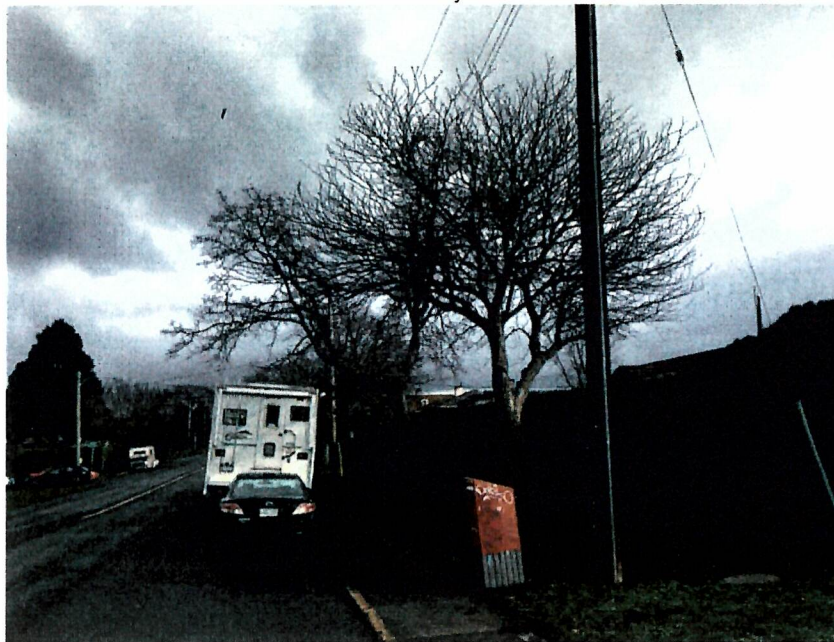
Image 5: Harriet Road Horse chestnut 767 and Garry oak 768 street trees north of Chown Place.

Little or no impact, if site power / communications services are taken from the north power pole straight south to the Chown Place service trench (see Image 5 and Appendix 2). If brought north from the south power pole (see Image 4), to avoid street tree rootplate disruption, consider burying under hedge then west of building 'O' outside the tree 766's PRZ. If required, revised utility trench location to be determined by; Number 10 Architectural Group, CJF and any other relevant party.

8. To reduce Harriet Road street tree root disturbance CJF recommends, Hydro and communications services be taken from the power pole north of Chown Place. If not possible, CJF to be included when determining appropriate routing between south power pole and Chown Place trench.

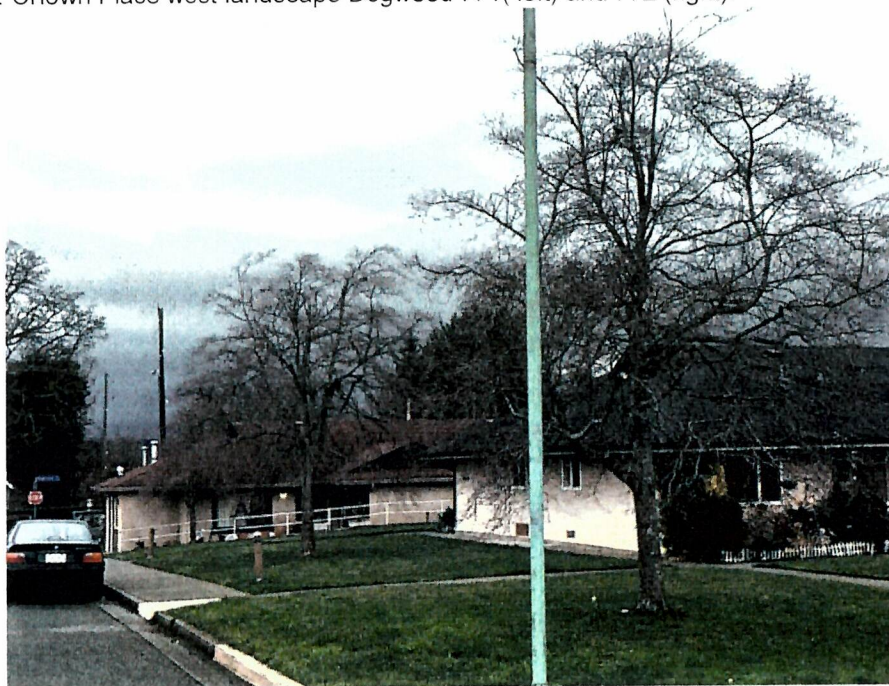
Image 6: Chown Place west landscape Dogwood 771(left) and 772 (right).

Landscape Dogwood located along Chown place east and west of the building site (ID Tags 770-772 and 779, 788, 789) will be retained and surrounded by Tree Protection Fencing (TPF) set outside their Protected Root Zone (PRZ) or canopy dripline (Appendix 1 'Symmetrical Crown Rad(ius)' as determined by the Project Arborist. With careful excavation, and CJF oversight, five Dogwood west of the building site will not be impacted by underground utility installation. Any renewal of existing or construction of a new sidewalk, curb and gutter / drains should be discussed with CJF before proceeding. Although, protected by TPF, CJF does not expect Chown Place Dogwood east of the proposed building (ID tags 779, 788, 789) to be impacted by construction.

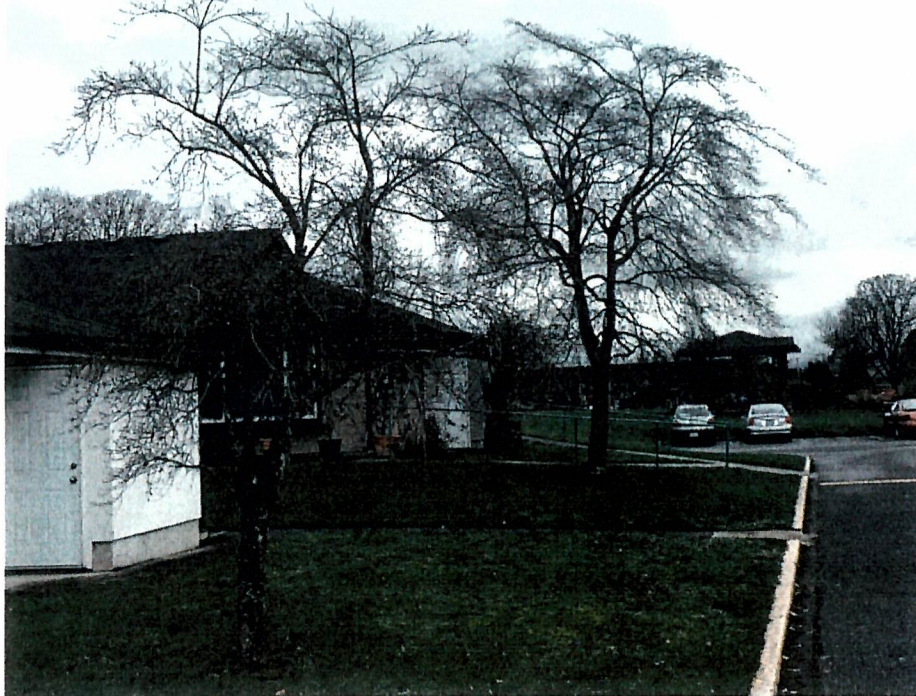
Image 7: Chown Place east landscape Dogwood 788, 789.

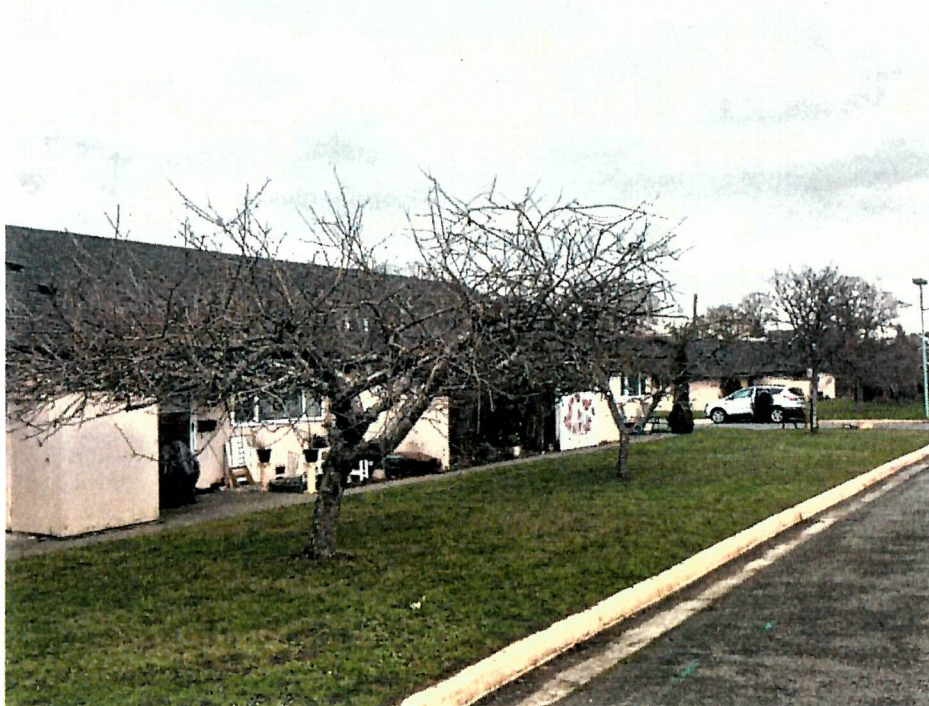
Image 8: Building 'N' landscape featuring fruiting Apple trees 800 and 801 (left and centre) and Ash tree 802 (right).

7. Where project TPF surrounds a fruit tree the side facing away from construction should be left open (i.e. ID tags 800, 801). This will allow removal of ripe fruit before it decays and attracts wasps in August / September. Continued lawn maintenance is also beneficial.

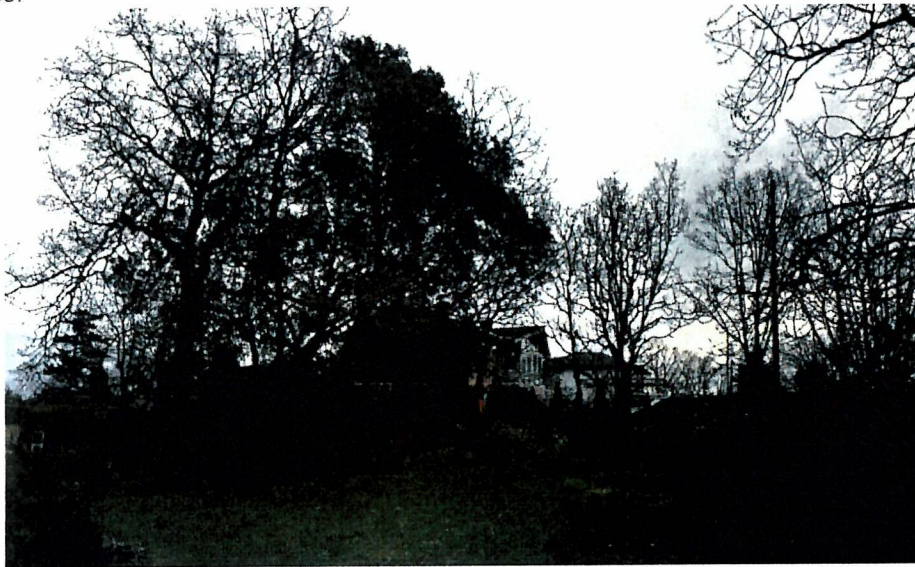
Pathway construction will occur within the PRZ of Oaks closest to the woodland boundary. CJF therefore expects root damage but believes careful location, design and Project Arborist oversight will minimize rootplate disruption allowing impacted trees to remain viable. Garry oak canopy clearance pruning may be required to create required safe machine access. East and west halves of the woodland will be protected from construction disturbance by TPF set between the pathway and adjacent Garry oaks (see Appendix 2).

Image 10: TMA 2017 and CJF 2019 inventoried south Garry oak and Arbutus east of Irma Street entrance.

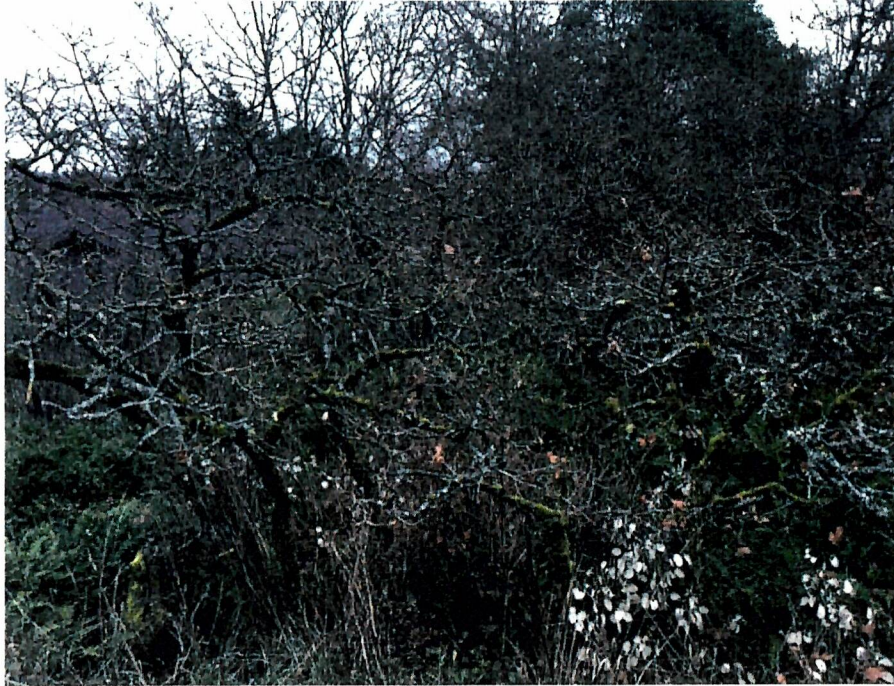
Image 12: Stunted south Garry oak woodland trees west of Irma Street property entrance.
