Tree Preservation Plan

Redevelopment at 55-43 Gorge Road East, 2831, 2833, 2827 and 2829 Irma Street  
Victoria, BC.

June 10, 2020

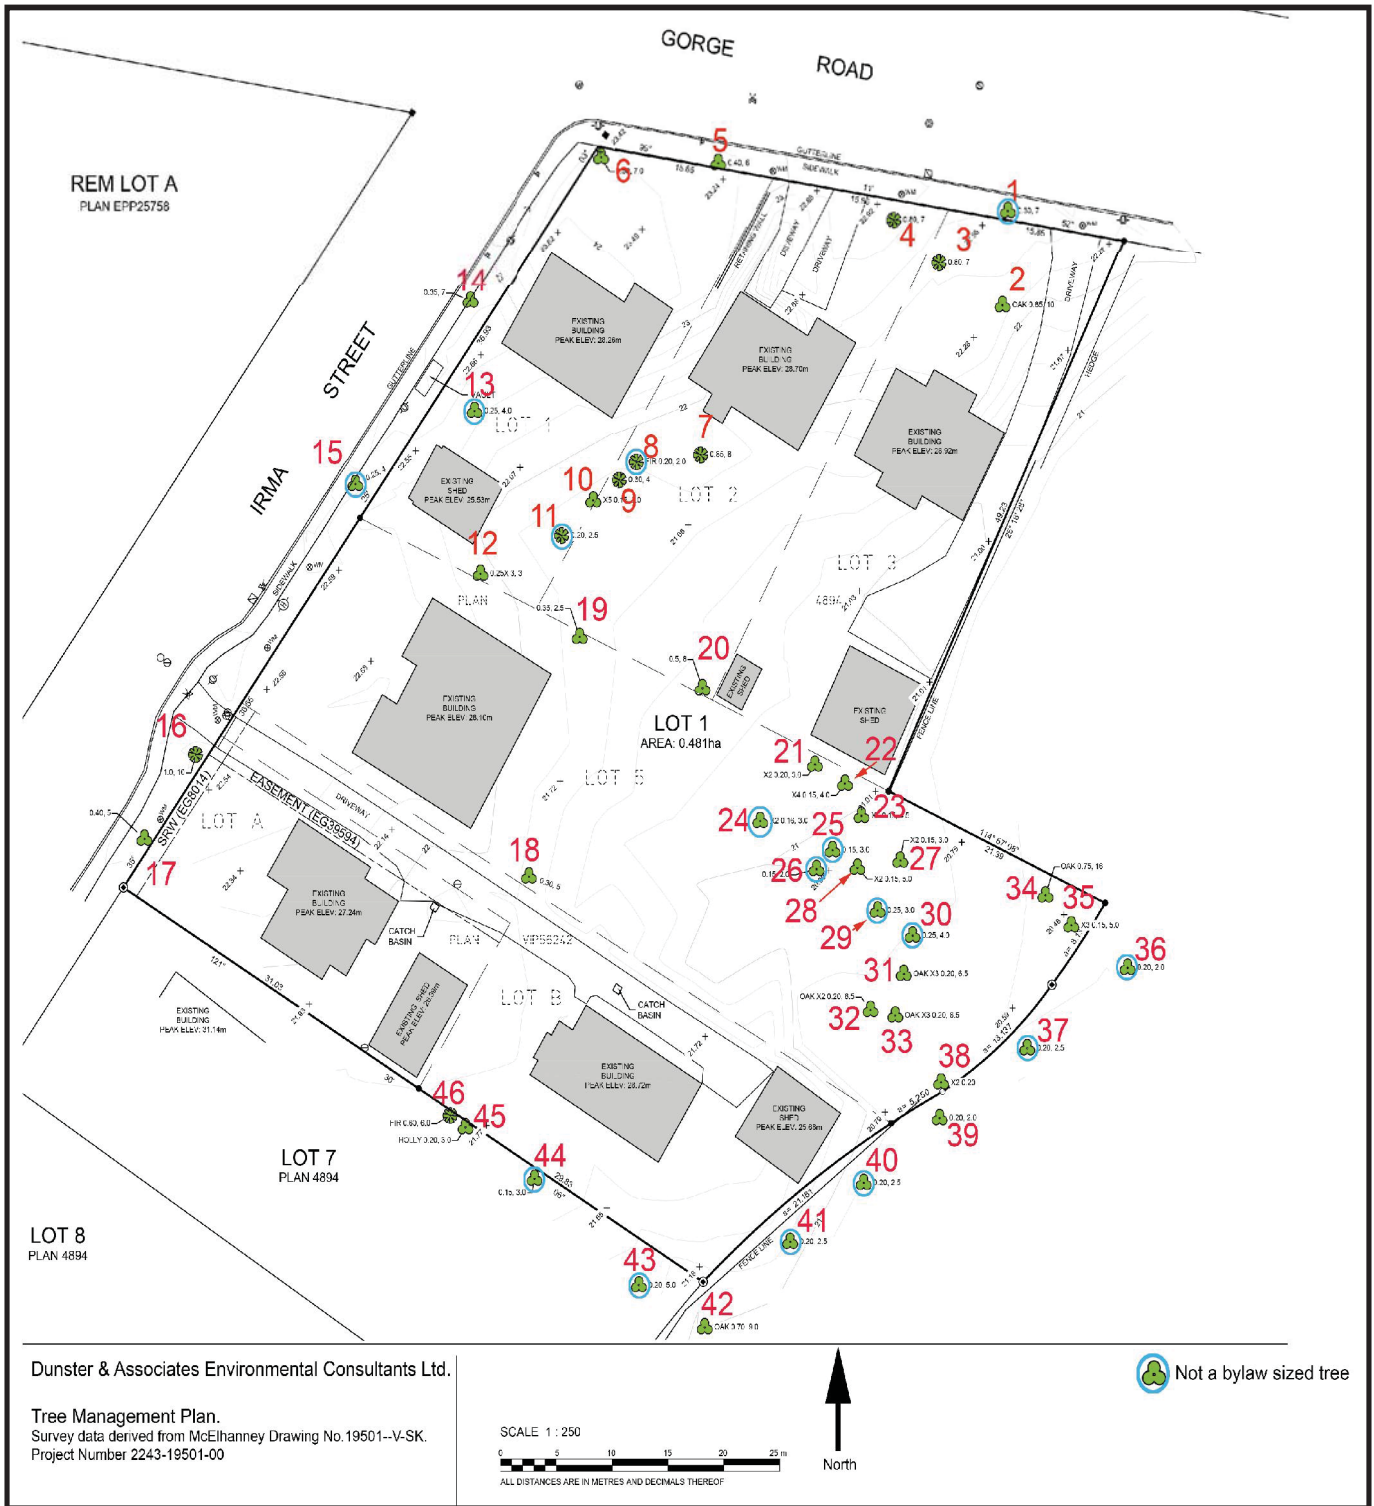
Figure 2. Location of trees.

Figure 2 shows the location of bylaw sized trees and trees between 10 cm and bylaw sized.

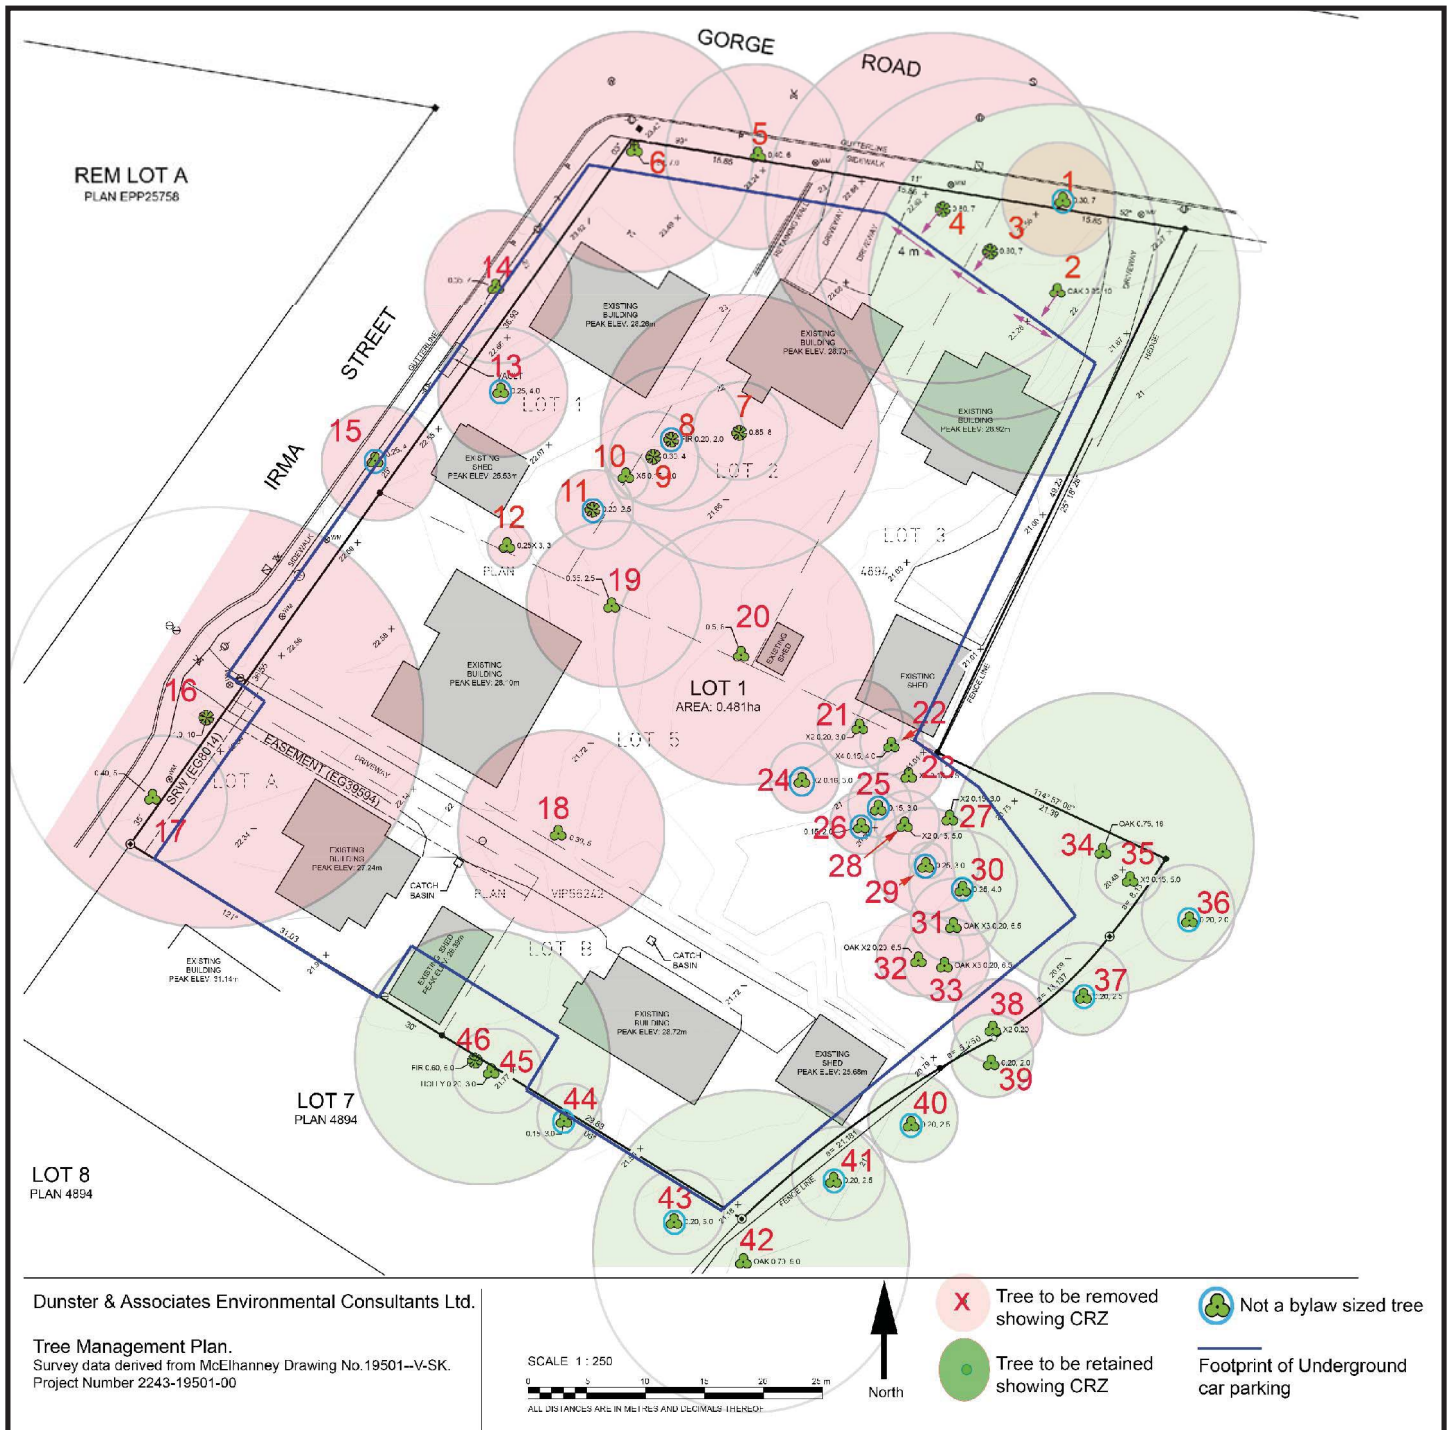
Figure 3. Critical Root Zones and the planned footprint.

Using the data shown in Table 1, Figure 3 shows the identified trees with the critical root zone (CRZ) superimposed, based on diameter multiplied by 18. The CRZ data is depicted as trees to be removed or trees to be retained, based on the proposed development plans provided to Dunster & Associates, and in particular the excavation required for the underground car parking area (shaded blue area).

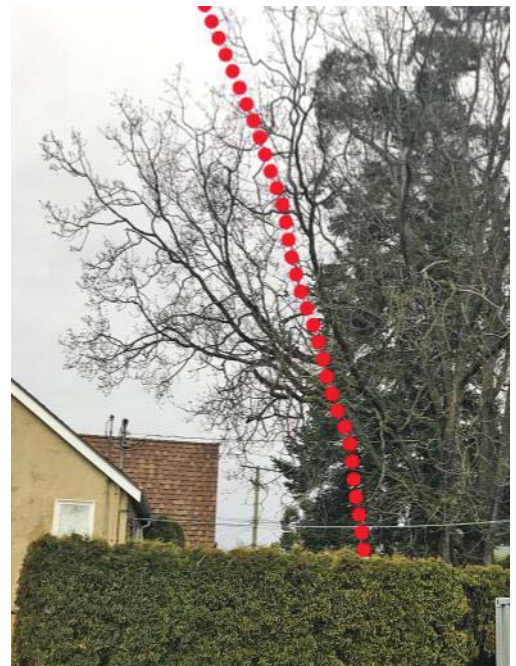
Figure 4. Pruning work for tree # 2.

This is a Garry Oak and I understand that the discussions with the city focussed on retaining this tree due to its high profile on Gorge Avenue. I have discussed options with the client and concluded that we can retain the tree with a 4.5 metre setback from the edge of the excavation to the centre of the tree. There will be a need to prune back some of the south face of the tree canopy, but again, this should be feasible and still allow for retention of a reasonably complete tree at the end of the work.

**Step 1.** Once the house is vacant and before any other work commences, the oak tree will need pruning. The anticipated pruning work is shown in Figure 4. It shall be done under my supervision.

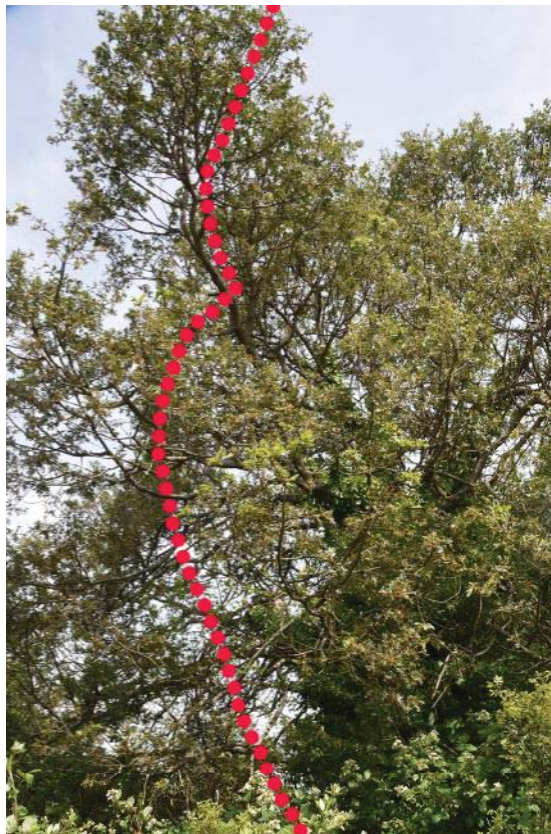
Figure 7. Tree # 34 - pruning concept.

The large Garry Oak on the east boundary is in fair condition. I have reviewed it on site, cut the ivy at the base, examined the tree trunk and canopy (to the extent possible with the ivy in place in the crown), and concluded that there are no obvious structural or health problems with the tree trunk or initial scaffold branches. When I first observed it on June 28th 2019 the crown foliage showed signs of looper defoliation. That is not an insurmountable problem, and the tree may recover. I have recommended a setback distance of 4.5 metres from the centre of the tree to the excavation for that tree.

**Step 1.** Once the site is vacant the ground vegetation at the base of the oak tree shall be cleaned off by hand to a radial distance of 6.3 metre to the west, along the property line, and 5 metres to the south. That will include tree # 35, but the stump of that small tree is to be left on the ground. There will be a need for some crown pruning to accommodate the above ground building on the south side. That work shall be conducted under my supervision. Because the site is currently overgrown it is not possible to know exactly which limbs will need pruning back. Once the ground vegetation has been cleaned away, I will lay out the 4.5 metre setback line on the ground and then work with the tree crew retained to carefully reduce some limbs and remove others. That will remove the potential for limbs growing into the new building, but retain as much canopy as possible. Figure 7 is a concept sketch and will be refined once access to the site is feasible.

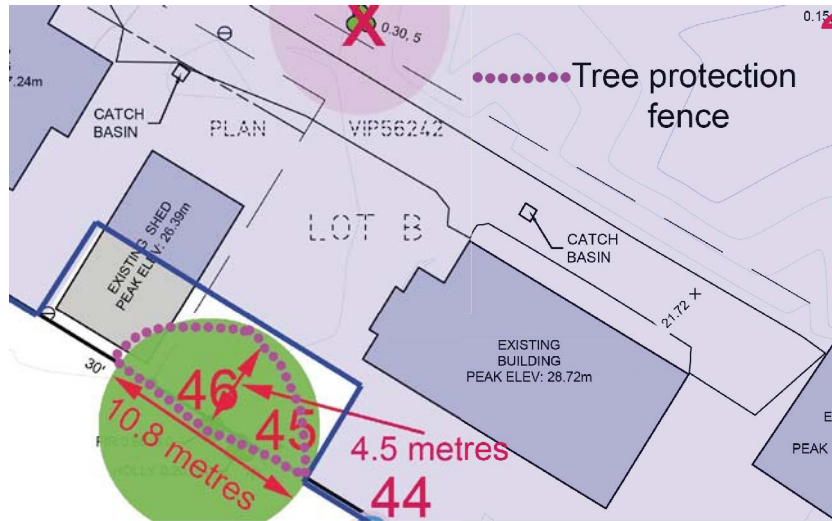
Figure 9. Fencing at tree # 46.

This is the Douglas-fir tree close to the boundary and located on 2815 Irma Street. I have recommended a setback of 4.5 metres from the centre of the tree to the excavation, and the underground footprint has been adjusted to reflect that. This should be sufficient room to accommodate the tree roots and the above ground branches.

**Step 2** The adjacent houses will be demolished using the existing concrete pavers by the carport as a running surface. Once the two houses have been demolished the concrete pavers are to be very carefully removed under my supervision. This may be done by machine. Once all the pavers have been removed a final tree protection fence shall be installed at a distance of 4.5 metres to the north and 5.4 metres on either side along the boundary line. Figure 9 shows this detail.
