GYE + ASSOCIATES

**Summary Arborist Report
2920 Prior Street,
Victoria, BC**

Date of Report: December 17, 2019

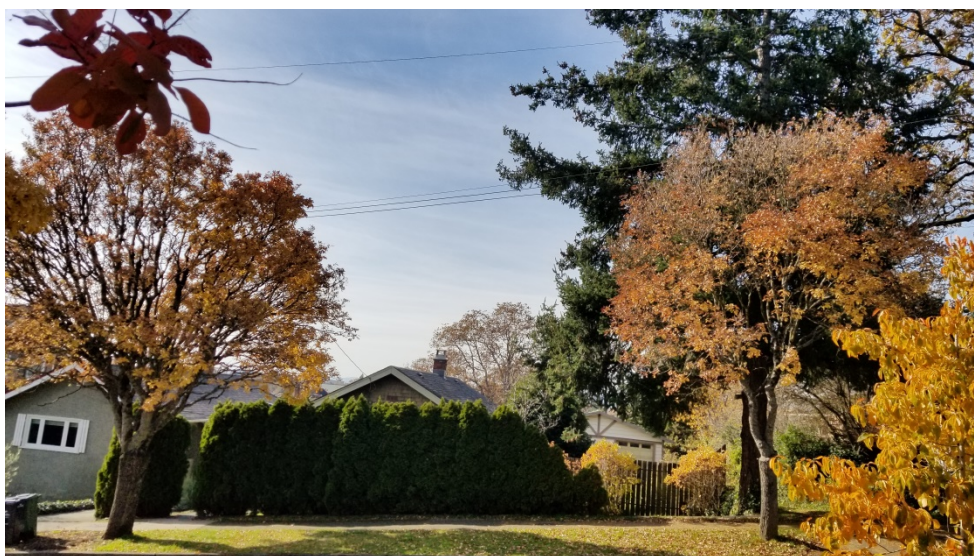
The existing site is a residential property with one accessory building located on the west side of Prior Street. The lot slopes gently from north to south and from east to west. A mature Douglas-fir is located in the front of the property beside the existing driveway and municipal boulevard, both of which are approximately 60cm higher in grade than the base of the tree and retained by a dry-stacked wall (in the case of the driveway) and a concrete retaining wall (in the case of the boulevard). The fir is 65 cm DBH and exhibits an 80% live crown ratio, stable height-to-girth ratio and a typical excurrent form with strong apical dominance. The crown of the tree shows good vitality through its foliage colour, density and twig growth. No fungal fruiting bodies are visible and there are no other indications of structural defect in the tree, which has a single leader.

Two mature ash trees are located on the municipal boulevard (*Fraxinus* sp. cultivars), both of which appear to be in good health and condition. A large off-site Garry oak tree is located in the front yard of the adjacent lot to the north of the subject property. It is estimated that its root system extends partially over the shared property boundary. Several fruit and flowering trees are located off-site with root systems that extend into the property, as indicated on the attached tree plan drawing. (See the Tree Table below for details of the tree inventory.)

Figure-2 Mature Douglas-fir and two boulevard ash trees

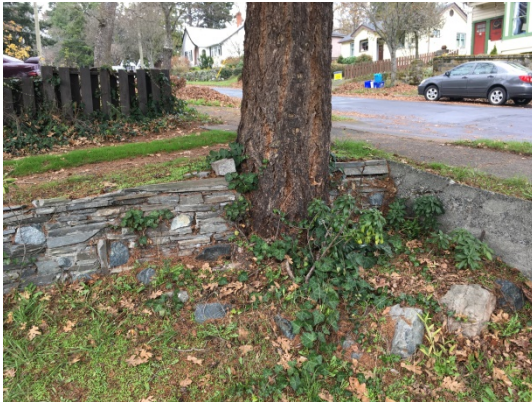
The site plan indicates a sub-division of the present residential lot into two smaller lots. A new house is proposed for the upper lot. The siting of the new house has in part been determined in consultation with the neighbour to the north, who has sight lines that he wishes to retain and would be obscured were the house to be sited further toward the rear of the lot. Building setbacks for the new zoning of the upper lot are another constraint. The proposed house encroaches by 2.75m into the west portion of the *protected root zone* (PRZ) of the fir tree (Tree 001 on the tree plan), which has an estimated root radius of 8m; however, the root investigation described above indicates that the house could be placed where proposed without compromising the health or stability of the fir, provided best management practices are followed during the excavation for the house foundation.

Figure-3 Douglas-fir 001 and retaining walls

The proposed driveway for the upper lot encroaches into the PRZ of both the fir tree (TR-001) and boulevard tree BT-002. In order to mitigate potential impacts to the root systems of these two trees, the following design changes have been made:

- The original driveway width has been narrowed;
- The finished elevation and the cross-section design of the driveway have been modified to allow the excavated bed for the driveway to remain above the ceiling of the tree root horizon. (See the cross-section detail provided on the tree plan).

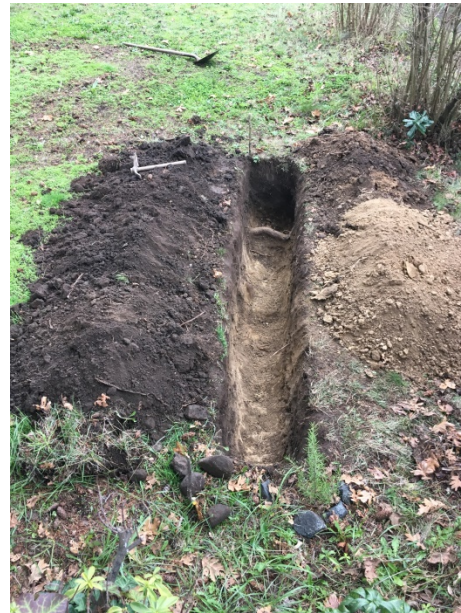
A visual assessment was completed of a single bylaw-protected tree located in the front yard in relation to a conceptual site plan. A trench was hand dug 4.1m west of the tree close to the front wall of a proposed new home in order to investigate the depth of the root horizon and the number and size of tree roots at this location that might be impacted. The trench was

2.5m long and 60cm deep. Two fir roots were found: one 5.5 cm diameter crossed the trench, while 5 cm root was revealed at the east side of the trench and appeared to be a sinker root. The roots were below the A horizon and within clay.

Figure-4 Exploratory trench
