Talbot Mackenzie & Associates

1114 Rockland Ave, Victoria

Construction Impact Assessment &

Tree Preservation Plan

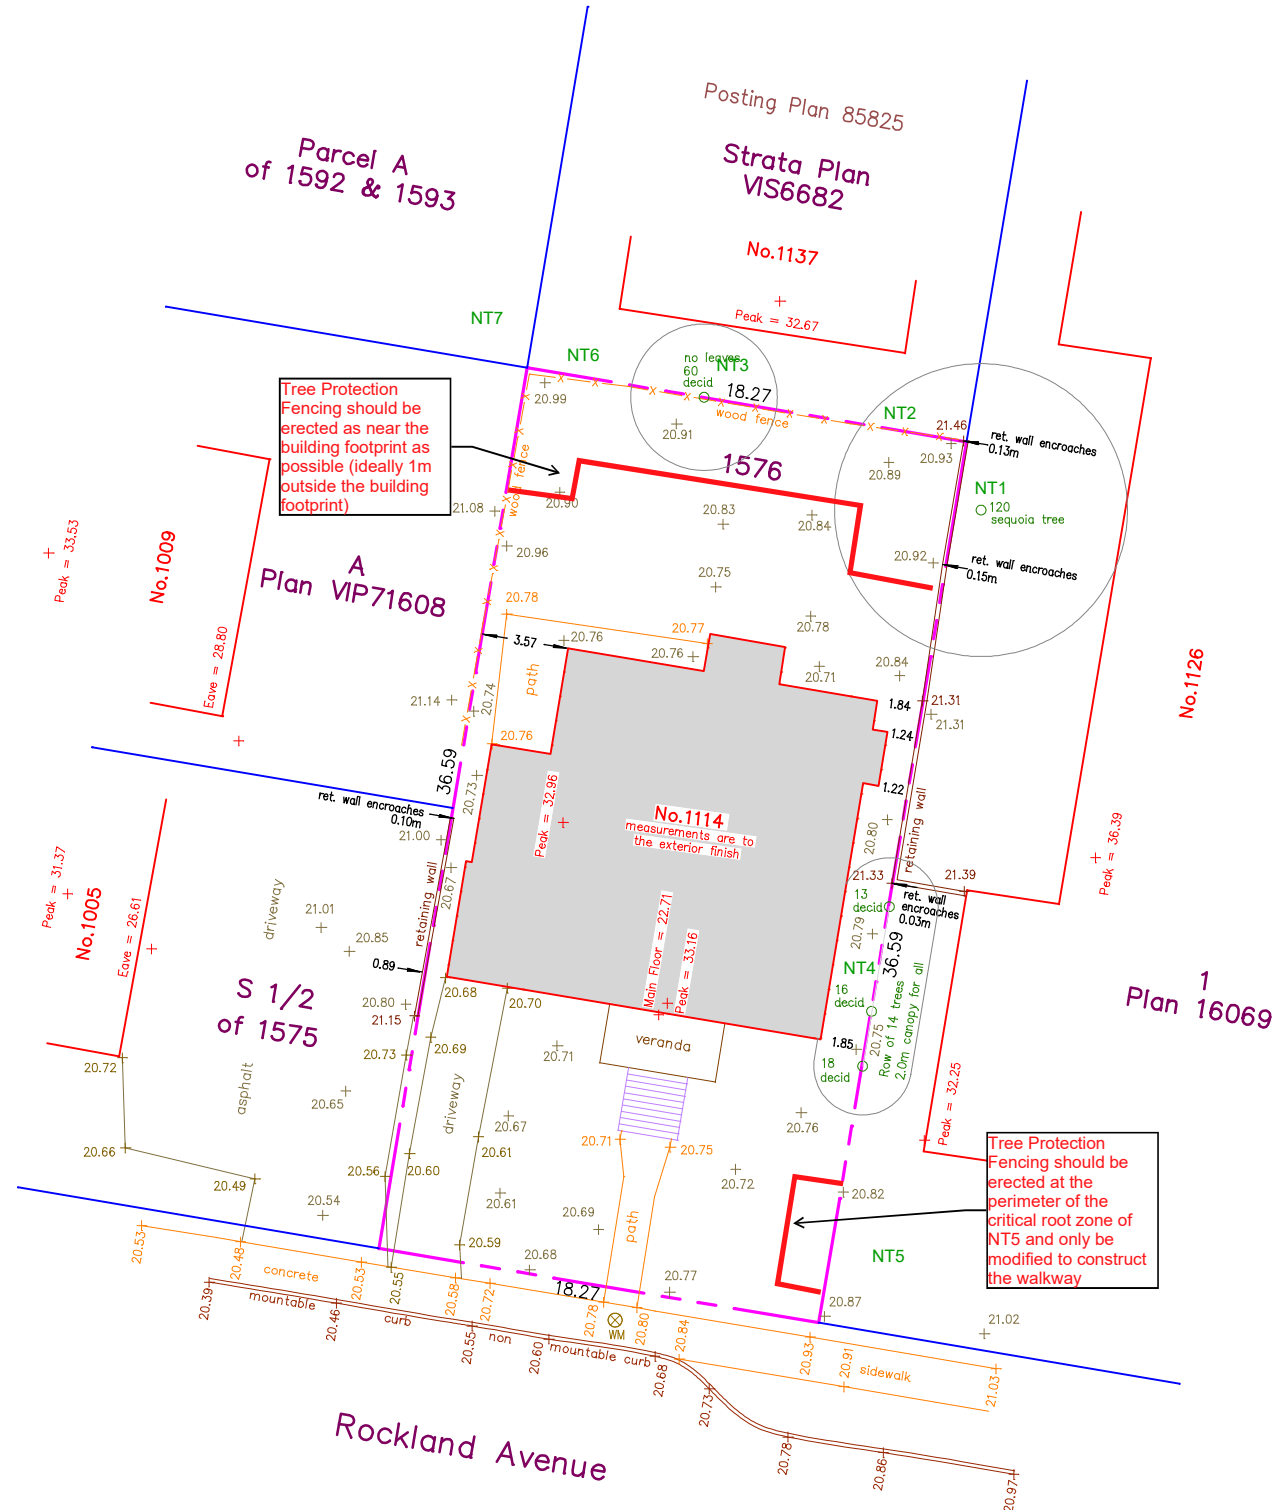
Tree Protection Fencing should be erected as near the building footprint as possible (ideally 1m outside the building footprint)

Tree Protection Fencing should be erected at the perimeter of the critical root zone of NT5 and only be modified to construct the walkway

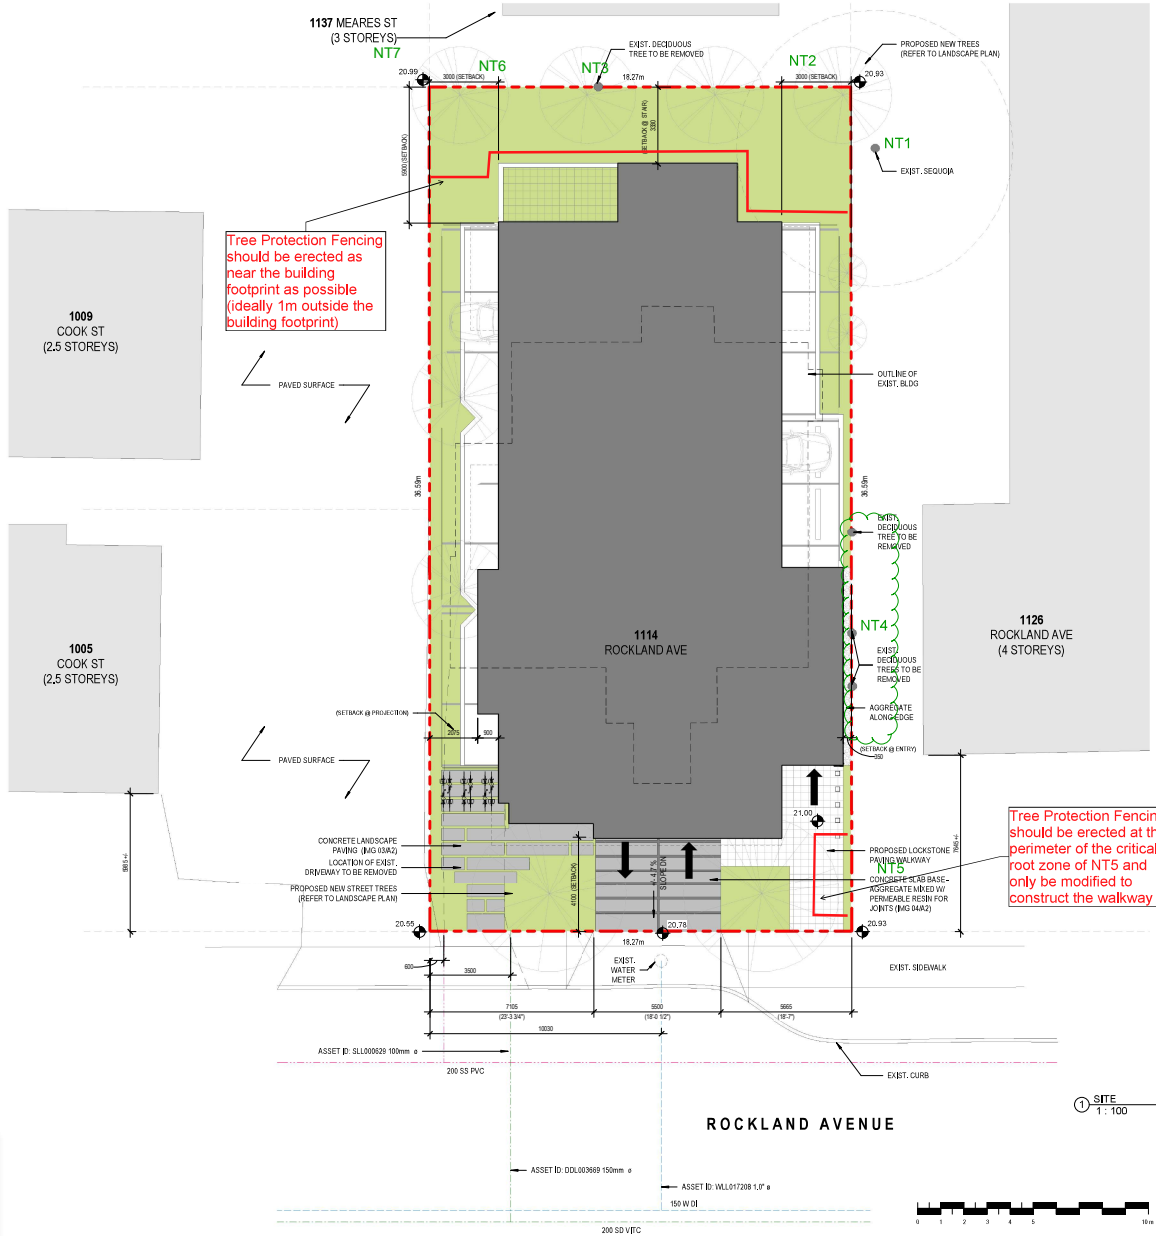
Tree Protection Fencing should be erected as near the building footprint as possible (ideally 1m outside the building footprint)

Tree Protection Fencing should be erected at the perimeter of the critical root zone of NT5 and only be modified to construct the walkway
