# 3130 Jutland Road, Victoria, BC

## Construction Impact Assessment &

## Tree Management Plan

PREPARED FOR:	TL Housing Solutions 1212 – 450 SW Marine Drive Vancouver, BC V5X 0C3
PREPARED BY:	Talbot, Mackenzie & Associates Noah Talbot – Consulting Arborist ISA Certified # PN-6822A Tree Risk Assessment Qualified
DATE OF ISSUANCE:	December 10, 2020

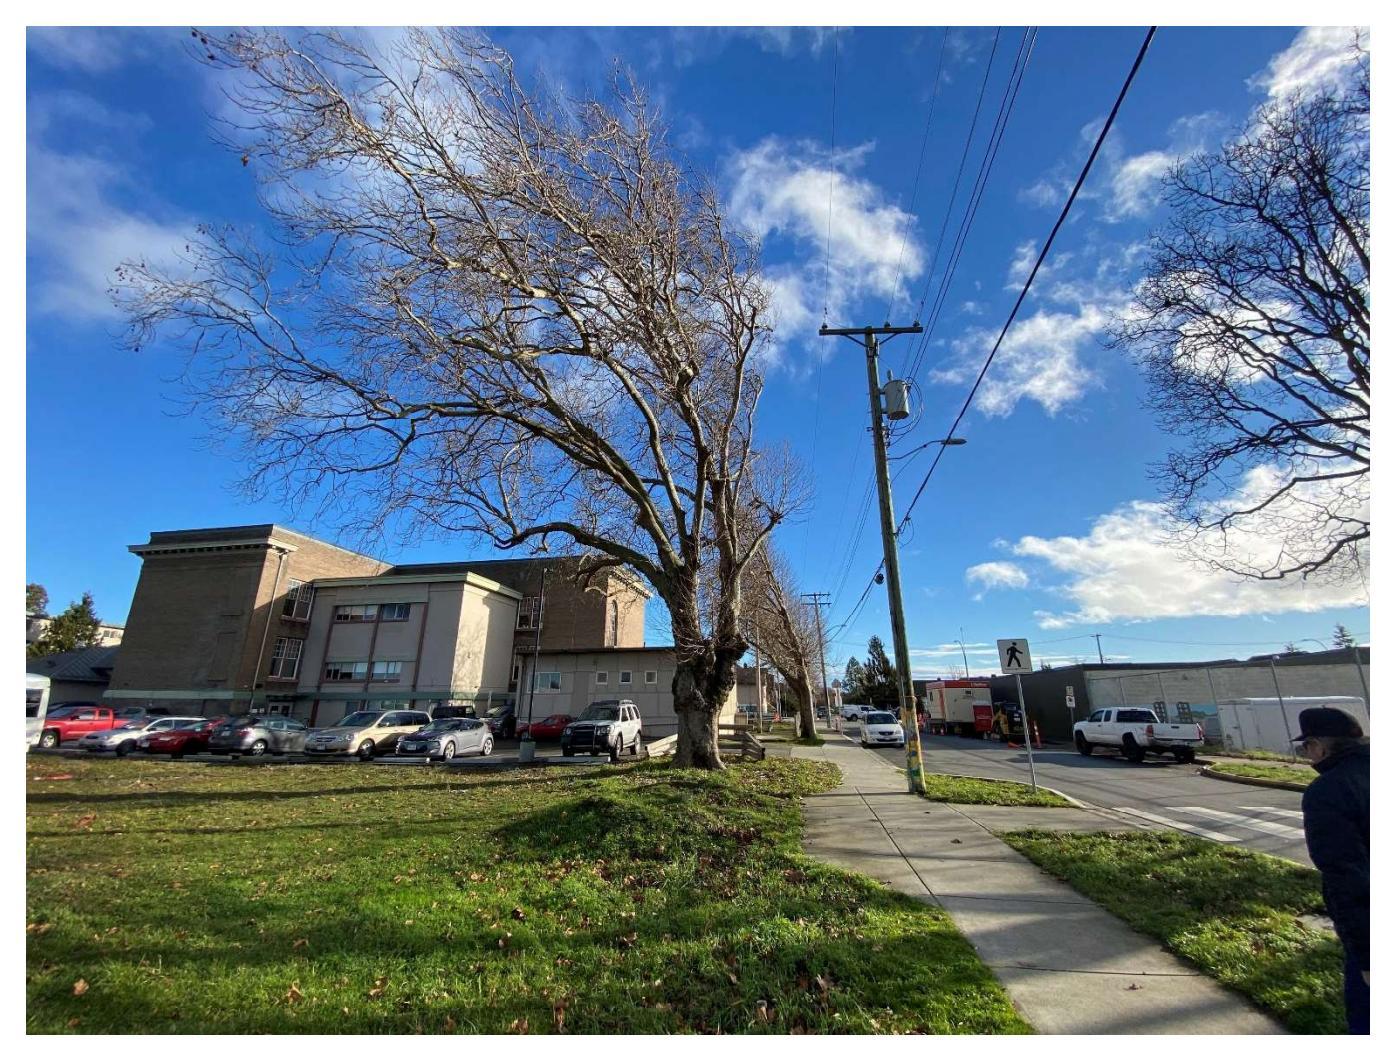
Photograph 1. Onsite London Plane (NT 4).

- 1. Onsite London plane (NT 4):
- All excavation within the critical root zone during proposed storm and sanitary sewer service installations (refer to Stantec civil servicing drawing).

- All excavation and fill placement required within the critical root zone to remove the existing turf and install new reinforced grass, for the proposed fire truck access (refer to LADR Landscape Architects - Landscape drawing).

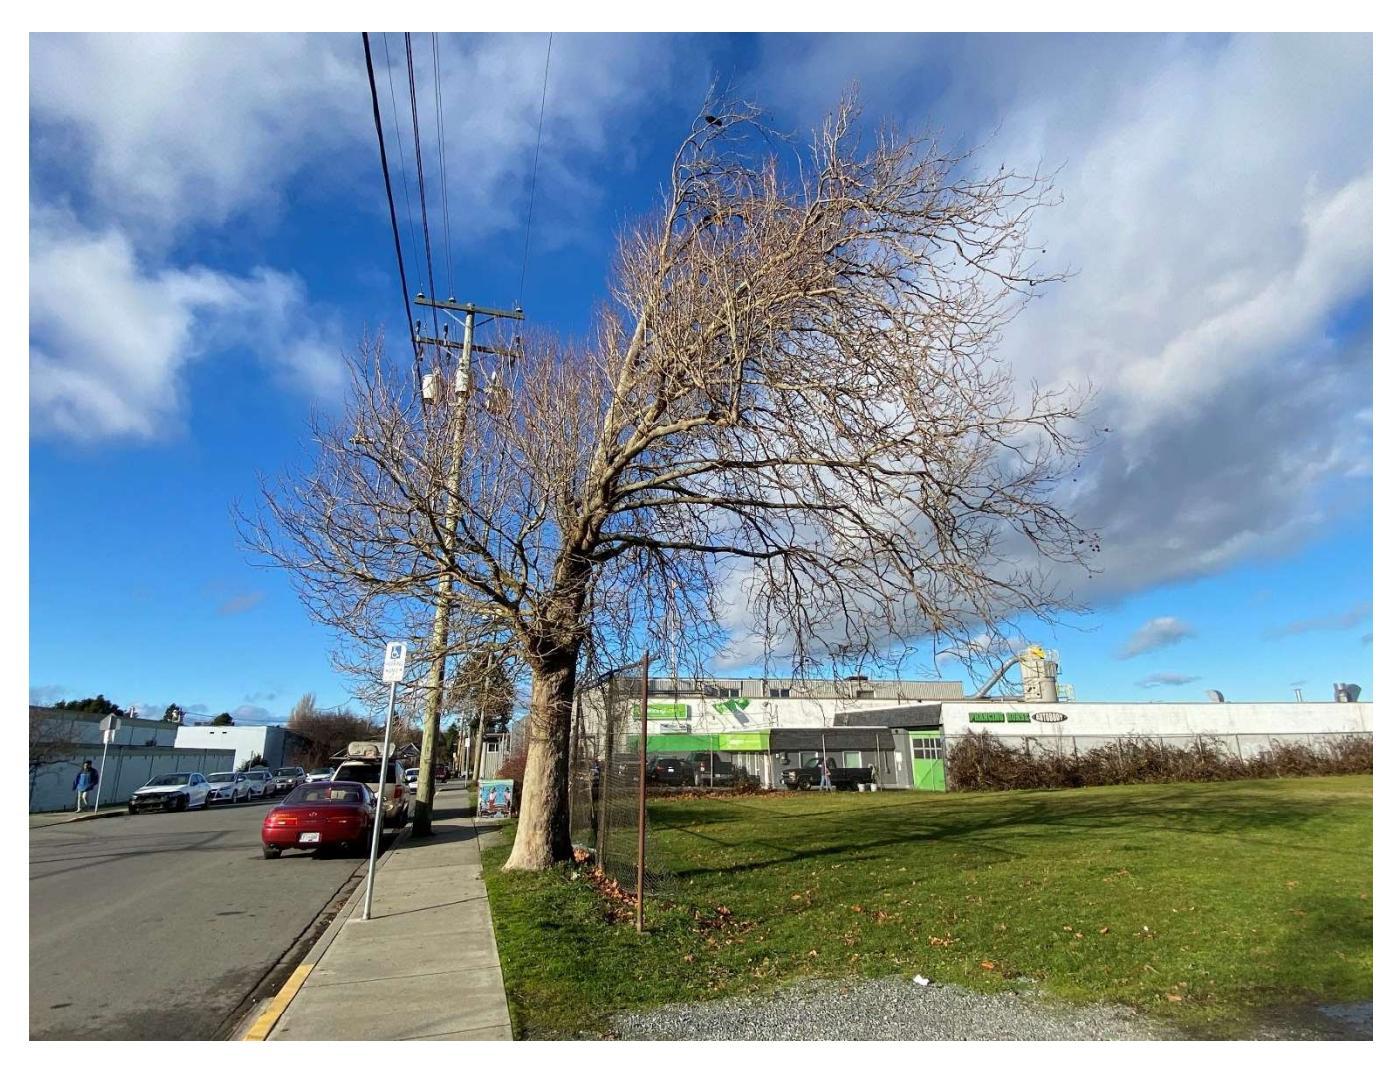
Photograph 2. Municipal London Plane (NT5).

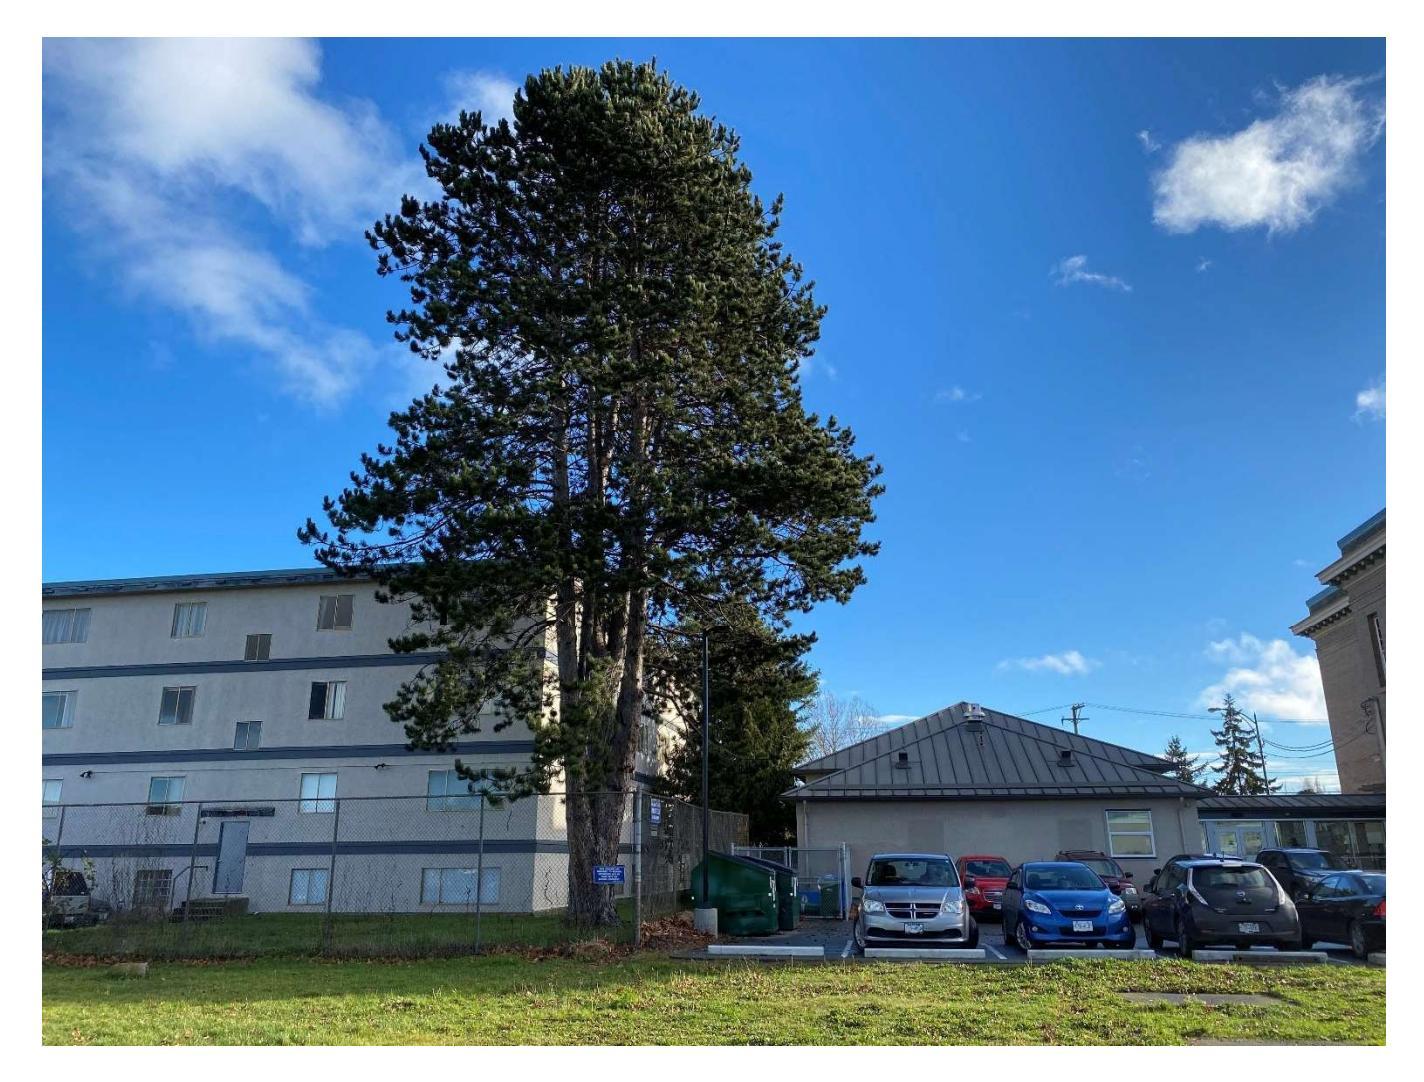
The onsite tree resource consists of 1 London Plane tree (NT 4), located at the Southwest corner of the property. The offsite tree resource consists of 1 London Plane tree (NT 5) located on the Cecelia Road frontage, and 1 Austrian pine (NT 6) located on the neighbouring property at 3150 Jutland Road. The subject site is an open field, and all three trees included in the inventory are growing singularly, in open landscape conditions (see *figure 1*). London Plane NT 4 and NT 5 have been heavily side pruned historically for hydro clearance pruning (see photographs 1 and 2 - *appendix B*). Offsite Austrian pine (NT 6) was observed to has included bark at the stem unions (see photograph 3 – *appendix B*).

Photograph 3. Offsite Austrian pine (NT6).

- 3. Private offsite Austrian pine (NT 6):
- All excavation within the critical root zone during exaction required for the footprint of the proposed underground parkade (refer to Christine Lintott Architects architectural site plan).

- All excavation and fill placement required within the critical root zone to remove the existing turf and install new walkway (refer to LADR Landscape Architects Landscape drawing).

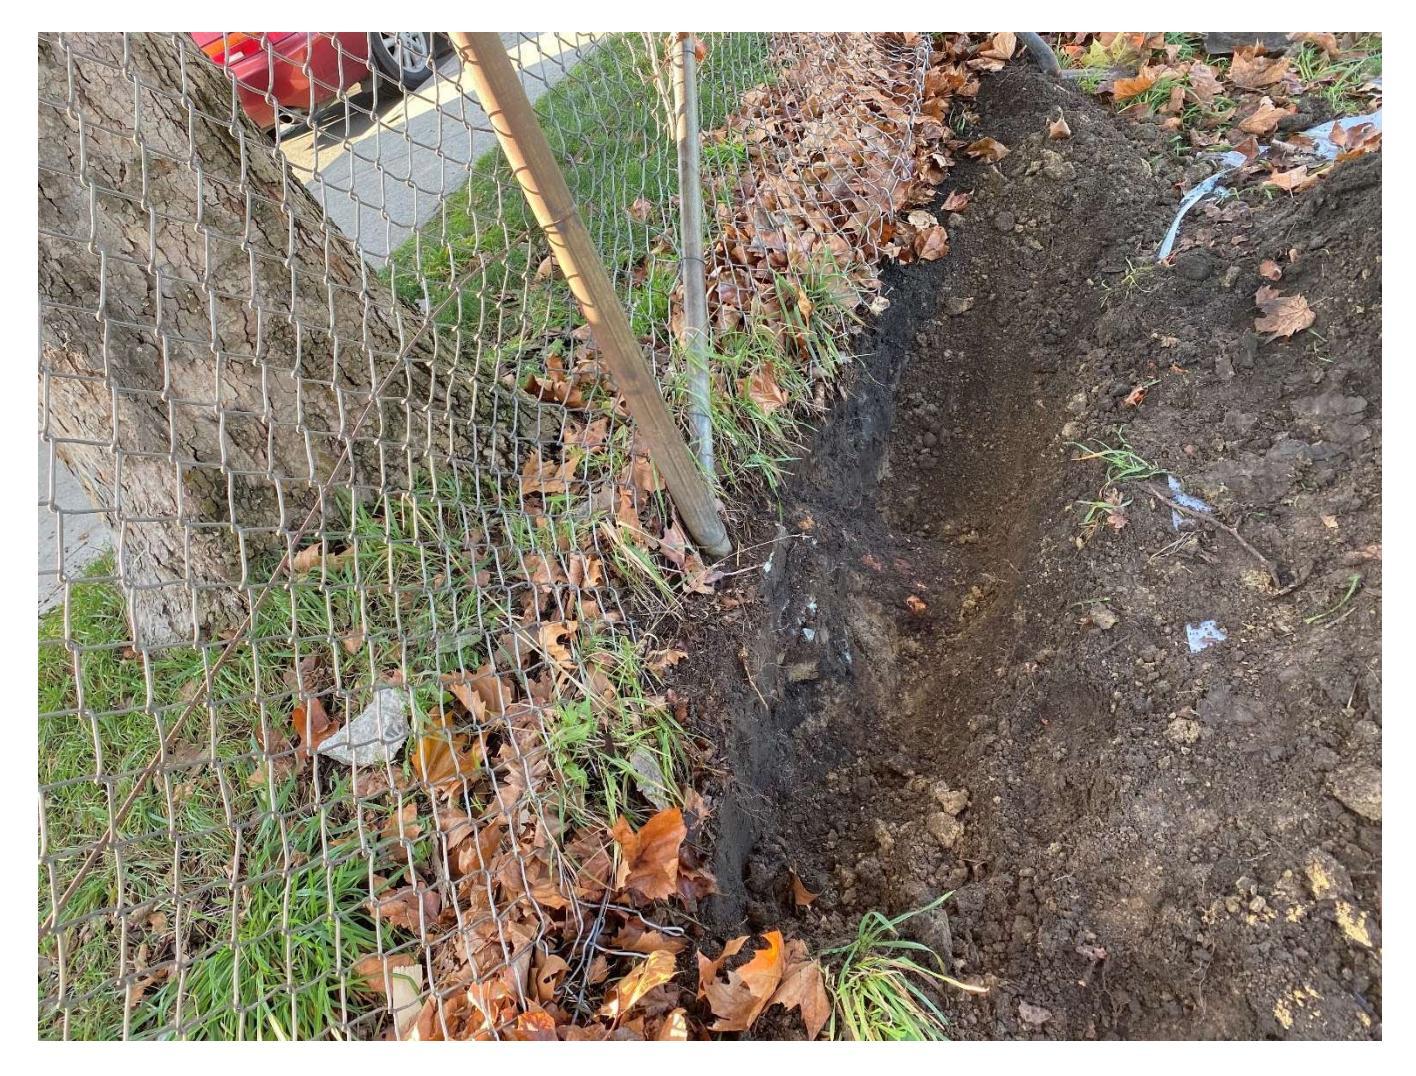
- Hand excavation was performed along the existing fence line (which is approximately the property boundary). The West edge of the exploratory trench is 0.8 meters from the center of the stem of NT 5.
- The depth of the exploratory excavation was 0.4 meters below the existing grade (at the location of the proposed sidewalk footprint).

- A large buttress root (approximately 35 cm diameter) was encountered (see photographs 4 and 5 in *appendix B*) at 0.8 meters distance from the center of the stem of NT5). This root was observed to grow sharply downward at approximately the property boundary, then grows horizontally at 1.1 meters from the center of the stem.

- The topside of the root is approximately 40 cm below the existing grade at a distance of 1.1 meters from the center of the stem of NT 5.
- No other roots were encountered from this tree, along the limits of our exploratory excavation.

Photograph 4 – Municipal London Plane (NT5) – Exploratory excavation to determine root depth within the proposed sidewalk footprint.

- An asphalt sidewalk is recommended, within the critical root zone of NT5, due to the close proximity of the proposed sidewalk to the trunk and root flare. There will not be sufficient working space for concrete forming on the West side of the proposed sidewalk.

- The sidewalk must be constructed above the elevation of the buttress root that was exposed by exploratory excavation. If the sidewalk is constructed in its proposed location, excavation cannot occur below the existing grade that would require the removal of this structural root.

- If a narrower sidewalk is possible, or if it can be shifted East no closer than 1.1 meters from the center of the tree, it would avoid the conflicts with the root flare of NT 5, and could be constructed at grade (using concrete).

- It is recommended that the project arborist review a grading plan, once one is available, to review the proposed site grading within the critical root zone of NT 5.

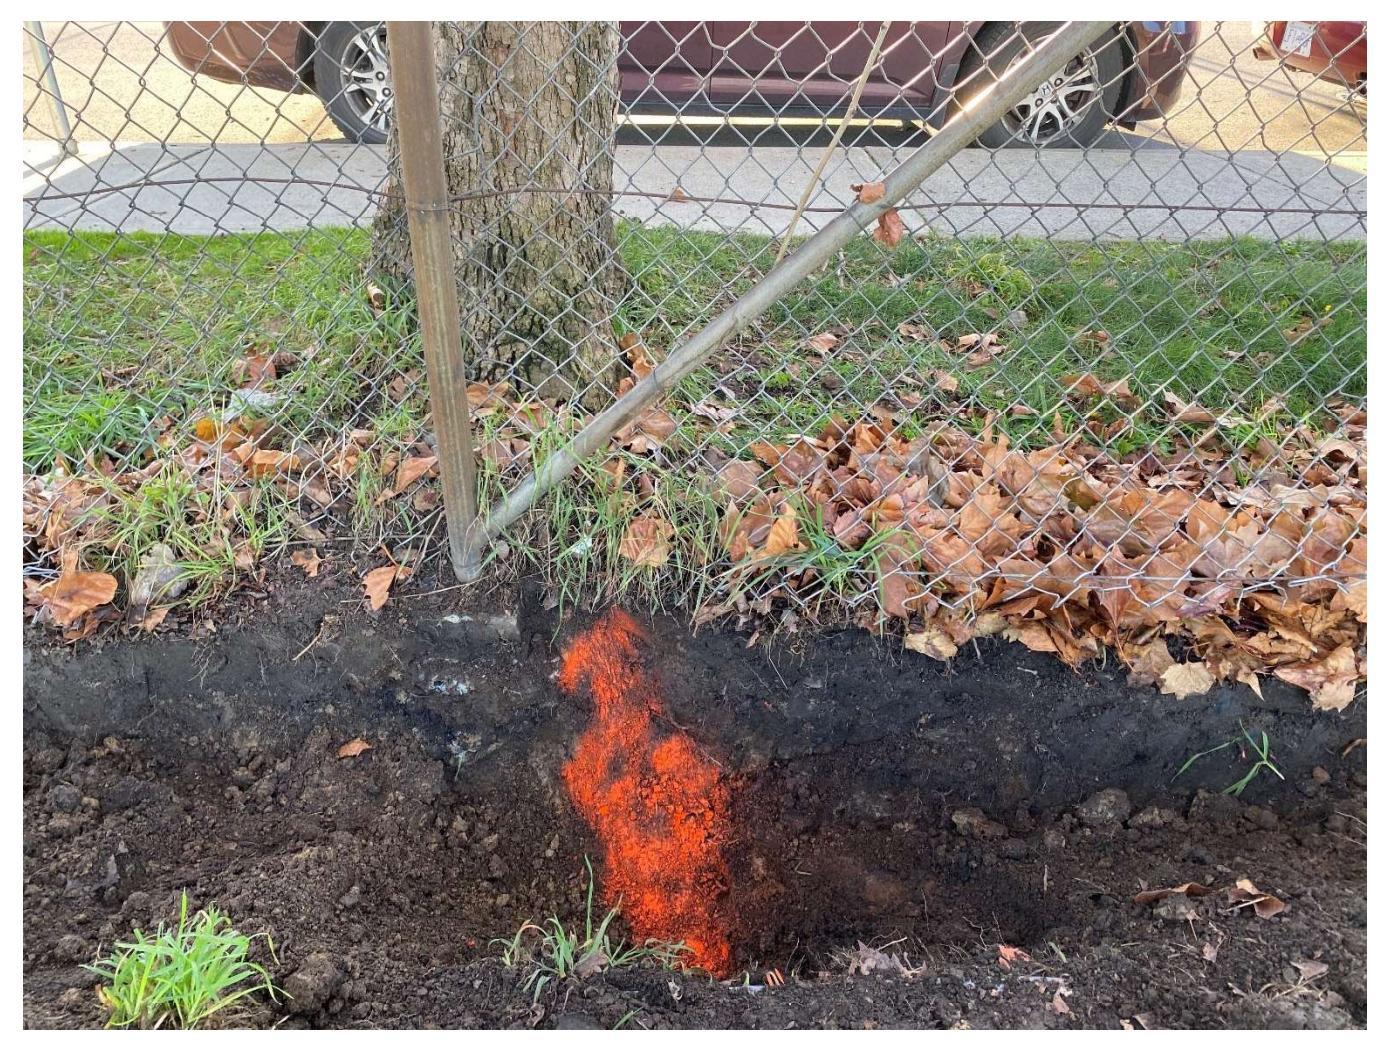
- Based on the results of the exploratory excavation, the proposed new sidewalk is conflicting with the root flare of the tree; therefore the following is recommended:

Photograph 5 – Large buttress root (painted orange) found within the exploratory trench. No other roots were found during exploratory excavation.
