January 21, 2021

Scott Davies, Cube Project Management Ltd., 1605 - 728 Yates St., Victoria BC V8W 0C8

As requested I have visited the site and reviewed the trees on site. Figure 1 is a survey plan of the trees. Table 1 provides details about each tree.

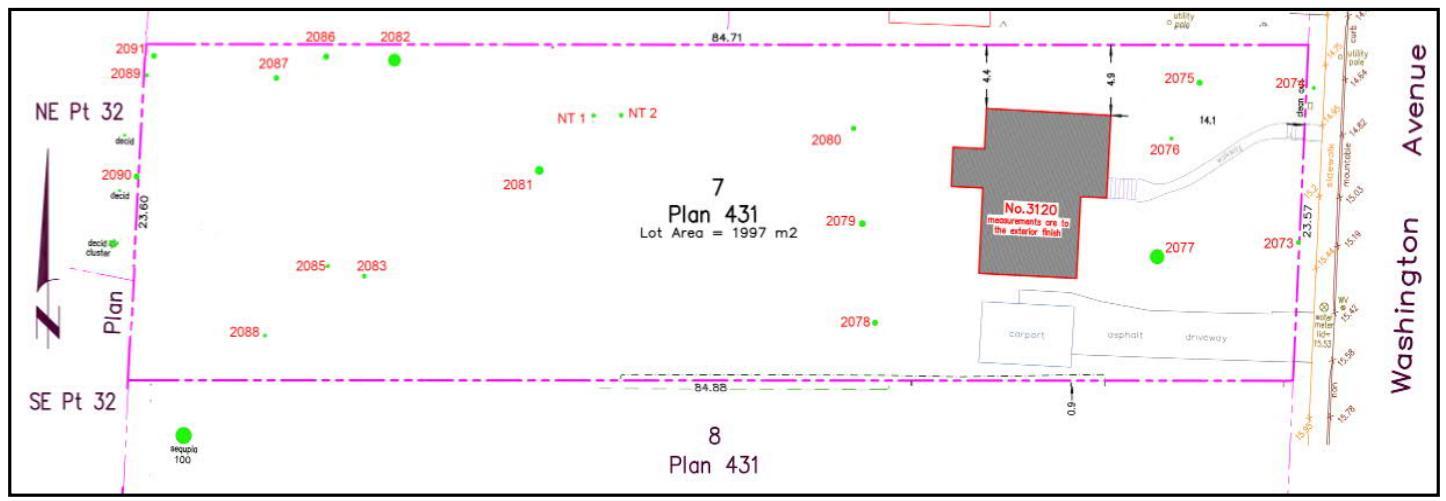
Figure 1. Location of trees on site.

There are 11 bylaw sized trees on site. One tree (# 2074) is on City property. There is also a bylaw sized sequoia tree on the adjacent property in the south west corner. Two trees straddle the property line. One of those (# 2073) is between the site and City land. The other (# 2090) is at the west end of the site. The proposed works will require removal of all but four of the trees on site. That means removal of 16 trees, of which 8 are not protected trees, and 8 are protected trees. The four trees to be retained are one Garry Oak (# 2082), and 3 hawthorns ((#2089, #2090, #2091).

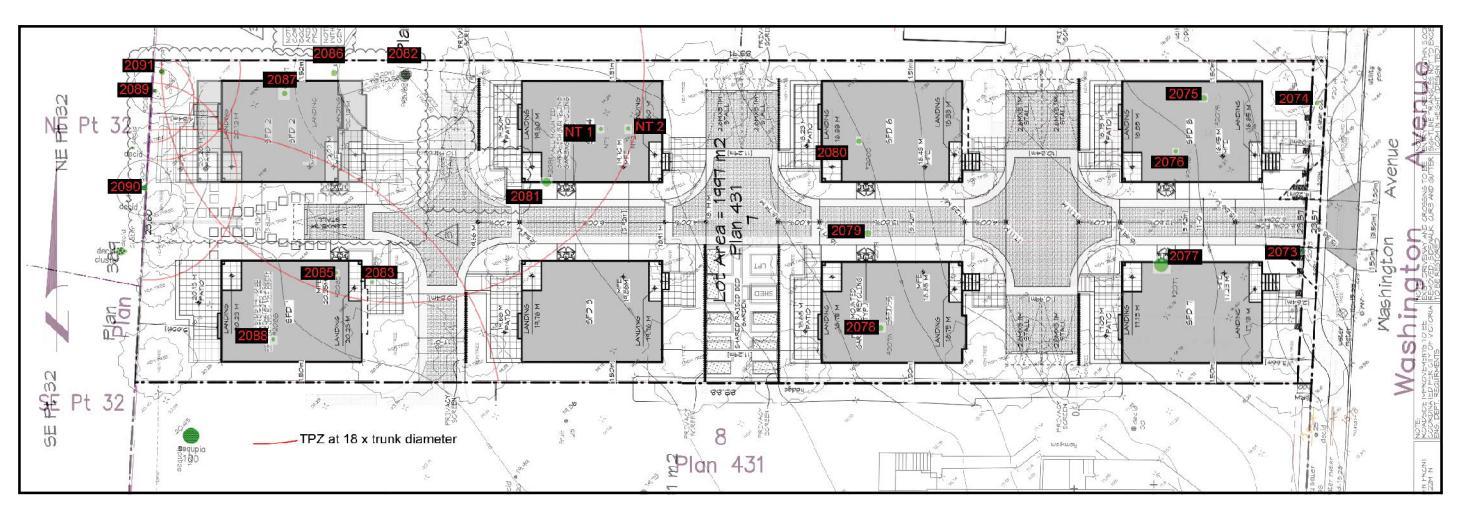
Figure 2. Proposed design with building footprints.

Figure 2 shows the footprints of the eight units planned. I have also included the tree protection zones for the trees to be retained. The three hawthorn trees along the west boundary (#2089, #2090, #2091) are all small and are also being retained. There may be a need to prune back some parts of them to clean them up after many years of bramble growth. Since that part of the site is a rear yard there will not be a major disturbance affecting them.

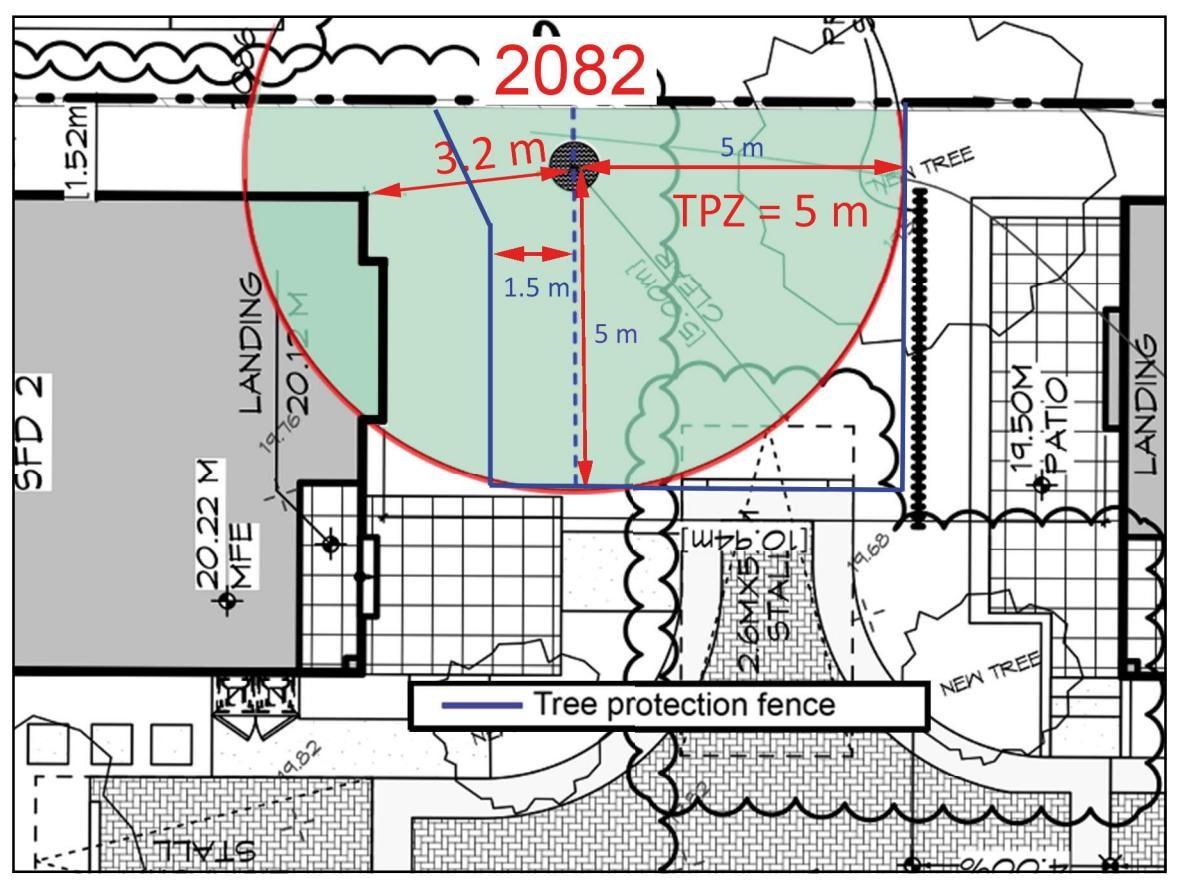
Figure 4. Fencing detail by tree # 2082.

The original design had this unit set further back to offer more protection for the tree. Council rejected that design on the basis that the rear yard would be too small, so the unit is now located in line with the other unit in the south west corner. In the new design the corner of new house is 3.2 metres from the centre of the oak tree. In order to try and ensure effective retention of the Garry oak tree I have worked with the design team to come up with a way to minimise the disturbance to the ground and roots in this area. The new design will see the north east corner of the house built on a grade beam installed on helical piles. The base of the beam is designed to be above ground, and the slab beyond it is poured on top of a gravel base so that there is no disturbance of the existing soils within the 5 metre TPZ. The parking space for the unit to the east has been modified to get it away from the TPZ, the patio for the unit in the north west corner has been modified, and the landscape irrigation will be surface drip lines or spray heads installed outside of the TPZ.

The oak tree (# 2082) shall be fenced off as shown in figure 4 below.

The tree protection zone (TPZ) is set at a radial distance of 5 metres from the centre of the tree (the green area in figure 4). The fence shall extend 5 metres to the east and 5 metres to the south. Using a north - south line from the centre of the tree (dashed blue line in figure 4), set the west side of the fence 1.5 metres to the west of that centreline. Closer to the tree, angle the fence over towards the boundary.

1 **Prior to any other site preparation**, the oak tree shall be fenced off at as shown in detail in Figure 4.

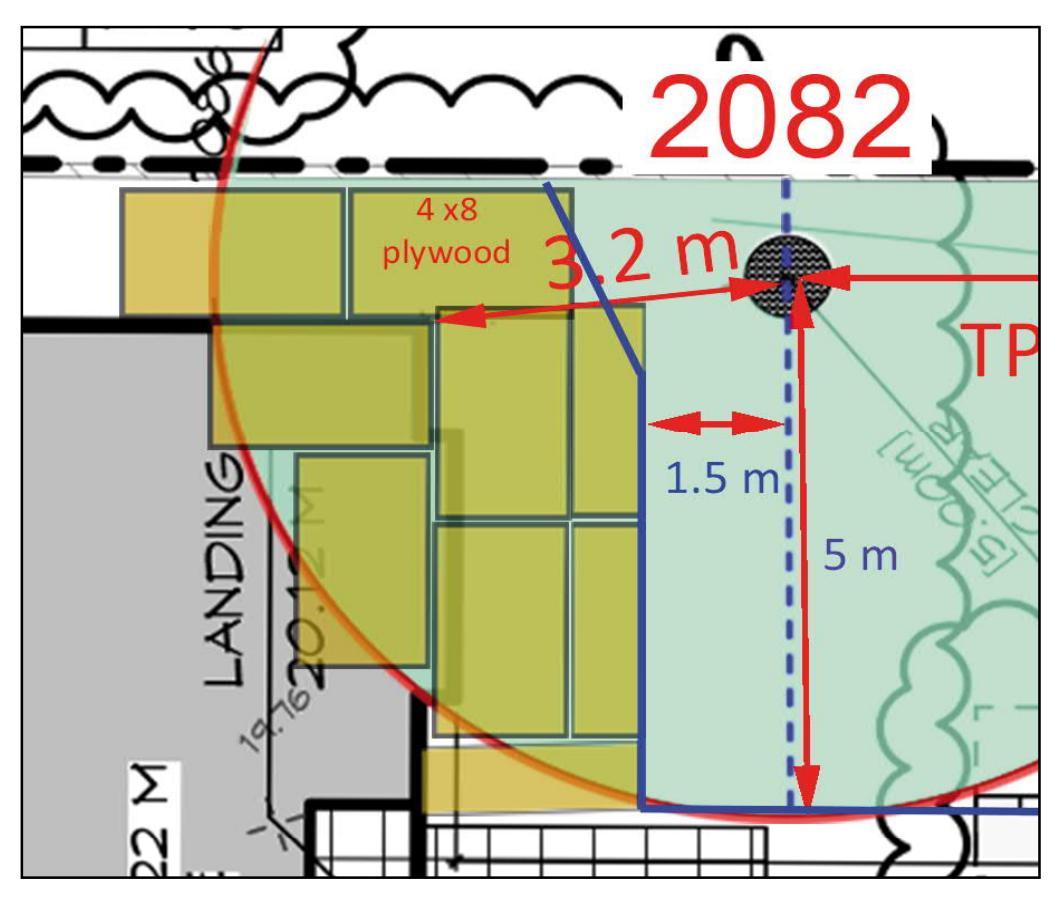
Figure 5. Conceptual layout of plywood beyond fence, and under grade beam and slab.

The intent of this plywood is to protect the ground below from any further compaction, and root damage. The area beyond the wall will create a working space of 6 feet or about 1.83 metres (1 and half sheets of plywood wide). The rest of the plywood protects the ground that will be under the grade beam and slab.

2 Once the protection fence is in place around the oak tree, sheets of 5/8" plywood shall be laid down on the ground as shown in figure 5. The sheets should be screwed together with wood strips or plywood overlaps.

The grade beam will be placed onto a series of helical piles. The machine used to drive these piles shall operate from the west side and shall approach the location by driving on the plywood area that will be inside the planned building footprint. If necessary, double the plywood within the footprint area to sustain the machine load. Once the piles are installed, the formwork for the grade beam can be created. That will need a base layer for the bottom of the form, so that can be created with plywood on the native soil. Minor flattening of the existing soil will be fine in order to create the formwork, but no excavation is permitted without first checking with the project arborist. NOTE. The base of the grade beam is above ground not recessed into the ground. It may be wise to place that base layer of the beam form on wood spacers. These can then be knocked out after curing so that the plywood can be stripped off from the beam.
