# Village Gardens Development

### Construction Impact Assessment &

### Tree Preservation Plan

Date of Issuance: June 12, 2020  
*Revised:* December 9, 2020  
(changes marked with a red asterisk \*)

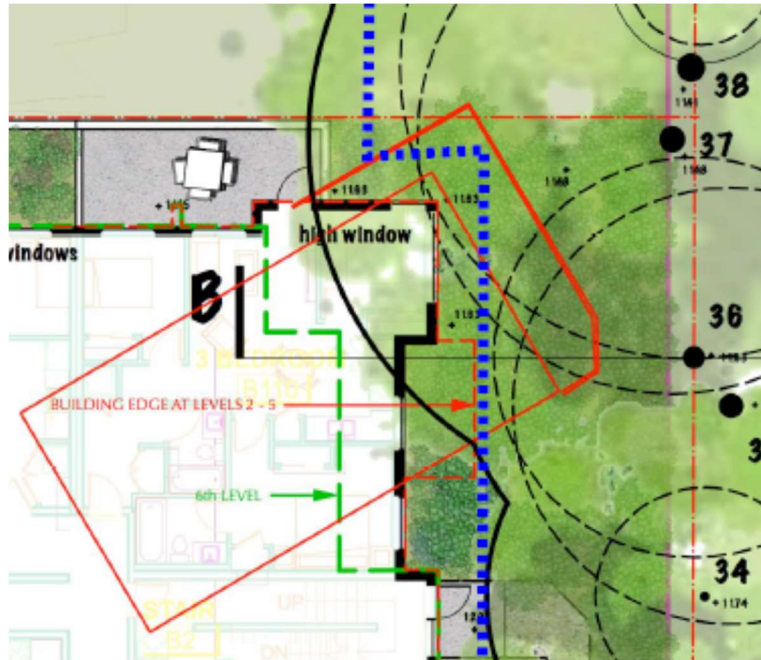
We do not anticipate a significant impact as a result of the foundation or parkade excavations (the parkade is farther away from this tree than the other elms). However, approximately 40-50% of the live canopy of the tree will require removal if 1m of clearance from the building and balconies is desired (see photographs #1 and 2, and Figures #1 and 2 for close-ups of the landscape plan).

Figure 1: Close-up of building extents in relation to elm #37. The red rectangle is an existing paved picnic table area.

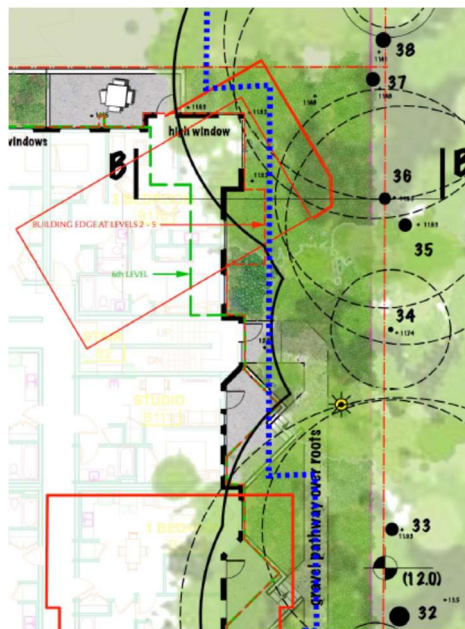
Figure 2 (right): Farther view of same plan.

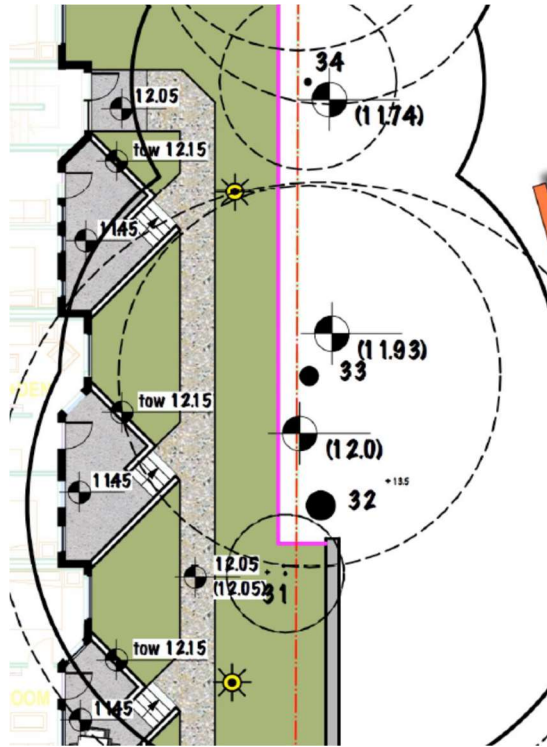
The permeable gravel pathway proposed through the root zones of the elm trees #32-37 (see Figure 3) should be constructed above existing grade in order to avoid root loss. The grading plan shows the plan at the same grade as existing (12.05m); in reality, the gravel may be slightly above existing if surface roots are encountered immediately. Any excavation should be supervised by the project arborist.

Figure 3: Grading plan for the gravel pathway within the CRZs of retained elms trees.

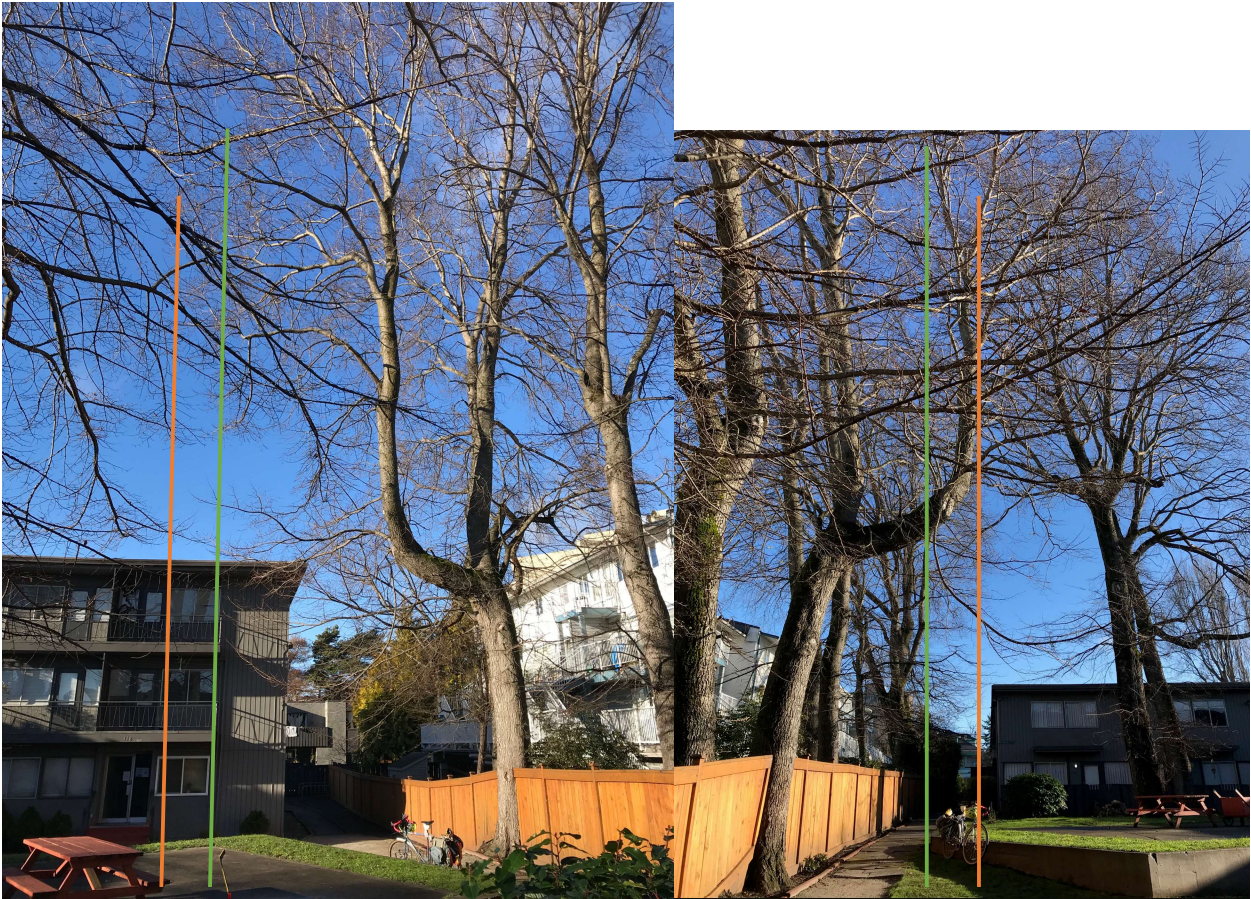
A codominant union exists at 6m above ground and the larger stem leans and conflicts with the proposed building façade and to a lesser extent the balconies. The main trunk of the stem will not require removal, but almost all of the horizontal limbs will have to be removed or reduced. Elms will typically sucker rapidly and therefore reducing some limbs to branch stubs may be preferable instead of removal wounds to the trunk (there does not appear to be many suitable laterals to cut back to as almost all of the live growth is at the ends of the limbs).

*Photographs #1 (left photo, facing west) and #2 (right photo, facing east towards Menzies St):  
The red lines indicate the approximate location of the closest building corner to elm #37. The orange lines  
indicate the approximate location where minimum pruning cuts would be to allow 1m of clearance from the  
building and balconies.*

**\*This pruning will likely result in sucker growth from the pruning wounds and along the length of this stem. If an attempt is made to properly restructure the tree after building clearance pruning, it will likely require ongoing cyclical pruning in the long-term.**
