TALBOT MACKENZIE & ASSOCIATES

Construction Impact Assessment & Tree Management Plan

2621 Douglas Street

DATE OF ISSUANCE: December 16, 2020

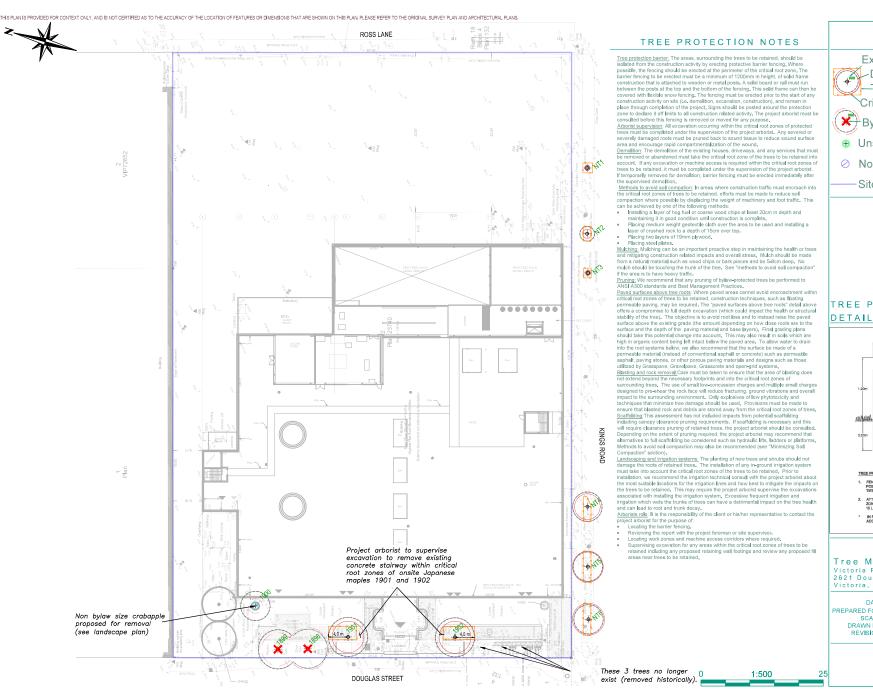
APPENDIX A - TREE MANAGEMENT PLAN (T1)

The following municipal trees (indicated by ID #) are located where they is possible for retention providing that their critical root zones are adequately protected during construction. The project arborist must be onsite to supervise and excavation or fill placement required within the critical root zone (shown on the tree management plan (T1) in *appendix A*):

The following <u>Bylaw protected</u> size onsite trees (indicated by tag #) are located where they are possible for retention providing that their critical root zones are adequately protected during construction. The project arborist must be onsite to supervise and excavation or fill placement required within their critical root zones (shown on the tree management plan (T1) in *appendix A*):

Tree Protection Barrier: The areas, surrounding the trees to be retained should be isolated from the construction activity by erecting protective barrier fencing (see *Appendix A* for municipal barrier specifications). Where possible, the fencing should be erected at the perimeter of the critical root zone. The barrier fencing to be erected

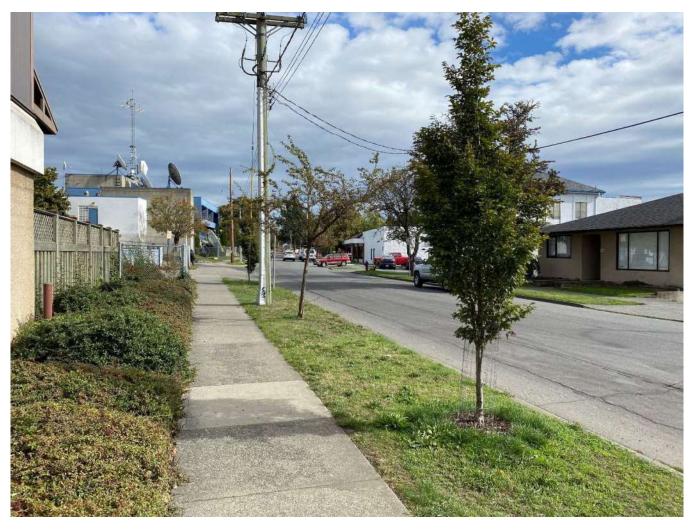
| Location Tag (On, Off, | | | | Name | | | | Critical | | Condition | | Retention | | | | |
|---|---|---|---|---|---|---|---|---|---|---|---|---|---|---|--|---|
| NT1 | City | No | Yes | Upright European hornbeam | Carpinus betulus 'fastigiate' | 5 | 4 | 0.53 | 0.5 | Good | Good | | Good | Located on municipal boulevard, juvenile tree. | Project arborist to supervise any excavation required within the critical root zone. | Retain |
| NT2 | City | No | Yes | English hawthorn | Craetagus laevigata | 9 | 4 | 0.95 | 1.5 | Fair | Fair | | Good | Located on municipal boulevard, weed water damage at root collar. | Project arborist to supervise any excavation required within the critical root zone. | Retain |
| NT3 | City | No | Yes | Upright European hornbeam | Carpinus betulus 'fastigiate' | 4 | 4 | 0.42 | 0.5 | Good | Good | | Good | Located on municipal boulevard, juvenile tree. | Project arborist to supervise any excavation required within the critical root zone. | Retain |

Photograph 1. City trees NT1, NT2 & NT3 located on the Kings Road frontage.

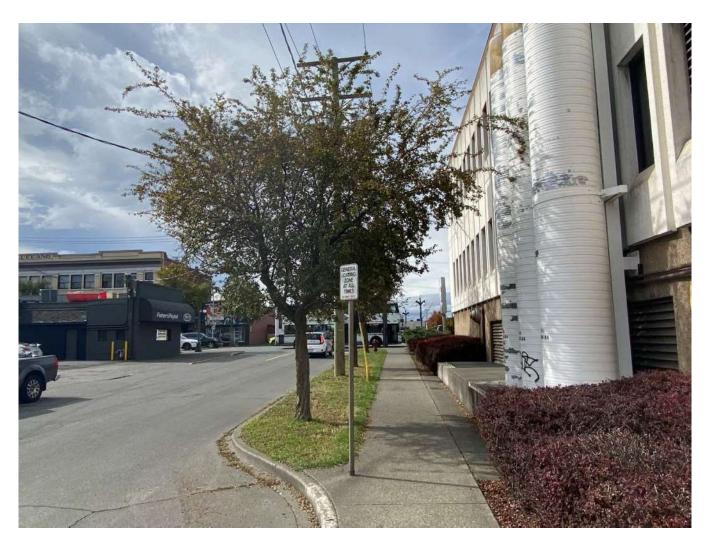
| Location Tag (On, Off, | | | | Name | | | | Critical | | Condition | | Retention | | | | |
|---|---|---|---|---|---|---|---|---|---|---|---|---|---|---|--|---|
| NT4 | City | Yes | Yes | English hawthorn | Craetagus laevigata | 25 | 6 | 2.63 | 3 | Fair/good | Fair/good | | Good | Located on municipal boulevard, beginning to conflict with overhead utilities, multiple leaders form at 2m above grade - no major weaknesses visible at stem unions. | Project arborist to supervise any excavation required within the critical root zone. | Retain |
| NT5 | City | Yes | Yes | English hawthorn | Craetagus Iaevigata | 30 | 6 | 3.15 | 3 | Fair/good | Fair/good | | Good | Located on municipal boulevard, beginning to conflict with overhead utilities, codominant leaders form at 2m above grade - no major weaknesses visible at stem union, historic pruning wounds with associated surface decay. | Project arborist to supervise any excavation required within the critical root zone. | Retain |
| NT6 | City | Yes | Yes | English hawthorn | Craetagus Iaevigata | 31 | 6 | 3.26 | 3 | Fair/good | Fair/good | | Good | Located on municipal boulevard, beginning to conflict with overhead utilities, multiple leaders form at 2m above grade - no major weaknesses visible at stem unions, pruning and small tear out wounds with associated surface decay. | Project arborist to supervise any excavation required within the critical root zone. | Retain |

Photograph 2 – City trees NT4, NT5 & NT6 located on the Kings Road frontage.

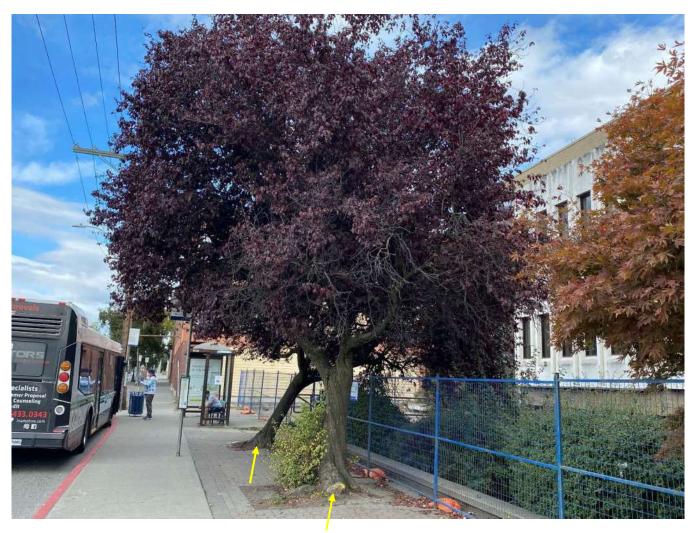
1898, 1899.

Photograph 3 – Yellow arrows indicate location of onsite plum trees 1898 (front), and 1899 (back).

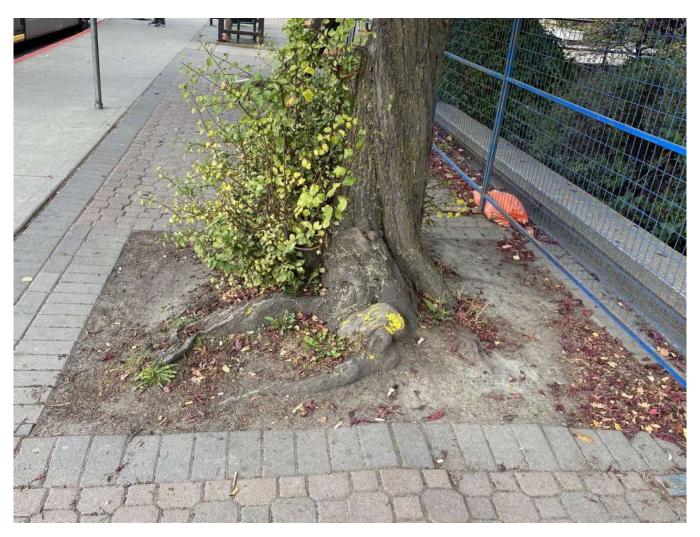
Based on review of the Landscape plans and site servicing plan, 2 bylaw protected size onsite plum trees are proposed for removal due to impacts associated with the proposed new sidewalk design. An additional 1 non bylaw protected size onsite crabapple tree is proposed for removal due to due to impacts associated with the proposed new landscape design. The three trees proposed for removal were rated unsuitable for retention, due to their existing structural defects, poor rooting environment and poor soil conditions. Plum 1898 is infected with the wood decay pathogen *Ganodema applanatum*.

| Location Tag (On, Off, | | | | Name | | | | Critical | | Condition | | Retention | | | | |
|---|---|---|---|---|---|---|---|---|---|---|---|---|---|---|--|---|
| | On | Yes | Yes | Purple leaf plum | Prunus cerasifera | 41 | 7 | 4.31 | 4 | Fair/good | Fair/poor | Unsuitable | Good | Located on municipal property, heavily compacted soils surrounding root collar, growing within confined area (existing concrete retaining wall to East, existing concrete sidewalk to West, existing brick pavers to North and South), Ganodema applanatum fruiting bodies attached to root collar, suckering from base, injuries to topsides of surface roots with associated decay. | Located within footprint of the proposed new sidewalk. | Remove |

Photograph 4 – Closeup of root collar and existing growing conditions of onsite plum (tag# 1898).

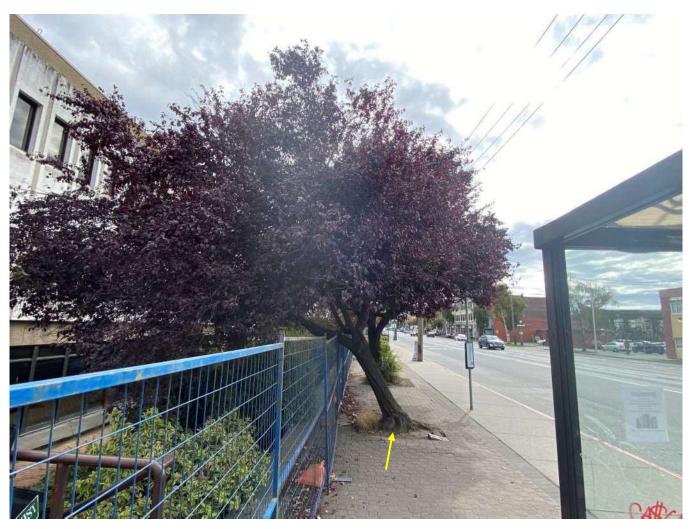
| Location Tag (On, Off, | | | | Name | | | | Critical | | Condition | | Retention | | | | |
|---|---|---|---|---|---|---|---|---|---|---|---|---|---|---|--|---|
| 1899 | On | Yes | Yes | Purple leaf | Prunus cerasifera | 32 | 7 | 3.36 | 4 | | Fair/poor | Unsuitable | Good | Located on municipal property, heavily compacted soils surrounding root collar, growing within confined area (existing concrete retaining wall to East, existing concrete sidewalk to West, existing brick pavers to North and South), trunk leaning to East - corrected, injuries to topsides of surface roots, asymmetric crown on West side due to sidewalk clearance pruning. | Located within footprint of the proposed new sidewalk. | Remove |

Photograph 5 – Yellow arrow indicates existing growing conditions and structure of onsite plum (tag# 1899).

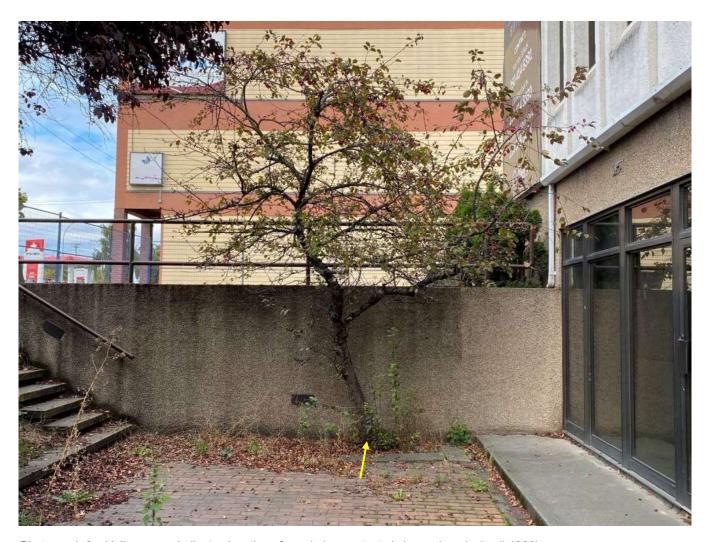
| Tag | Location (On, Off, | | | Name | | | | Critical | | Condition | | Retention | | | | |
|---|---|---|---|---|---|--|---|---|---|---|---|---|---|---|--|---|
| 1900 | On | No | No | Crabapple | Malus sp. | 14 | 5 | 1.47 | 3 | Fair | Fair/poor | Unsuitable | Good | Non bylaw protected size tree, growing within confined root environment - existing retaining wall .3m from North side of root collar, existing concrete planter within .3m of South/East/West side of root collar, sucker it from base, pruning wounds with associated surface decay, shaded by building. | Shown on landscape plan to be removed and replaced with a new shrub. | Remove |

Photograph 6 – Yellow arrow indicates location of non-bylaw protected size crabapple (tag# 1900).

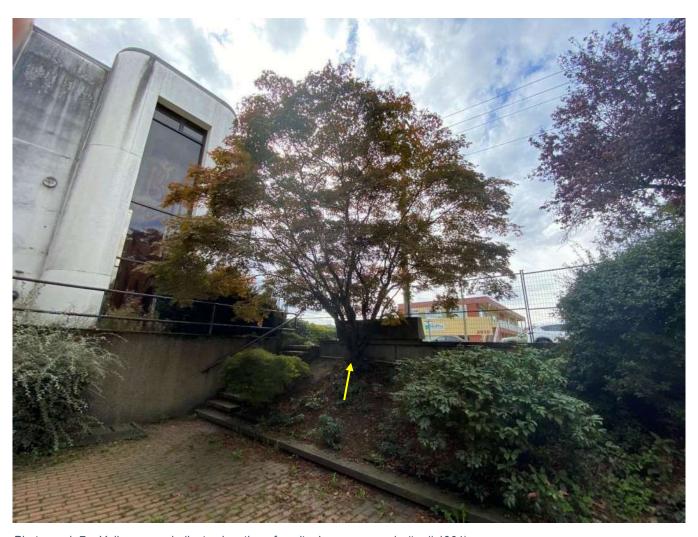
| Tag | Location (On, Off, | | | Name | | | | Critical | | Condition | | Retention | | | | |
|---|---|---|---|---|---|--|---|---|---|---|---|---|---|---|--|---|
| 1901 | On | Yes | Yes | Japanese maple | Acer palmatum | 12,6,14,14 ,11,14 | 5 | 3.23 | 4 | Good | Fair | Suitable | Good | Located within landscape bed - on slope, confined root system on South side - existing retaining wall within .2m of root collar, heavily surface rooted on embankment, multiple stems form at 3m above grade - narrow angles of attachment. | *Existing concrete stairway within critical root zone proposed for removal. Project arborist to supervise all excavation and fill placement required within the critical root zone. | Retain* |

Photograph 7 – Yellow arrow indicates location of onsite Japanese maple (tag# 1901).

- Excavation to remove the existing concrete stairway within the critical root zone of maple 1901
- Excavation to remove the existing concrete stairway within the critical root zone of maple 1902
- Any fill addition within the critical root zones of maple 1901 and 1902.
- Any excavation to upgrade of install new underground utilities within critical root zones of bylaw protected trees or trees located on municipal property.

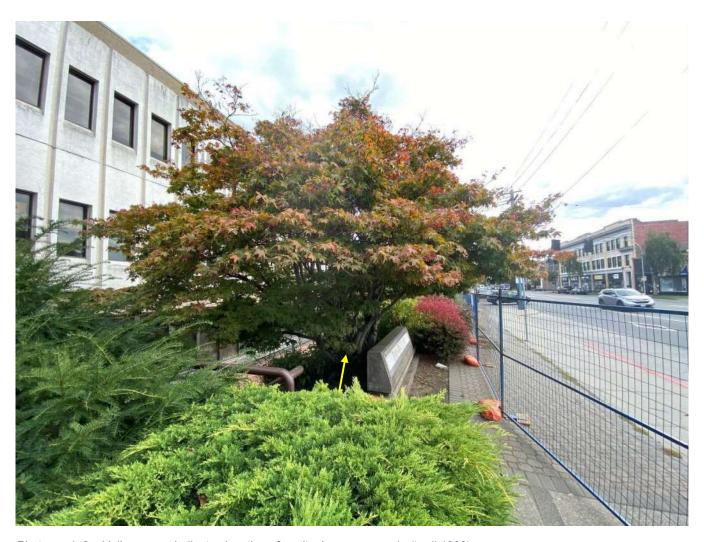
| Tag | Location (On, Off, | | | Name | | | | Critical | | Condition | | Retention | | | | |
|---|---|---|---|---|---|--|---|---|---|---|---|---|---|---|--|---|
| 1902 | On | Yes | Yes | Japanese maple | Acer palmatum | 7,7,13,13, 10,10,5,7, 12,12,16,6 | 5 | 3.26 | 4 | Good | Fair | Suitable | Good | Located within landscape bed - on slope, confined root system on South side - existing retaining wall within .2m of root collar, heavily surface rooted on embankment, multiple stems form at3m above grade - narrow angles of attachment. | *Existing concrete stairway within critical root zone proposed for removal. Project arborist to supervise all excavation and fill placement required within the critical root zone. | Retain* |

Photograph 8 – Yellow arrow indicates location of onsite Japanese maple (tag# 1902).
