# **1030 Fort Street—Victoria, BC**

## Construction Impact Assessment &

## Tree Management Plan

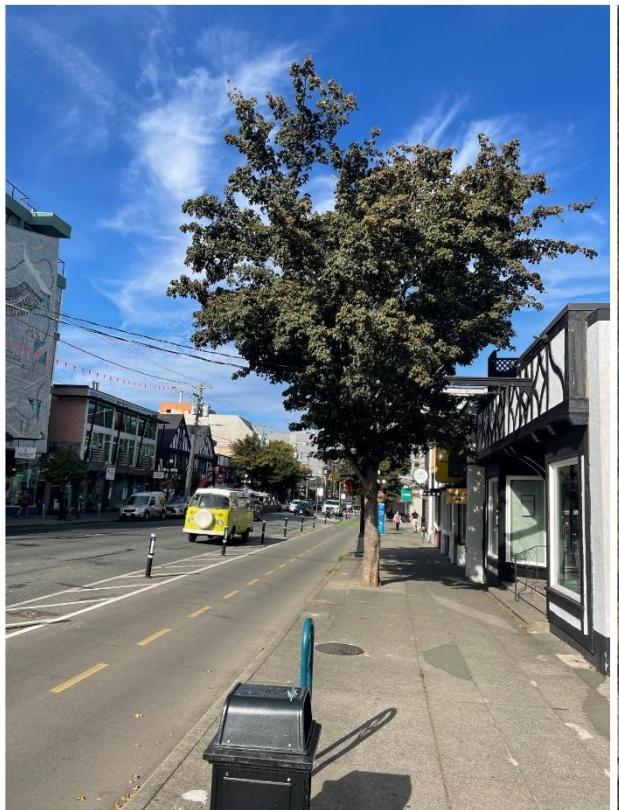
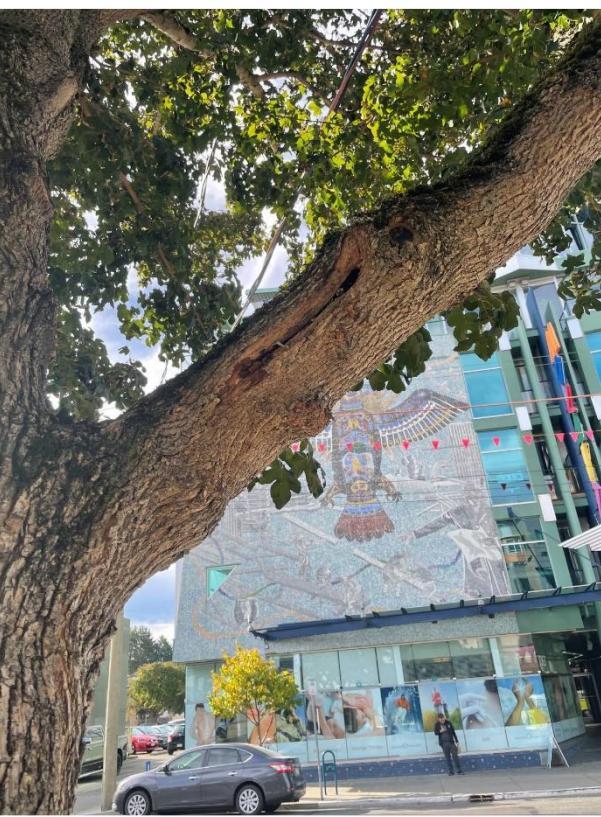
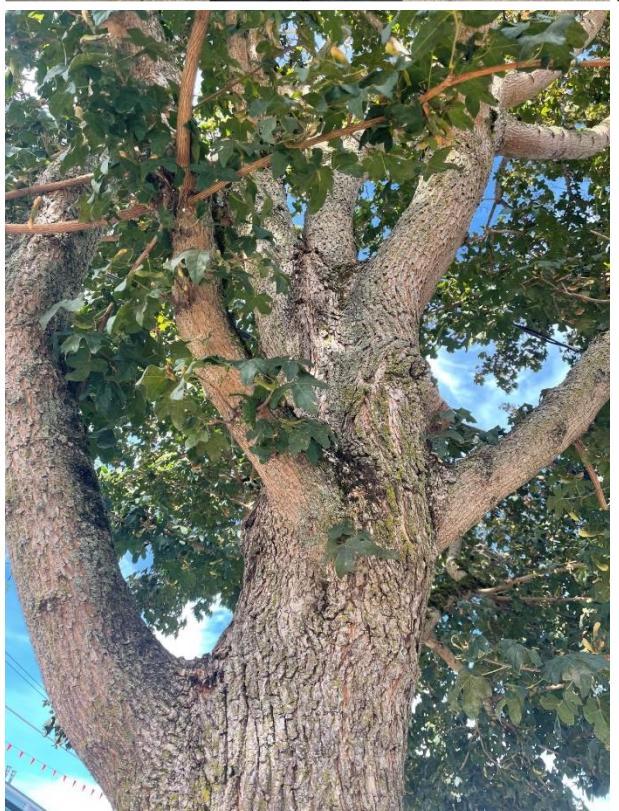
Photograph 1-3. Field Maple #26189 (looking west, upper left) with some decay in wounds and narrow branch unions.

The following municipal trees (indicated by city ID#) are located where they are possible for retention providing that their critical root zones are adequately protected during construction. Recommended barrier fencing locations are shown on the tree management plan (T1) in *appendix A*:

• Field Maple (*Acer campestre*) #26189 (35cm DBH)

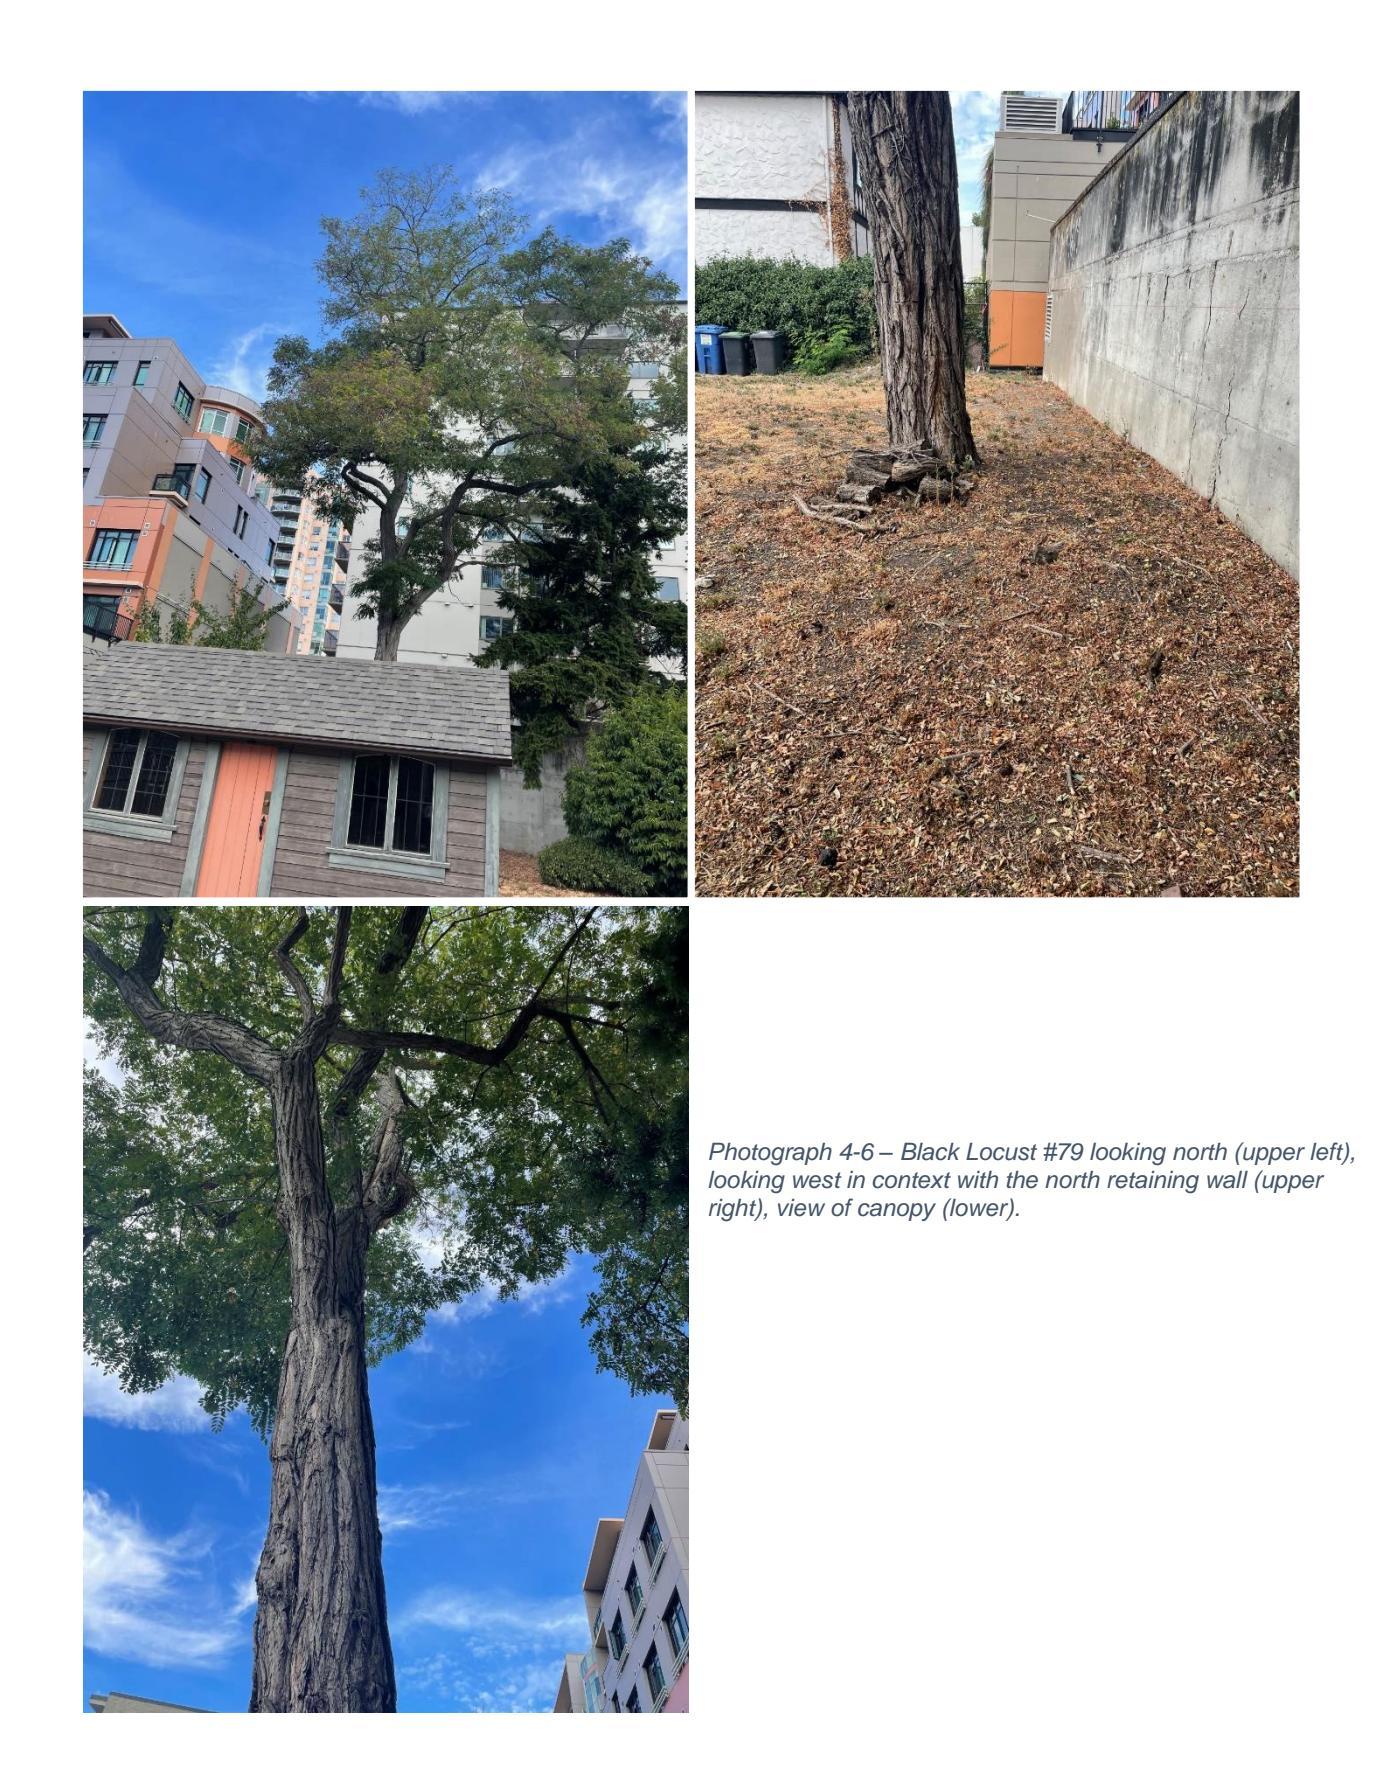
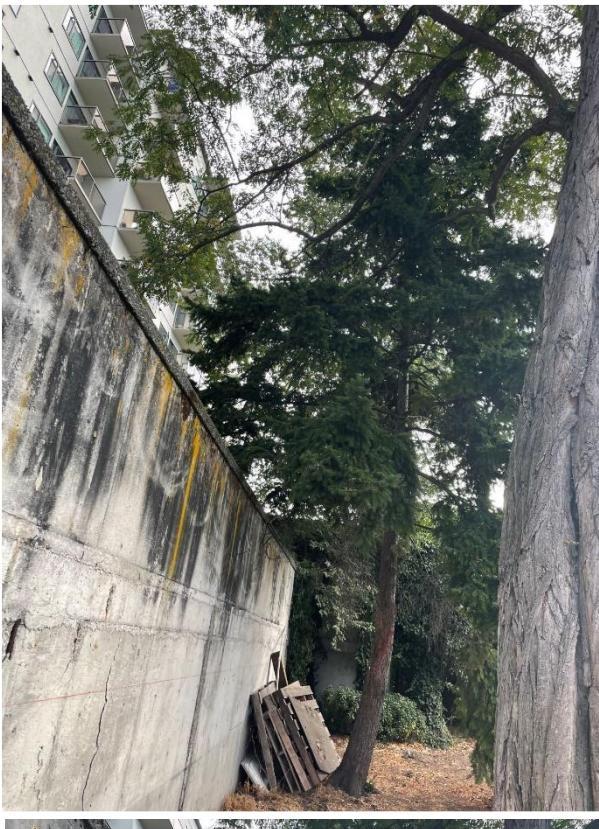
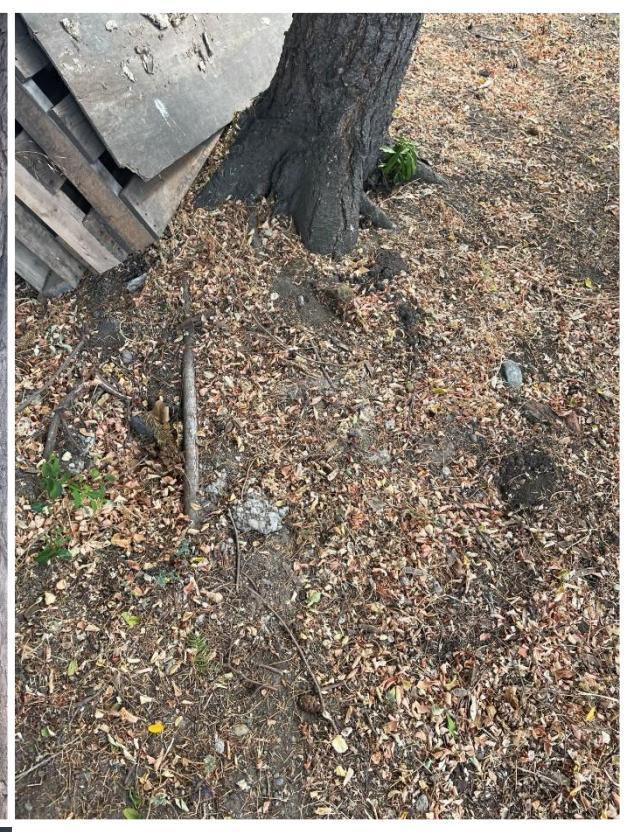
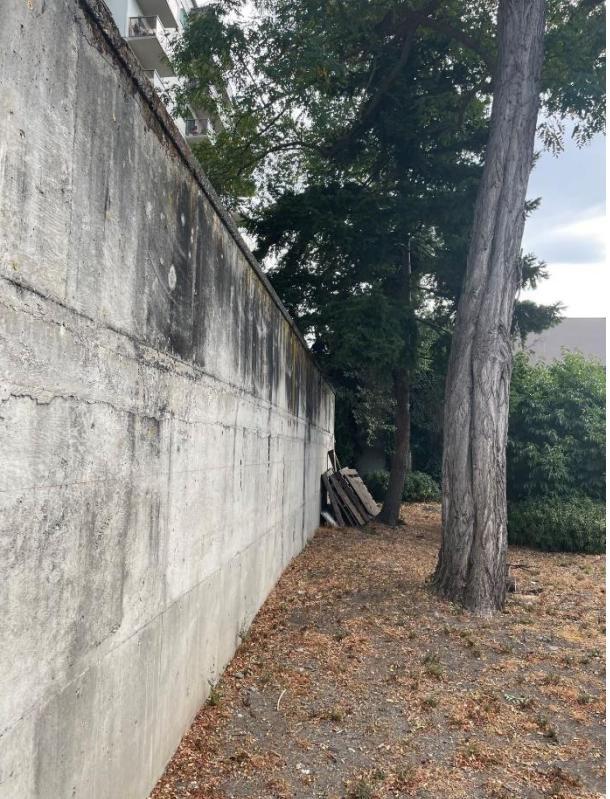
Photographs 6-9 – Douglas-fir #80 in relation to north retaining wall and #79 (upper left and lower), root collar (upper right).

• Douglas-fir (Pseudotsuga menziesii) #80 (35cm DBH).

\*Prior written consent from the tree owner at 1039 View Street is required prior to the removal of any trees located on neighbouring properties.

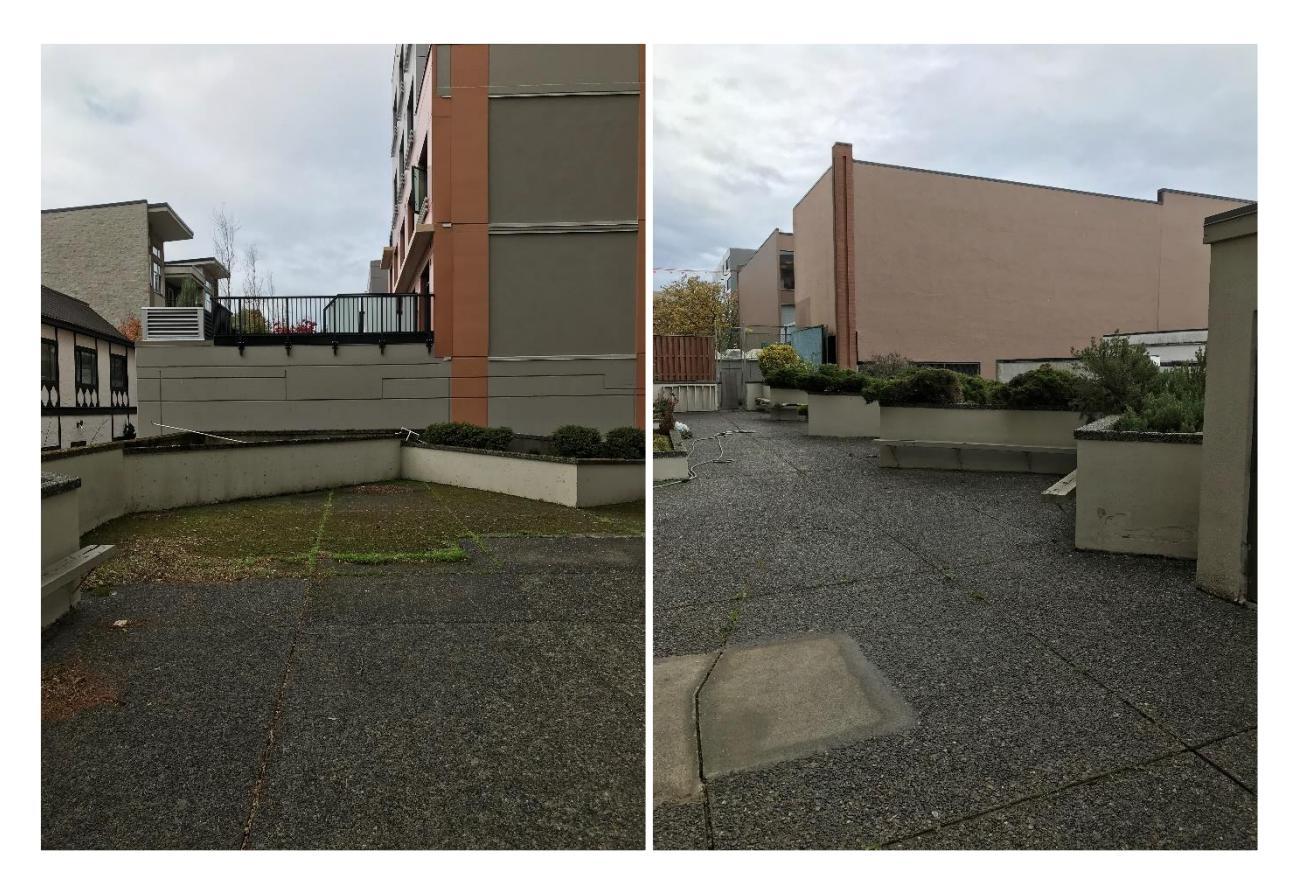
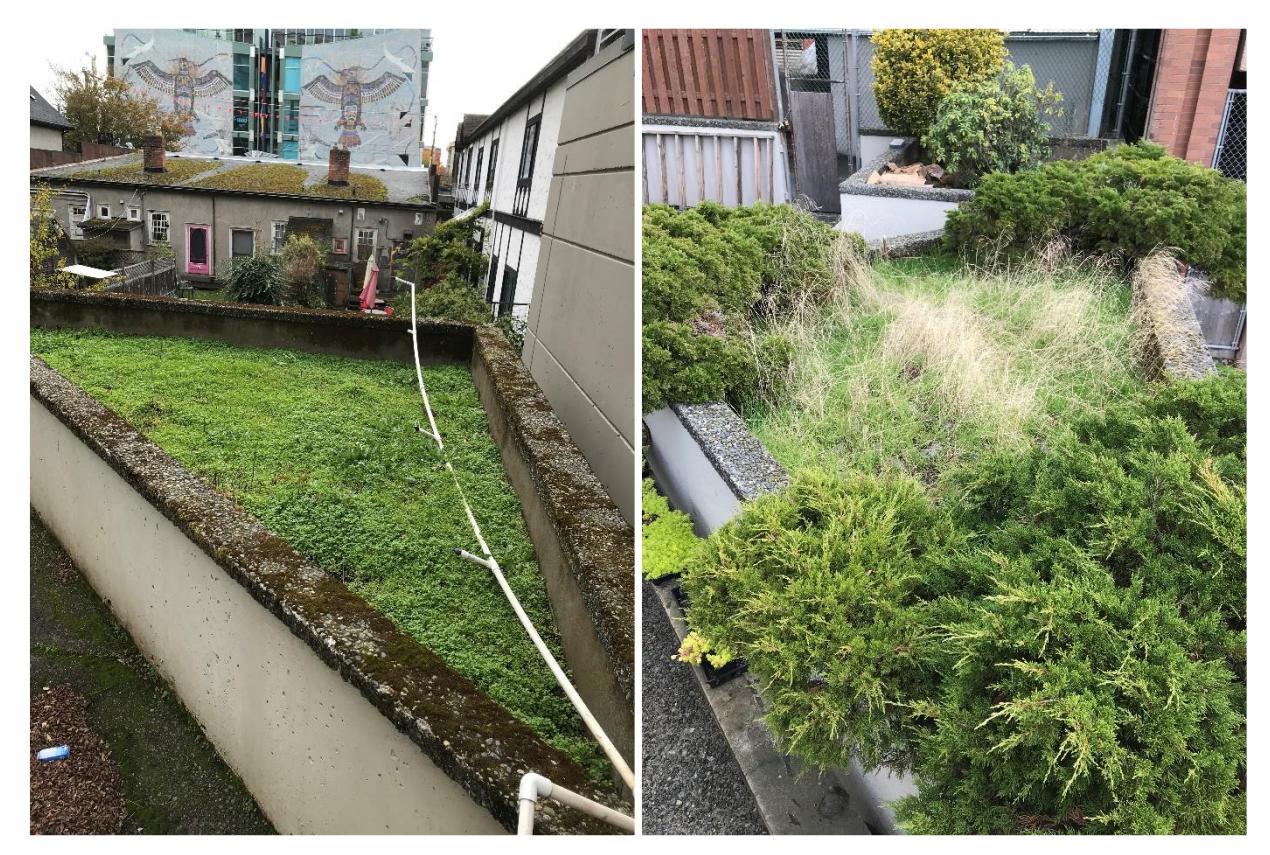
Photographs 10-13 – Concrete planters at 1039 View St. Planting Area OSA #1 & 2 below.
