Talbot Mackenzie & Associates

1693 Fort St.—Victoria, BC

Construction Impact Assessment & Tree Management Plan

Date of Issuance: November 25, 2020

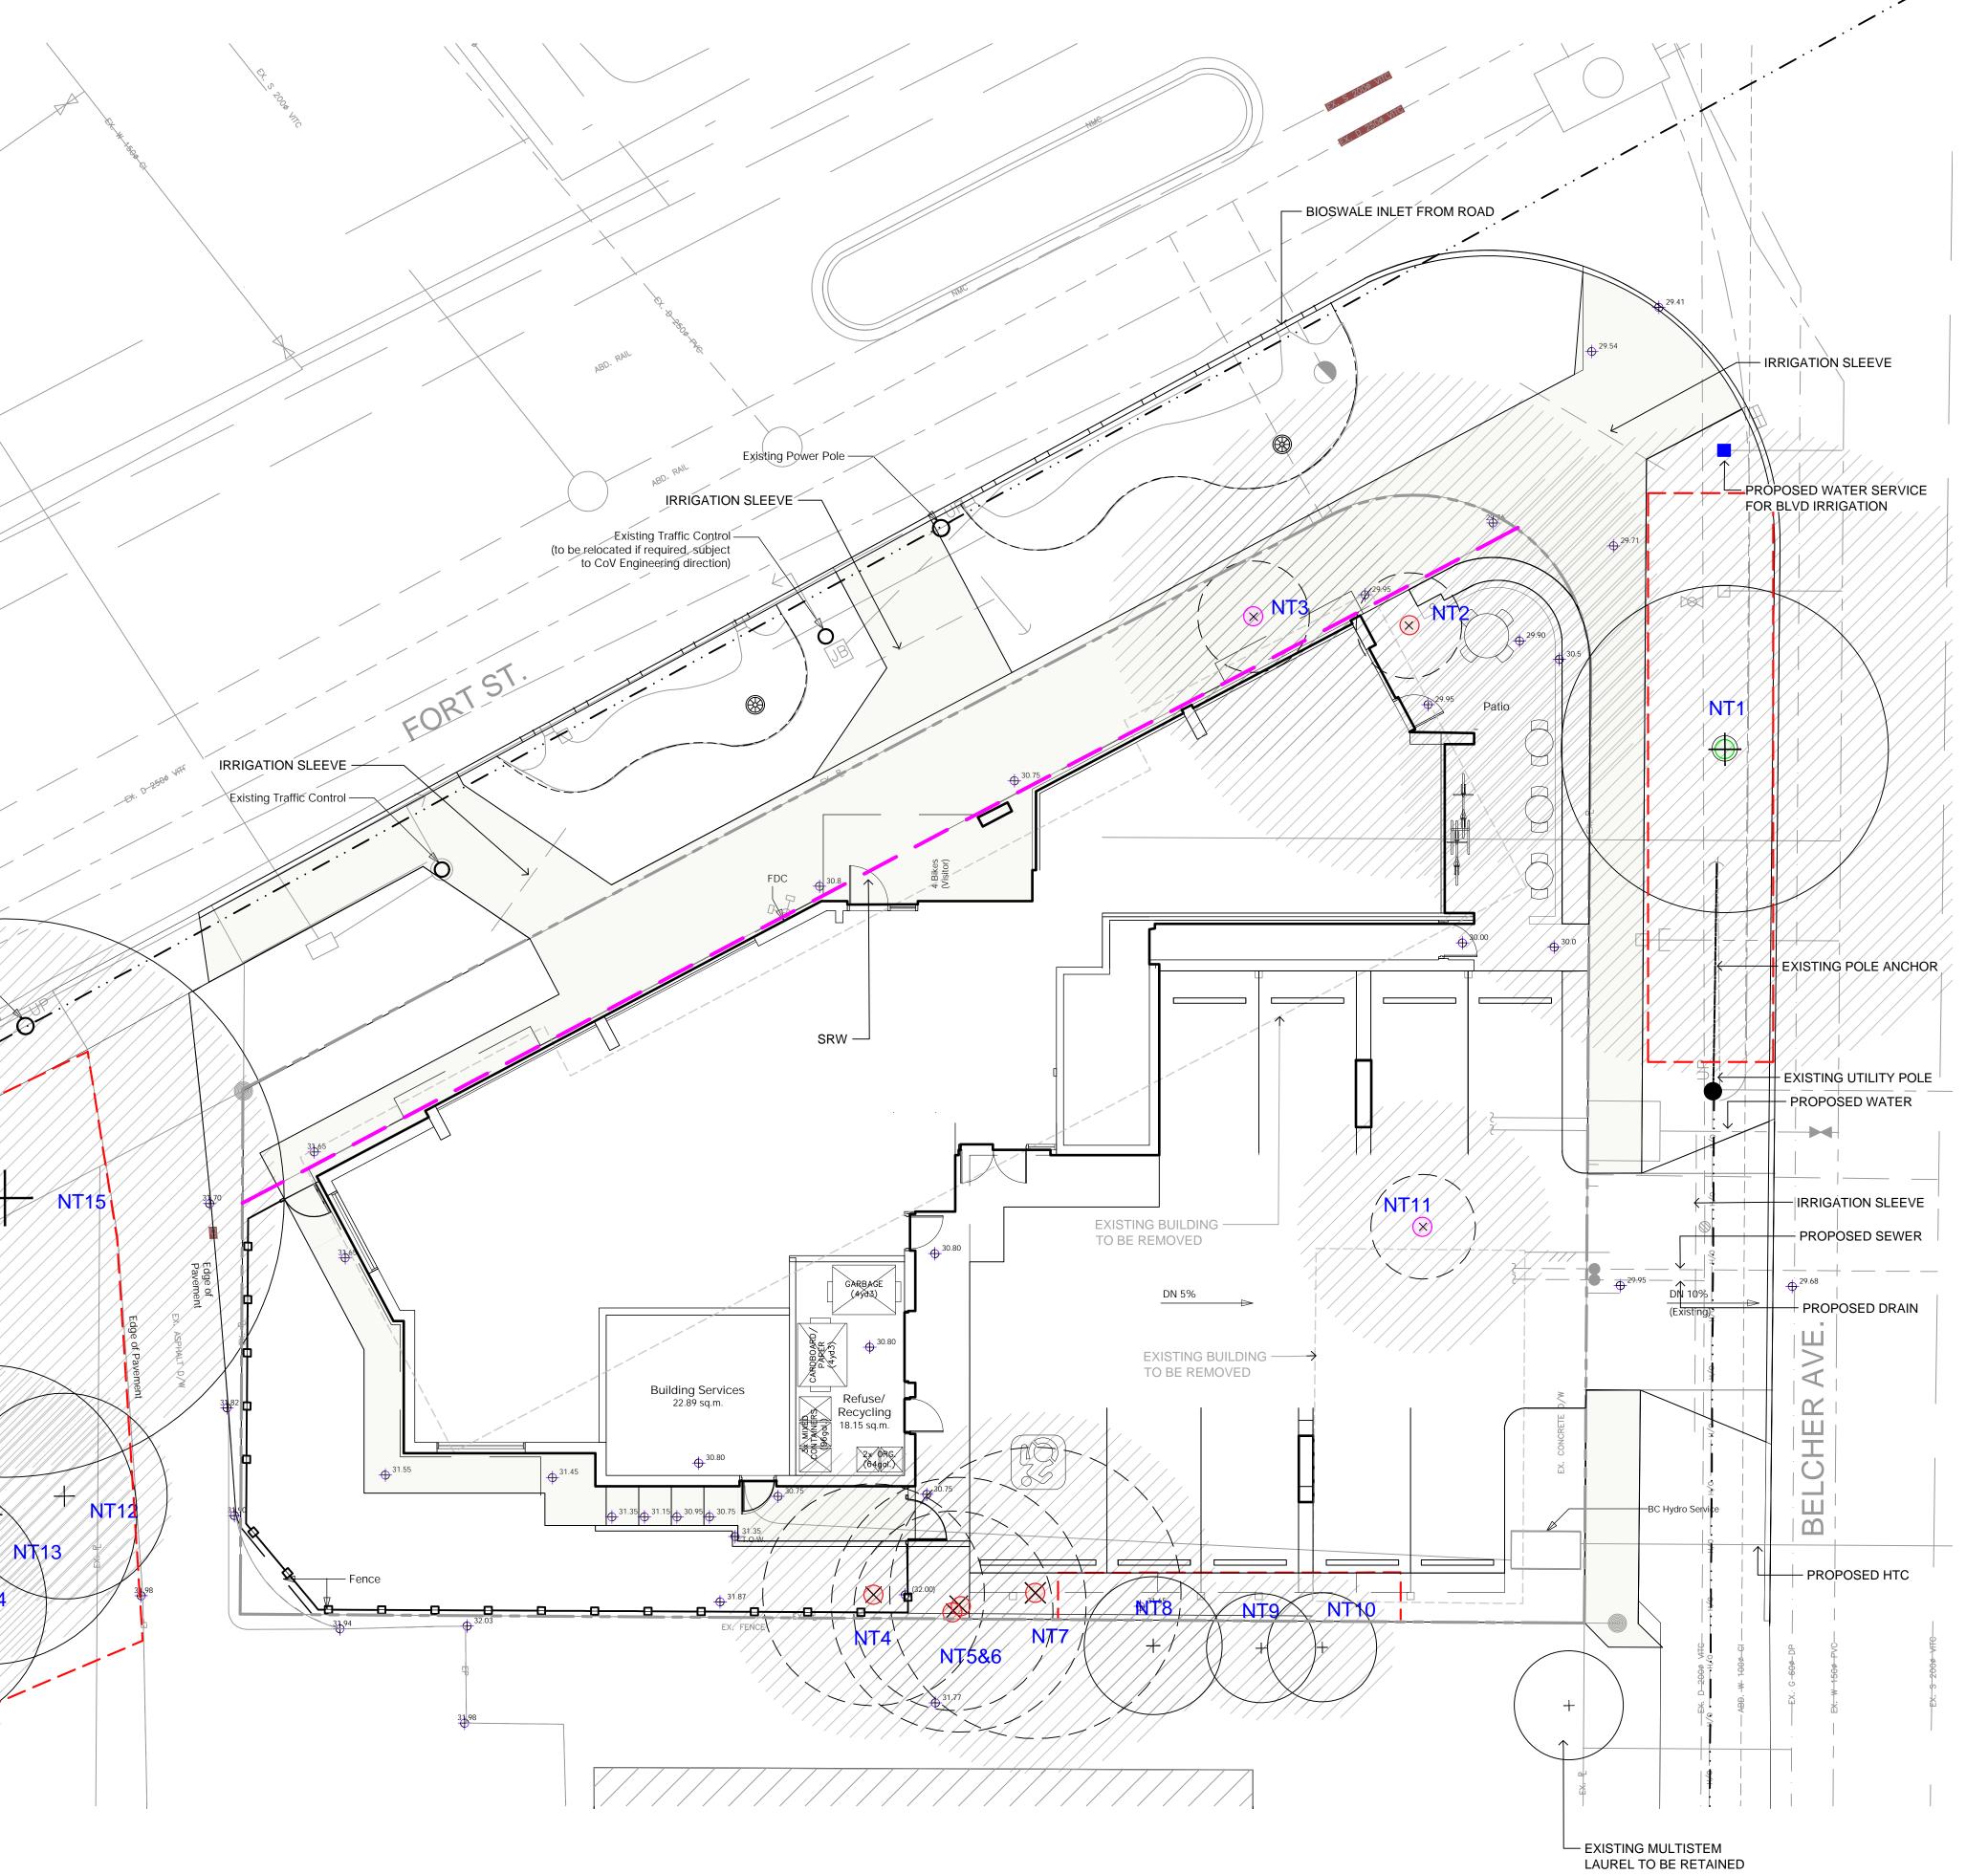
TREE IMPACT SUMMARY TABLE					
TREE STATUS	TOTAL	To be RETAINED	To be REMOVED		To be PLANTED
ON-SITE TREES BYLAW PROTECTED	5		5	10	8
ON-SITE TREES, NOT BYLAW PROTECTED	2		2		
MUNICIPAL TREES	1	1		0	4
NEIGHBORING TREES, BYLAW PROTECTED	4	4			
NEIGHBORING TREES, NOT BYLAW PROTECTED	3	3			
TOTAL	15	8	7	10	12

REPLACEMENT TREES REQUIRED	10
REPLACEMENT TREES PROPOSED	8
REPLACEMENT TREE SHORTFALL	2
