Capital Tree Service Inc.

Arborist Report

722 & 726 Discovery St,

August 17, 2022

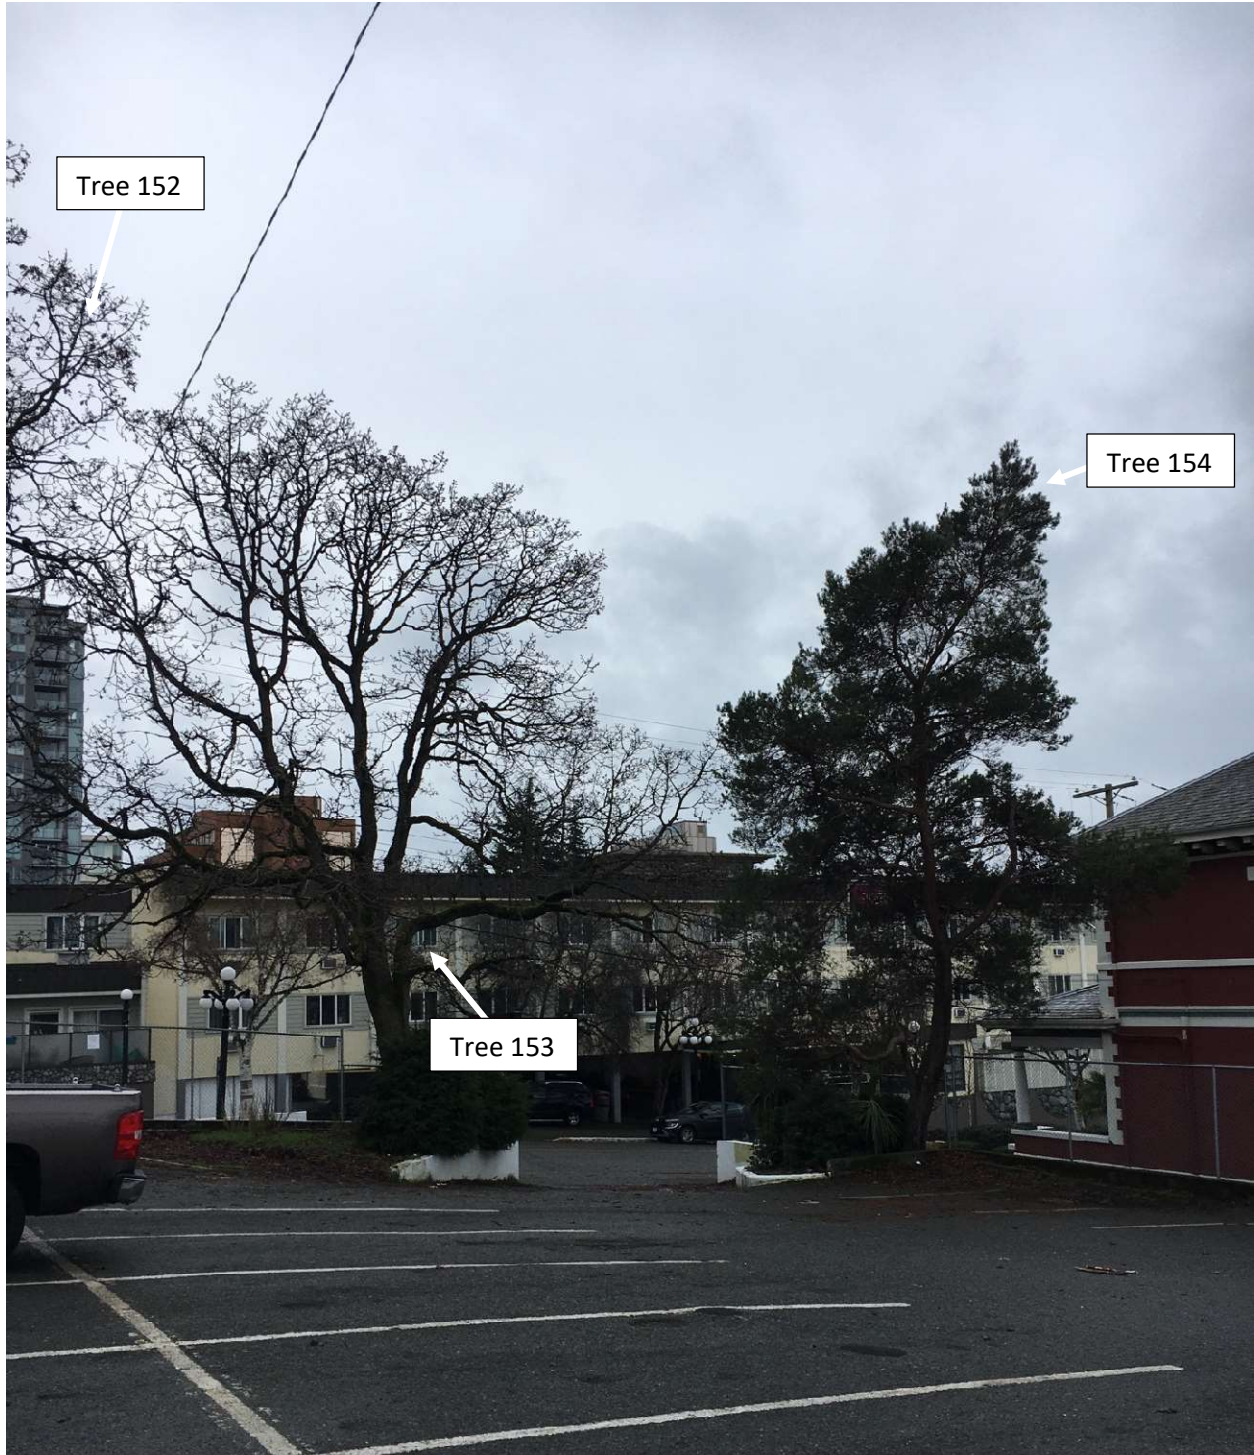
Figure 3. Trees 153 and 154. A long horizontal branch can be seen reaching over the driveway.

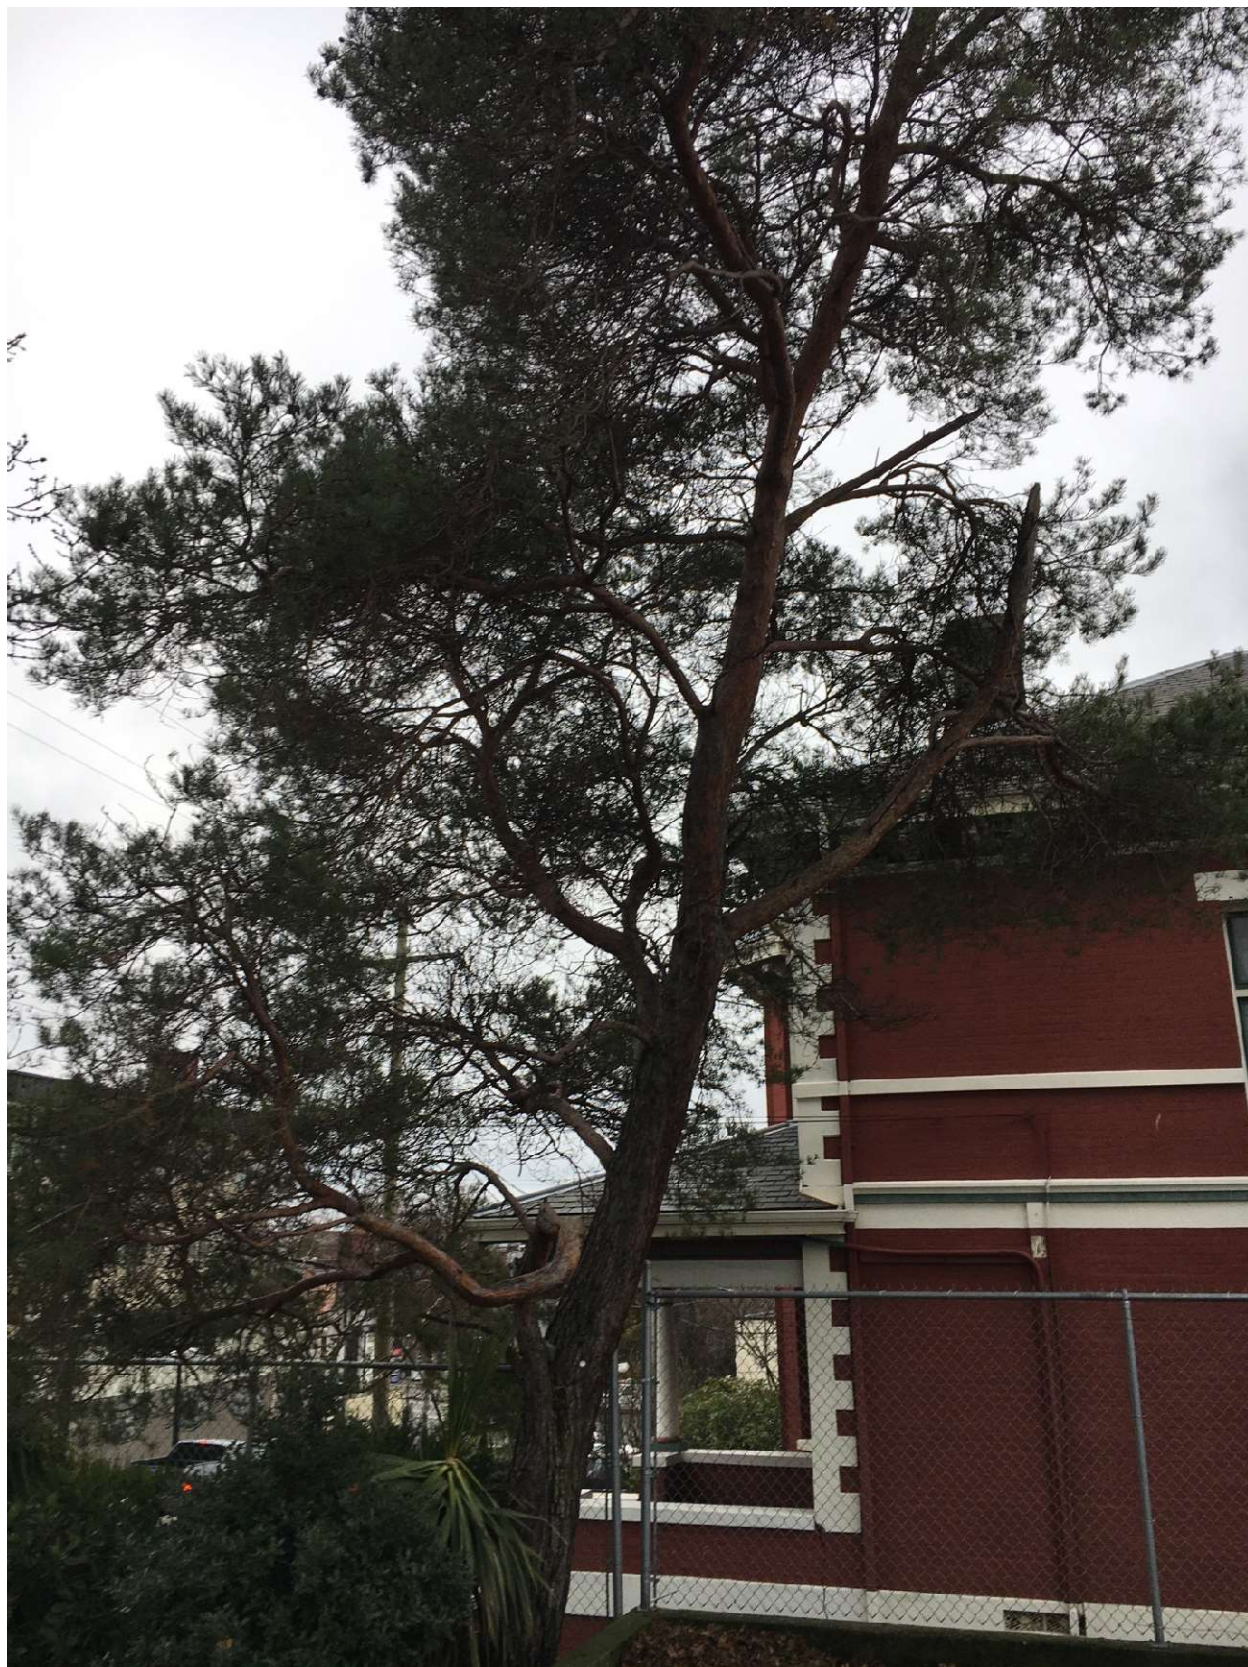
Capital Tree Service Inc.									
Appendix A - Tree Inventory/Hazard Ratings Summary									
Location: 722 Discovery St, Victoria, BC V8T 1H2									
Date: January 6, 2022					Conditions: Overcast, 2°C, 11km/hr light breeze				
Tag #	Species	DBH (cm)	PRZ (m)	Height (m)	Health/Structure	Canopy Spread (m)	Bylaw Protected	Comments/Recommendations	
151	Garry oak	87	10	16	F-P/F	8	Yes	Deadwood. Pavement over entire rooting area. Rooting area partially restricted by retaining wall. Great CODIT. Some older epicormic shoots.	
152	Garry oak	87	10	19	F/P	7	Yes	Pavement over entire rooting area. Rooting area partially restricted by retaining wall. 2x stem 10m above grade with seam at union. Good CODIT on pruning wounds. Some narrow angles of attachment.	
153	Garry oak	74	9	16	F/P	8	Yes	2x stem 4m above grade. Rooting area restricted by retaining walls and pavement. Epicormic growth.	
154	Shore Pine	49	6	13	F/P	6	Yes	Some narrow angle of attachments. 10cm deadwood. Leaning stem.

Figure 4. Tree 154. Tree 154, a Shore Pine. Landscape plants can be seen to the left (south) of the tree.

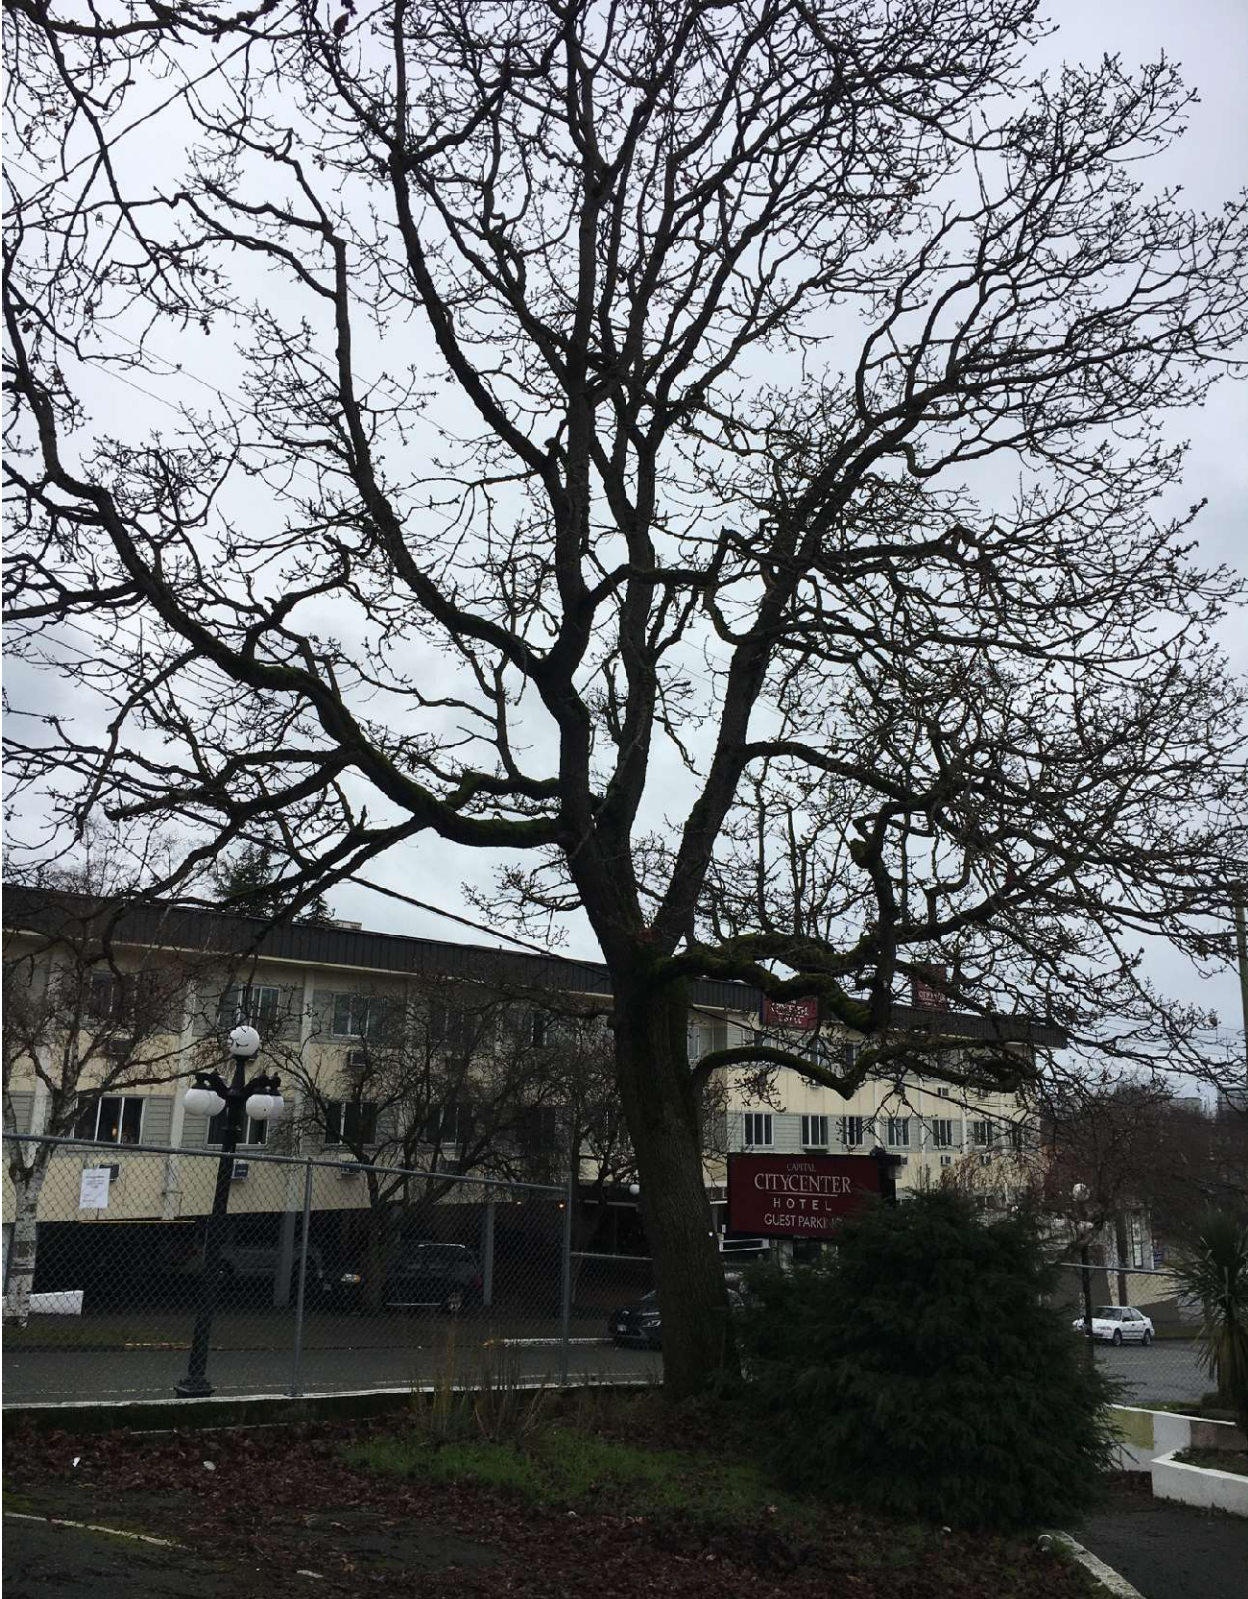
Figure 5. Tree 153. Note retaining walls restricting rooting area and pavement over available rooting area.

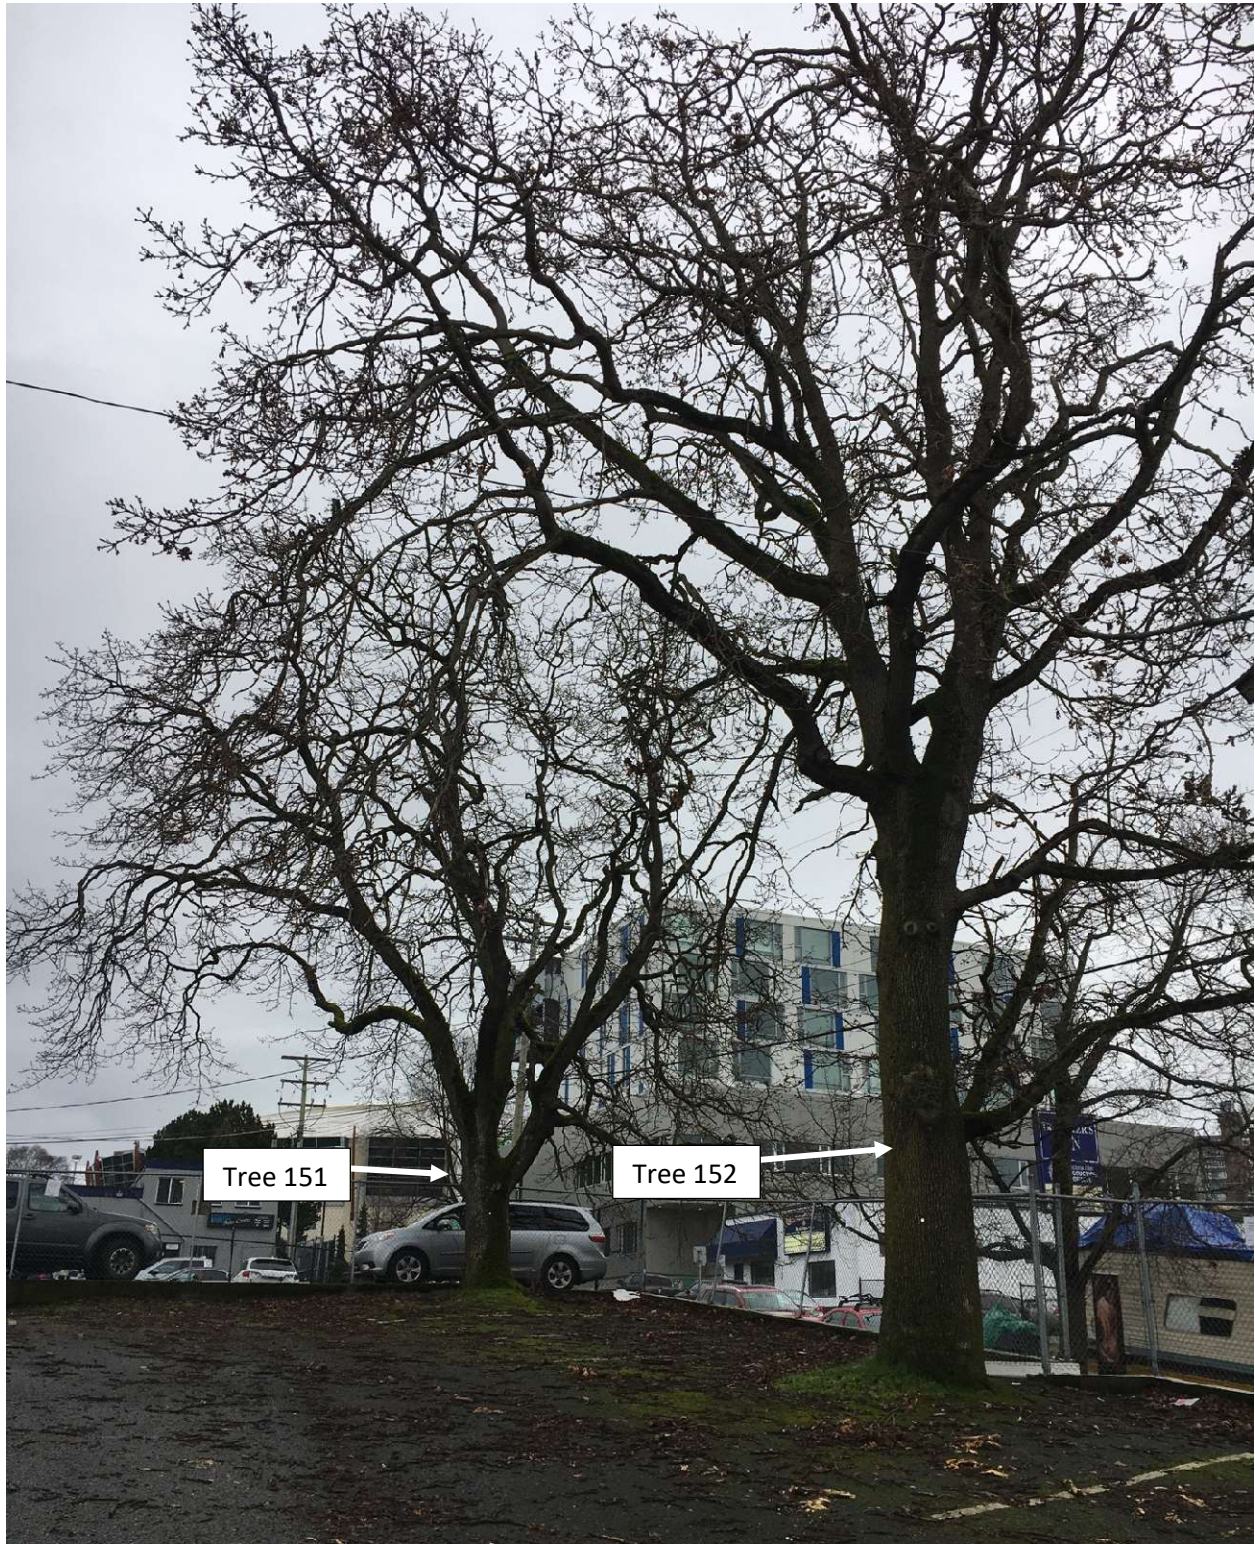
Figure 6. Trees 151 and 152. Note retaining walls restricting rooting area and pavement over available rooting area.

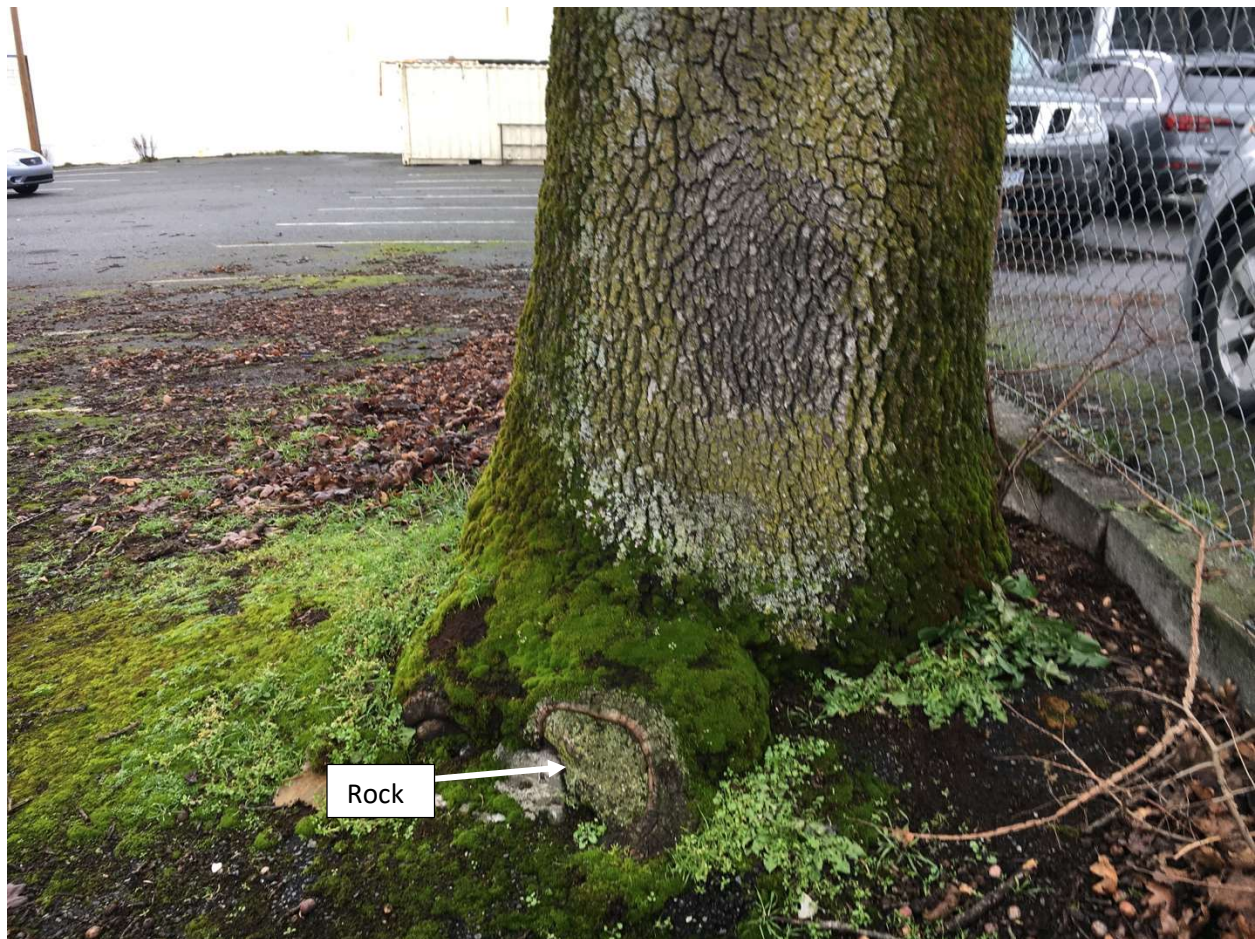
Figure 7. Trunk and root crown of Tree 151. Note rock enveloped by tree. Rooting area is restricted by pavement.

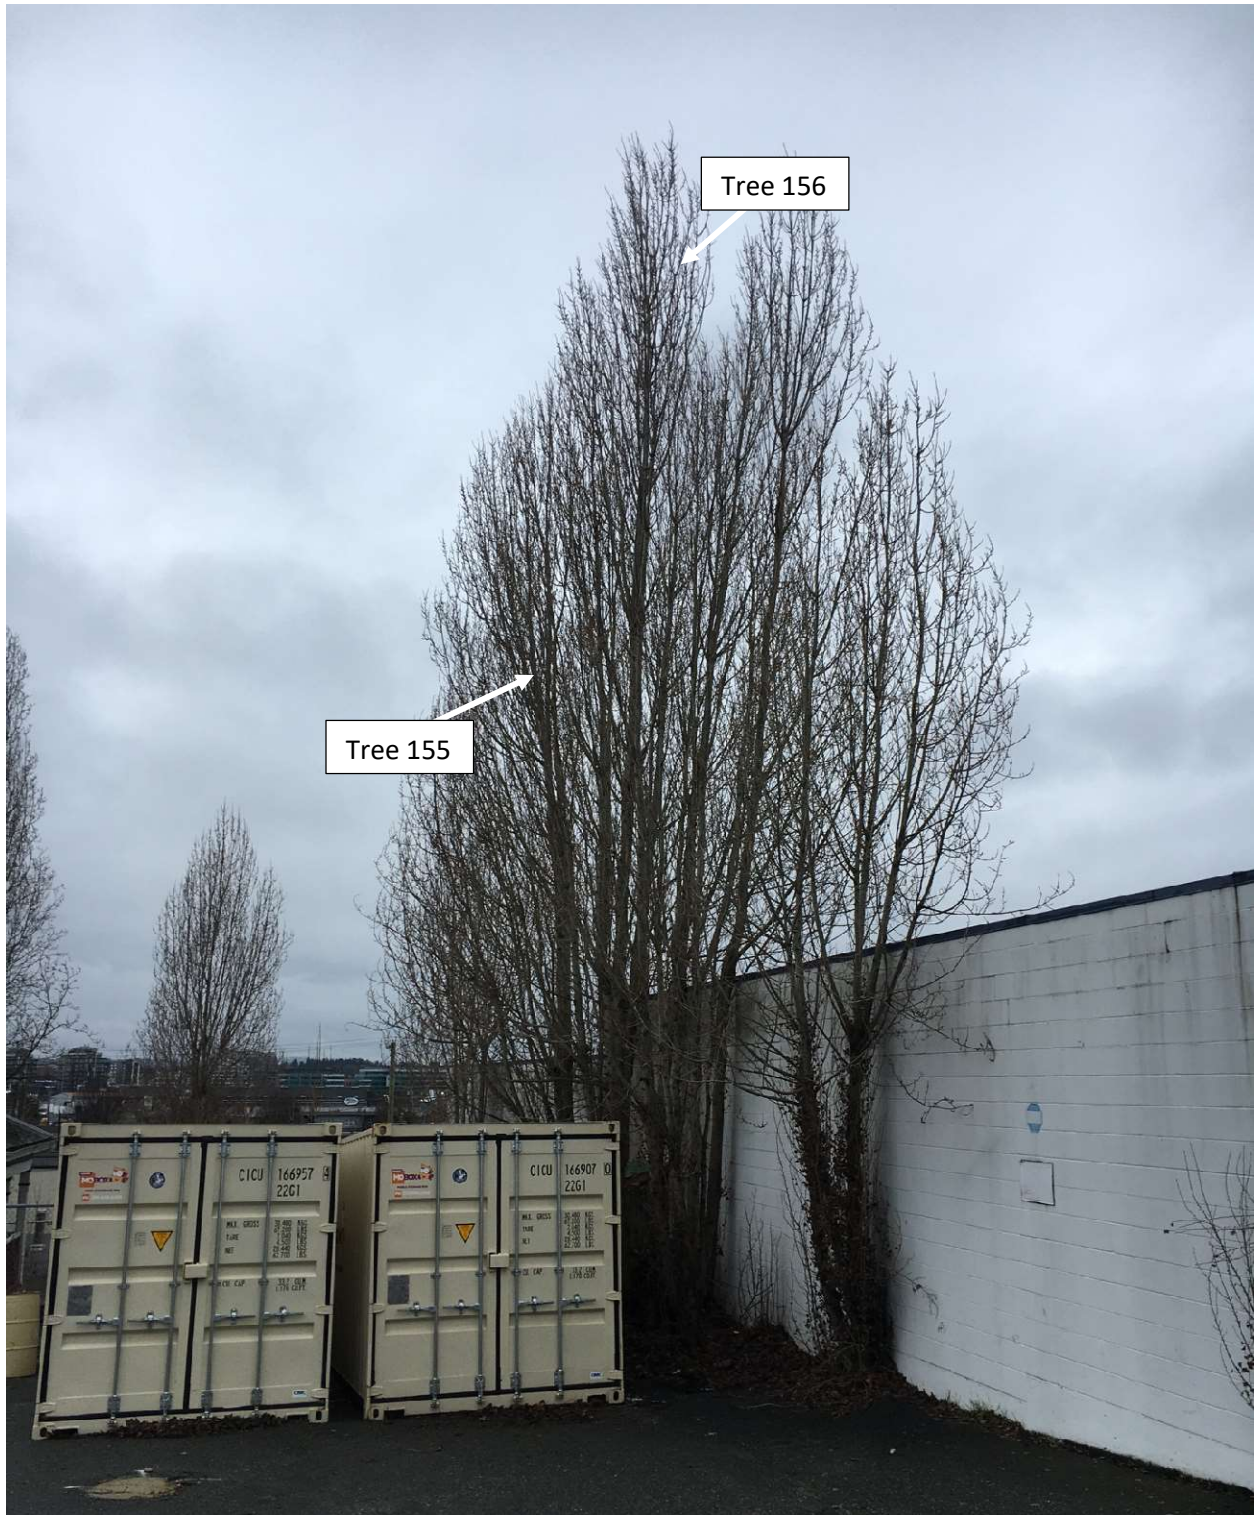
Figure 8. Black Cottonwoods in the Northwest corner of the parking lot. Trees 155 and 156 growing at the edge of the parking lot with a couple of smaller opportunistic cottonwoods. Rooting area is restricted by the building, pavement, and a retaining wall.

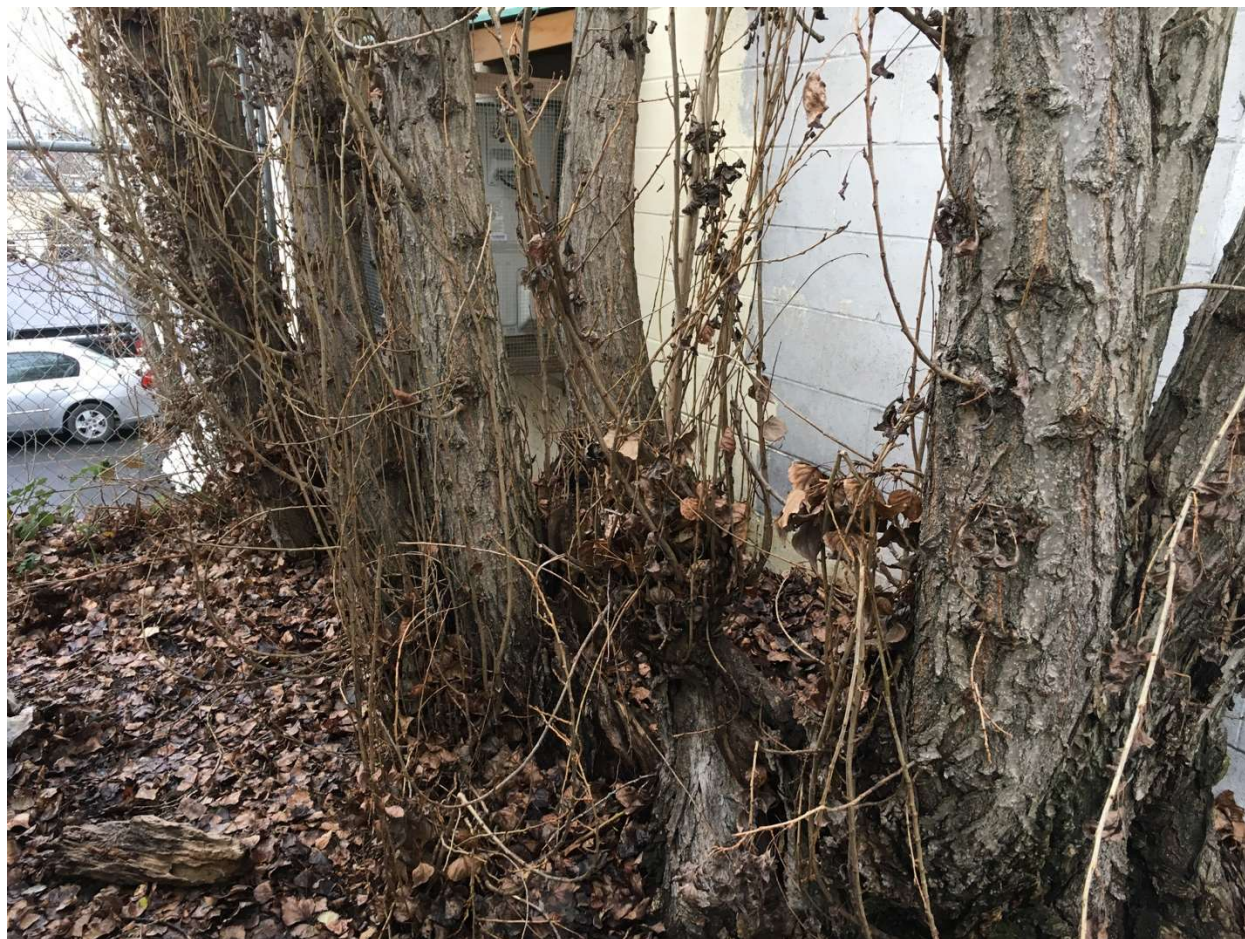
Figure 9. Tree 156 Trunk. Tree 156 is growing from the trunk of a removed tree with multiple codominant stems.

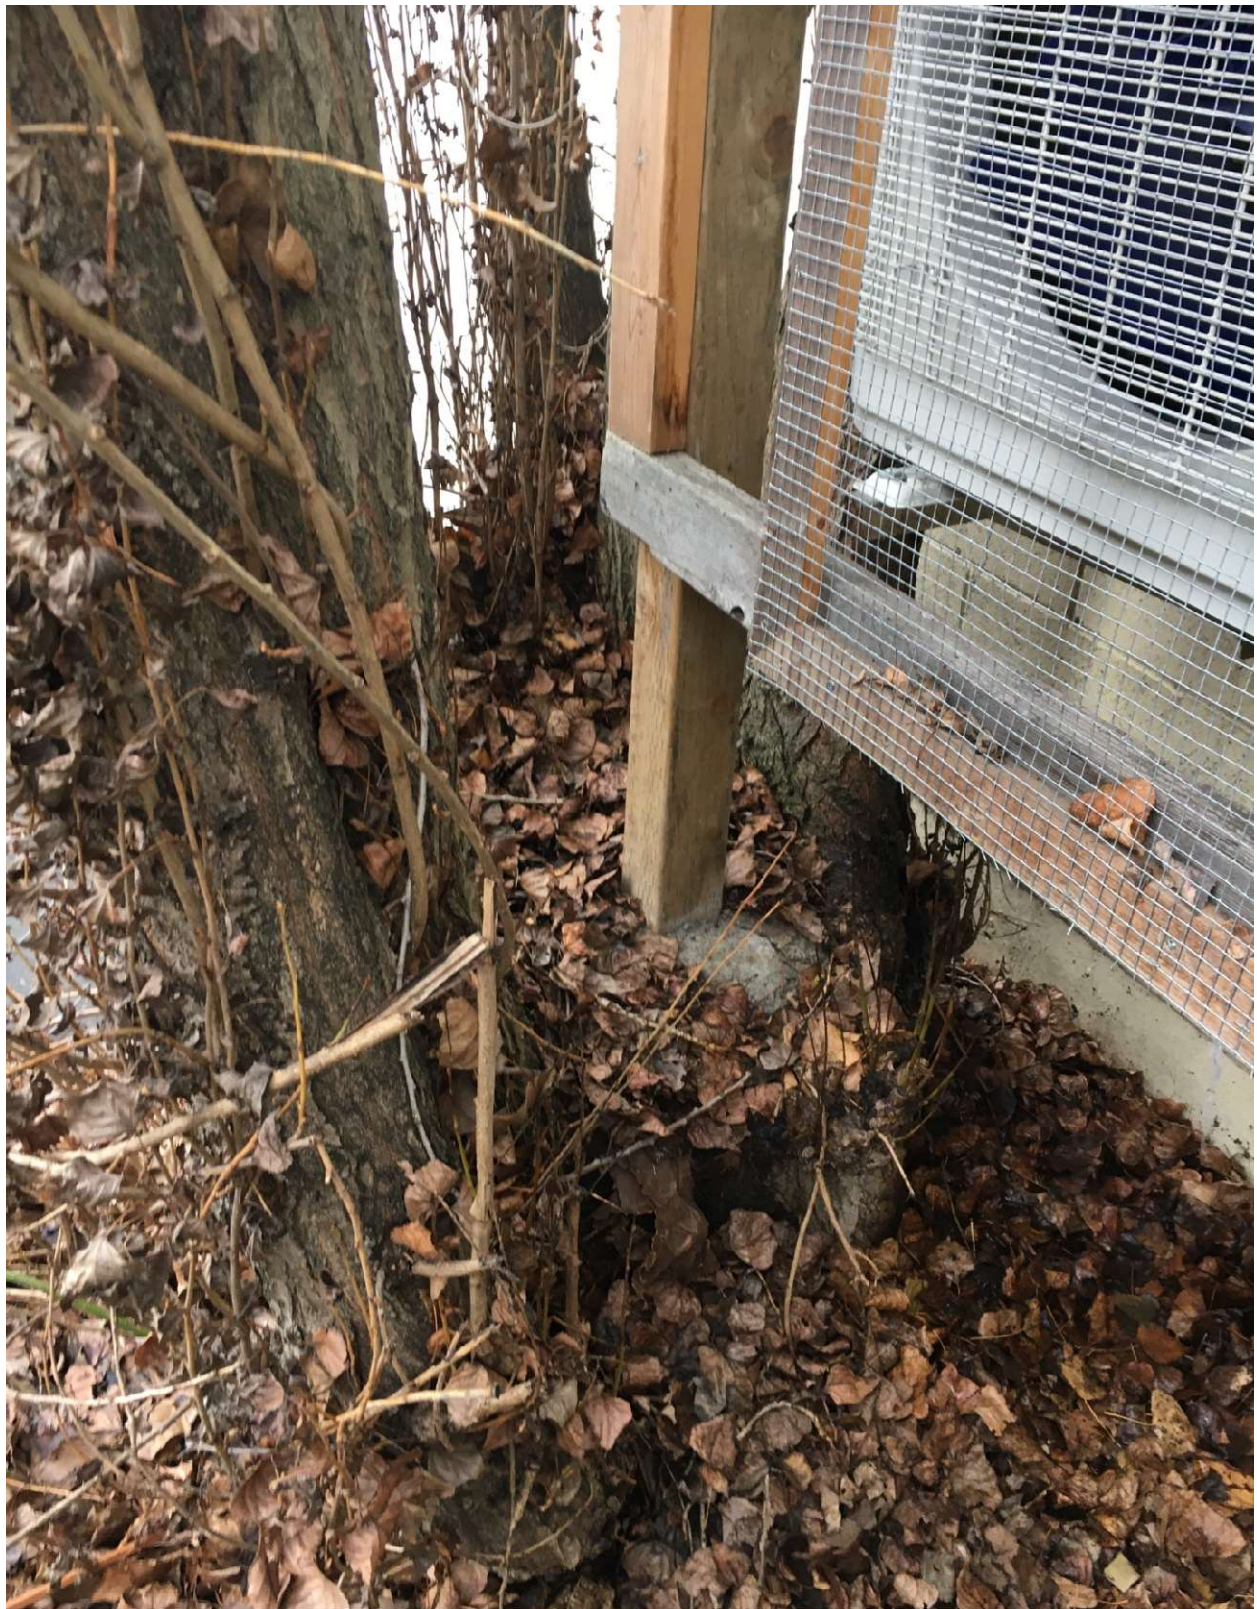
Figure 10. Trunk of tree 155. Multiple codominant stems with epicormic growth. Cement footing poured in trunk cavity.
