Capital Tree Service Inc.

Arborist Report

633 Belton Ave,

May 17, 2021

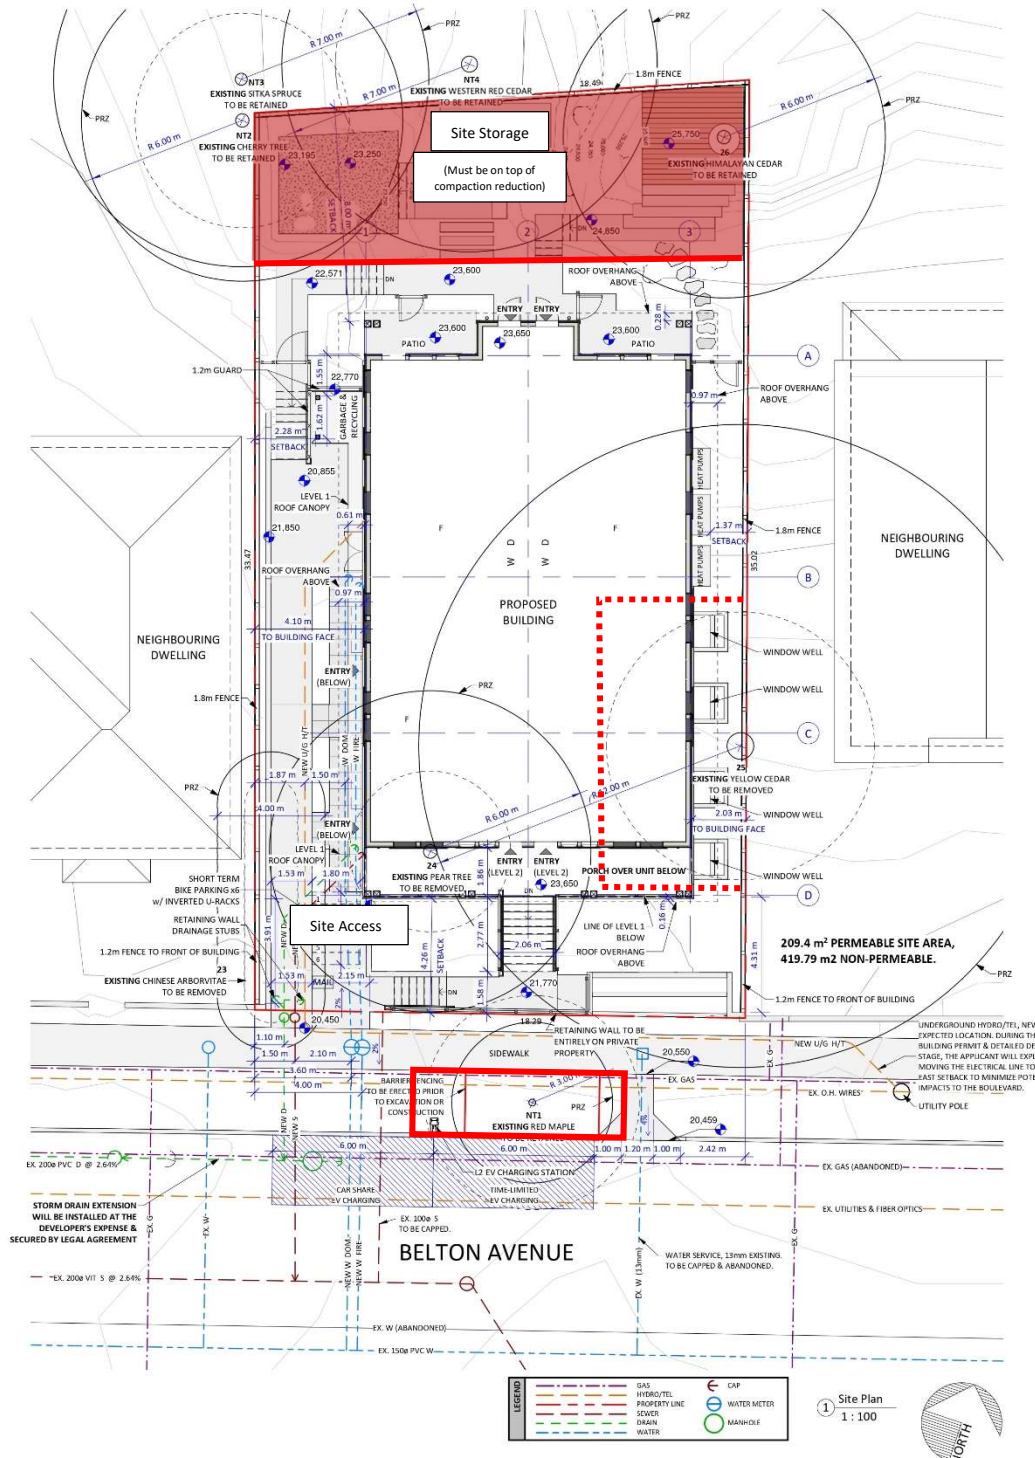
Figure 1. Site Plan. Red lines indicate Tree Protection Fencing. Solid red lines indicate fencing that will be up for the duration of the project, while dotted red lines indicate tree protection fencing for the demolition phase of the project. Site storage will be within the PRZ of several trees and therefore must be on top of compaction reduction. If a section of the storage area is not used, it must be protected by Tree Protection Fencing. Tree #24 will be removed for demolition access.

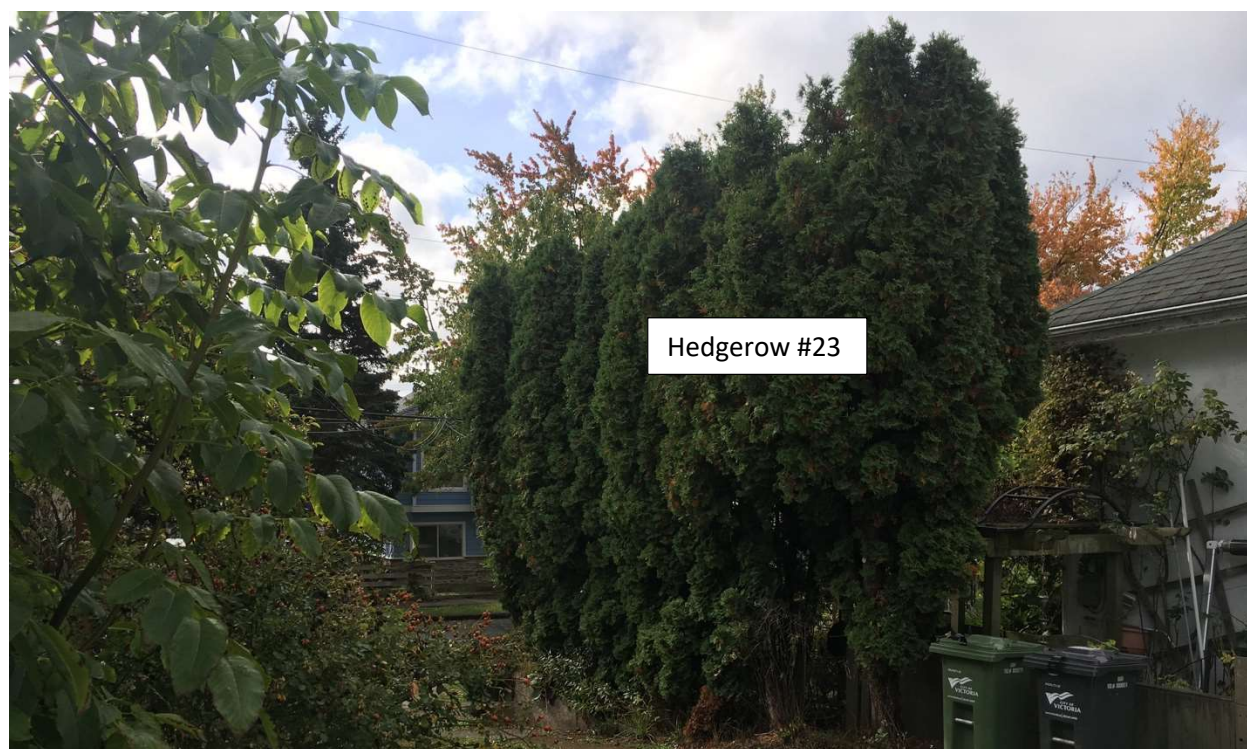
Figure 3. Hedgerow and Site Access.

One (1) tree, Pear #24, and one non-protected hedge will be removed during the demolition phase of the project to allow access to the site. Impact to retained trees will be **'Low'** during demolition.

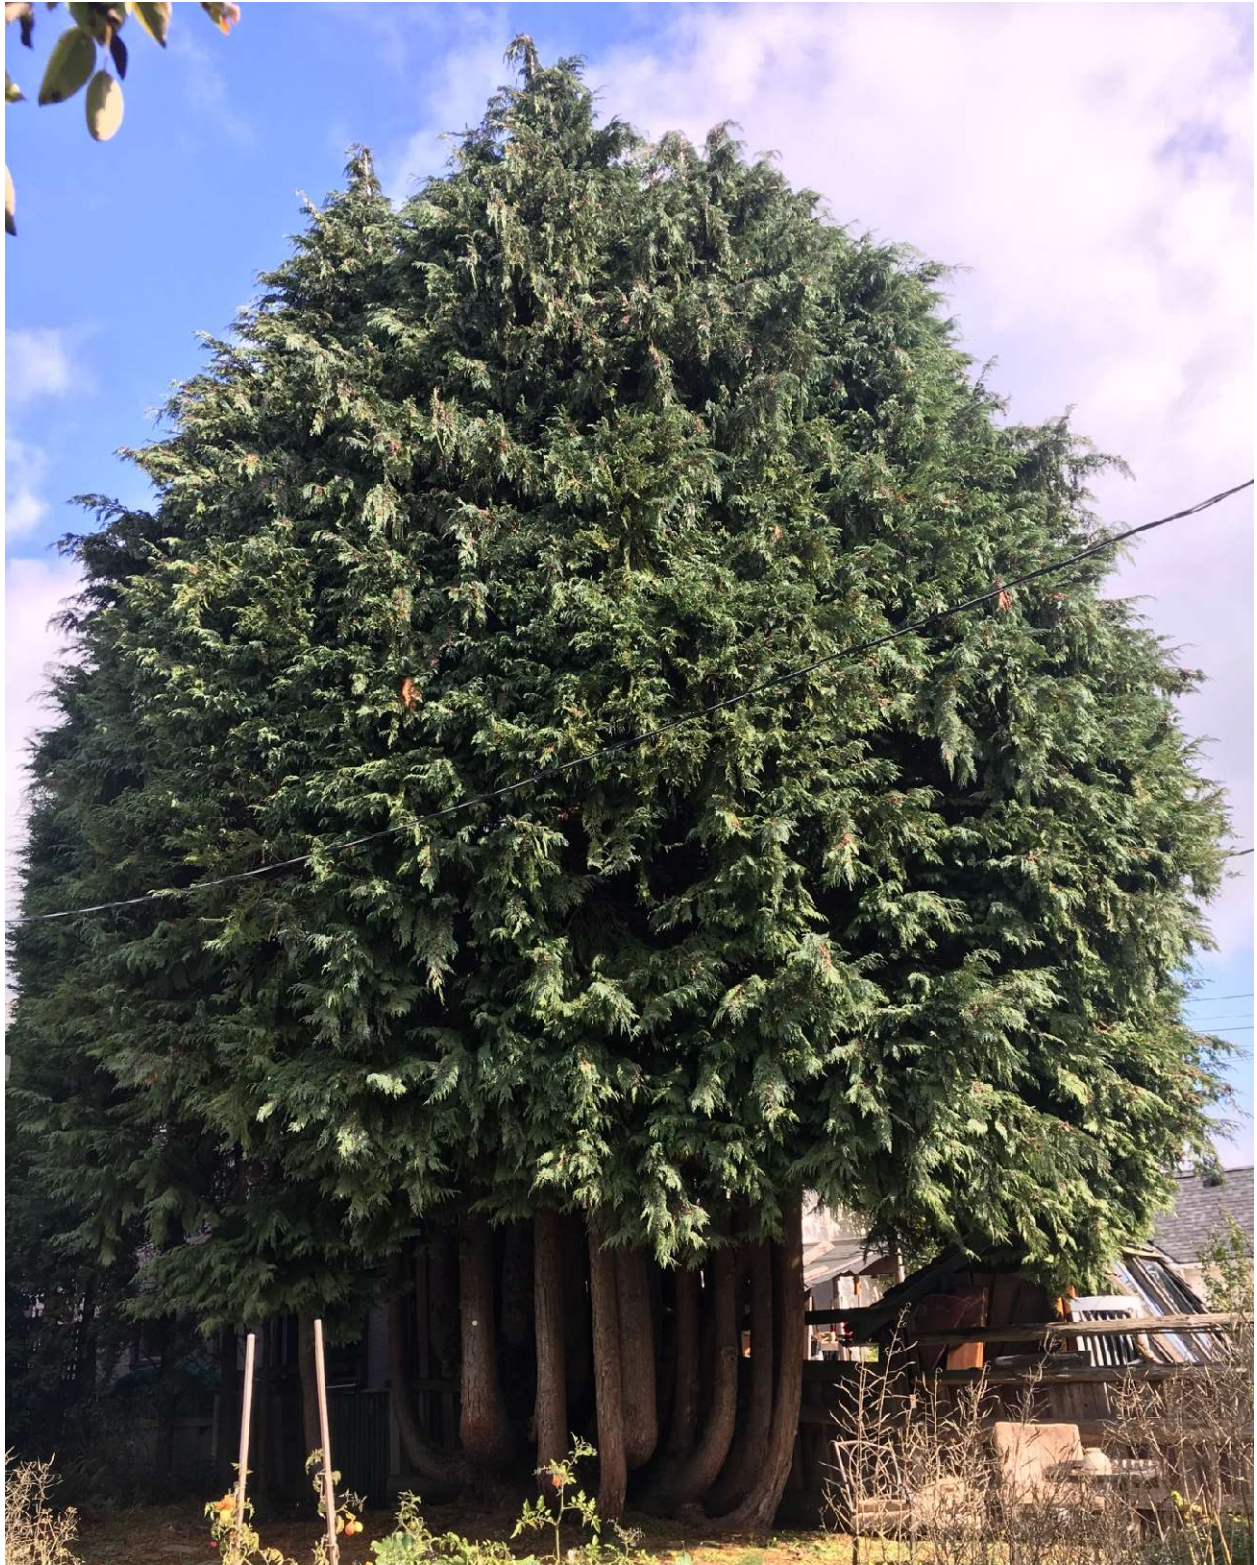
One (1) protected trees is proposed for removal due to construction impacts. Tree #25, a Yellow cedar, is proposed as the proposed development will require significantly more than 35% of the trees rooting area to be removed.

25	Yellow cedar	100	12	13	F/P	5	Yes	Remove	23 time stem between grade and 1.4m above grade. Sweeping J shaped stems. Seams and included bark at many unions. Previously topped. Stems and branches growing into each other. Leaves showing good colour.
NT2	Cherry	Est 50	6	10	F-P/P	4	Yes	Retain	Private Tree. Previously Topped. Some poor pruning cuts. Narrow angles of attachment. Included bark in unions. Fungal ooze. Poor CODIT. Many large waterspouts. Retain and Protect
NT3	Sitka spruce	Est 55	7	20	F/F	7	Yes	Retain	Private Tree. Vigorous growth. Fence obscuring view of basal stem. Healthy Tree. Retain and Protect
NT4	Western red cedar	Est 60	7	20	F-P/F	5	Yes	Retain	Private Tree. Drought stressed. Fence obscuring view of basal stem. Retain and Protect
	Himalayan								Growing through deck. Large J shaped branches. Branches pruned at property line on 2 sides. Healthy CODIT. Retain and Protect
26	cedar	50	6	8.6	F-F-P	6	Yes	Retain

Figure 4. Yellow Cyprus (Tree #25).

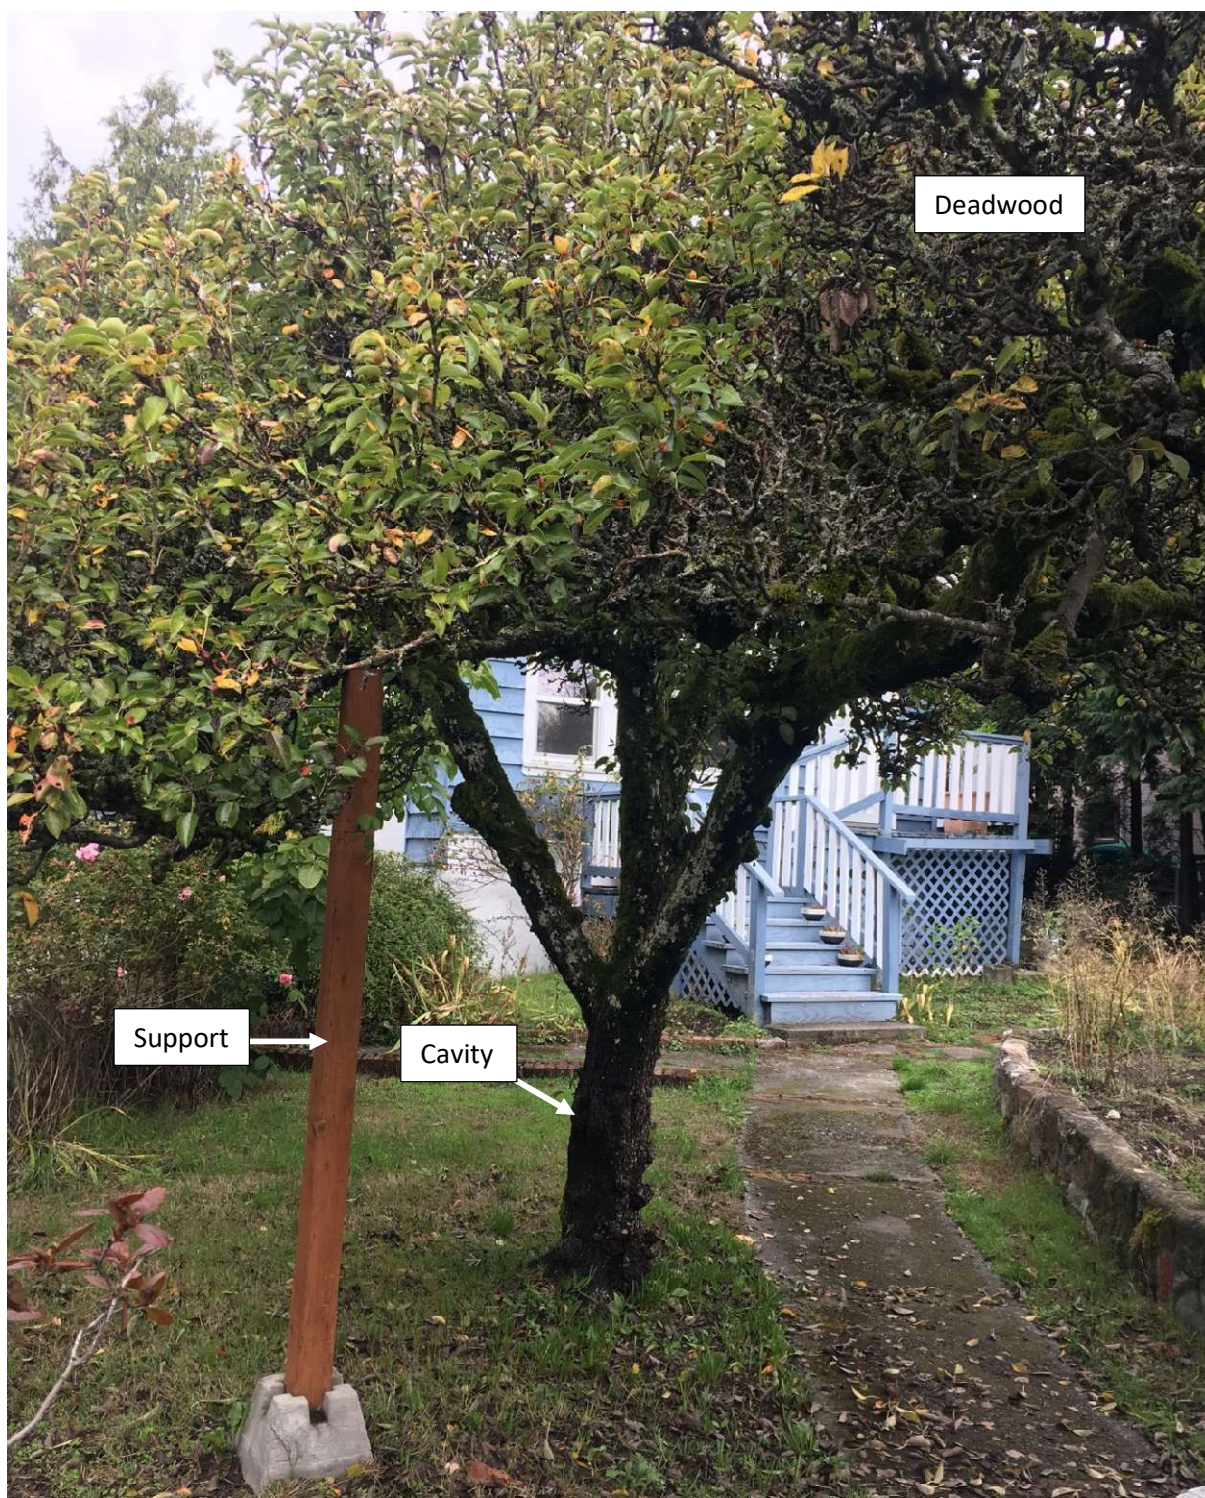
Capital Tree Service Inc.									
Appendix A - Tree Inventory/Hazard Ratings Summary									
Location: 633 Belton Ave, Victoria, BC V9A 2Z5									
Date: October 1, 2021									
Conditions: Mostly Cloudy, 11°C, N 10 km/h									
Tag #	Species	DBH (cm)	PRZ (m)	Height (m)	Health/Structure	Canopy Spread (m) (r)	Bylaw Protected	Action	Comments/Recommendations
NT1	Red maple	26	3	9	F-P/P	4	No	Retain	Heavily Utility Pruned. Seams and included bark at unions. Epicormic growth. Viable rooting area minimized by hardscapes. Retain and Protect
23	Chinese arbutus	13	2	5	F-P/P	1	No	Remove	Hedge row. Multiple stems splitting between grade and 0.5m above grade. Seams and included bark at unions. Poor CODIT. Rooting area minimized by retaining wall.
24	Pear	51	6	4	F-P/F-P	3	Yes	Remove	Overly mature pear. Heavily pruned for fruiting potential. Moss on branches and one side of trunk. One branch supported. Cavity on basal stem. 3 time stem 1 meter above grade. Small deadwood.

Figure 5. Pear Tree. Pear tree in front yard. Cavity on lower stem. Large branch supported. Moss growing on branches and stem.

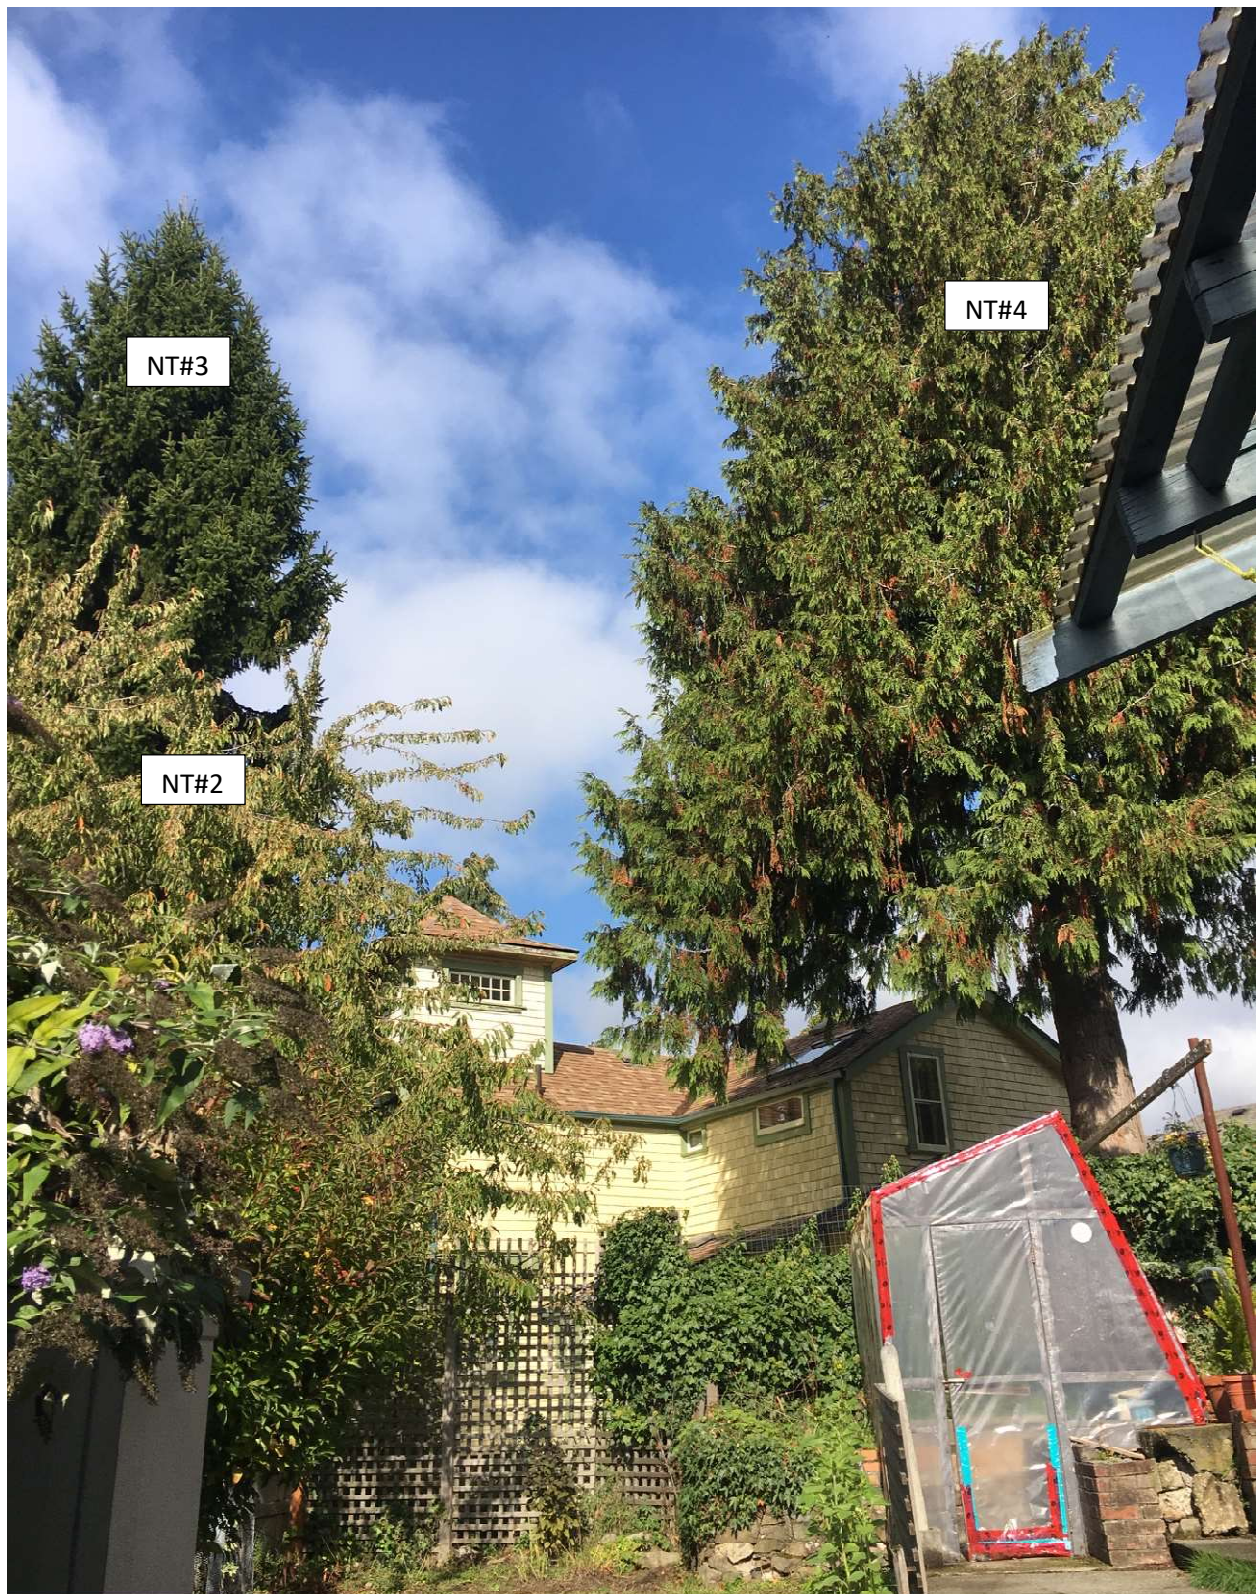
One (1) protected tree in the Northern corner of the property, three (3) protected private trees, and one (1) boulevard tree are all outside the zone of impact and will be retained and protected. The client has requested access to the backyard (the Northwest side of the property) for storage and staging. This entire area is within the PRZs of Trees #26 and NT2-NT4. If compaction reduction (2 layers of ¾" plywood, woodchips maintained at a depth of at least 20cm, matting, or existing decking) is used in the PRZs, impact from storage and construction will have a **'Low'** impact on the retained trees.

Figure 6. Private Trees on Neighbouring Properties.

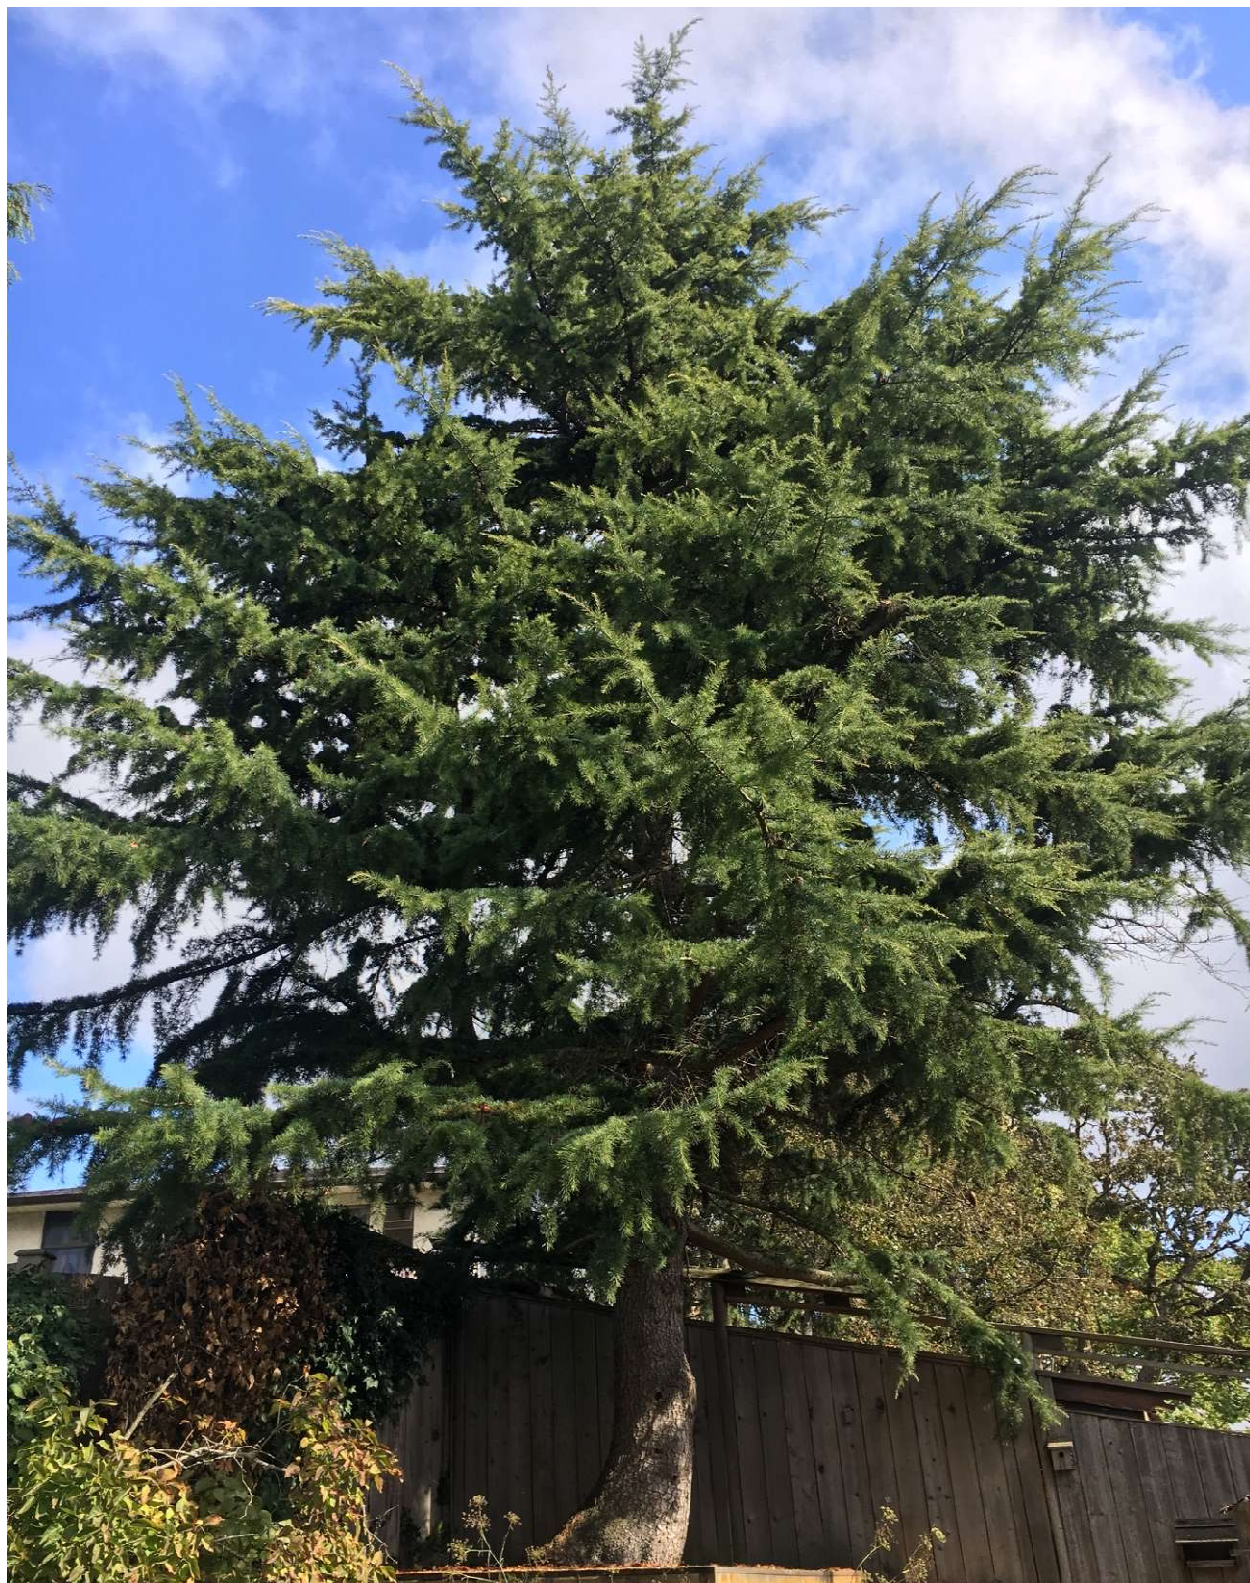
Figure 7. Himalayan cedar in Northeast corner of lot. Himalayan cedar growing through a deck in the Northeast corner of the lot. Pruned at two property lines.
