# Construction Impact Assessment & Tree Management Plan

DATE OF ISSUANCE: June 08, 2021  
Updated: November 05, 2021

Site:	2848 and 2852 Shelbourne Street Street
Municipality	City of Victoria
Client Name:	Jesse Baidwan
Dates of Site Visit:	May 07, 2021
Site Conditions:	A consolidation of 2 urban lots, no ongoing construction activity
Weather During Site Visit:	Clear and sunny

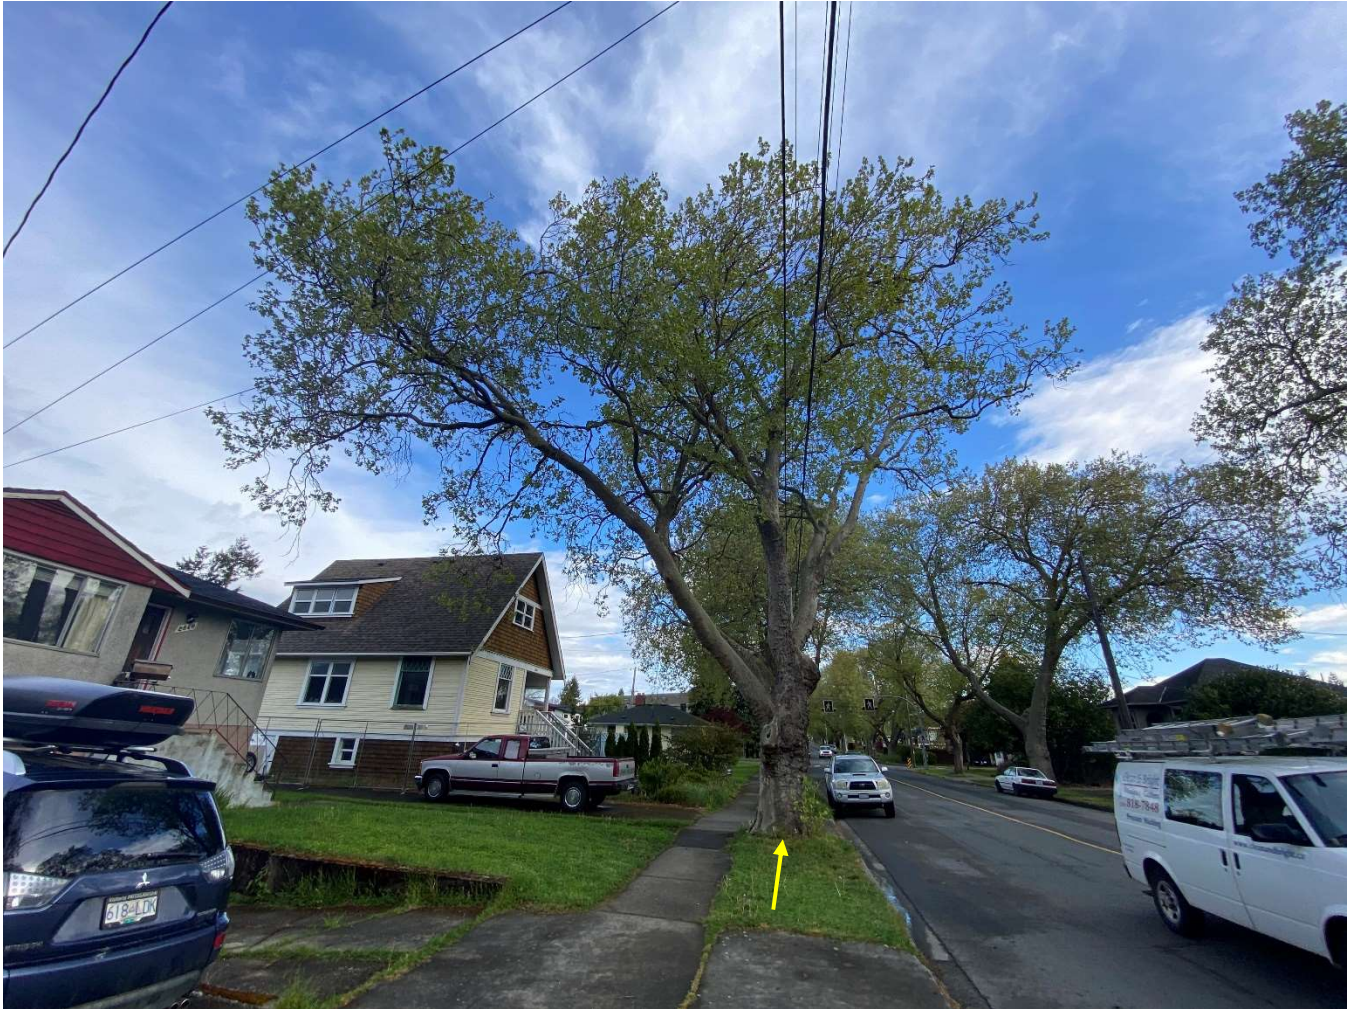
*Photograph 1- Yellow arrow indicates municipal London plane (M1).*

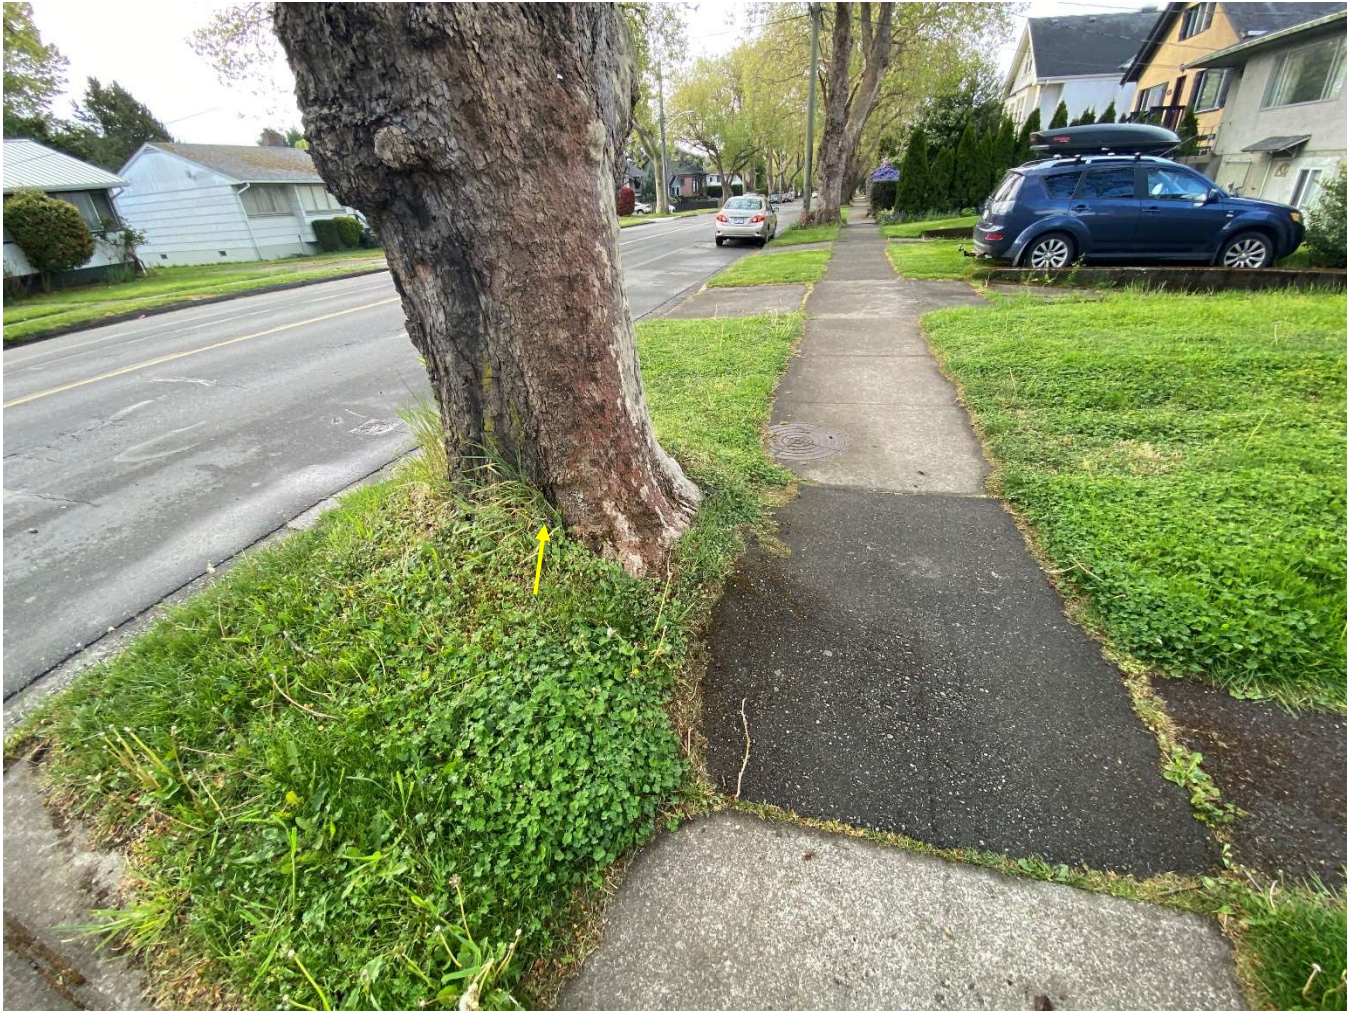
*Photograph 2 – Yellow arrow indicates municipal London plan M1.*

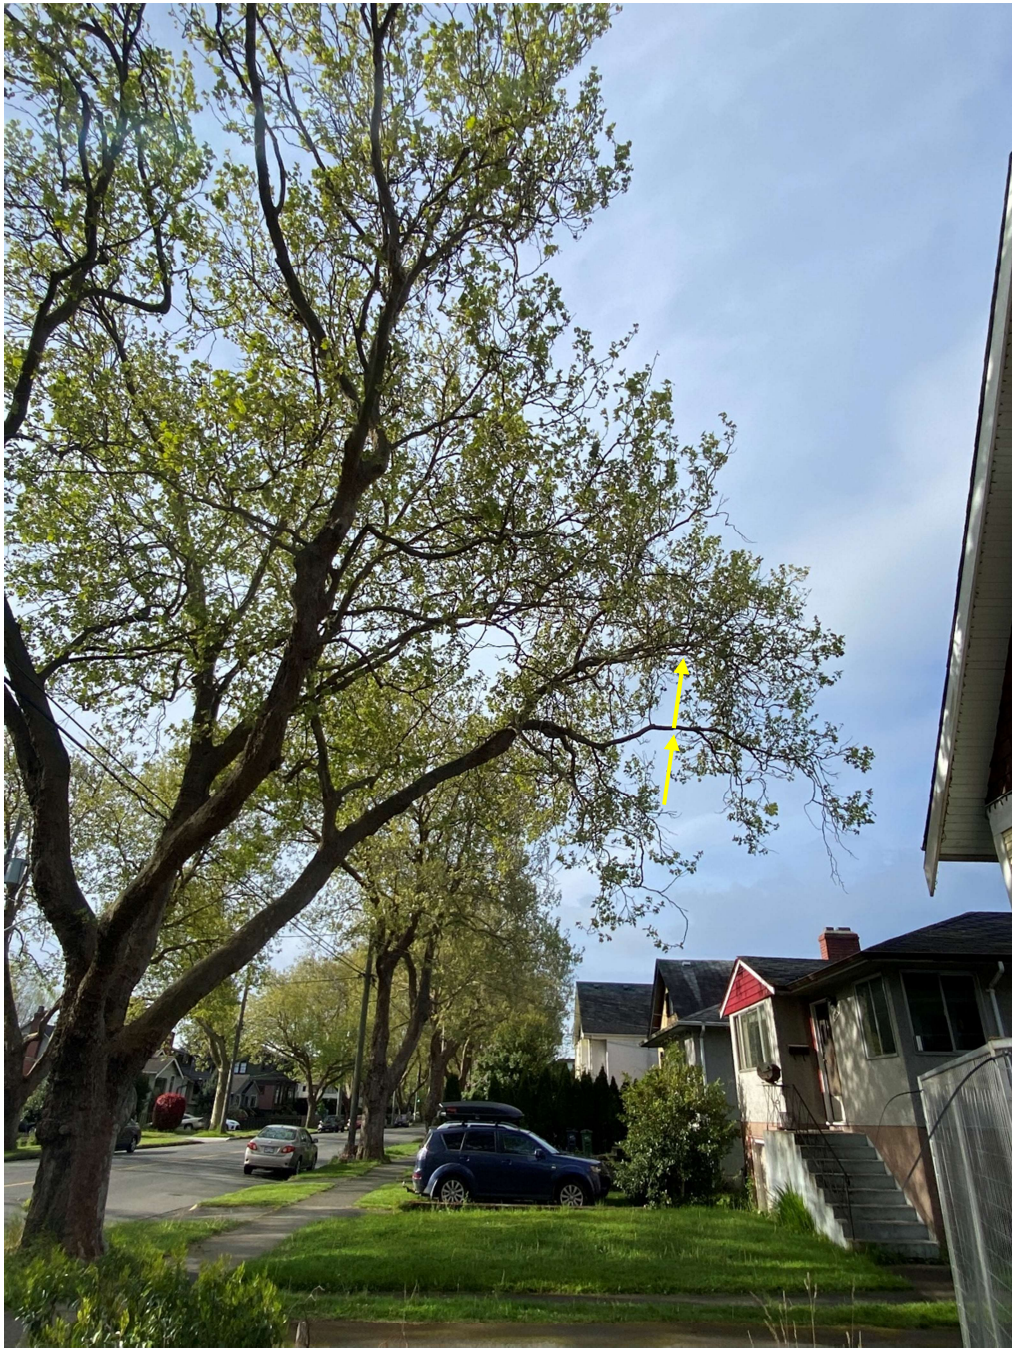
\*5 branches (between 2cm - 5cm diameter) on the west side of the crown (see photograph 3 in [appendix B](#)) will likely require pruning for building clearance and possibly for scaffolding installation. It is recommended that this pruning is performed after the first floor is constructed and the scaffolding is installed (so precise pruning requirements are known) All pruning to be performed to ANSI A300 standards.

*Photograph 3 – Yellow arrows indicate low branches of municipal London plane M1 that may require pruning for clearance from the proposed townhome building and possibly for scaffolding clearances.*

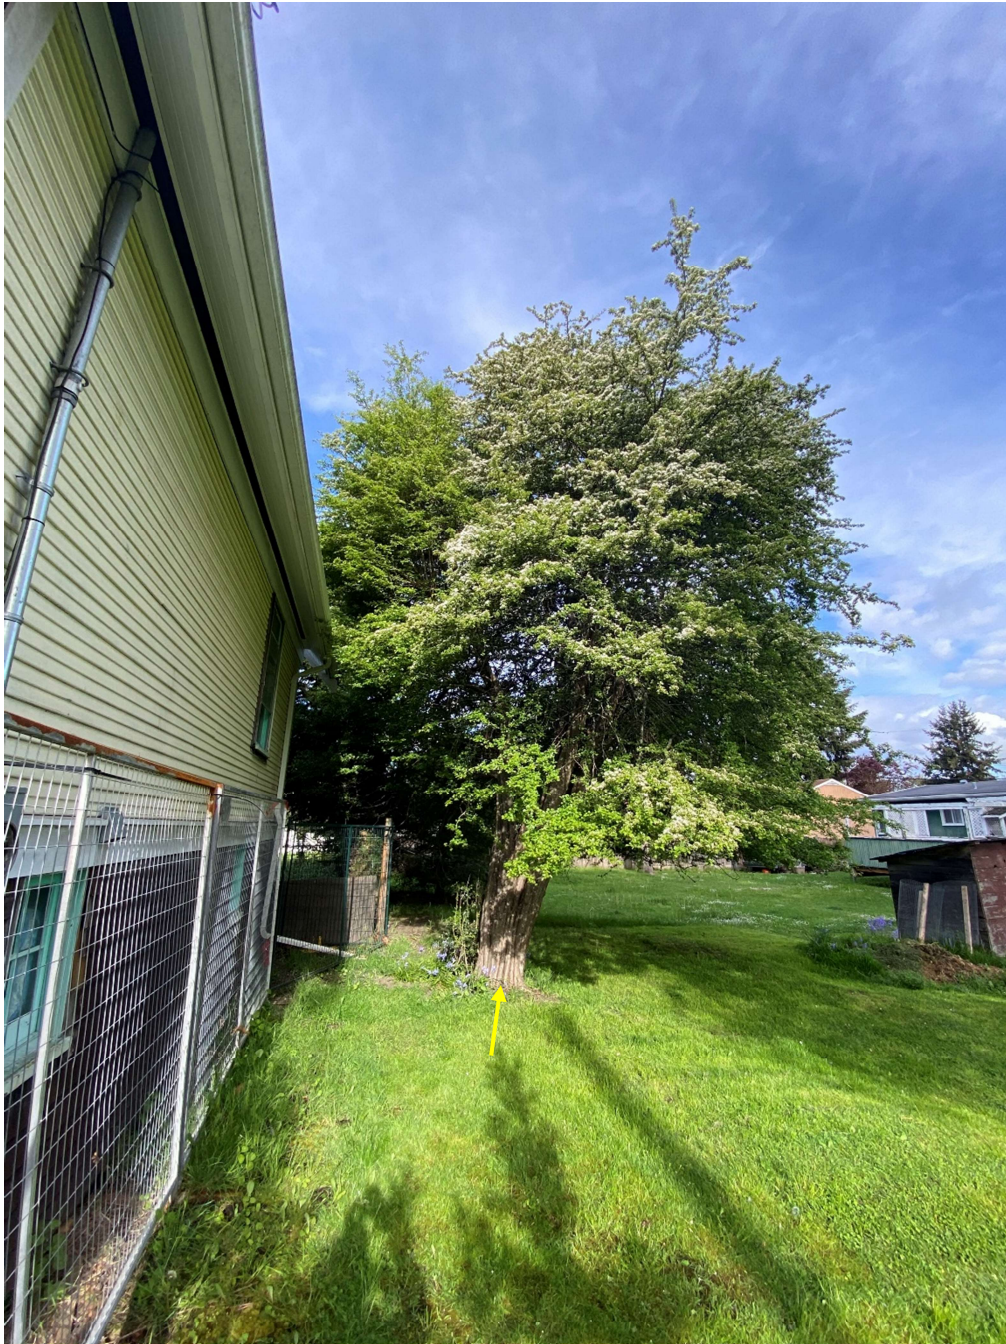
*Photograph 4 – Yellow arrow indicates offsite Hawthorn (OS1).*

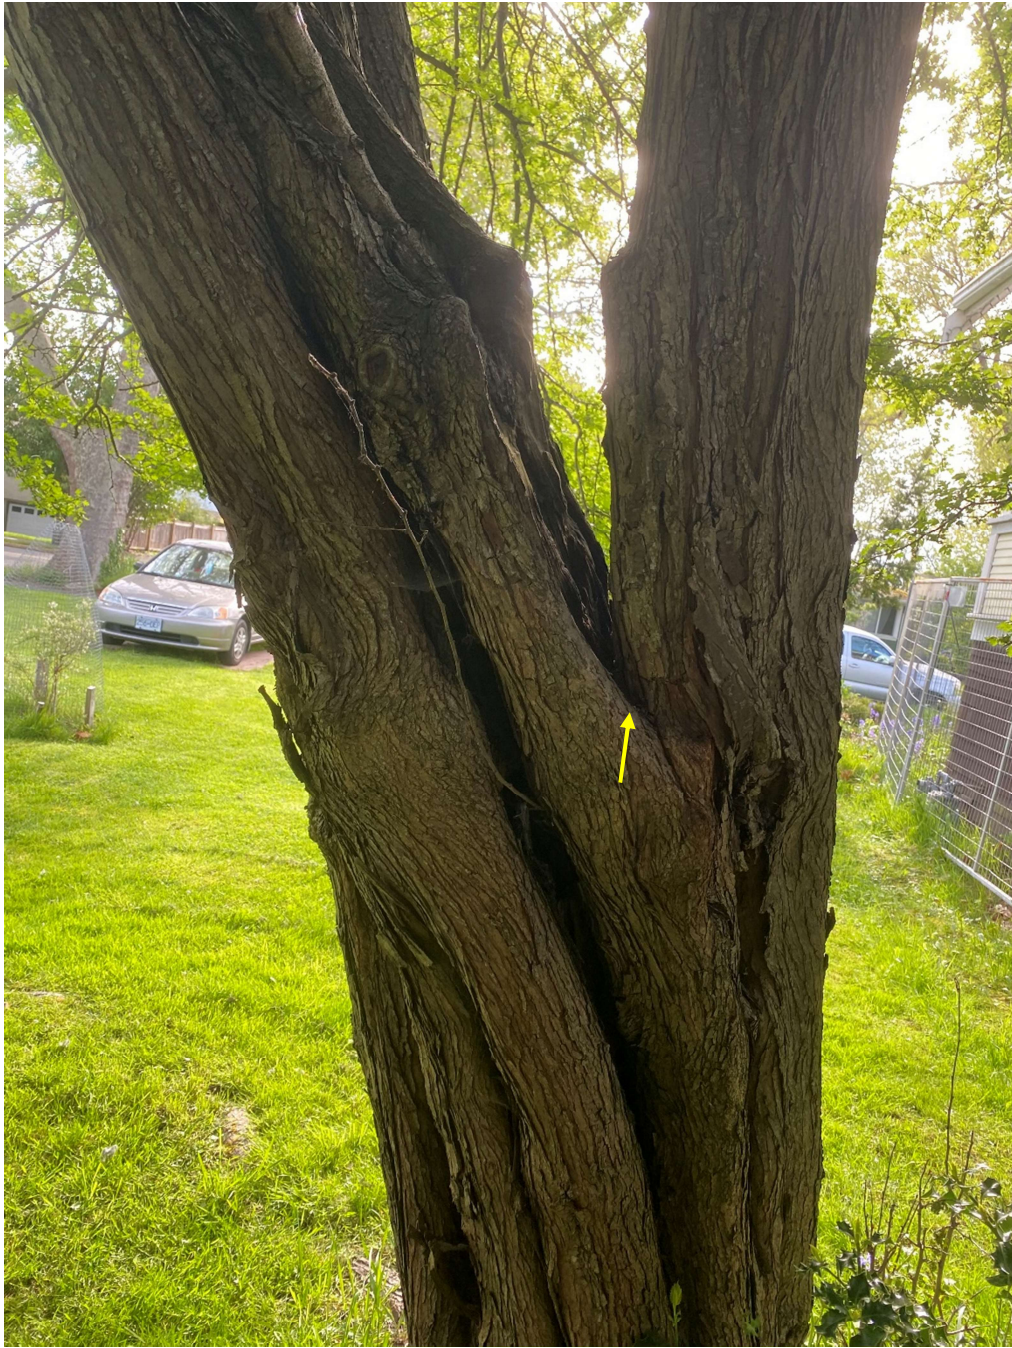
OS1	Yes	Off	Yes	English hawthorn	<i>Crataegus laevigata</i>	72~	10	7.6	4	Good	Poor		Good	Tridominant stems form at 1 meter above grade - narrow angles of attachment, 2 stems are separating.	*Driveway proposed within the critical root zone. Project arborist to supervise all excavation required within the crz. Crown raise pruning for driveway clearance to be performed to ANSI A300 standards.	Retain*
OS2	No	Off	No	Spruce	<i>Pricea sp.</i>	12~	5	1.9	1.5	Good	Good		Poor	Young tree, no visible defects.	Project arborist to supervise all excavation required within the crz	Retain
092	Yes	On	No	Leyland Cypress	<i>Cupressus x leylandii</i>	24	10	2.5	3	Good	Good	Unsuitable	Good	Young tree, no visible defects.	Located within the footprint of the proposed driveway.	Remove
093	Yes	On	Yes	Pear	<i>Pyrus sp.</i>	41	8	5.1	2	Fair	Poor	Unsuitable	Moderate	Topped historically at 5m above grade - water sprouts have not been maintained, large diameter topping wounds.	Located within the footprint of the proposed driveway.	Remove

*Photograph 5 – Offsite Hawthorn (OS1) – Yellow arrow indicates separating stem union.*

\* OS1 will require crown raise pruning of small lower branches (2 – 3cm diameter) for clearance from the proposed driveway. All pruning to be performed to ANSI A300 standards.

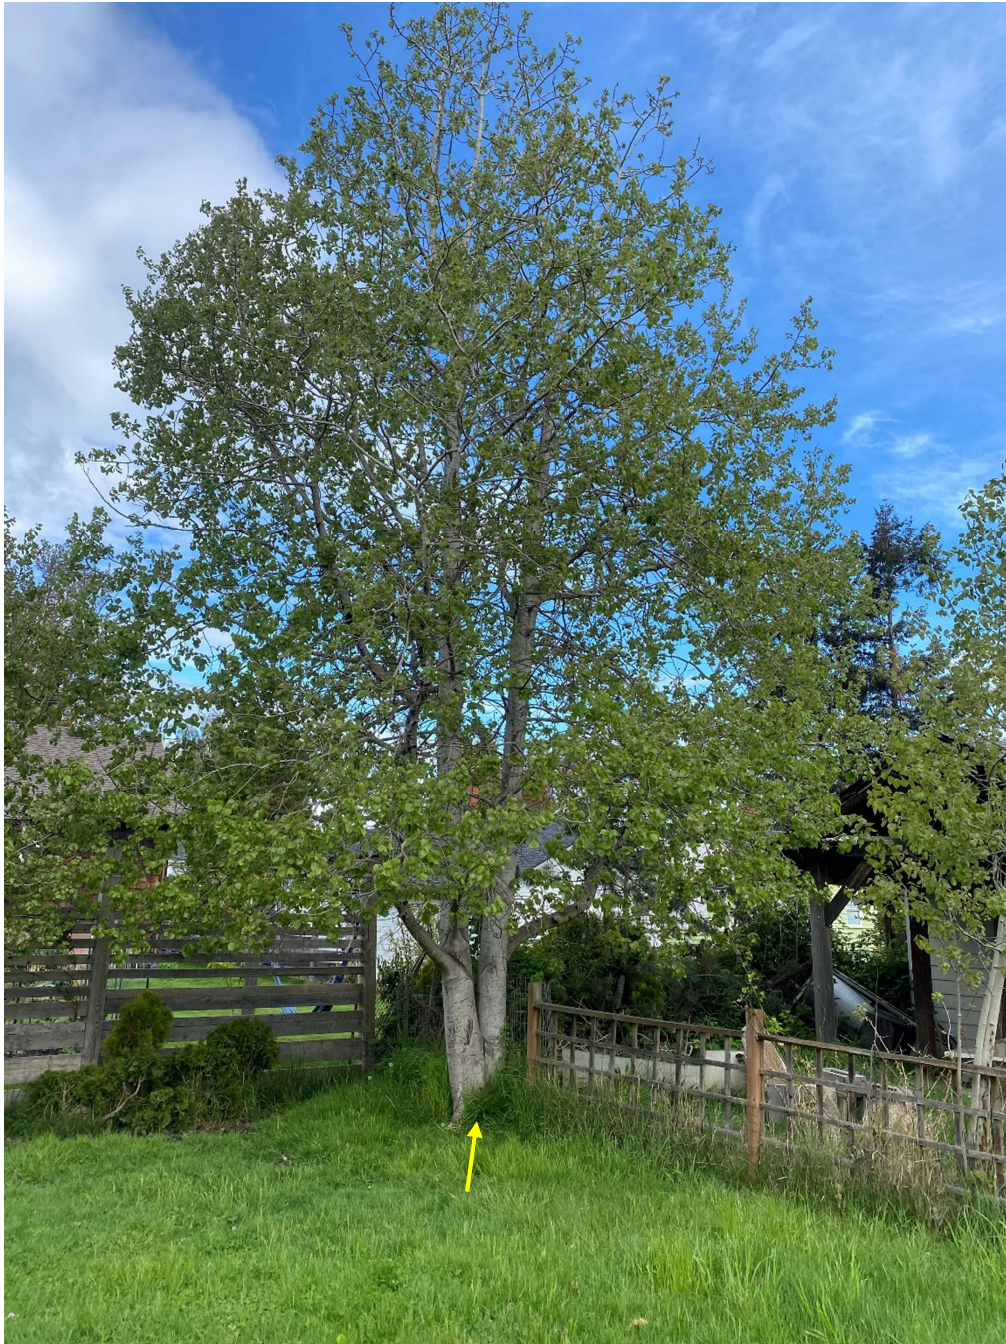
094	Yes	On	Yes	Trembling aspen	<i>Populus tremuloides</i>	32,33	15	8.1	4	Good	Fair/poor	Unsuitable	poor	Codominant leaders form at3m above grade - included and narrow stem union, 10cm diameter limb headed back on East side.	Will be heavily impacted by excavation required to construct the foundation of the proposed townhome.	Remove
OS 095	Yes	Off	Yes	Trembling aspen	<i>Populus tremuloides</i>	16,16,6,3	5	4.5	2.5	Good	Poor		Poor	Topped historically at 4m above grade - small regrowth leaders emerge near topping location, stem removed at 1m above grade.	*Townhome foundation and patio proposed within the crz. Project arborist to supervise all excavation required within the crz	Retain*
1222	No	On	No	Plum	<i>Prunus sp.</i>	10,10,9,6,6	5	2.7	3	Fair/good	Fair/poor	Unsuitable	Moderate	Fruiting plum, multiple stems with narrow angles of attachment.	Located within the footprint of the proposed driveway.	Remove

*Photograph 6 – Yellow arrow indicates onsite Trembling aspen (tag# 094).*
