SouthShore Forest Consultants

Arborist Report

419 Stannard Ave
City of Victoria, BC

September 8, 2020 – **Revision #3 November, 2022**

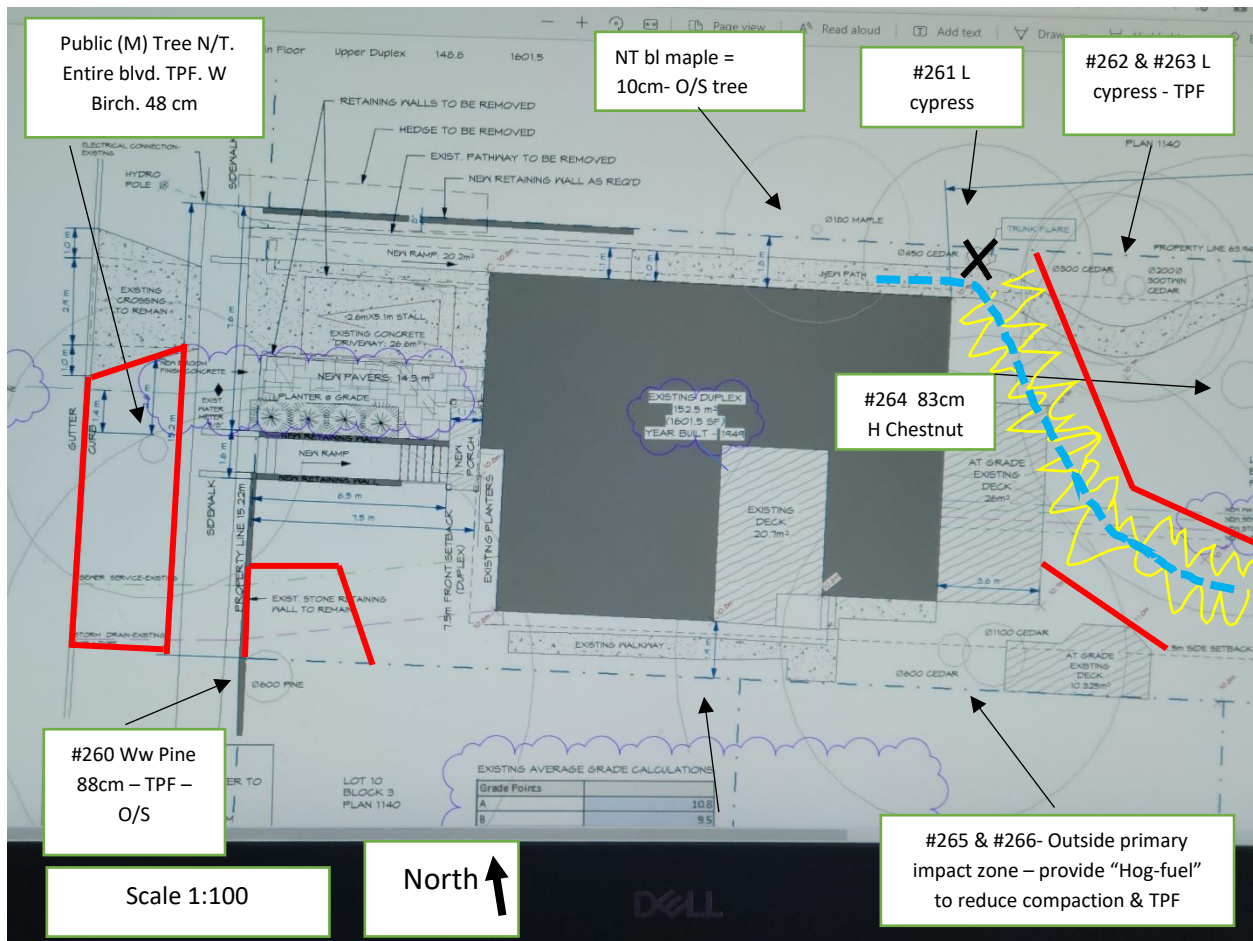
Figure #1 – Tree Site Map Section One (West End)

- Red hatched lines indicate Tree Protection Fencing.
- Yellow lines indicate Hog-Fuel/wood chip positioning. Wooden/rubber panel sheeting can be utilized to displace soil/root compaction.
- Blue Hatched Line – Path of travel into rear yard – Developer will be conditioned to follow a strict egress path into and out of the site.

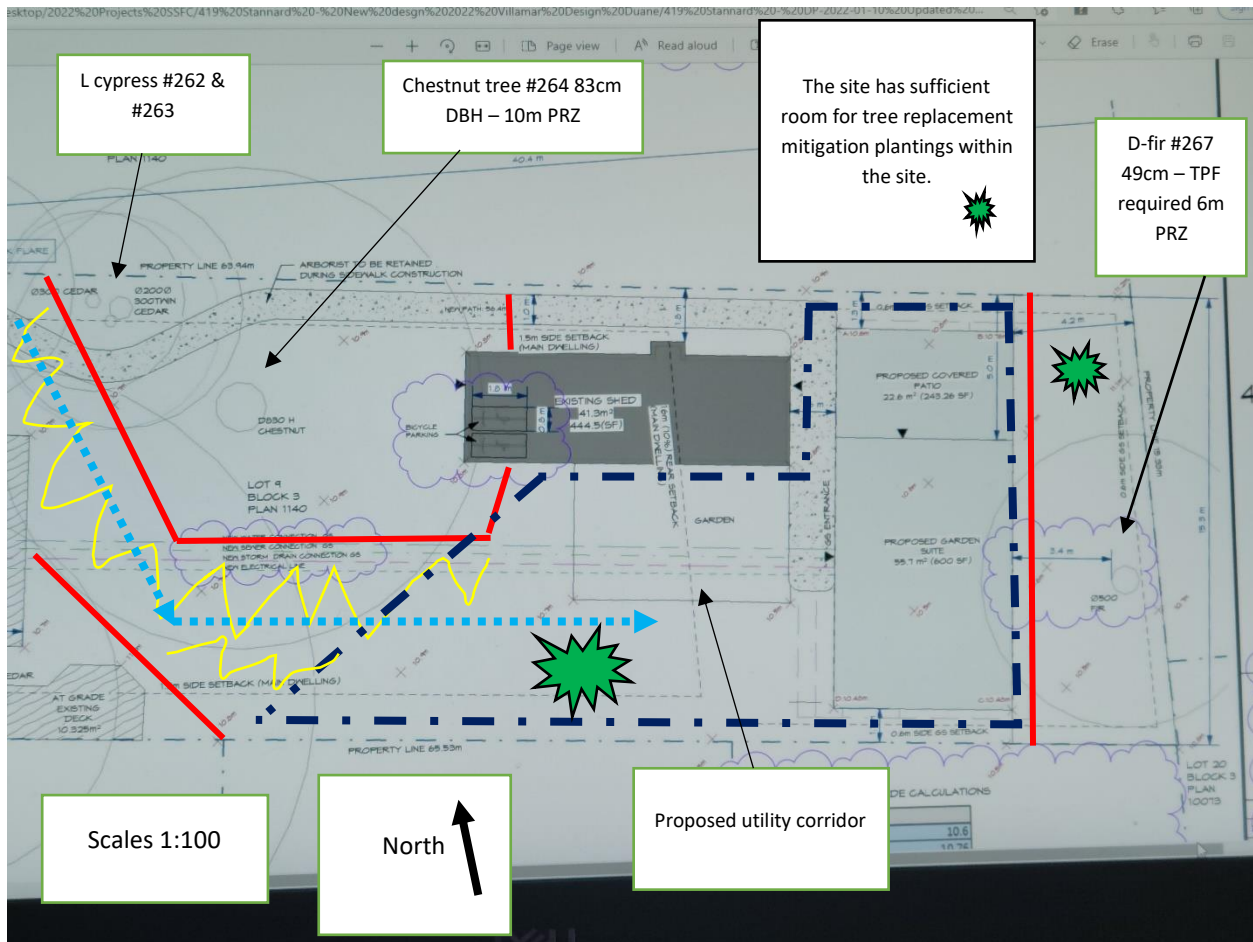
Figure #2 – Tree Site Map Section Two (East End)

- Red hatched lines indicate Tree Protection Fencing.
- Yellow lines indicate Hog-Fuel/wood chip positioning. Wooden/rubber panel sheeting can be utilized to displace soil/root compaction.
- Blue Hatched Line – Path of travel into rear yard – Developer will be conditioned to follow a strict egress corridor into and out of the site.
- Purple solid line indicates the Staging Area for the site.

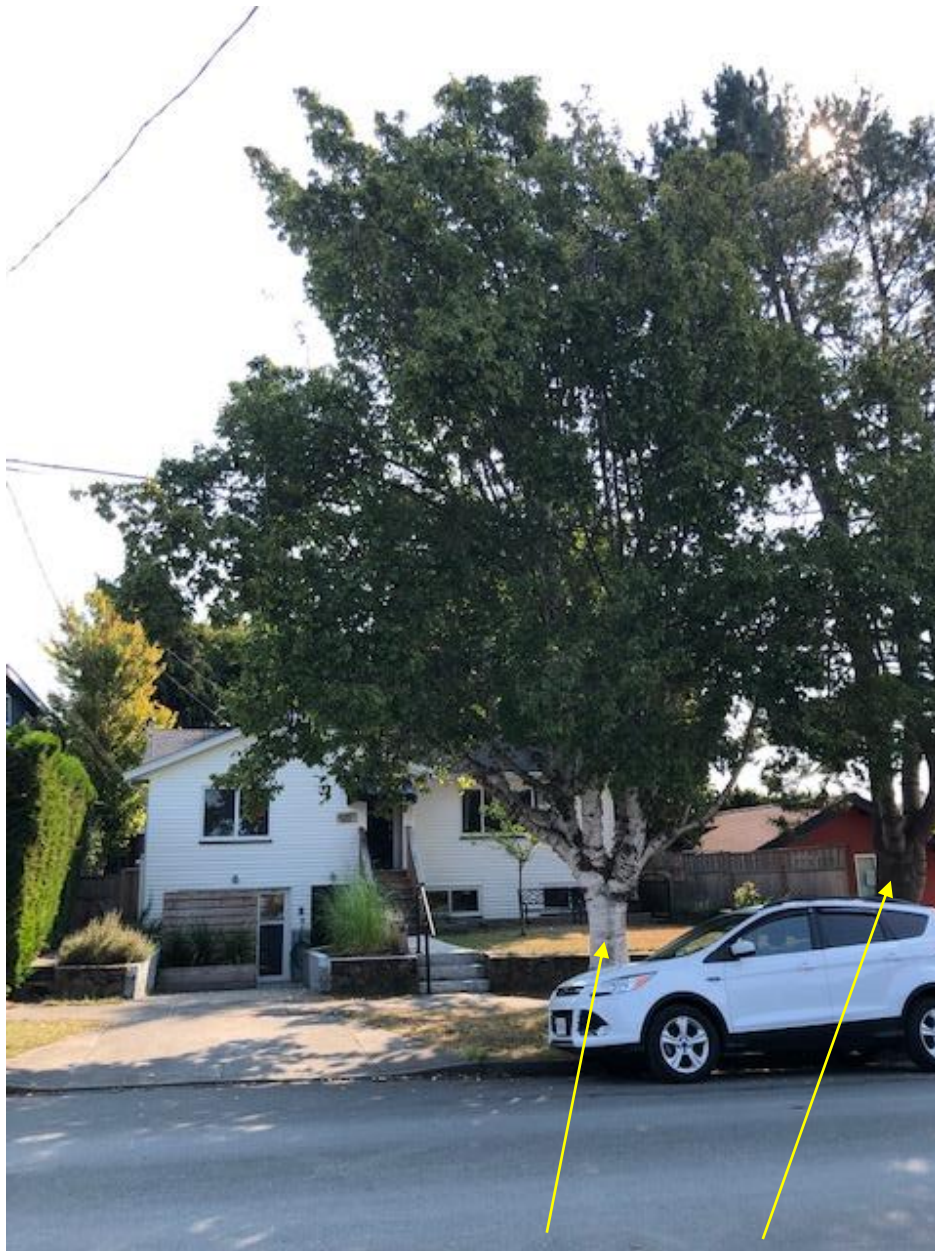
Figure #3 – Front of Site – Municipal Boulevard

View from Stannard of property frontage. 48cm DBH city owned White birch and 88cm DBH private Western white pine (#260) are visible in this photo.

- Public Tree NT W birch will be assessed during front yard improvements, <5% of PRZ may be impacted.

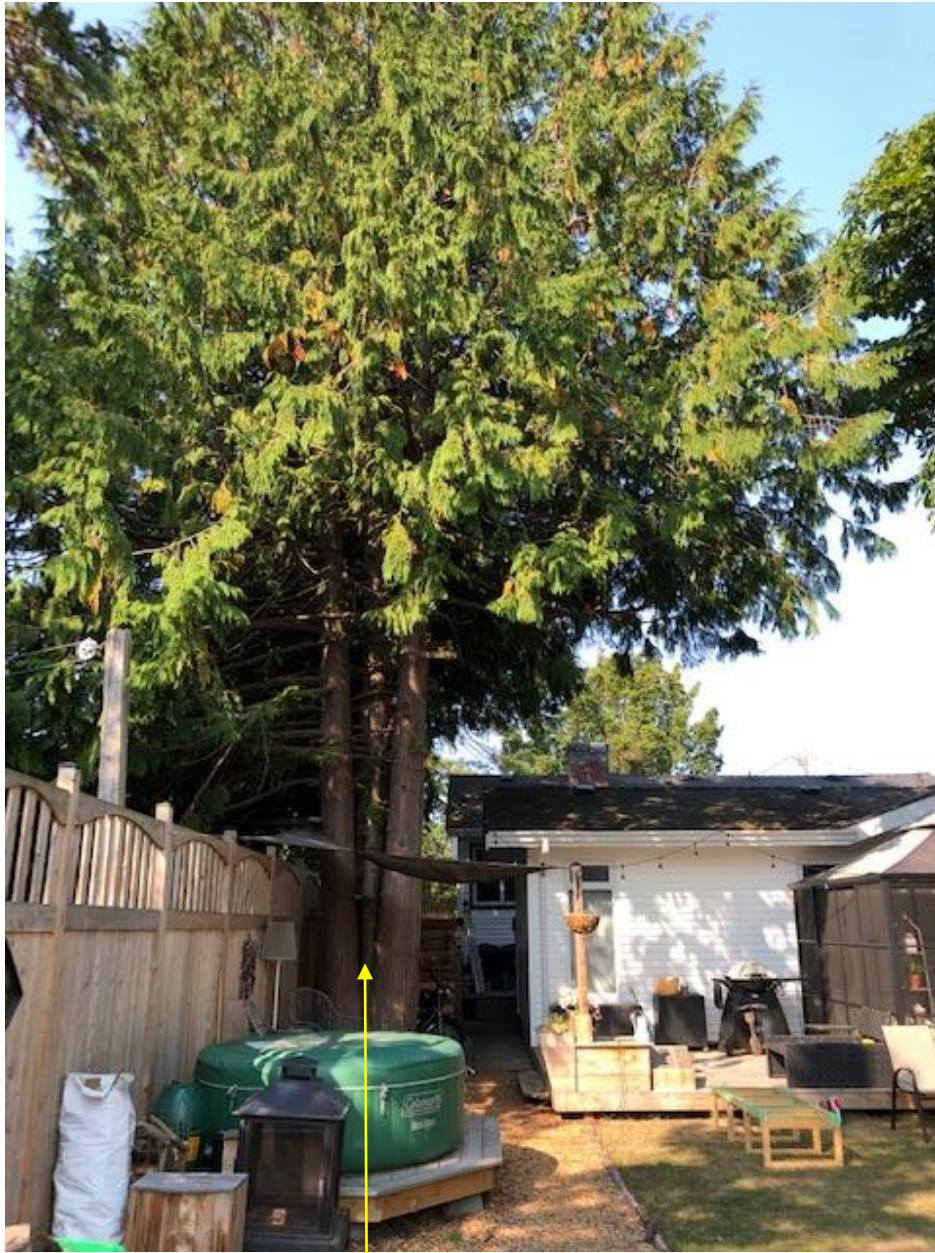
Figure #3 – Rear Yard – Tree #266 Western Red Cedar

Photo showing WRC #266. TPF will be used to protect this tree.

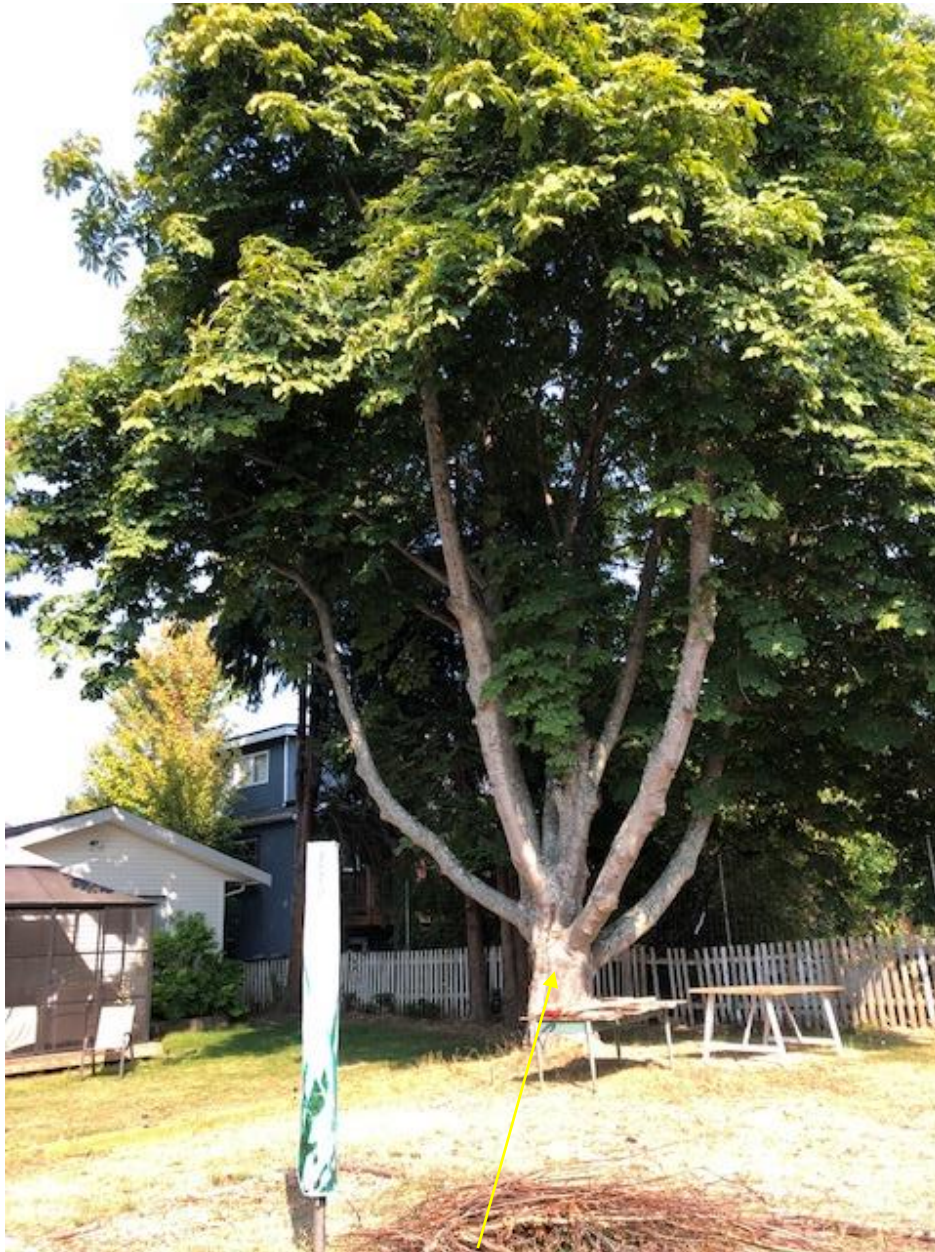
Figure #4 – Rear Yard – Tree #264 Horse Chestnut

Phot showing Horse chestnut #264. TPF will be used to protect this tree.

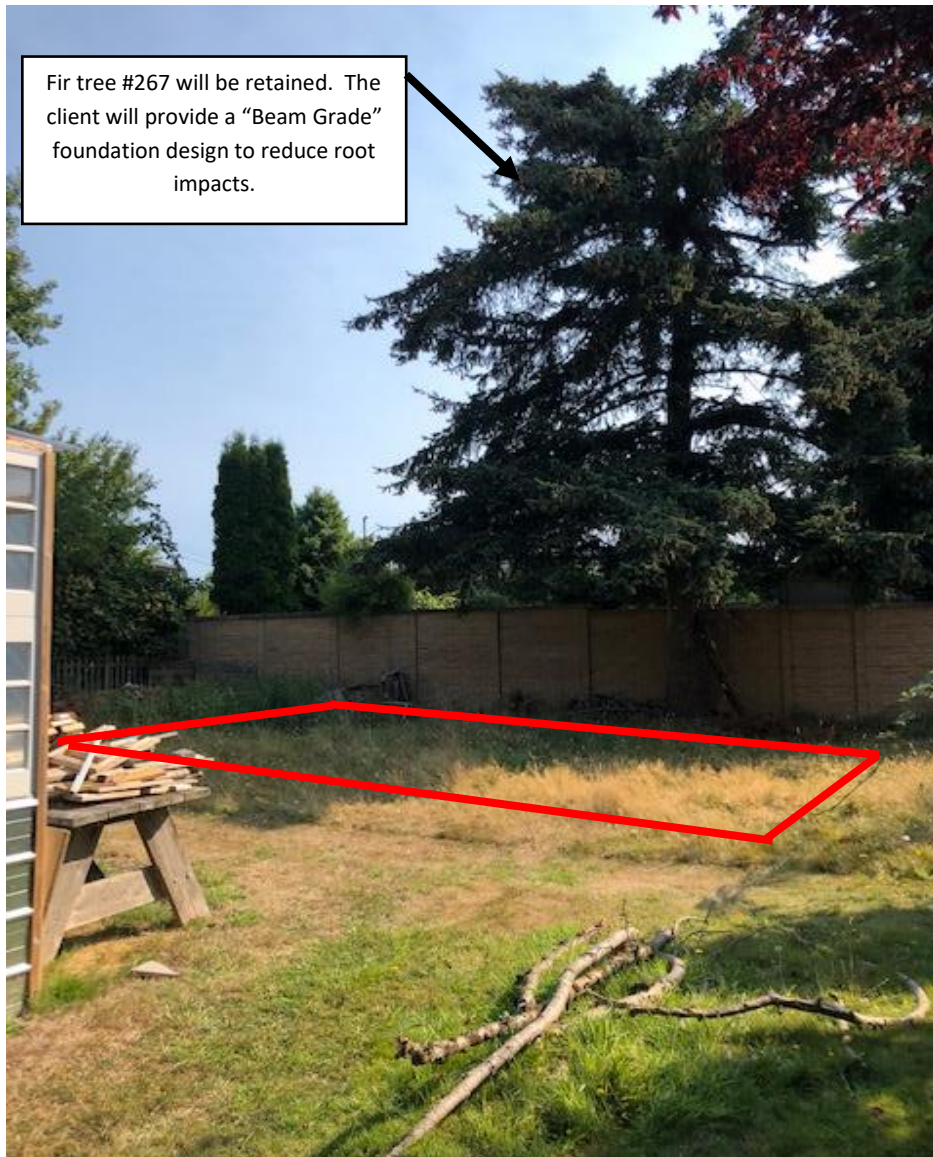
Figure #6 – Rear Yard – Proposed Garden Suite Location

The client has suggested that a “**Grade Beam**” design be utilized in this case. Requiring excavation depths of 60cm in specific areas (corners) of the footprint we believe root impacts to the fir will be minimized. Furthermore, existing root composition and/or formations within the proposed footprint of the suite have yet to be determined. An exploratory excavation along at 3.5m out from the base of the tree will help identify root size ad quantity. In this case we recommend that hand digging be performed for when providing the exploratory excavation.

Photo showing D fir #267 and the proposed location for a garden-suite. The red outline indicates where the suite would be positioned.

We suggest that the suites foundation be designed to reduce excavation and/ or impacts to tree roots and resulting compaction.
