**1039 & 1043 Meares Street**

**Tree Management Plan Report**

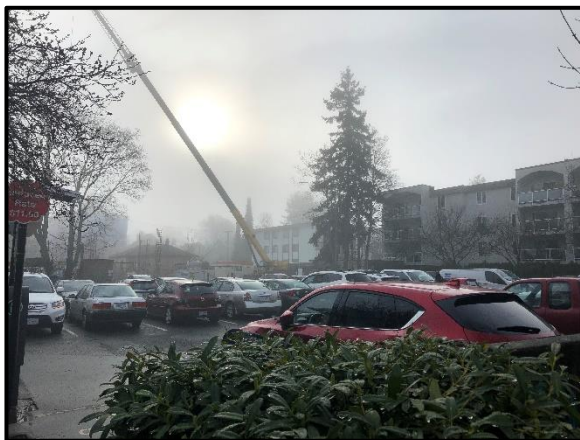
**Photo 1:** The front of the property as viewed looking in a southeastern direction. (03/01/2022)

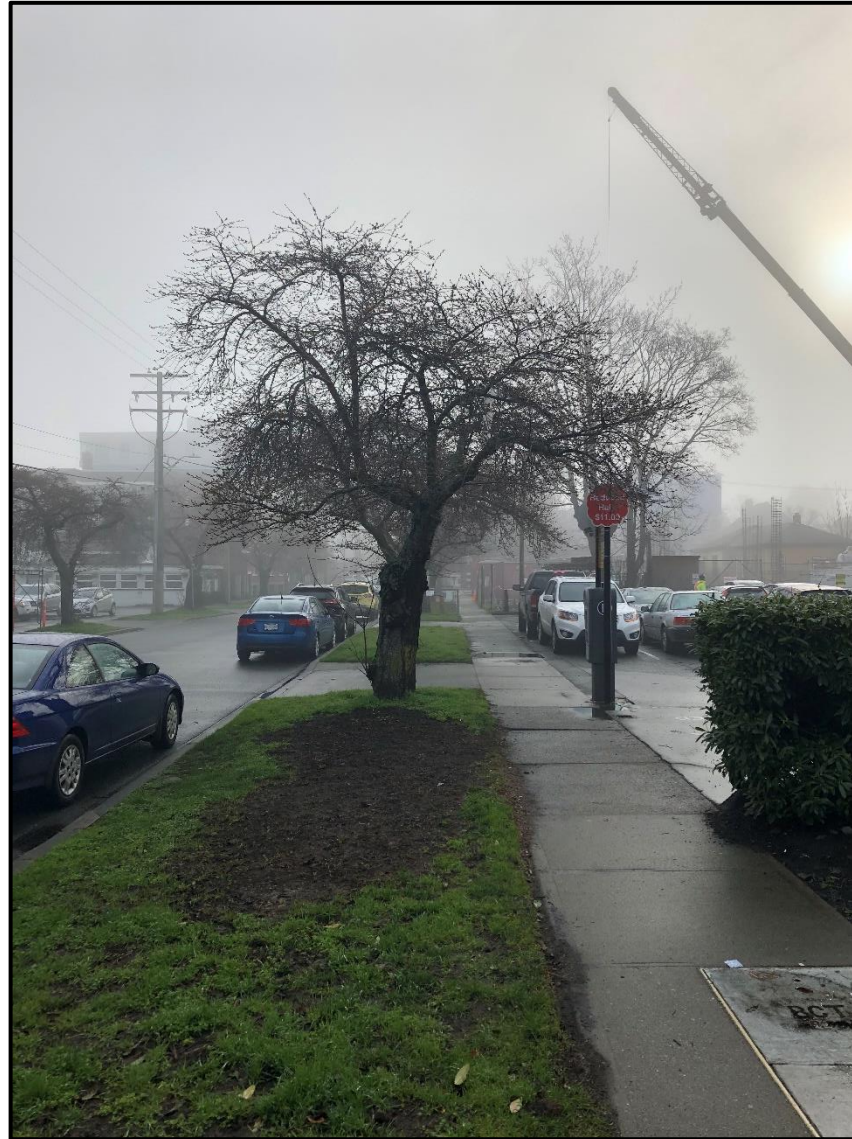
The two municipal owned Yoshino cherry (*Prunus yedoensis*) #M101 and M-102 boulevard trees are located next to the northwest corner of the site. One tree #M-101 will require removal for the installation of a new driveway access. Tree #M-102 is to be retained, and it will require tree protection fencing around the available protected root zone. However, due to the presence of the sidewalk and road, the fencing will not be able to fully protect the entire PRZ. Instead, only the area covered with grass will be protected by fencing. Arborist supervision will be required if construction activity takes place within the PRZ. These trees are intolerant of mechanical injury as they are poor wound compartmentalizers as such any excavation

**Tree #M-101, viewed with an east facing perspective (03/01/2022).**

if required, should be done with as minimal an impact as possible. Any roots larger than 1 cm in diameter will require careful excavation preferably by hydro-vacuum truck or hand digging. If any pruning is required the roots encountered will be photographed and documented for forwarding to the City in the form of a monitor report. Root pruning may only be done by the supervising arborist on site. No roots larger than 3 cm in diameter may be pruned without written permission from the City of Victoria.

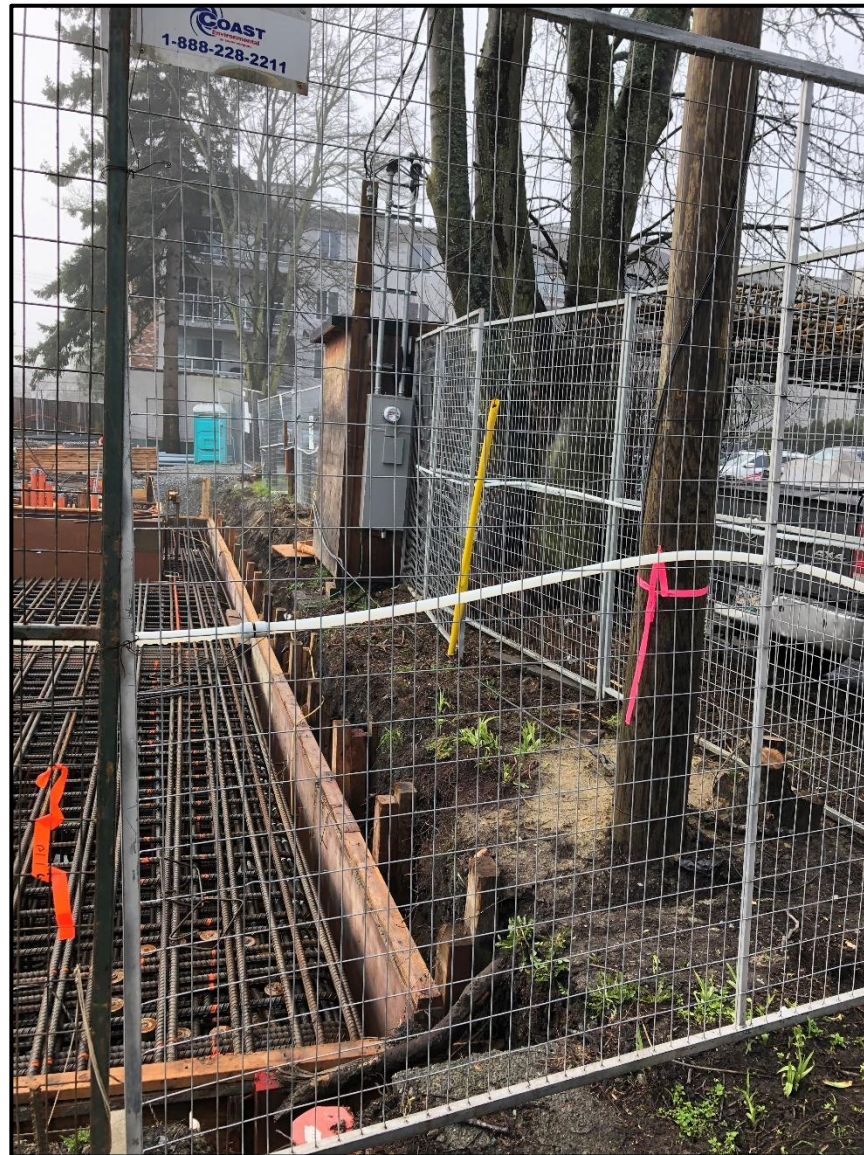
**Tree #114 incurred root loss from neighboring BC Housing project and was removed (03/01/2022).**

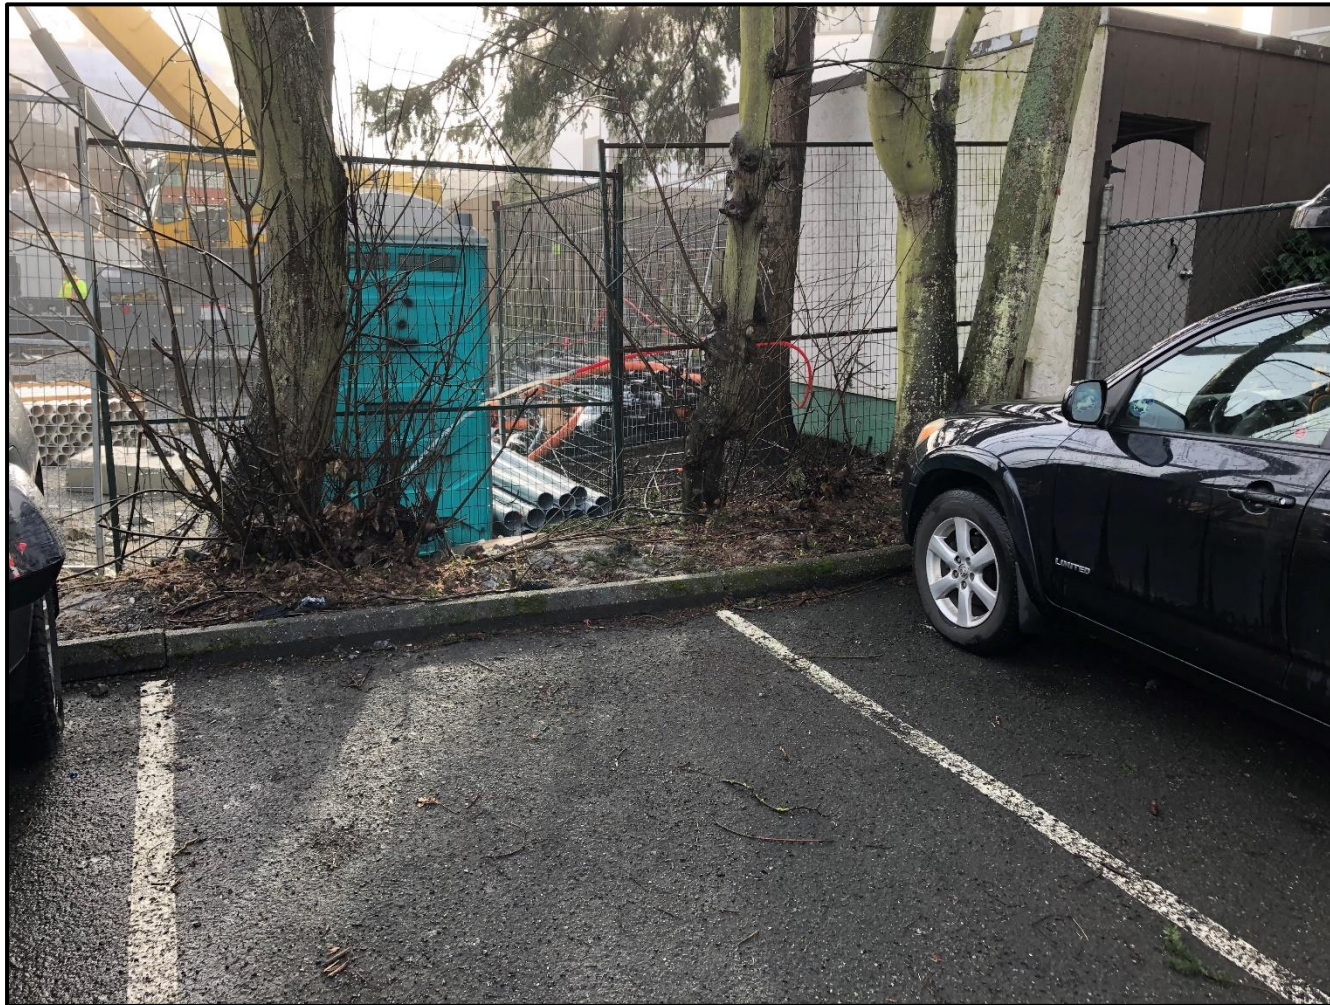
The Douglas fir (*Pseudotsuga menziesii*) #OS-113 is located on the neighbouring property adjacent to the southeast corner. It may incur impacts from potential excavation and these trees respond well to minimal root pruning when required. Most of the tree's PRZ will be protected by the Tree Protection Fencing. Much like the other trees, any roots encountered can only be pruned by an ISA certified arborist and must be documented.

**View of the trees bases in the southeast corner of the property (03/01/2022).**
