TALBOT MACKENZIE & ASSOCIATES

Construction Impact Assessment &

Tree Management Plan

February 10, 2022 July 27, 2023

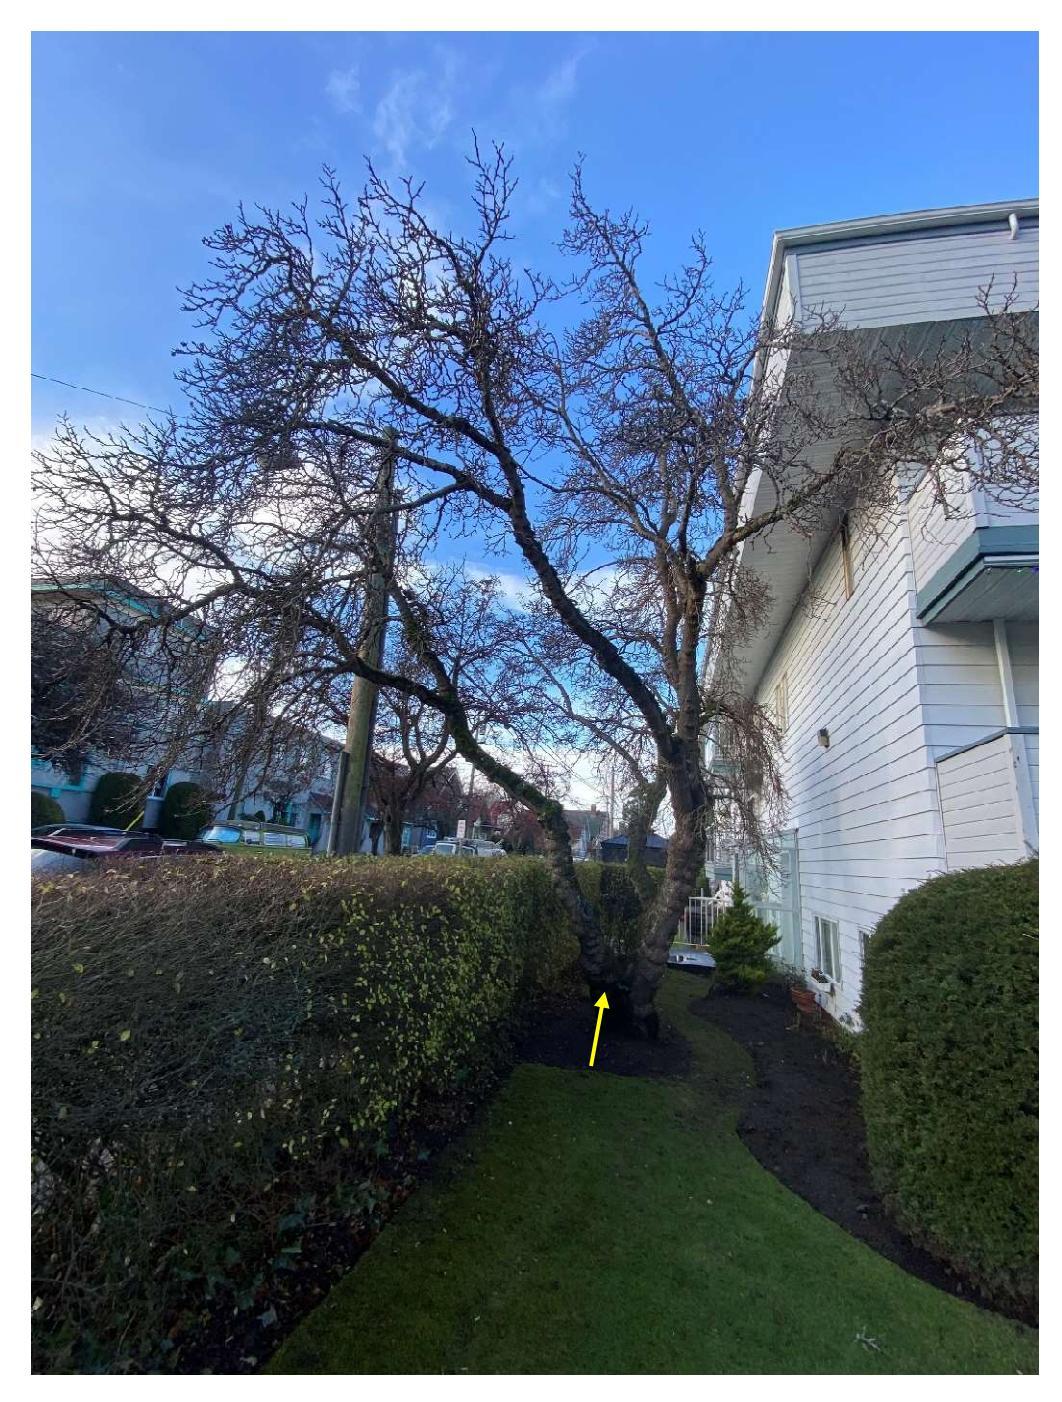
Photograph 1. Yellow arrow indicates tag# 1972.

- All excavation required within the critical root zone of 1972 to remove the existing building foundation and for the footprint of the proposed building foundation.

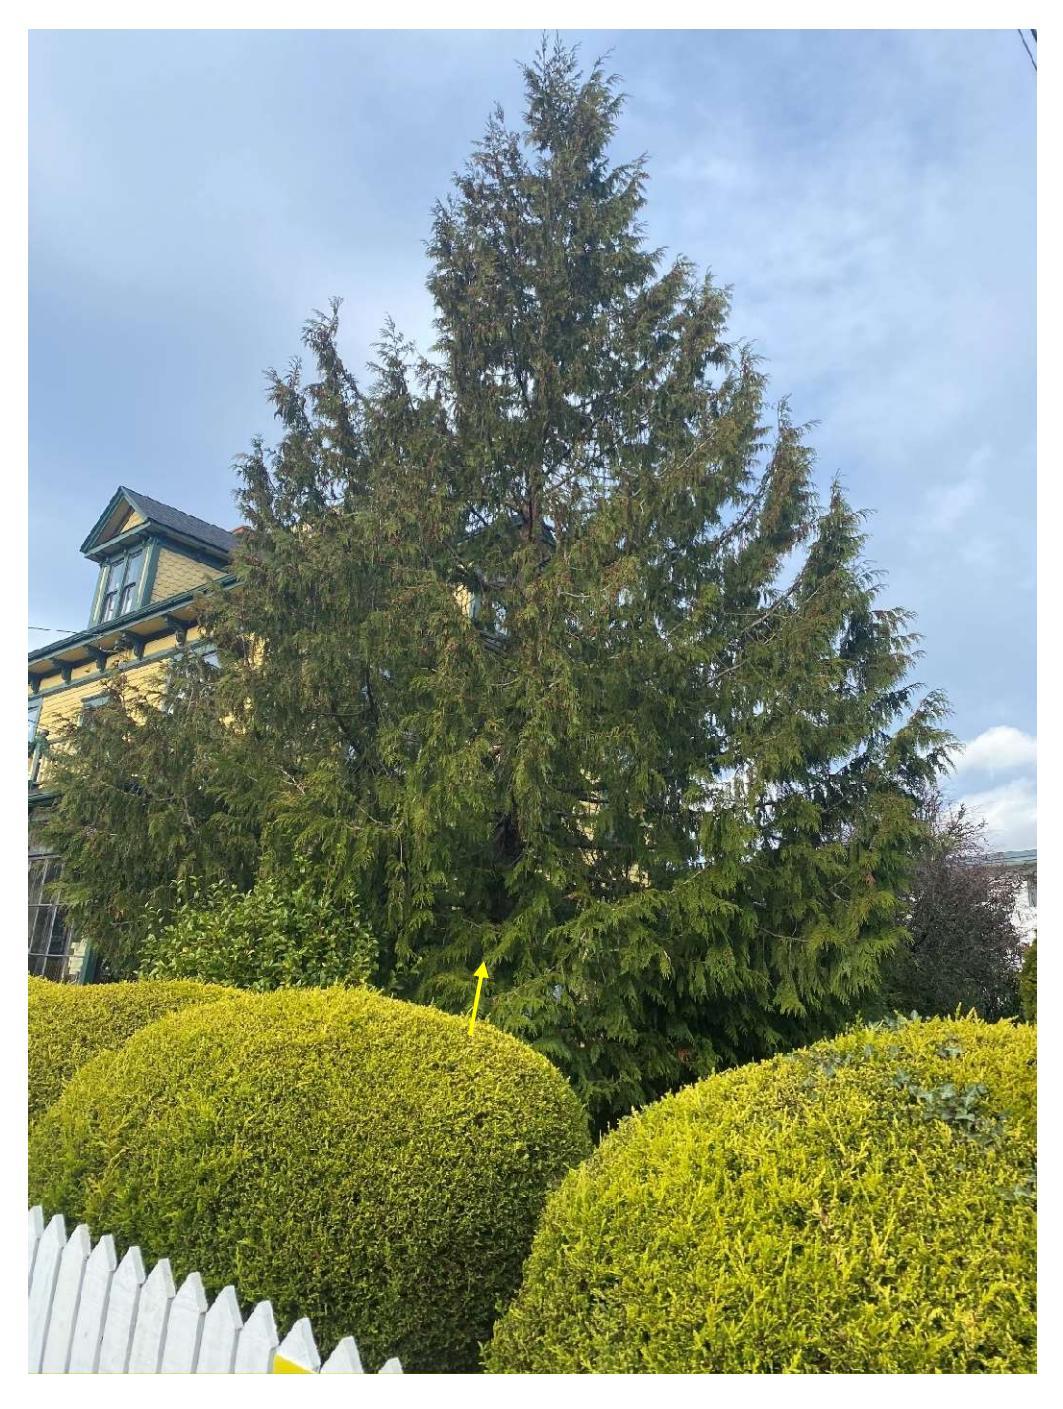
Photograph 2 – Yellow arrow indicates Western Redcedar (tag# 1974).

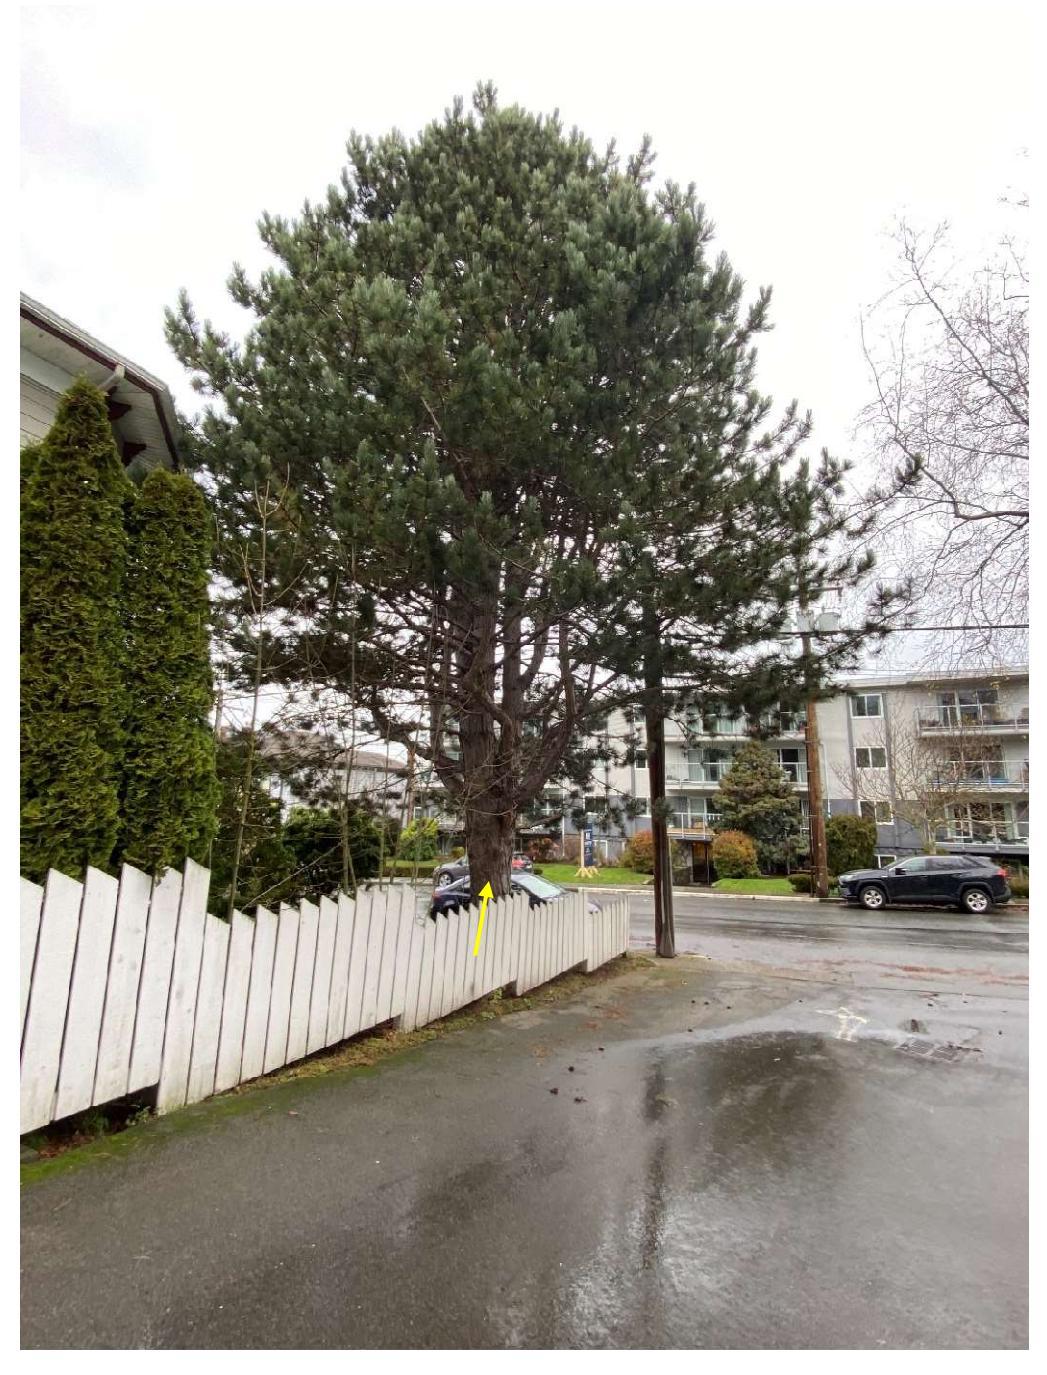
Photograph 3 – Yellow arrow indicates offsite pine (OS 3).

- All excavation required within the critical root zones of OS3 for the footprint of the proposed u/g parkade and entrance/exit ramp.
- All excavation required within the critical root zone of OS3 for the proposed relocation of the utility pole (*it is understood that the final utility pole location will be provided at detailed design stage).

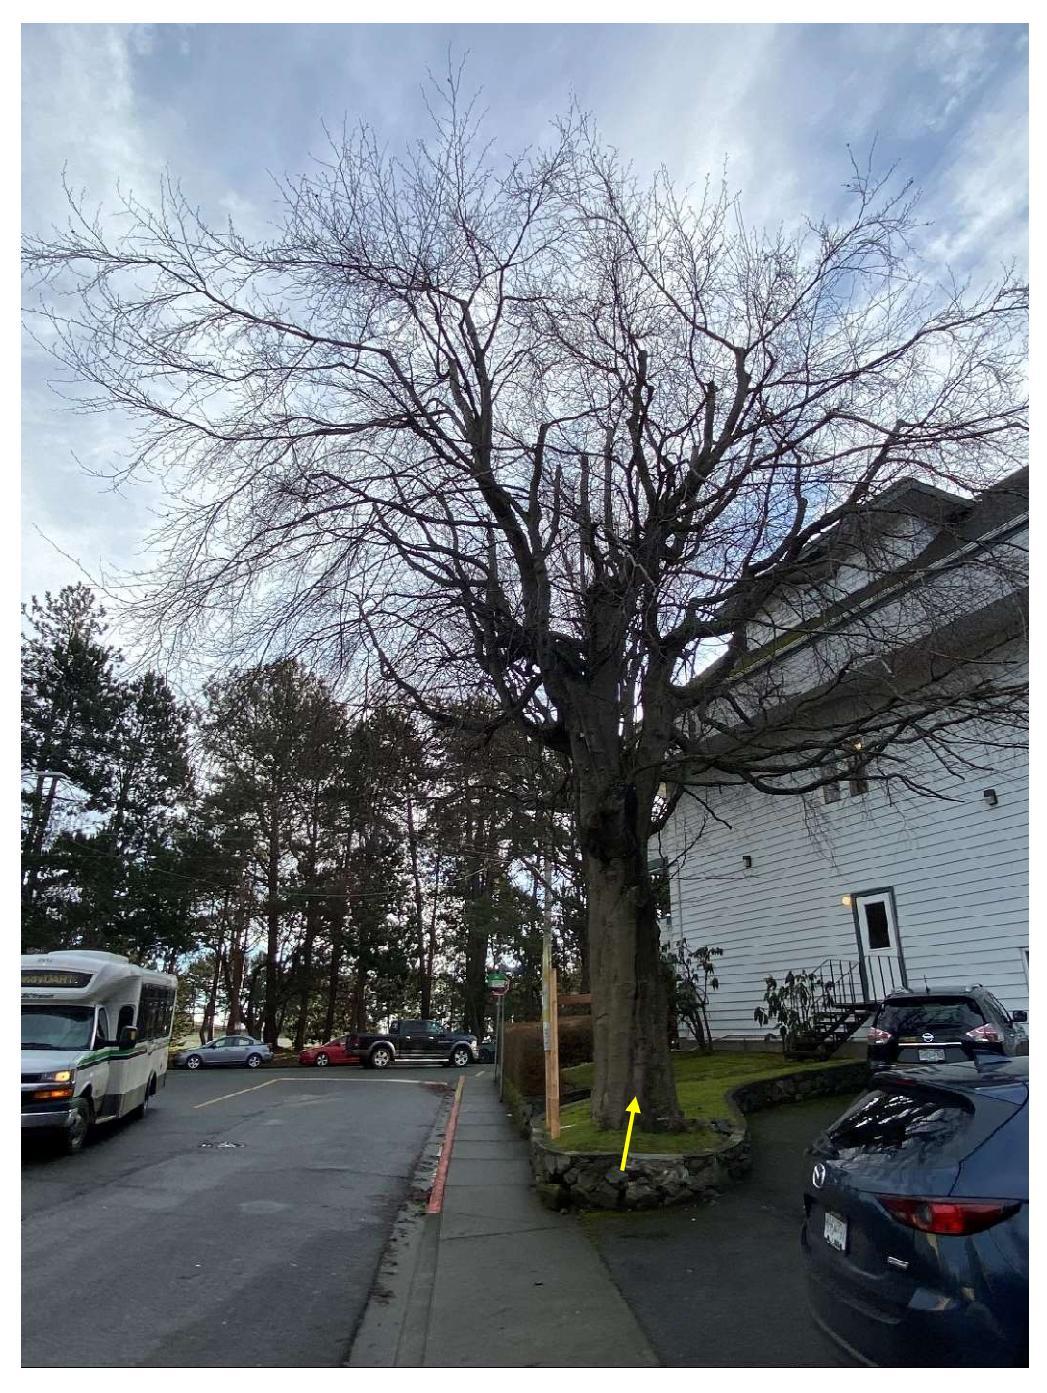
Photograph 4 – Yellow arrow indicates beech (tag# 1984).

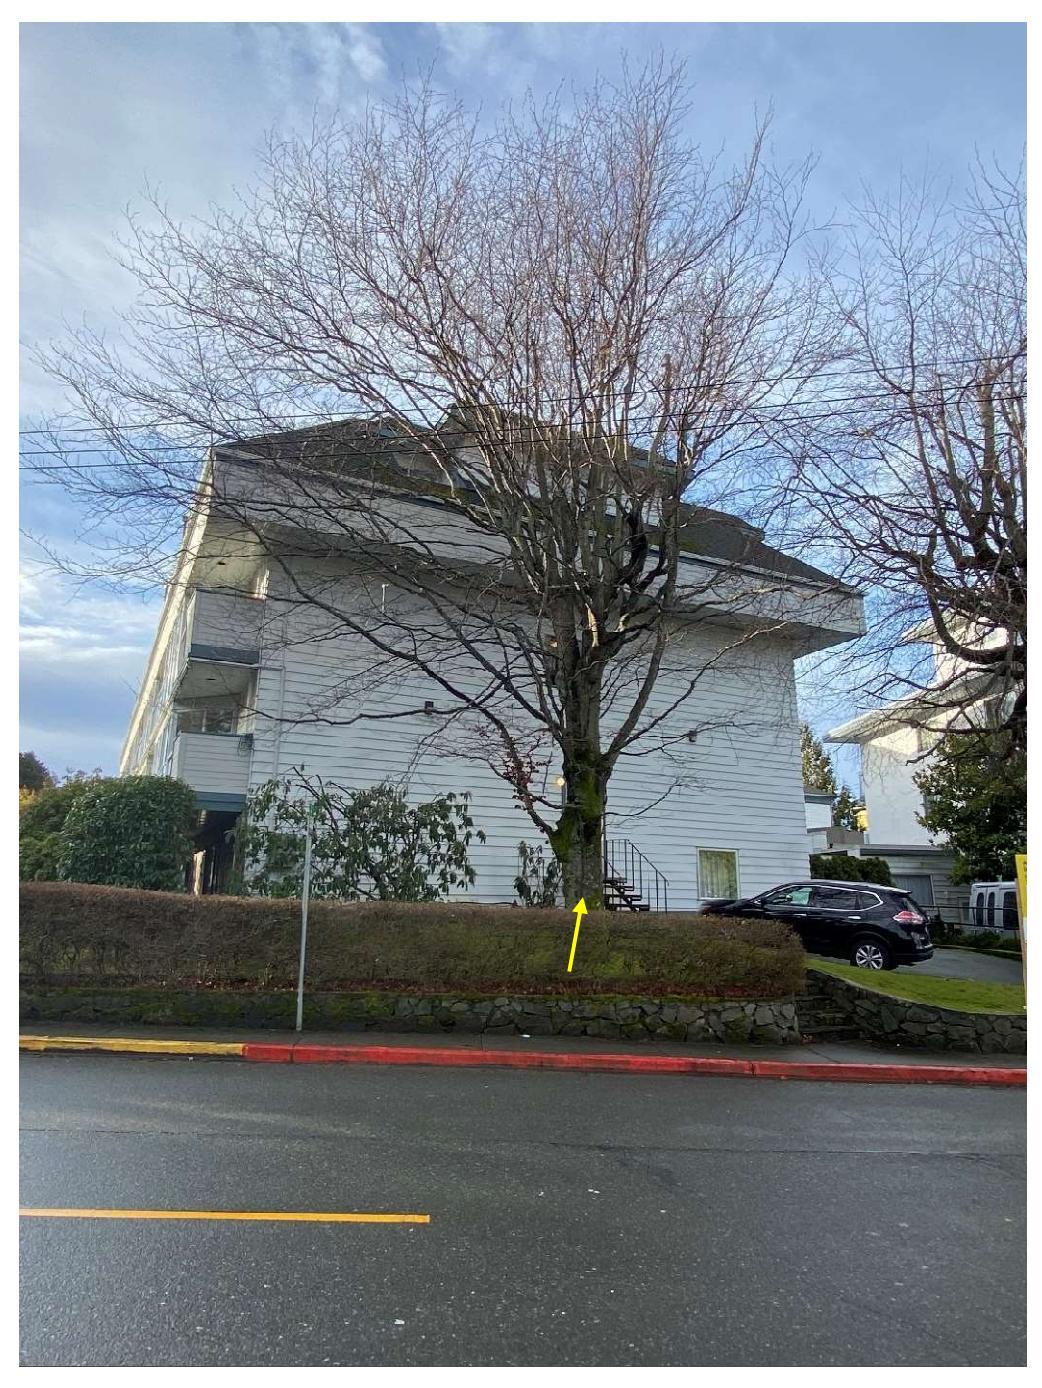
Photograph 5 – Yellow arrow indicates beech (tag# 1985).

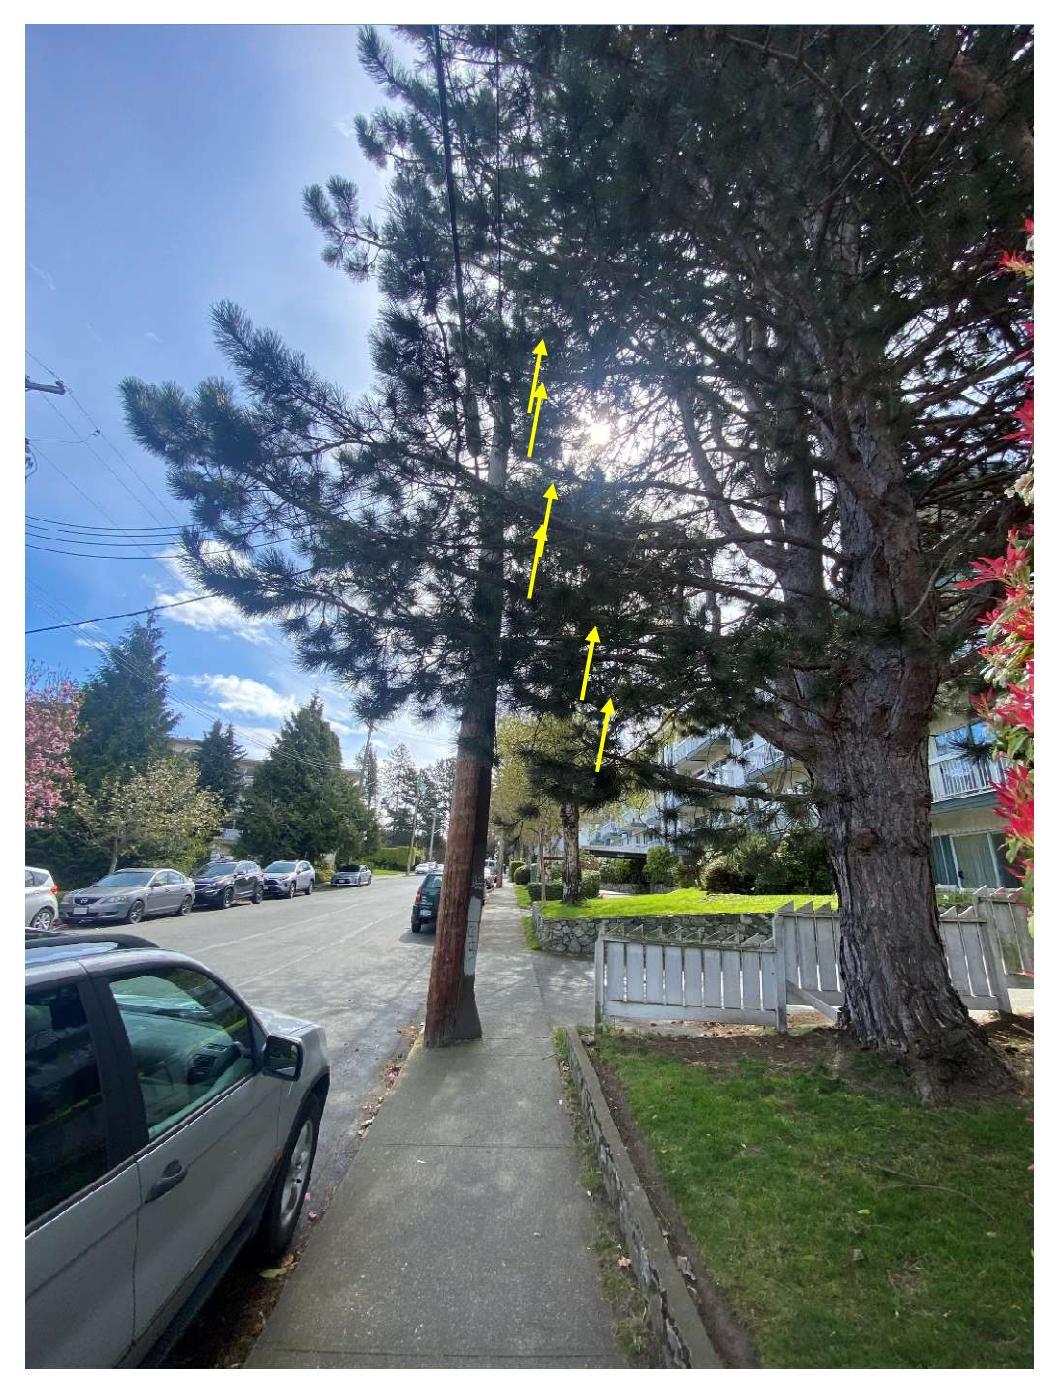
Pruning: Based on review of the civil plan provided, it is understood that the utility pole at the Northwest corner of the site will require relocation (Westward – and outside of the proposed driveway letdown). It is anticipated that branches of the following ~ sizes will require pruning back to the branch collar:

- 1 x ~ 12cm diameter
- 1 x ~ 10cm diameter
- 3 x ~ 8cm diameter
- 5 x ~ 5cm diameter

Photograph 6 – Yellow arrows indicate the branches from OS3 that we anticipate will require pruning for clearance from the new utility pole and utility line locations.

*See photograph 6 in *appendix C* for the limbs that are anticipated to be in conflict with the utility pole relocation and will require pruning. All crown pruning must be performed to ANSI A300 standards. One the exact new pole location is know (at detailed design stage), we can provide final pruning recommendations for OS3).
