Capital Tree Service Inc.

Arborist Report

515 and 519 Rithet Street

May 17, 2024

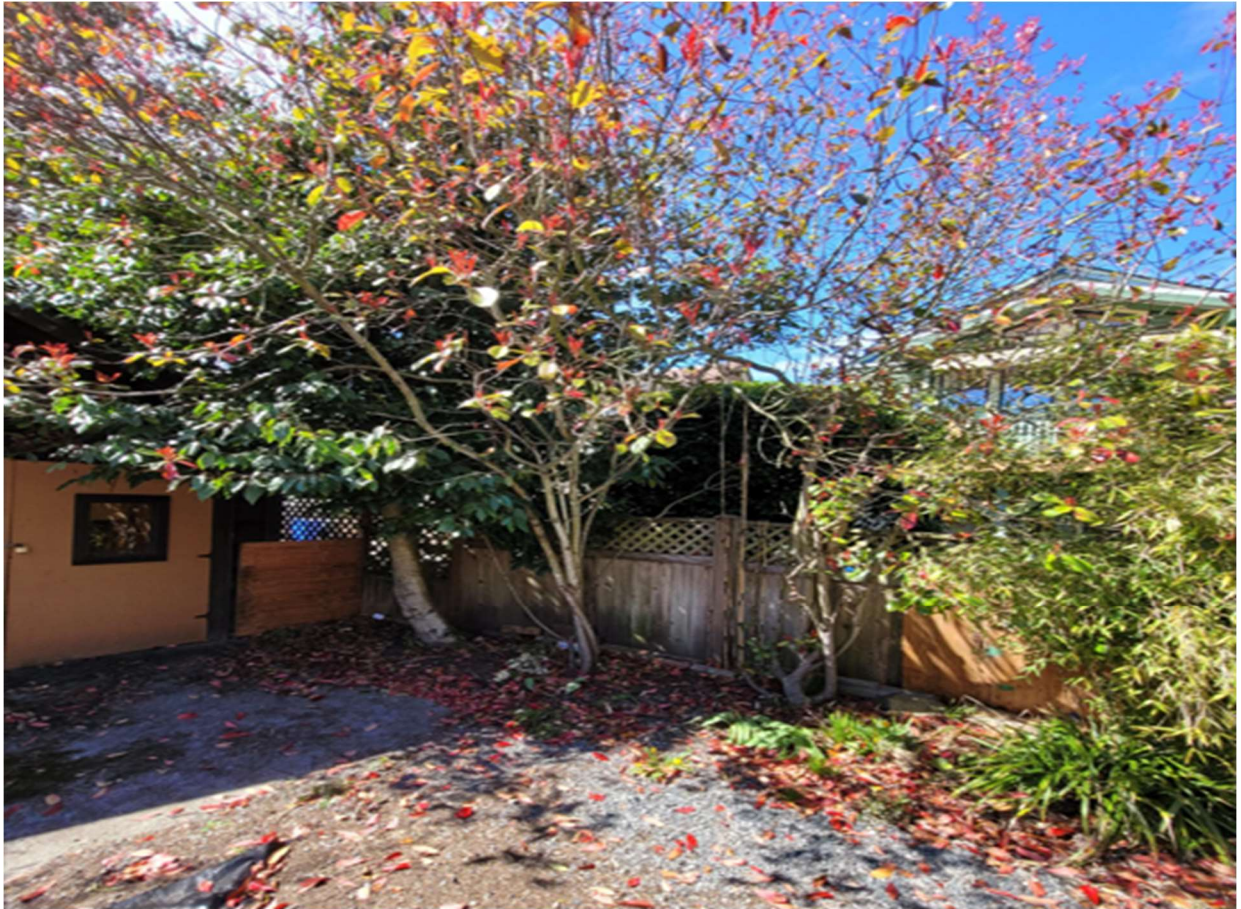
Figure 5 Site Photo. 515 Rithet St. back yard SE view. Showing N.T 7 private Laurel.

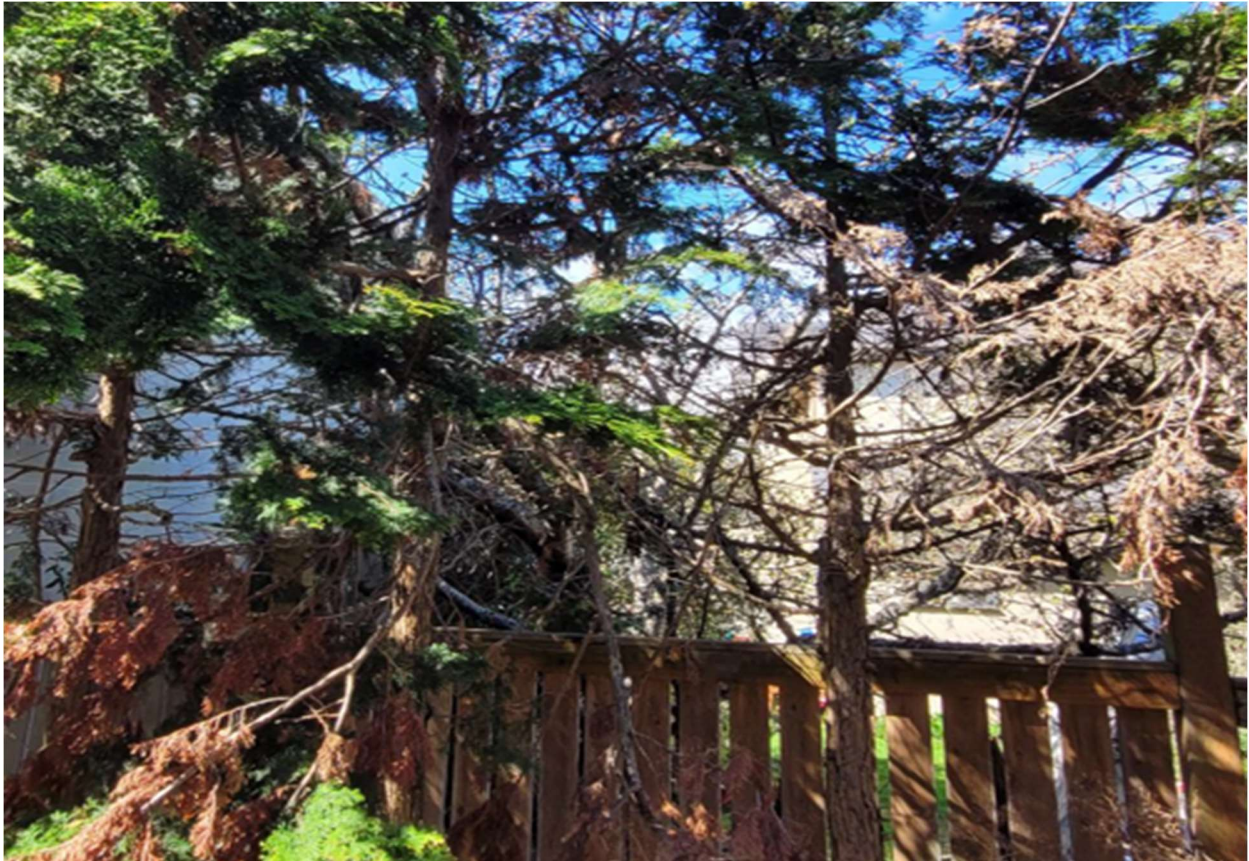
Figure 8 Site Photo. 515 Rithet St. E view. Showing N.T 6 private Cherry behind the hedgerow.

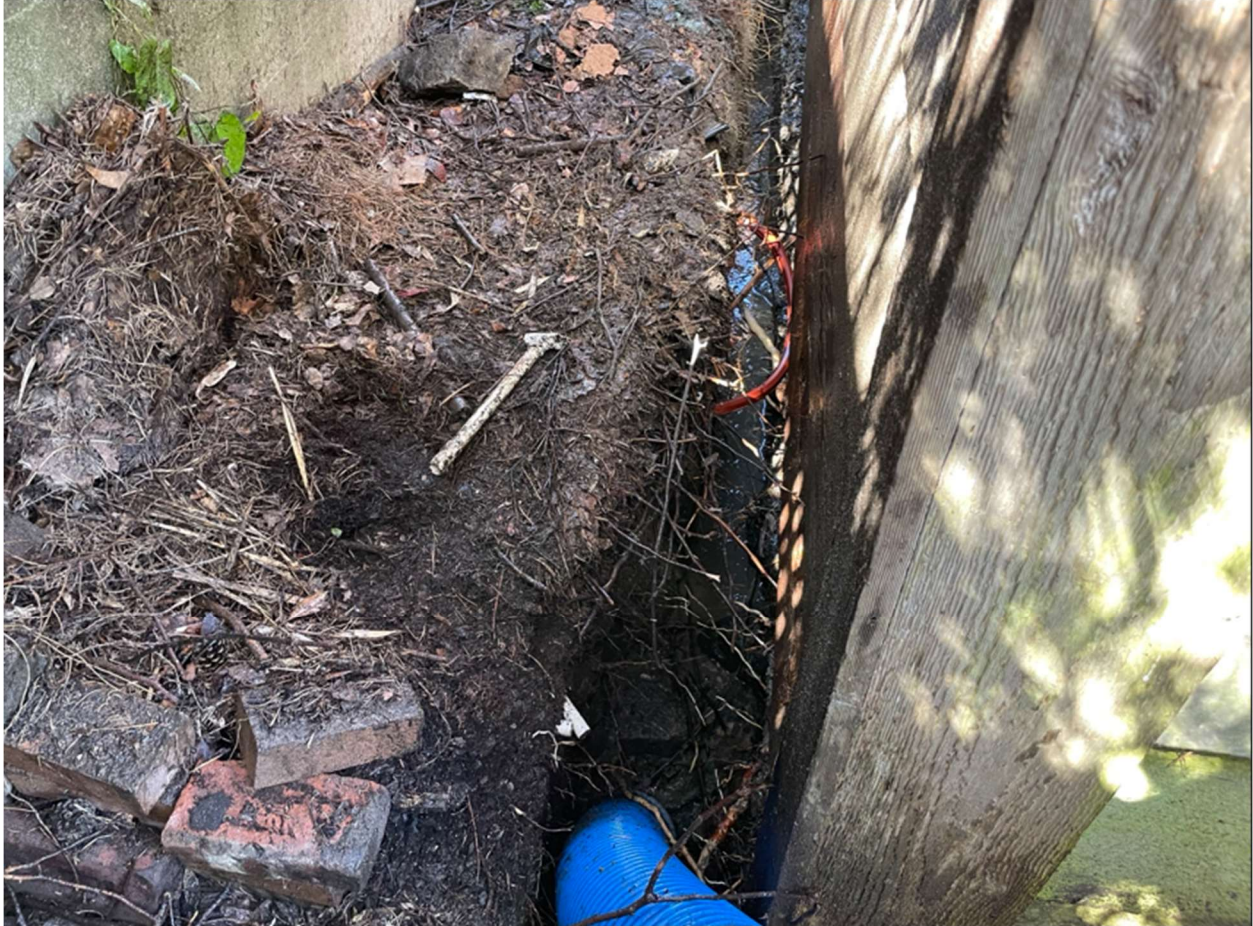
Exploratory excavation was conducted May 1st, 2024 with the use of a Daylighting vehicle to determine the extent of root systems of trees OS1 – OS6. No significant roots were encountered during the excavation. Excavation depth was to clay or ~0.9m.

Figure 1 Excavation within PRZ of OS1 & OS2.

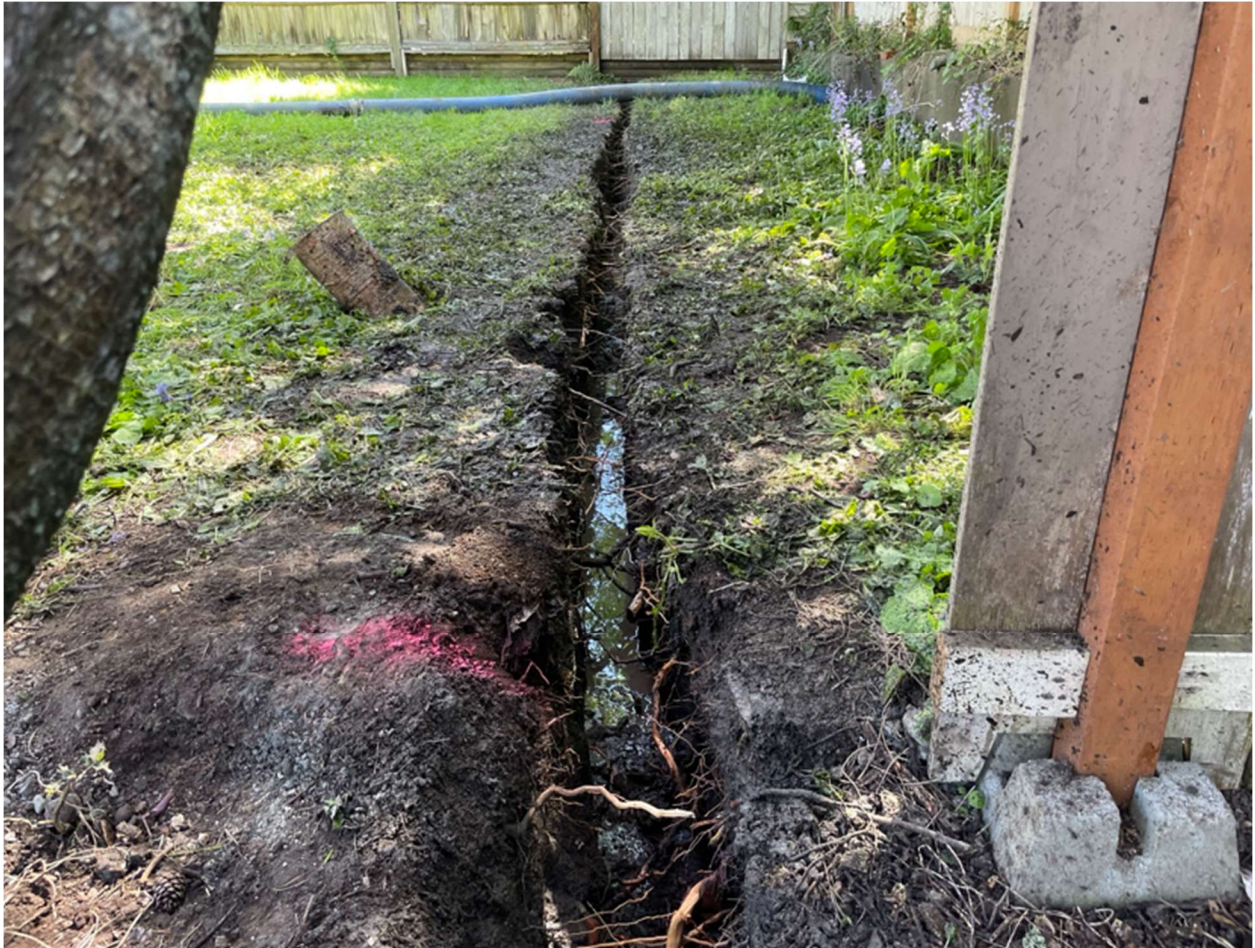
Figure 2 Excavation within PRZ of Trees OS3 – OS5

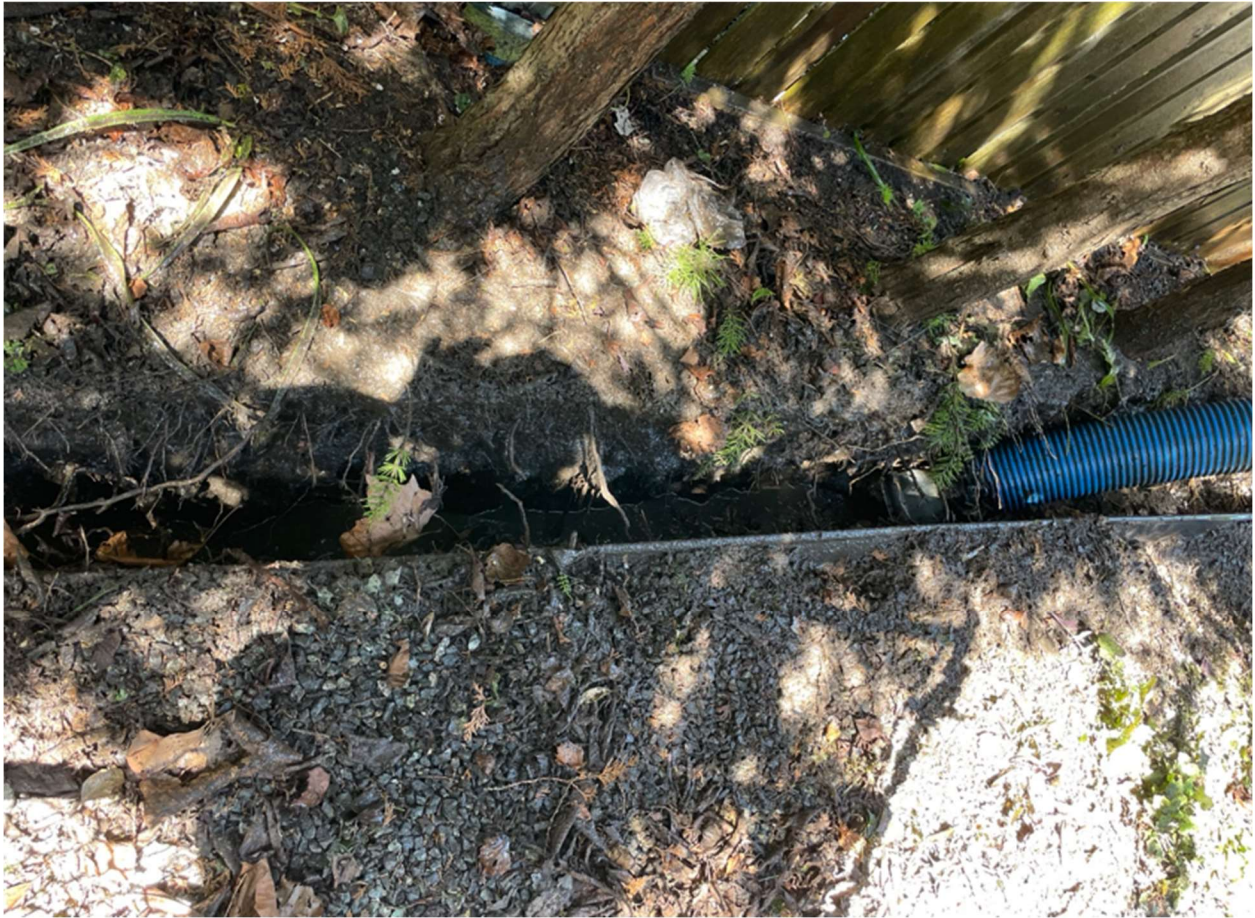
Figure 3 – Excavation within PRZ of Tree OS6
