## **953 Balmoral Rd, Victoria**

### **Construction Impact Assessment & Tree Preservation Plan**

Jobsite Property: 953 Balmoral Rd, Victoria

Date of Site Visit: January 19, 2018

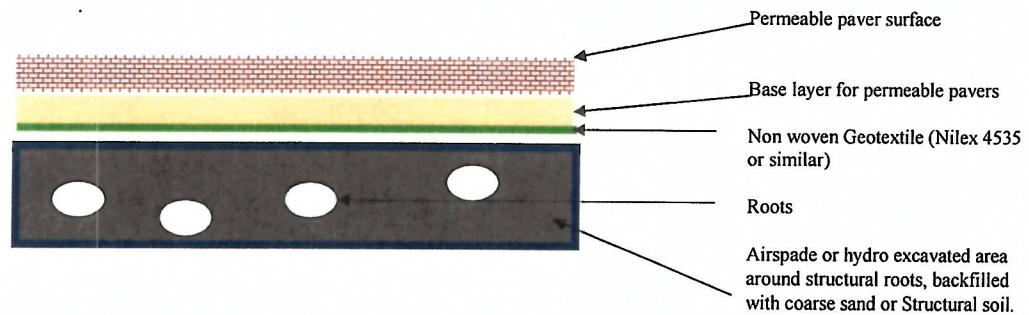
**Diagram –Permeable paver driveway crossing over Critical Root Zone**

- **Parking Stalls:** We estimate the nearest parking stall will be located approximately 3m from the base of the Horse chestnut tree. In order to preserve the tree's critical roots, a portion of the parking area will have to be elevated. Where the parking stalls overlap with the tree's CRZ, we recommend constructing a floating parking area. If the parking area is not elevated, several large structural roots are likely to be damaged resulting in a significant decline in the tree's health. The "floating parking area" specifications are attached. The objective is to avoid any excavation resulting in root loss and to instead raise the base layer of the paved surface above the roots to be preserved. This may result in the grade of the parking stalls being 15-30cm above the existing grade (depending on how close roots are to the surface of the existing grade). It may also mean that some of the A horizon soil layer (rich in organic material and roots) will be left intact below the driveway.

1. Excavate to a 6-8 inch depth, for the required permeable driveway surface, under the supervision of an ISA Certified Arborist.
2. Excavation for area around structural roots with an Airspade or by Hydro Excavation to bearing layer of soil if required.
3. Backfill area around roots with coarse sand or a structural soil mix
4. A layer of medium weight non woven Geotextile (Nilex 4535 or similar) is to be installed over the backfilled area of the driveway.
5. Construct base layer and permeable surface over Geotextile layer to required grade.
