**Talbot Mackenzie & Associates**

## **TREE PRESERVATION PLAN**

Jobsite Property: 1245 Vista Heights

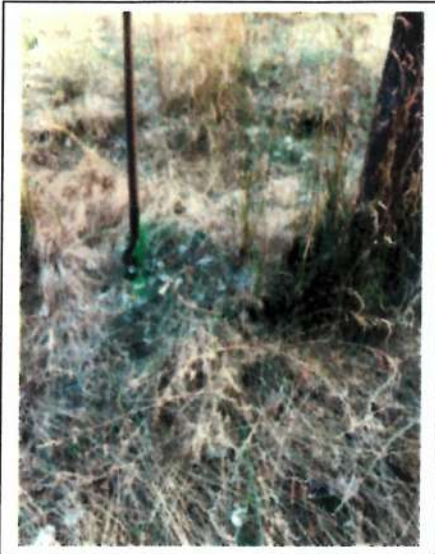
- The pool area and underground cisterns are to be installed on the west side of the tree location. The minimum distance required for excavation for these features was marked at 5.0 metres west of the existing concrete wall and 1.2 metres west of the oak tree.

Cistern location - west side

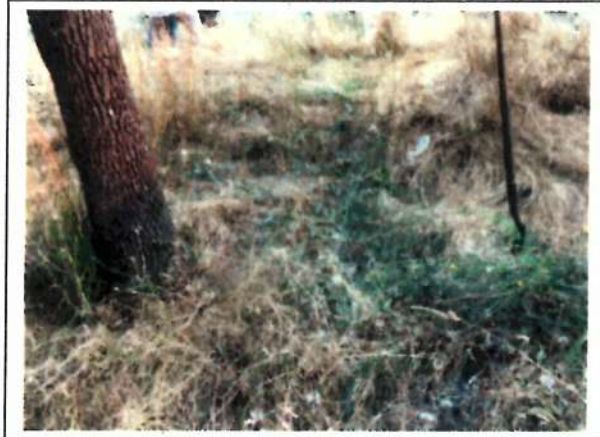
- The retaining wall will be constructed along the eastern property boundary and inside the existing cement wall. The minimum distance required for excavation of the wall footprint was marked at 2.5 metres west of the existing concrete wall and 1.3 metres east of the oak tree.

Wall footprint location - east side

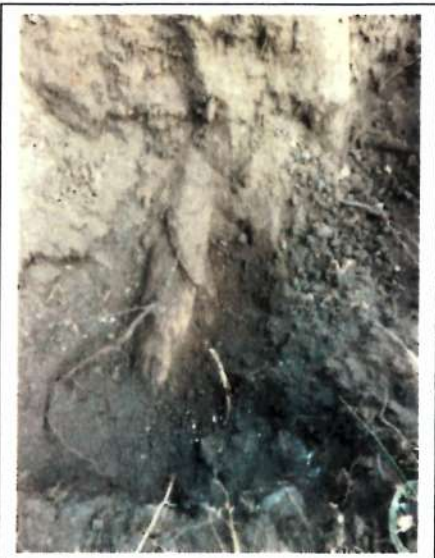
- One 10 cm diameter root and two 2 cm diameter roots on the east side of the root collar.
- One 5 cm diameter root on the south side of the root collar.
- One 8 cm diameter root on the west side of the root collar.

Exposed root - west side

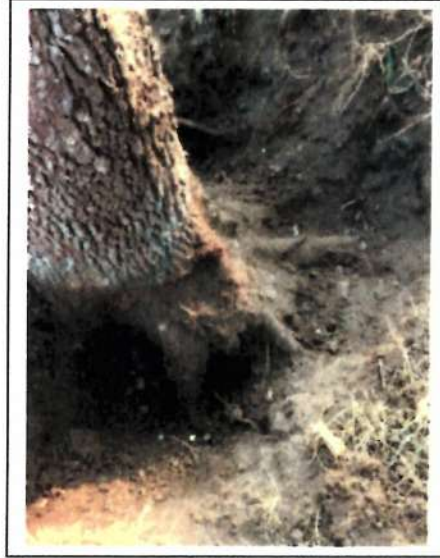
Exposed roots - south and east side
