Talbot Mackenzie & Associates

Re: Arborist report for 1358 and 1360 Thurlow Road

**TREE RESOURCE
for 1358 and 1360 Thurlow Road**

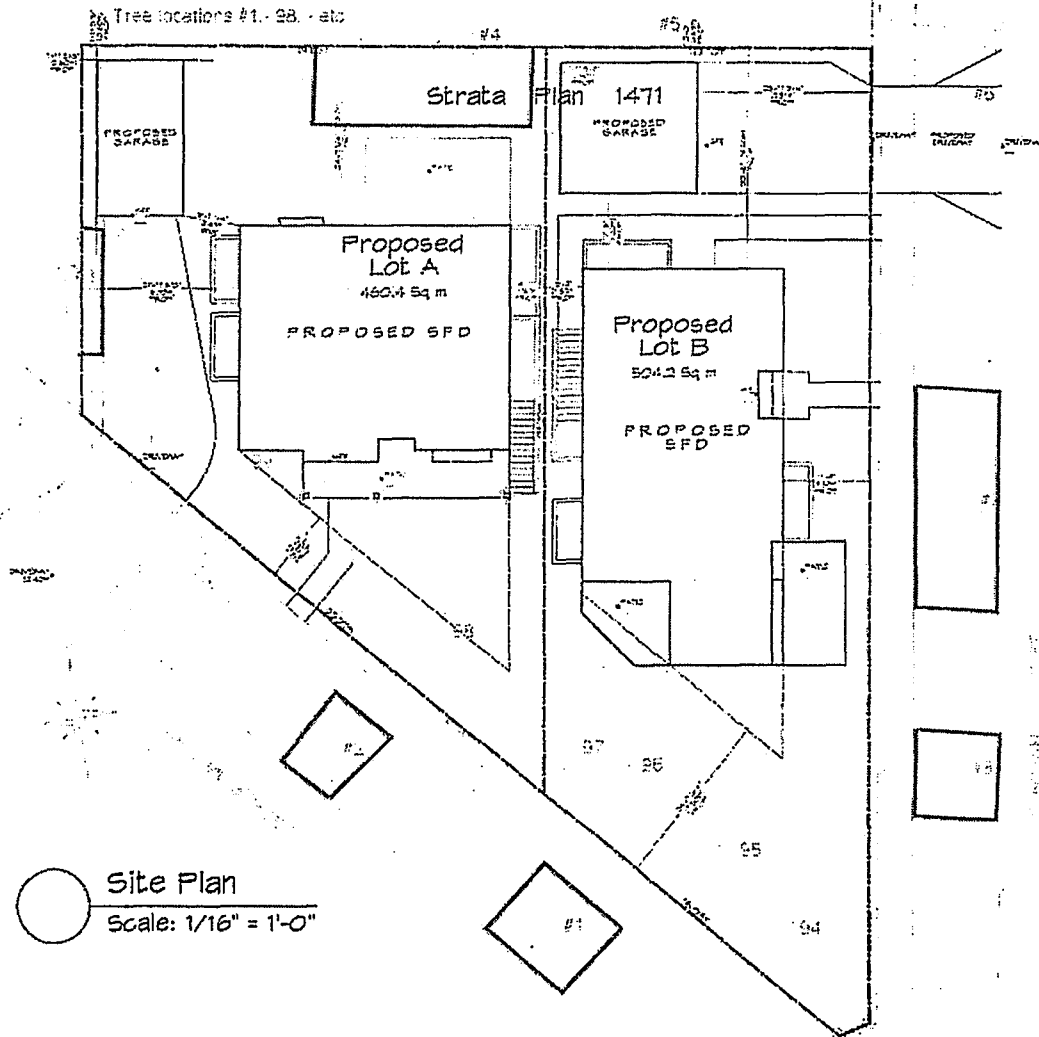
Site Plan
Scale: 1/16" = 1'-0"

Approximate locations for
barrier fencing

Tree locations #1 - 28 - etc

- To protect Western Red cedar #4, the fencing must be erected on the property side of the trunk 5.5 metres from the property boundary and extend 7 metres out on each side of the tree or up to the garage footprint and extend up to the property boundary.
- The municipal trees must be protected by erecting barrier fencing that runs along the street and sidewalk edge on each side of the tree and extends out to the edge of the canopy spread on each side of the tree.

These fencing locations are indicated on the attached plans.
